## CONDITION REPORT

Report No:  
2016957259  
DATE  
24/07/2025

Vehicle Type	PASSENGER VEHICLE	Registered Owner	
Manufacturer	VOLKSWAGEN	Registration Number	JD33LHGP
Model	CROSSPOLO 1.6 TDI COMFORTLINE 5-DR 77KW DSL [2009-2015]	Register Number	
VIN	AAVZZZ6RZCU046651	Date Of First Licensing	
Engine Number		Last COR	
Doors	5	License Expiry Date	31/08/2021
Color	SILVER	Power / Displacement	
Year Model	2012	Paint Finish	TWO COAT METALLIC
Km Reading	186,443 KM	Fuel	DIESEL
Cab / Body Type	HATCHBACK	Transmission	MANUAL

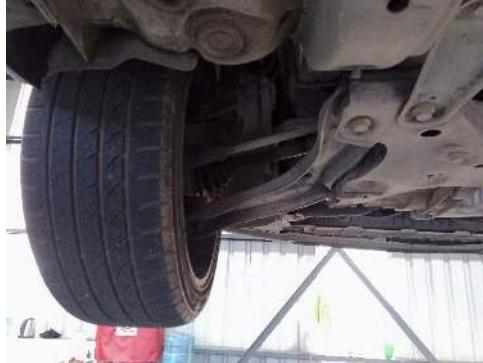
LF TYRE TREAD

Size	Load/Speed Index	Manufacture	Model	Type*	Production Date	Tread Depth (mm)
Front Left	215/40R17	87W	Rapid	Radial	V	0319	2 mm
Front Right	185/60R15	84H	Continental	Contipremiu	V	0412	2 mm
Rear Left	215/40R17	87V	Continental	Contipremiu	V	2818	0 mm
Rear Right	215/40R17	87W	Nexen	Radial	V	0119	2 mm

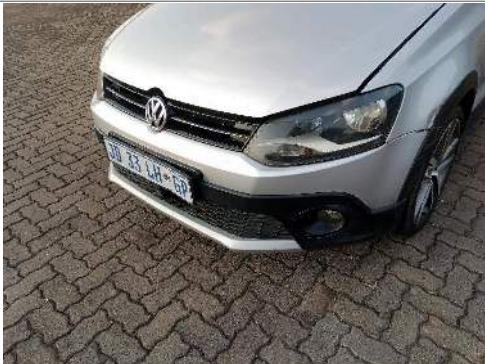
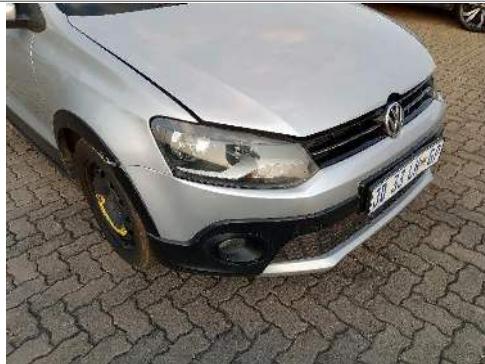
Damage	Repair Way
Engine Oil Leak	Repair
Seat Front Left Dirty	Repair
Seat Front Right Dirty	Repair
Seat Rear Dirty	Repair
Front Bumper Damaged	Repair
Bonnet Damaged	Repair
Front Fender Left Damaged	Repair
Front Fender Right Damaged	Repair
Rear Fender Left Damaged	Repair
Rear Fender Right Damaged	Repair
Door Front Left Damaged	Repair
Door Front Right Damaged	Repair
Door Rear Left Damaged	Repair
Door Rear Right Damaged	Repair
Rear bumper Damaged	Repair
Control Arm Bush(es) Front Axle Left Worn	Replace
Control Arm Bush(es) Front Axle Right Worn	Replace
Tyre Rear Left Worn	Replace
Engine Noise Excessive	Repair
Engine Smoke Excessive	Repair
