## CONDITION REPORT

2017271385

| Manufacturer | VOLKSWAGEN | Registration Number | CJ10NMGP |
| Model | POLO 1.6 TDI COMFORTLINE DSL 5-DR [2009-2015] | Register Number | |

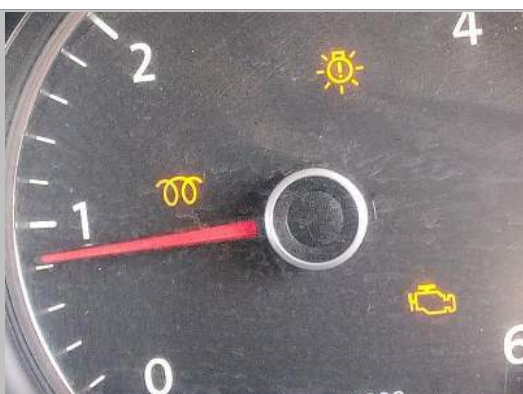
| Warning lights illuminated | Repair |

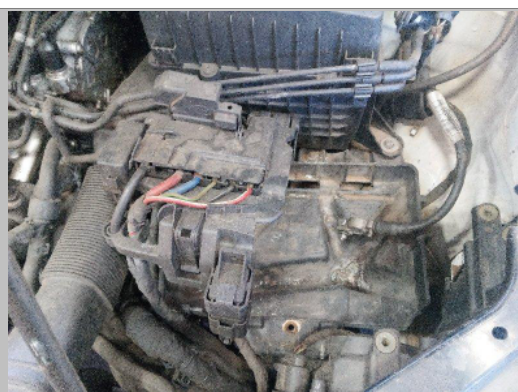
No battery

| Vehicle has no battery. | Replace |

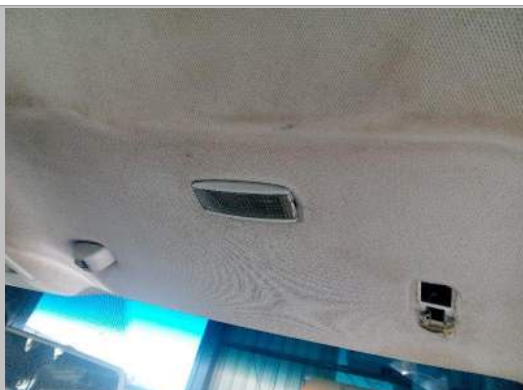
| Sun Visor Right Missing | Replace |

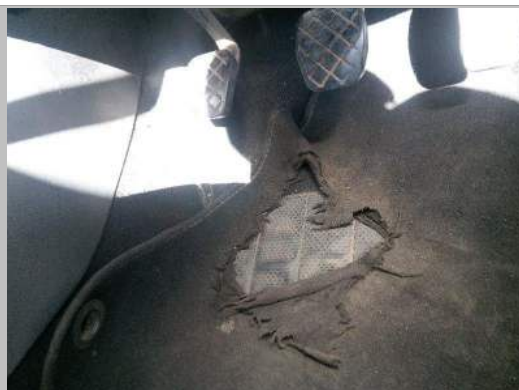
| Carpet Front Torn / Cut | Repair |

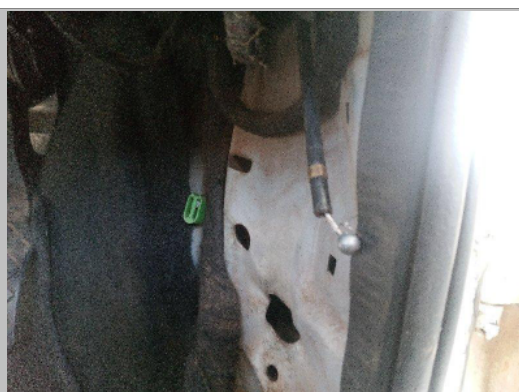
| Bonnet cable Damaged | Repair |

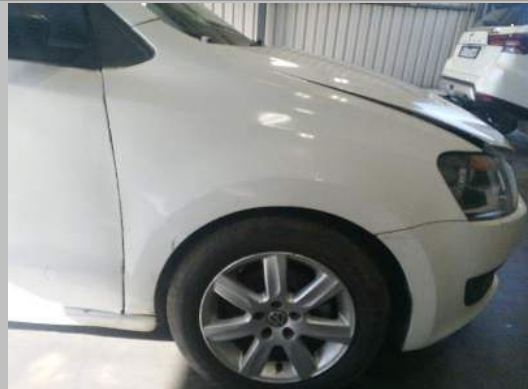
| Front Fender Right Residual Traces of Repair | Repair |

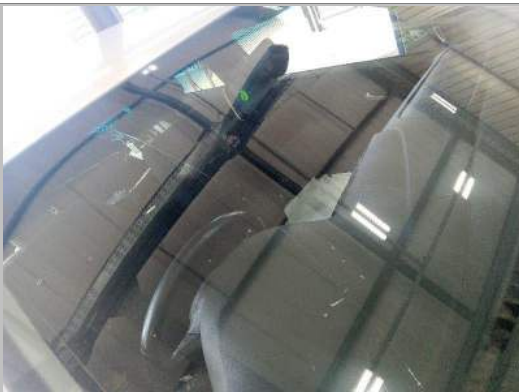
| Windscreen Cracked | Replace |

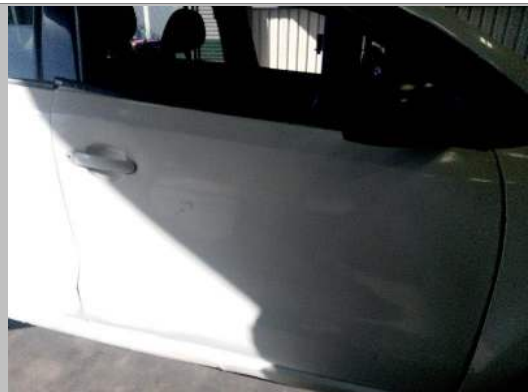
| Door Front Right Welded | Repair |

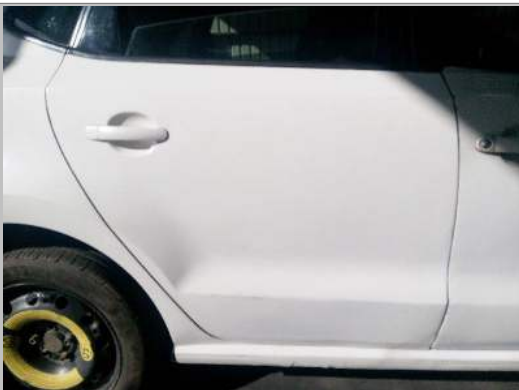
| Door Rear Right Residual Traces of Repair | Repair |

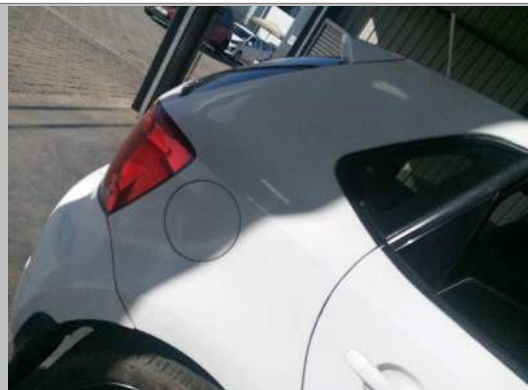
| Rear Fender Right Residual Traces of Repair | Repair |

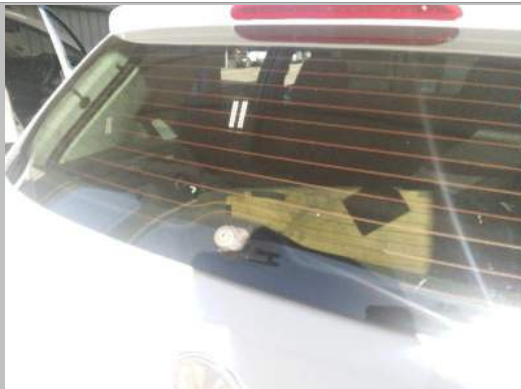
| Windscreen Wiper Missing | Replace |

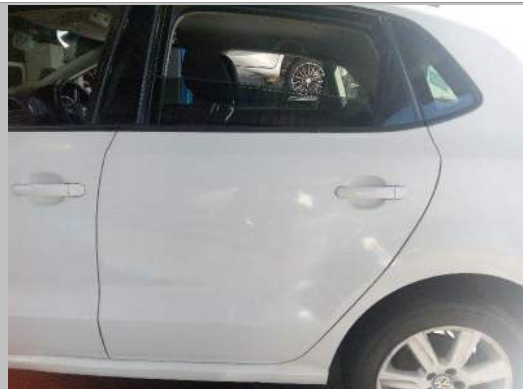
| Door Rear Left Residual Traces of Repair | Repair |

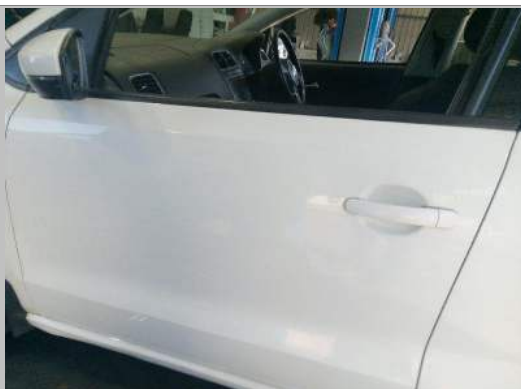
| Door Front Left Residual Traces of Repair | Repair |

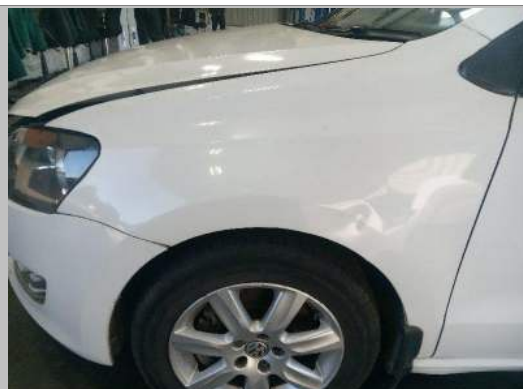
| Front Fender Left Residual Traces of Repair | Repair |

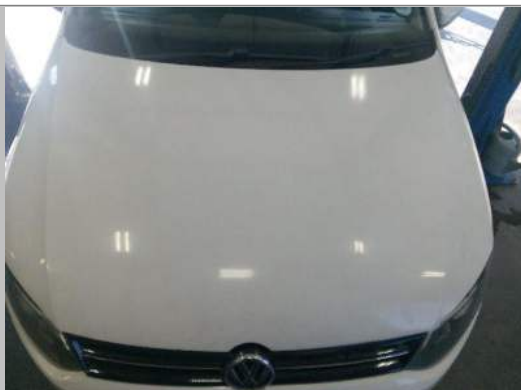
| Bonnet Residual Traces of Repair | Repair |

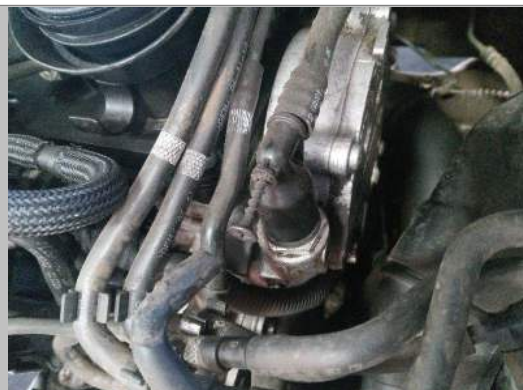
| Hoses Torn / Cut | Replace |

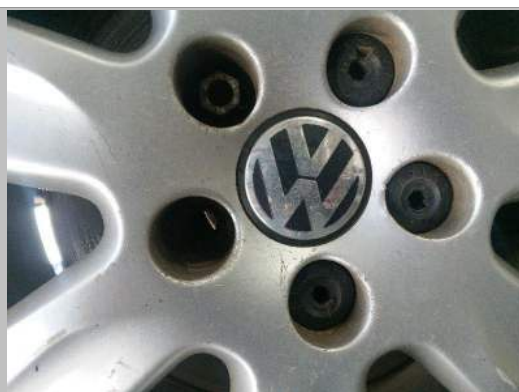
| Bolt(s) / Nut(s) Front Wheel Right Missing | Replace |

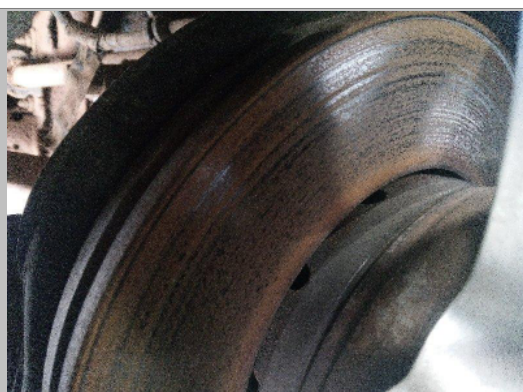
| Brake disc 1. Axle right Corrosion | Replace |

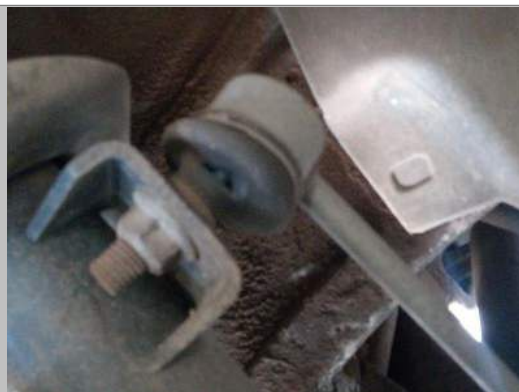
| Stabilizer Mounting Front Right Damaged | Replace |

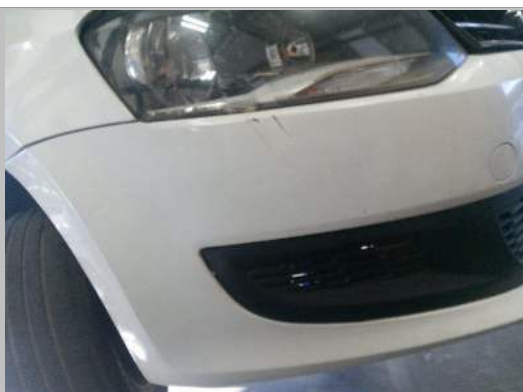
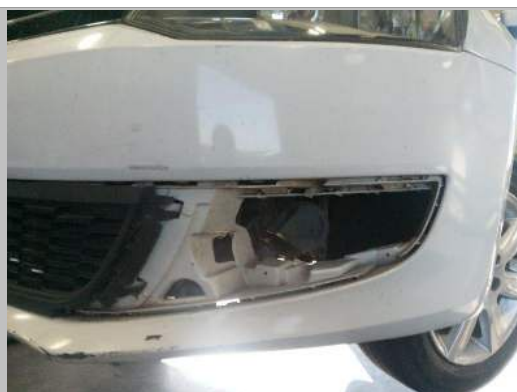
| Front Bumper Paintwork • Scratched | Repair |

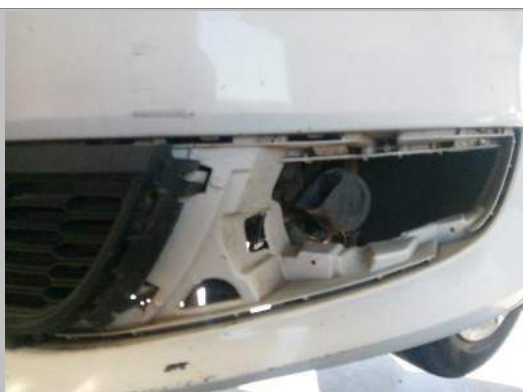
| Grill Damaged | Replace |

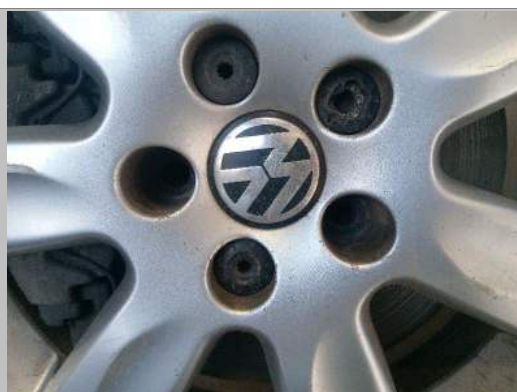
| Bolt(s) / Nut(s) Front Wheel Left Missing | Replace |

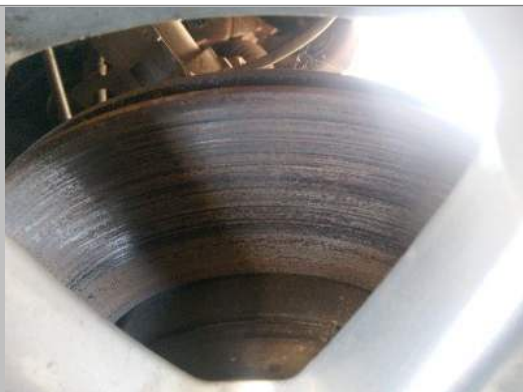
| Brake disc 1. Axle left Corrosion | Replace |

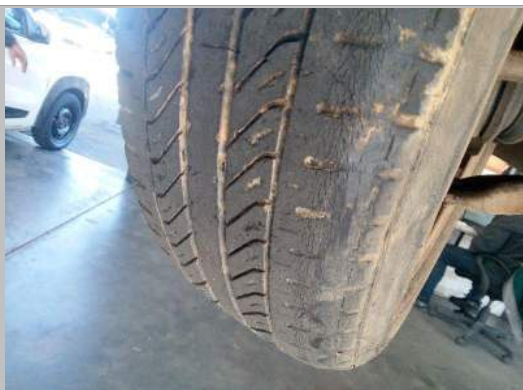
| Tyre Front Left Smooth | Replace |

| | Size | Load/Speed Index | Manufacture | Model | Type* | Production Date | Tread Depth (mm) |
|---|---|---|---|---|---|---|---|
| Front Left | 185/65R15 | 92H | Dunlop | Sport | V | 4419 | 0 mm |

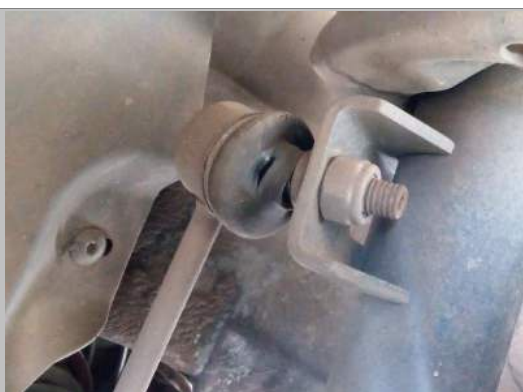
| Stabilizer Mounting Front Left Damaged | Replace |

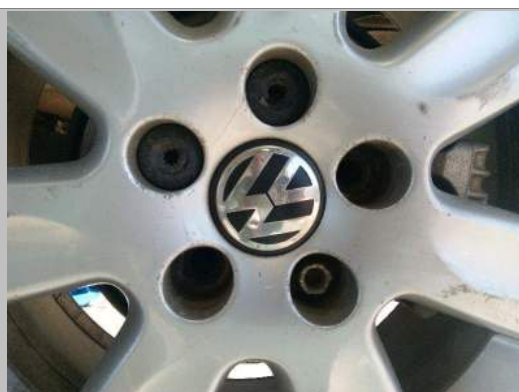
| Bolt(s) / Nut(s) Rear Wheel Left Missing | Replace |

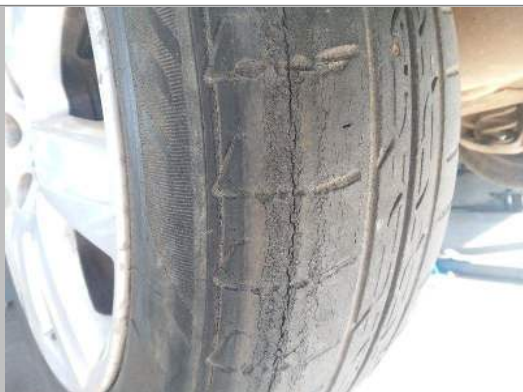
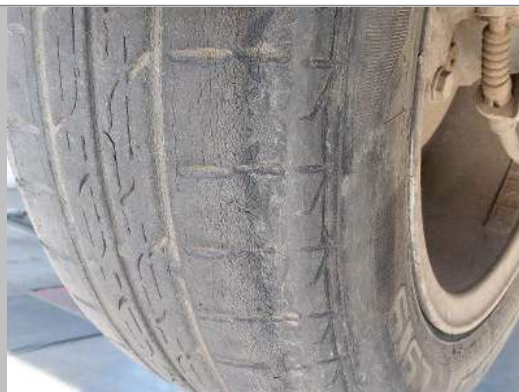
| Tyre Rear Left Smooth | Replace |

| | Size | Load/Speed Index | Manufacture | Model | Type* | Production Date | Tread Depth (mm) |
|---|---|---|---|---|---|---|---|
| Rear Left | 185/60R15 | 88H | Durun | L919 | V | 3118 | 0 mm |

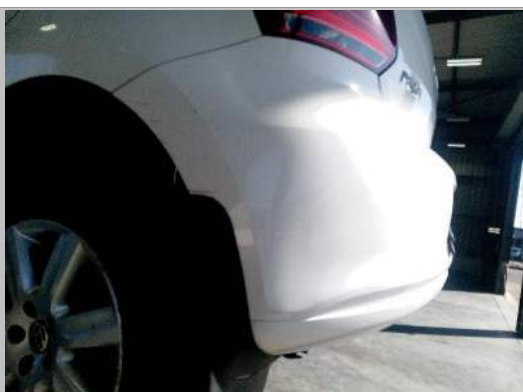
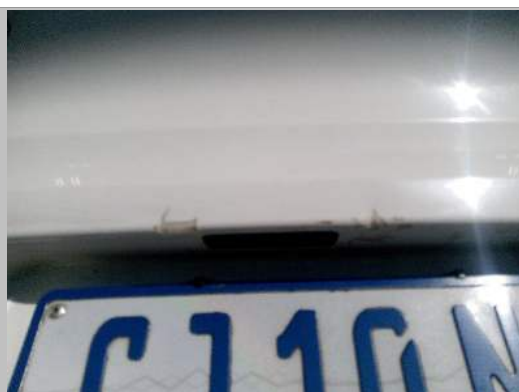
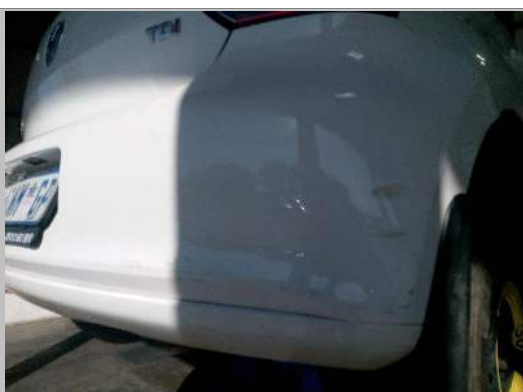
| Rear bumper Paintwork • Scratched | Repair |

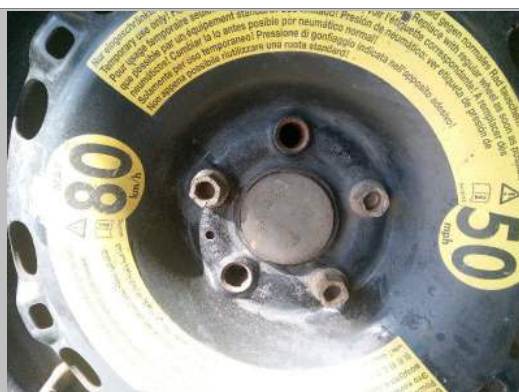
| Bolt(s) / Nut(s) Rear Wheel Right Missing | Replace |

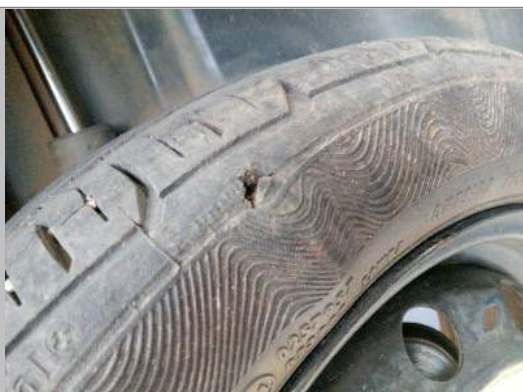
| Tyre Rear Right Torn / Cut | Replace |

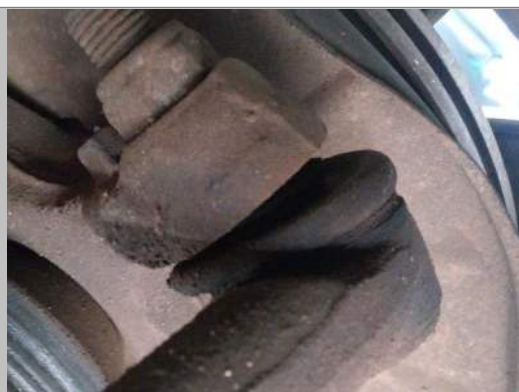
| Tie Rod End right Damaged | Replace |

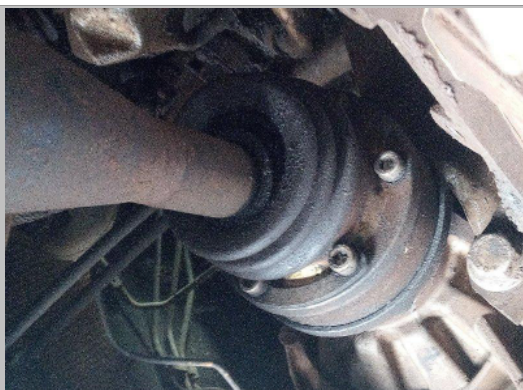
| CV Joint(s) Boot(s) Front Right (inner/outer) Damaged | Replace |

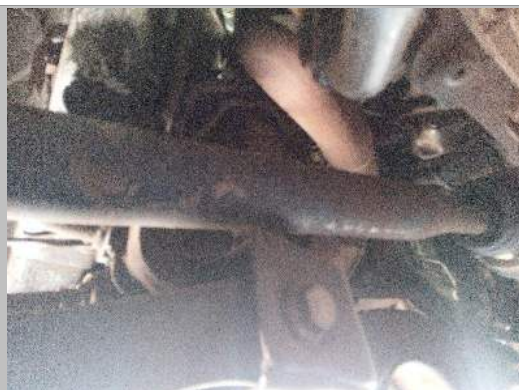
| Drive Shaft Front Right Defective | Replace |

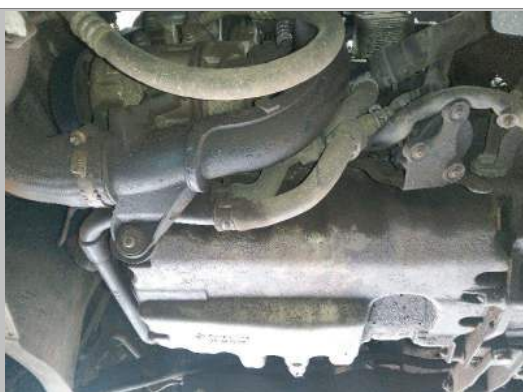
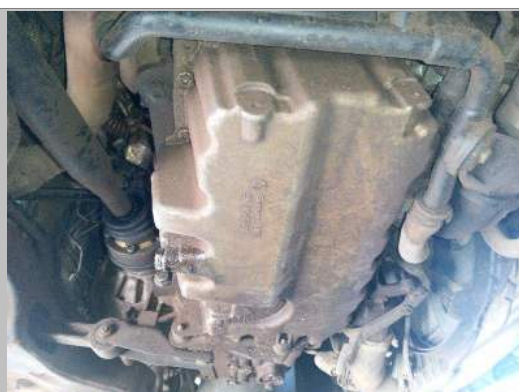
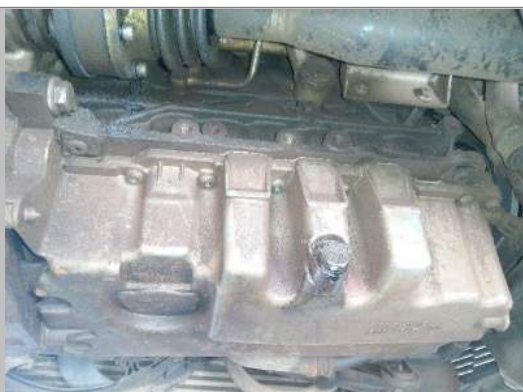
| Engine Oil Sweat | Repair |
| Engine Performance Insufficient | Repair |
| Engine Noise Excessive | Repair |
| Engine Smoke Excessive | Repair |

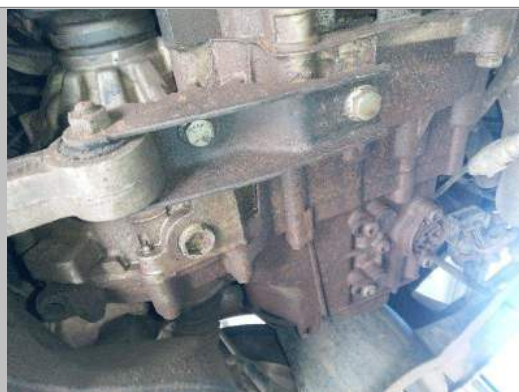
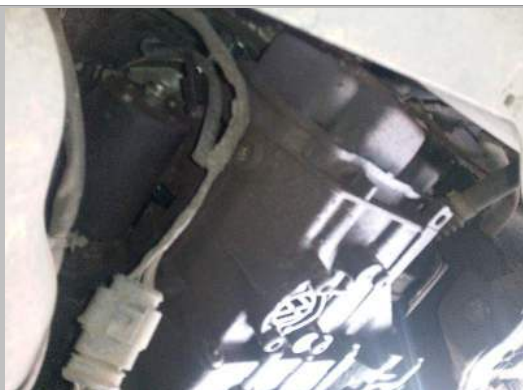
| Gearbox Oil Sweat | Repair |

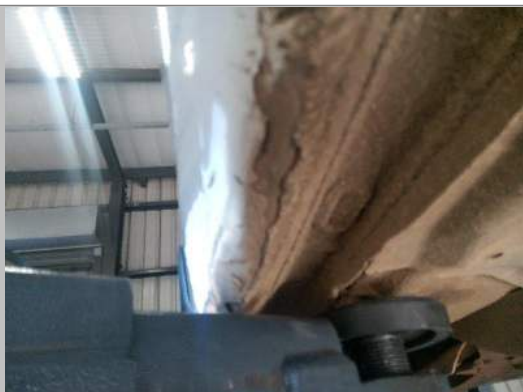
| Sill Panel Left Residual Traces of Repair | Repair |

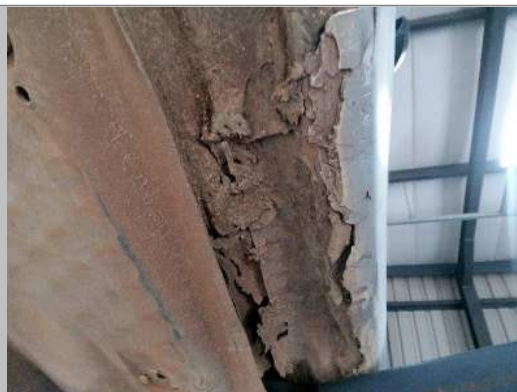
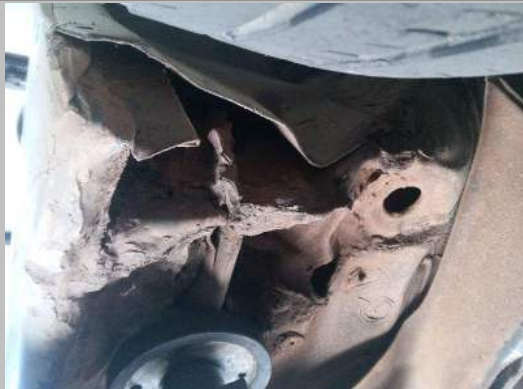
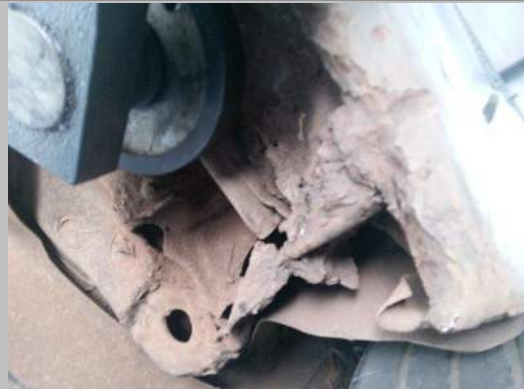
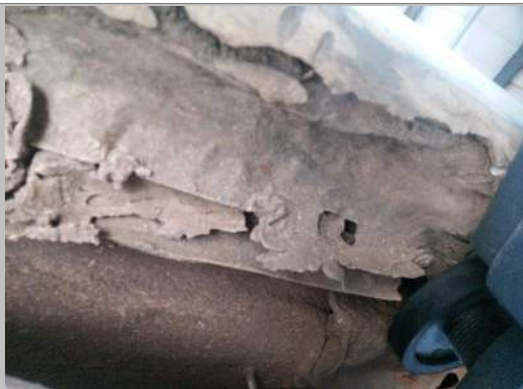
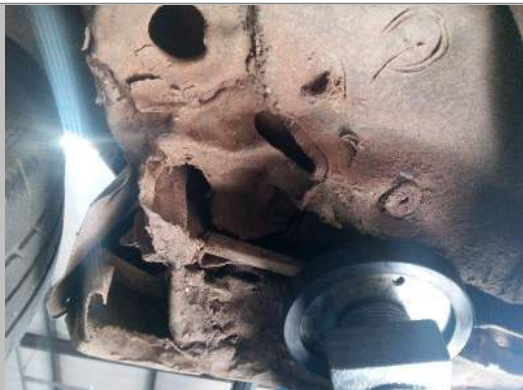
| Sill Panel Right Damaged | Repair |

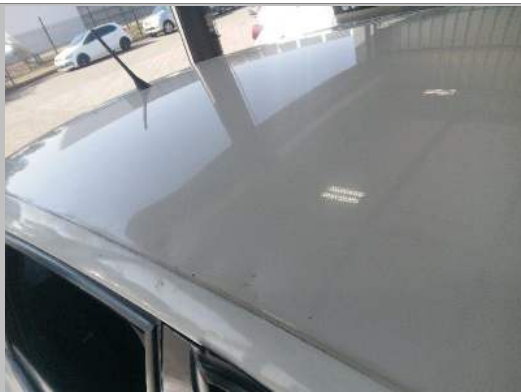
| Roof Dented | Repair |
