MFC Auction House  
M57 Pretoria Rd, Glenmarais, KEMPTON PARK  
Gauteng

DEKRA MFC  
M57 Pretoria Rd - 1619  
KEMPTON PARK - GT  
08610 33572

## Assignment

| Manufacturer | VOLKSWAGEN | Registration Number | KTH593NW |

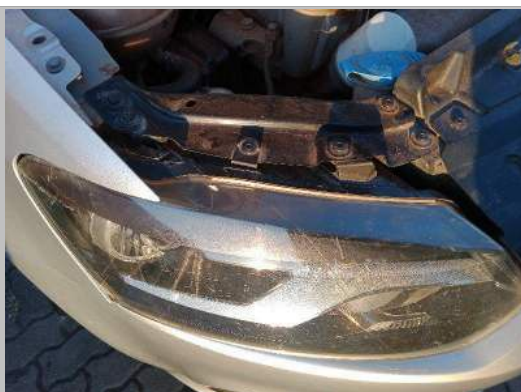
| Damage | Repair Way |
|---|---|
| Headlight Right Damaged | Repair |

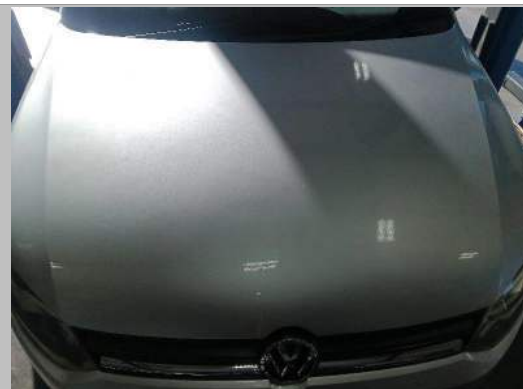
| Damage | Repair Way |
|---|---|
| Bonnet Residual Traces of Repair | Repair |

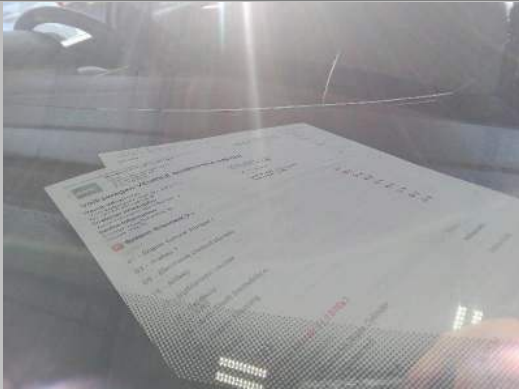
| Damage | Repair Way |
|---|---|
| Windscreen Cracked | Replace |

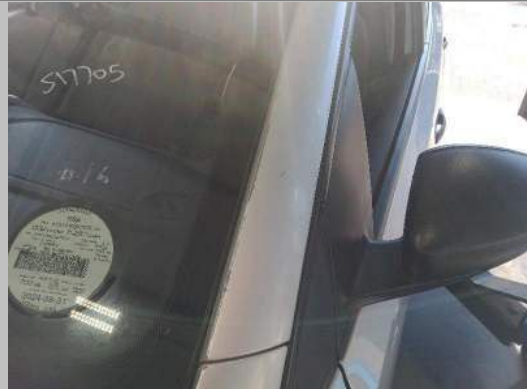
| Damage | Repair Way |
|---|---|
| A • Pillar Left Paintwork • Scratched | Repair |

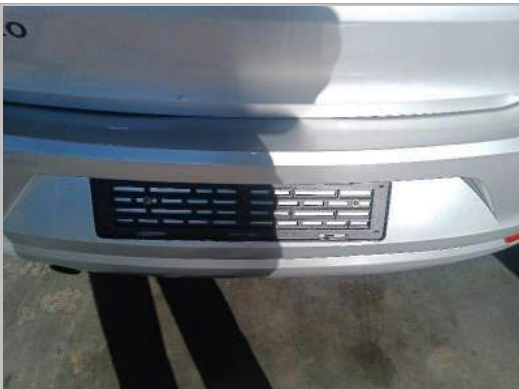
| Damage | Repair Way |
|---|---|
| Number Plate Rear Missing | Replace |

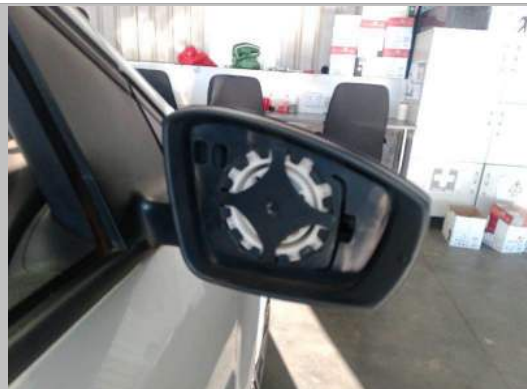
| Damage | Repair Way |
|---|---|
| Side Mirror Right Damaged | Replace |

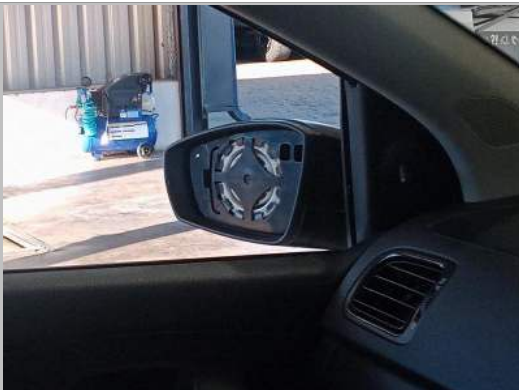
| Damage | Repair Way |
|---|---|
| Side Mirror Left Damaged | Replace |

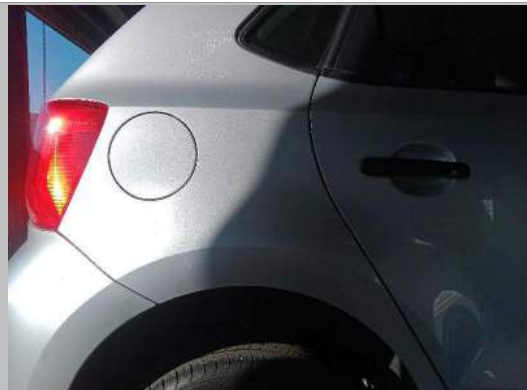
| Damage | Repair Way |
|---|---|
| Rear Fender Right Paintwork • Scratched | Repair |

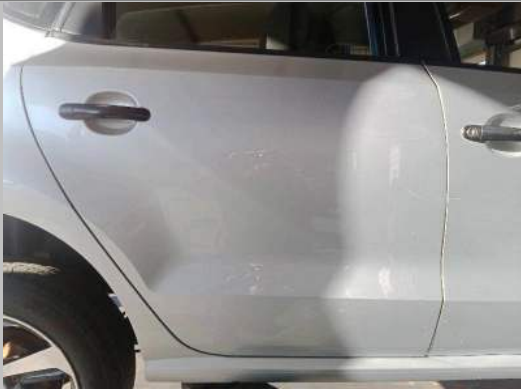
| Damage | Repair Way |
|---|---|
| Door Rear Right Paintwork • Scratched | Repair |

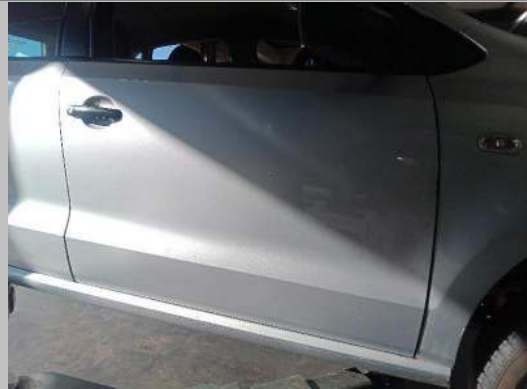
| Damage | Repair Way |
|---|---|
| Door Front Right Paintwork • Scratched | Repair |

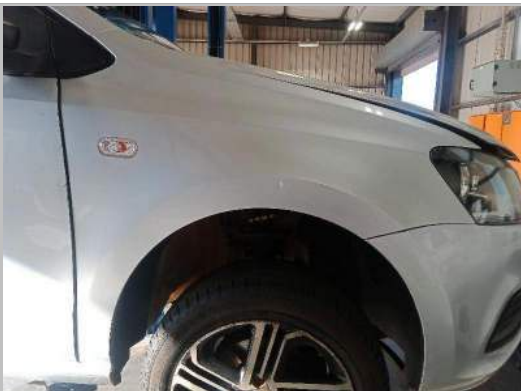
| Damage | Repair Way |
|---|---|
| Front Fender Right Paintwork • Scratched | Repair |

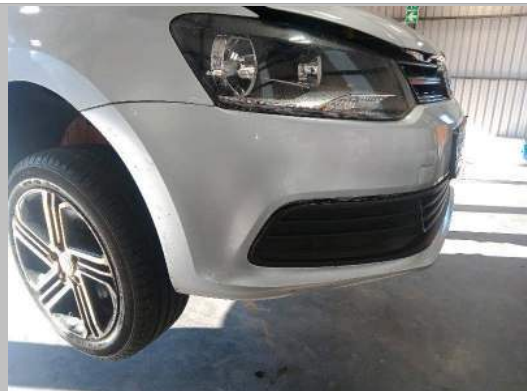
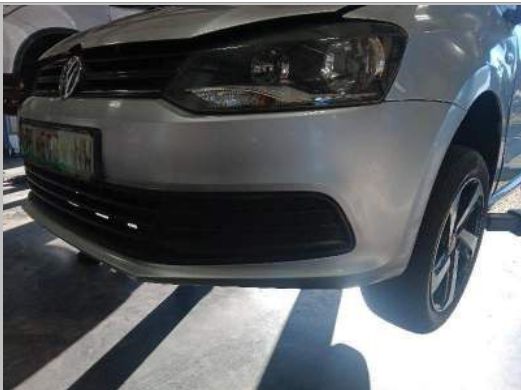
| Damage | Repair Way |
|---|---|
| Front Bumper Paintwork • Scratched | Repair |

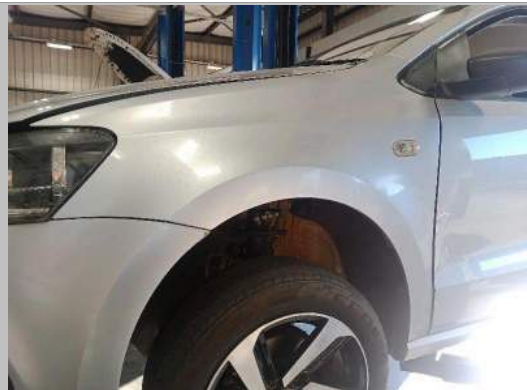
| Damage | Repair Way |
|---|---|
| Front Fender Left Paintwork • Scratched | Repair |

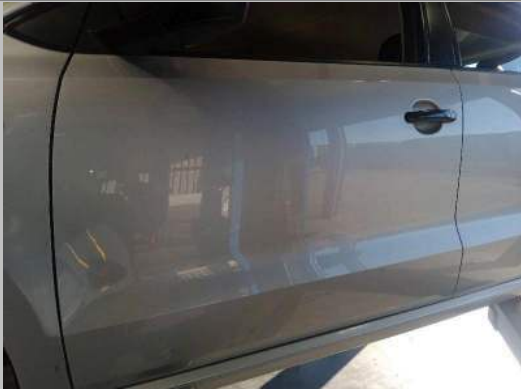
| Damage | Repair Way |
|---|---|
| Door Front Left Paintwork • Scratched | Repair |

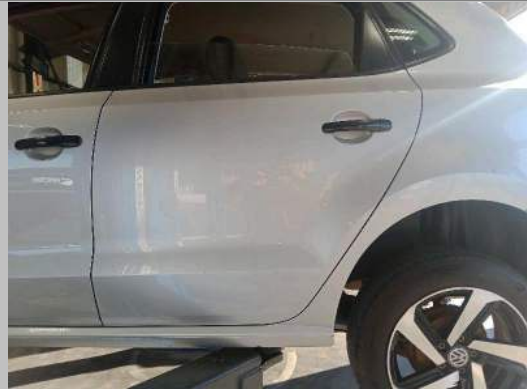
| Damage | Repair Way |
|---|---|
| Door Rear Left Paintwork • Scratched | Repair |

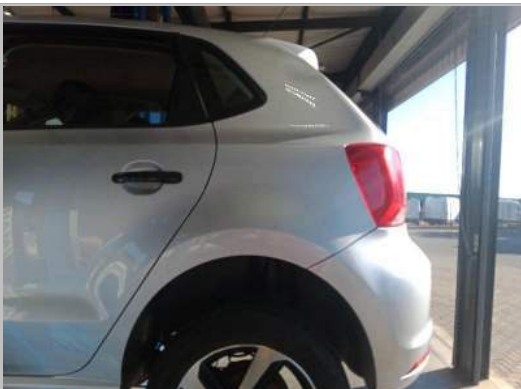
| Damage | Repair Way |
|---|---|
| Rear Fender Left Paintwork • Scratched | Repair |

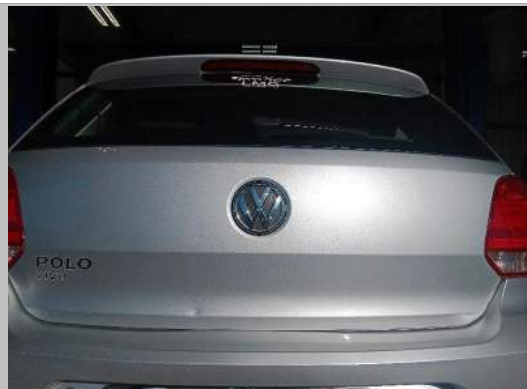
| Damage | Repair Way |
|---|---|
| Boot Lid / Hatch door Dented | Repair |

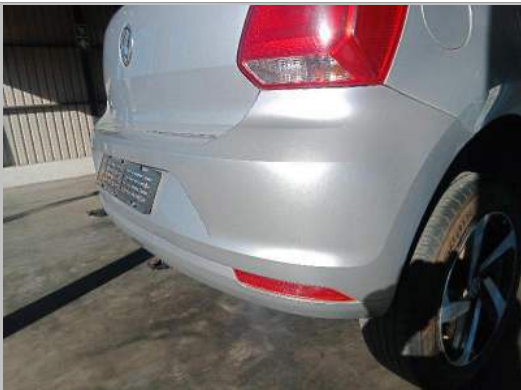
| Damage | Repair Way |
|---|---|
| Rear bumper Paintwork • Scratched | Repair |

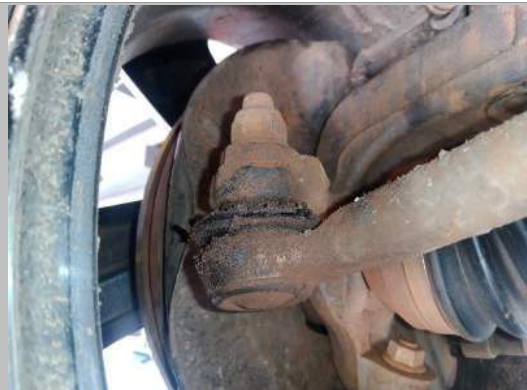
| Damage | Repair Way |
|---|---|
| Tie Rod End left Damaged | Replace |

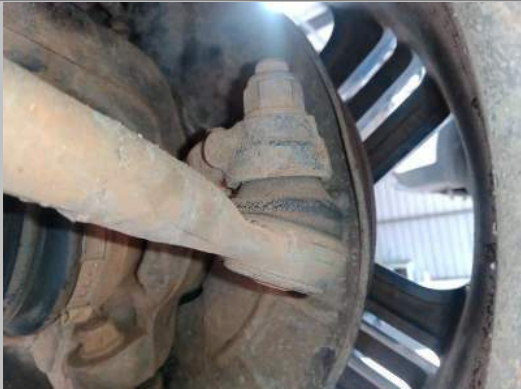
| Damage | Repair Way |
|---|---|
| Tie Rod End right Cracked | Replace |

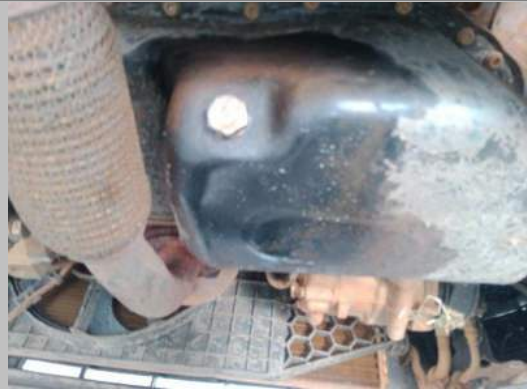
| Damage | Repair Way |
|---|---|
| Engine Oil Sweat | Repair |

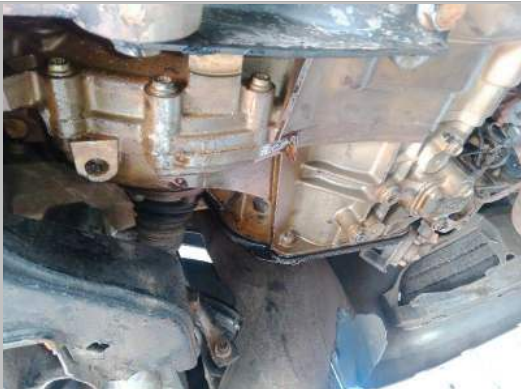
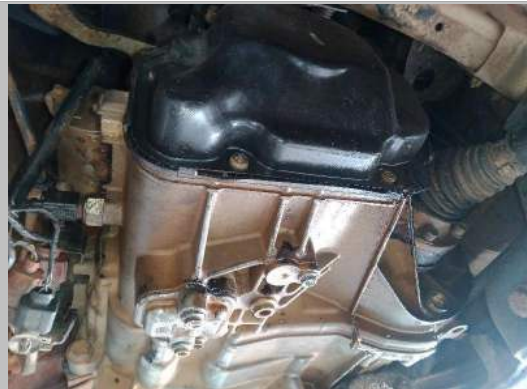
| Damage | Repair Way |
|---|---|
| Gearbox Oil Leak | Repair |
| Gearbox Noise Excessive | Repair |

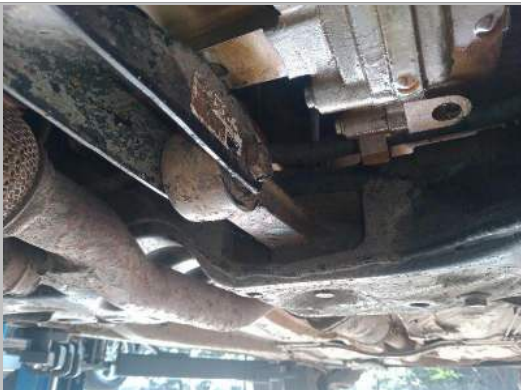
| Damage | Repair Way |
|---|---|
| Gearbox Mountings Defective | Replace |

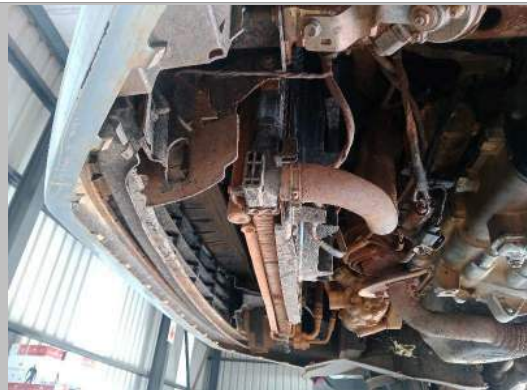
| Damage | Repair Way |
|---|---|
| Radiator Cradle Missing | Replace |

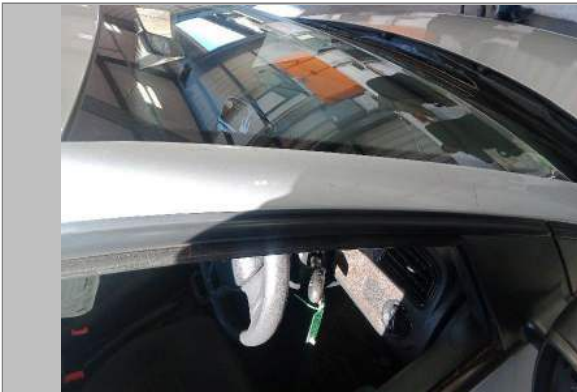
| Damage | Repair Way |
|---|---|
| A • Pillar Right Paintwork • Scratched | Repair |

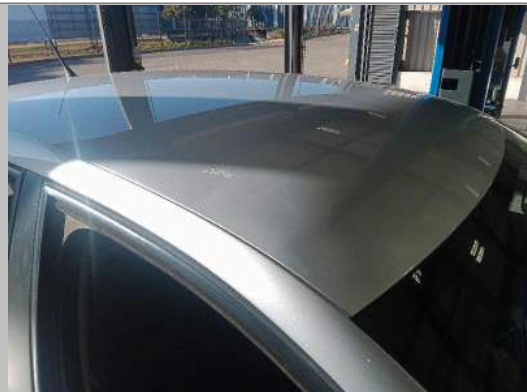
| Damage | Repair Way |
|---|---|
| Roof Dented | Repair |
