## CONDITION REPORT

Report No: 2016850234

| Manufacturer | VOLKSWAGEN | Registration Number | JRC363MP |
| Model | POLO VIVO 1.4 55KW TRENDLINE 5-DR [2018-2020] | Register Number | |

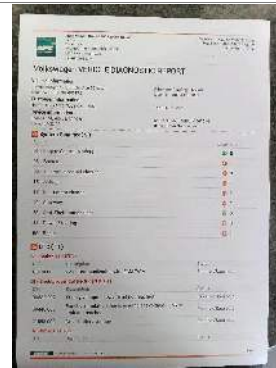
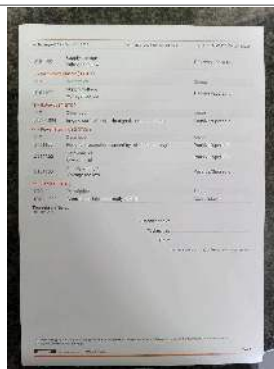
Diagnostic test

| No | System | Code | Description | Status |
|---|---|---|---|---|
| 1 | ELECTRONICS CENTRAL ELECTRIC | 01598:000 | DRIVE BATTERY VOLTAGE | |

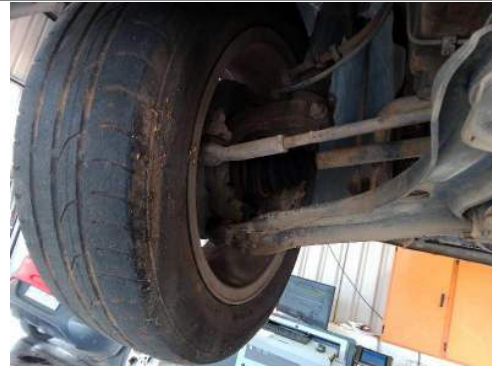
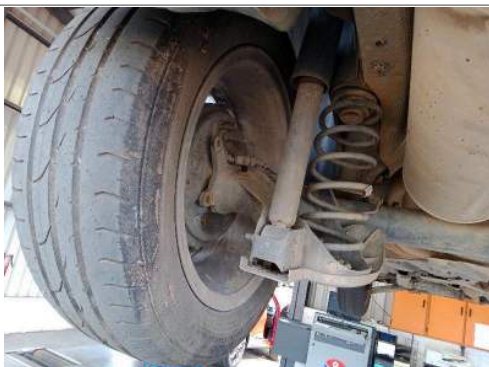
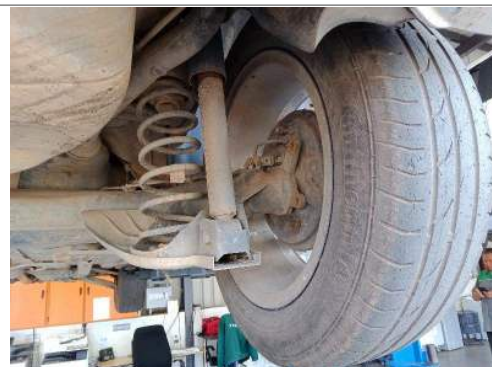
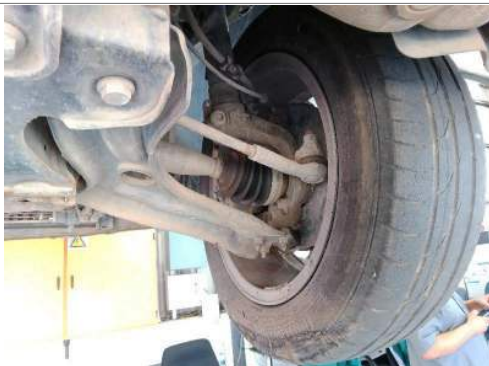
| | Size | Load/Speed Index | Manufacture | Model | Type* | Production Date | Tread Depth (mm) |
|---|---|---|---|---|---|---|---|
| Front Left | 185/60R15 | 84H | Continental | Contact | V | 2220 | 1 mm |
| Front Right | 185/60R15 | 84H | Continental | Contact | V | 2220 | 1 mm |
| Rear Left | 185/60R15 | 84H | Continental | Contact | V | 2220 | 1 mm |
| Rear Right | 185/60R15 | 84H | Continental | Contact | V | 2220 | 1 mm |

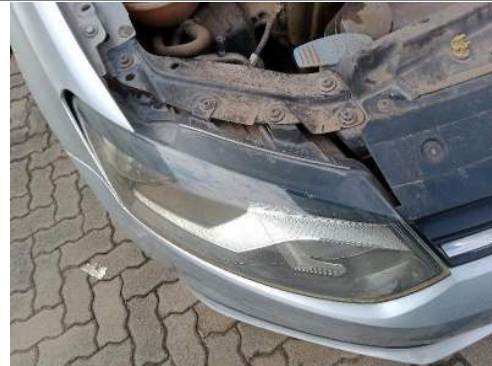
| Damage | Repair Way |
|---|---|
| R/F headlight clips broken headlight is loose | Repair |

R/F headlight clips broken

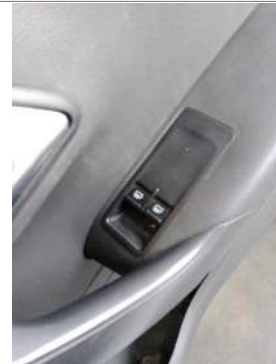
| Damage | Repair Way |
|---|---|
| Switch Electrical Window Winder front right Defective | Repair |

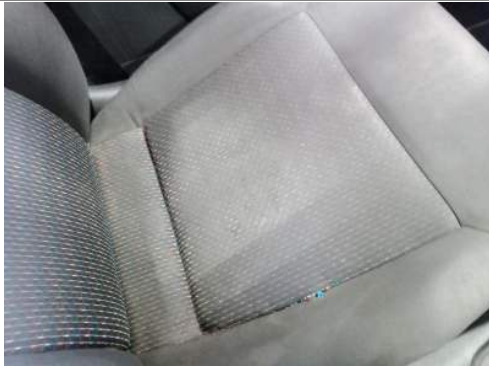
| Damage | Repair Way |
|---|---|
| Seat Front Left Torn / Cut | Repair |

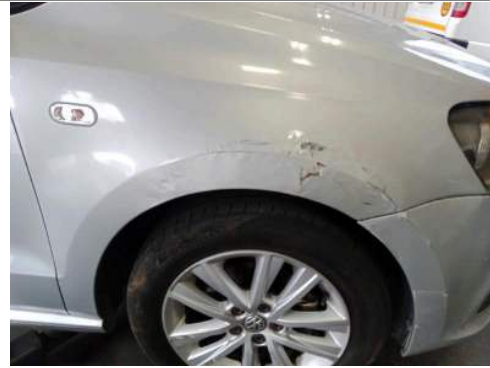
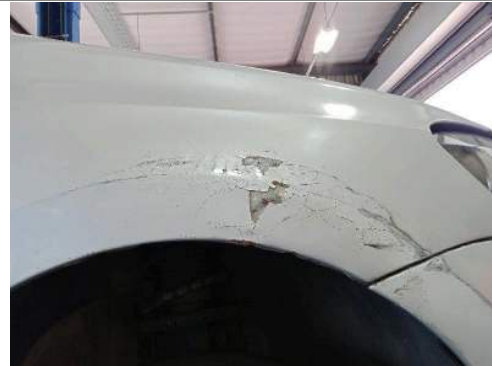
| Damage | Repair Way |
|---|---|
| Front Fender Right Residual Traces of Repair | Repair |

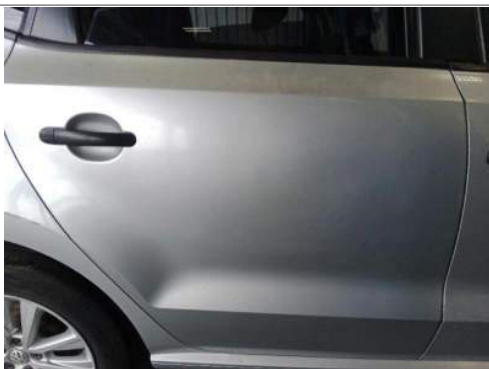
| Damage | Repair Way |
|---|---|
| Door Rear Right Residual Traces of Repair | Repair |

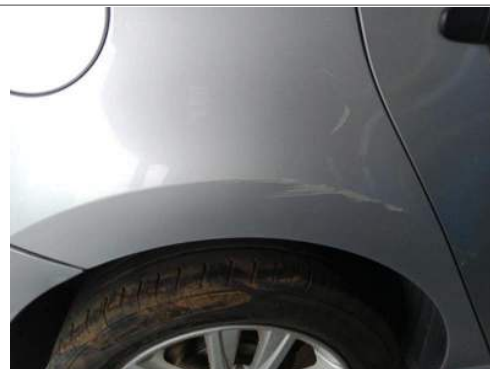
| Damage | Repair Way |
|---|---|
| Rear Fender Right Paintwork • Scratched | Repair |

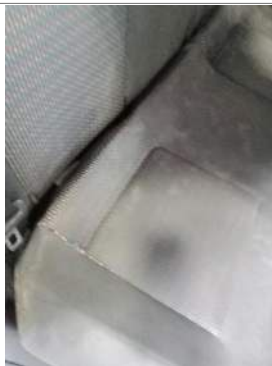
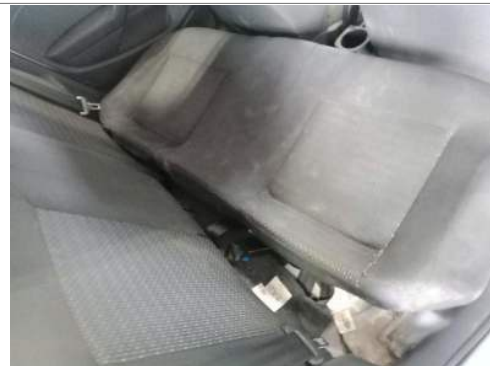
| Damage | Repair Way |
|---|---|
| Seat Rear Torn / Cut | Repair |

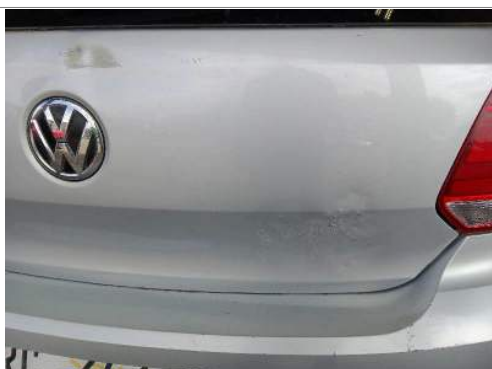
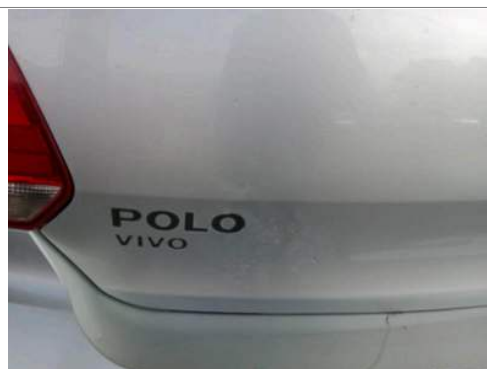
| Damage | Repair Way |
|---|---|
| Boot Lid / Hatch door Damaged | Repair |

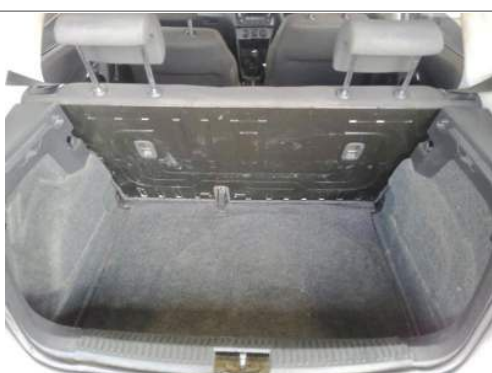
| Damage | Repair Way |
|---|---|
| Parcel Tray Missing | Replace |

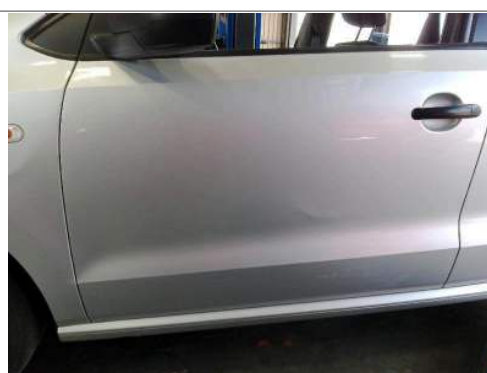
| Damage | Repair Way |
|---|---|
| Door Front Left Dented | Repair |

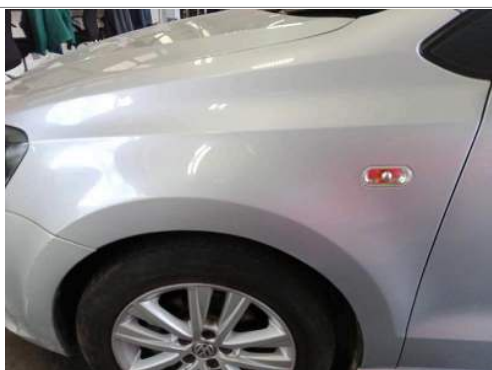
| Damage | Repair Way |
|---|---|
| Front Fender Left Dented | Repair |

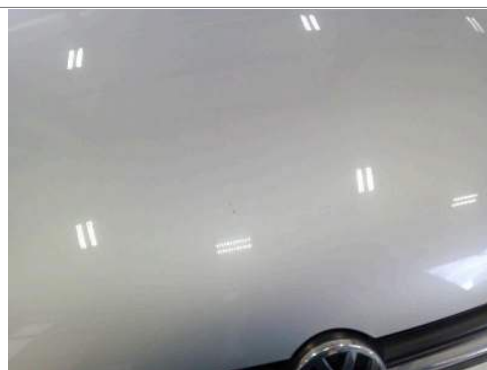
| Damage | Repair Way |
|---|---|
| Bonnet Paintwork • Chipmarks | Repair |

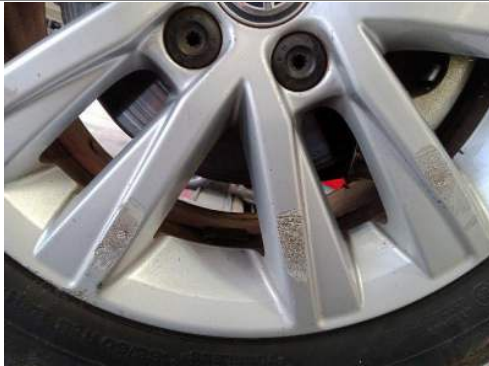
| Damage | Repair Way |
|---|---|
| Rim Front Right Scratched | Repair |

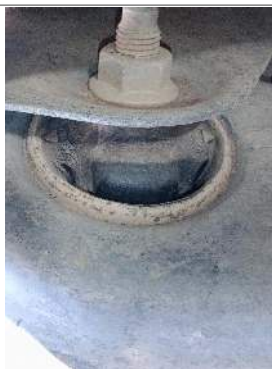
| Damage | Repair Way |
|---|---|
| Control Arm Bush(es) Front Axle Right Cracked | Replace |

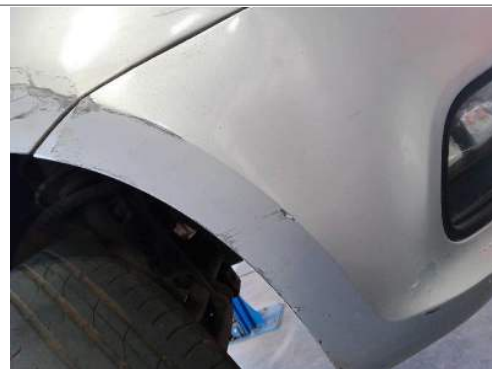
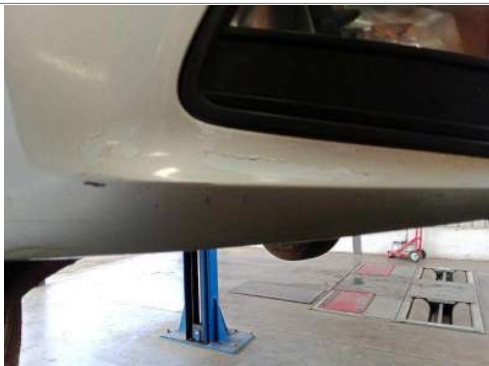
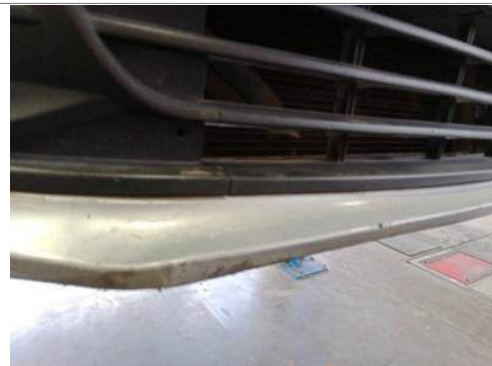
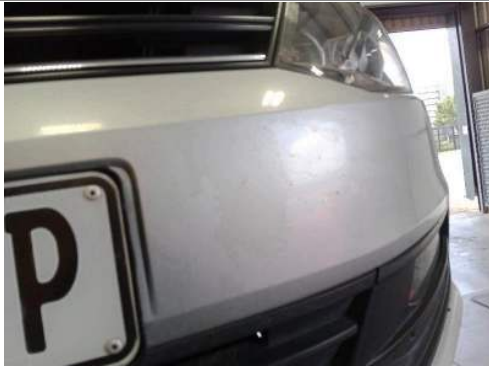
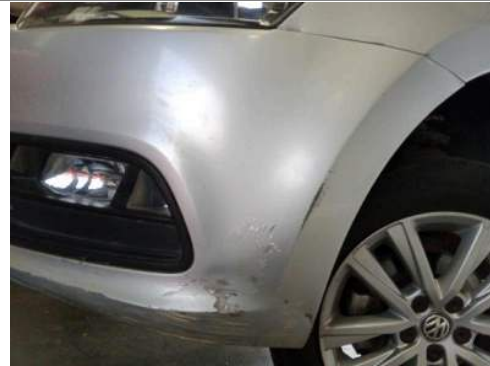
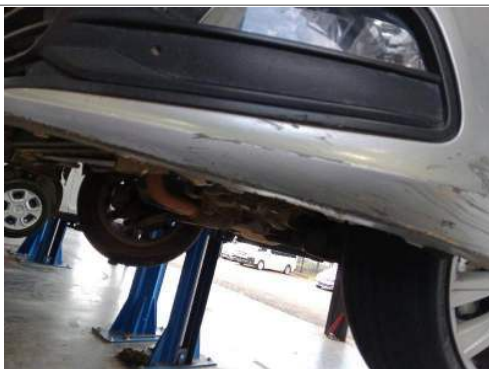
| Damage | Repair Way |
|---|---|
| Front Bumper Paintwork • Scratched | Repair |

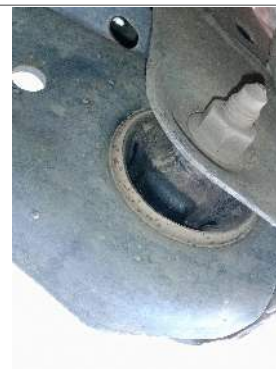
| Damage | Repair Way |
|---|---|
| Control Arm Bush(es) Front Axle Left Cracked | Replace |

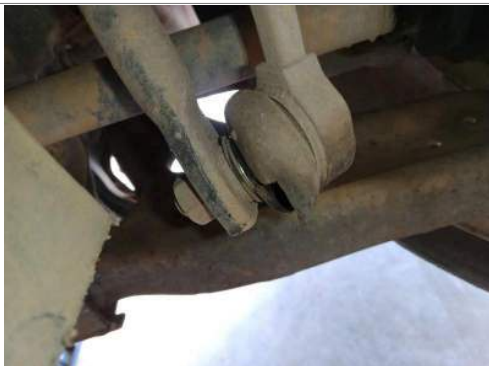
| Damage | Repair Way |
|---|---|
| Stabilizer Mounting Front Left Damaged | Replace |

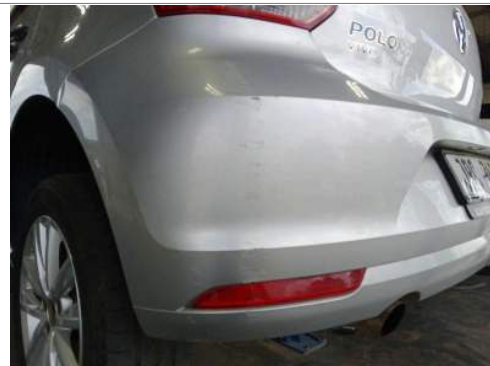
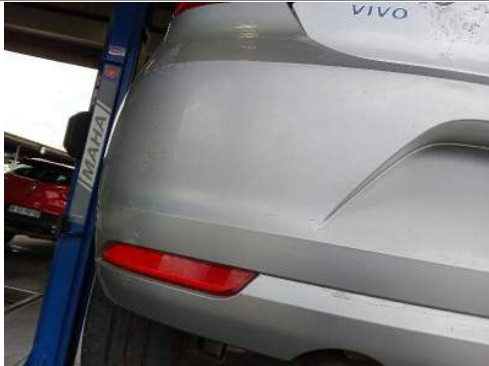
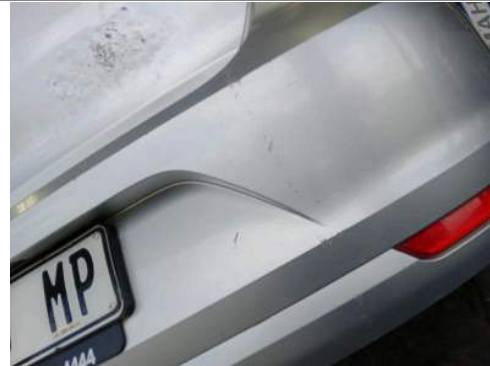
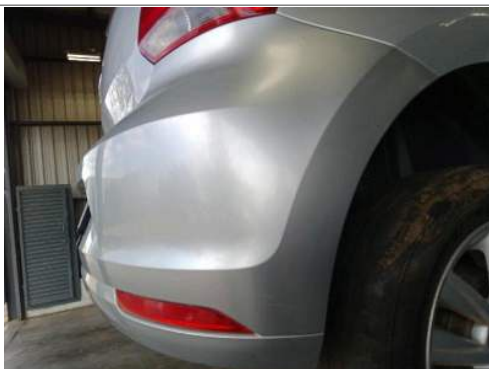
| Damage | Repair Way |
|---|---|
| Rear bumper Paintwork • Scratched | Repair |

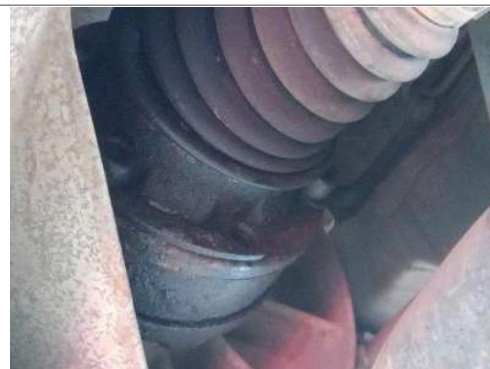
| Damage | Repair Way |
|---|---|
| CV Joint(s) Front Left (inner/outer) Damaged | Replace |

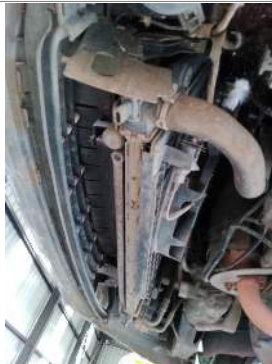
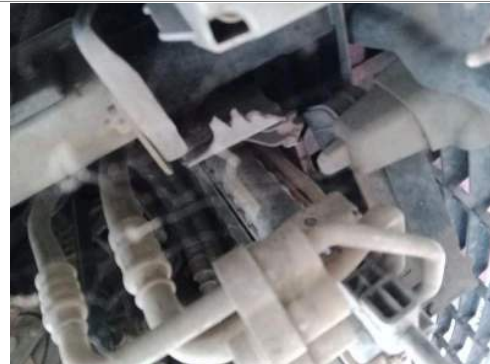
| Damage | Repair Way |
|---|---|
| Radiator Cradle Damaged | Replace |

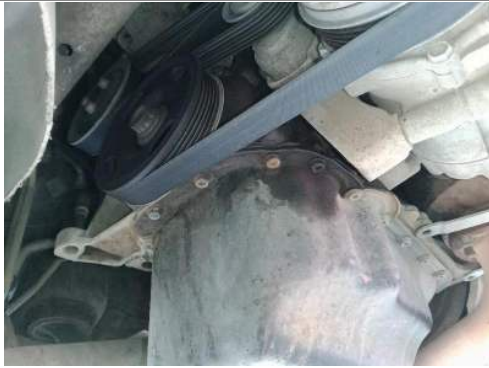
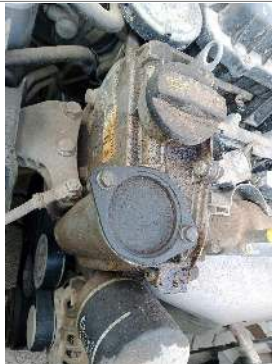
| Damage | Repair Way |
|---|---|
| Engine Oil Sweat | Repair |

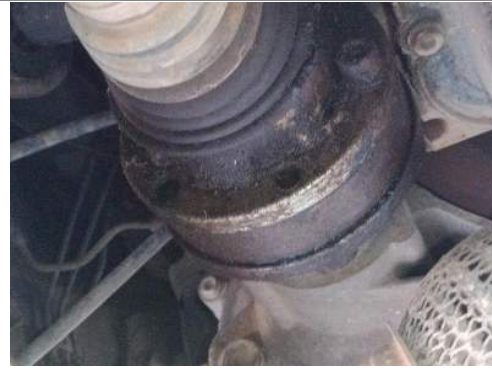
| Damage | Repair Way |
|---|---|
| CV Joint(s) Front Right (inner/outer) Damaged | Replace |
