## CONDITION REPORT

Report No:  
2017304590  
DATE  
29/09/2026

| Manufacturer | VOLKSWAGEN | Registration Number | HLF524L |
| Model | POLO VIVO 1.6 77KW HIGHLINE 5-DR [2018-2020] | Register Number | |

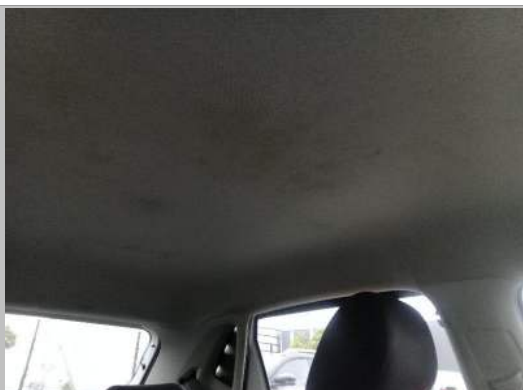
| Hood Lining Dirty | Repair |

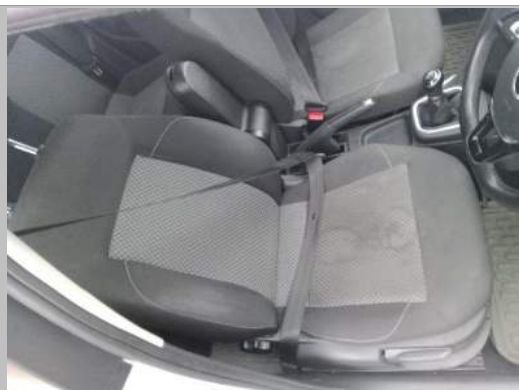
| Seat Front Right Dirty | Repair |

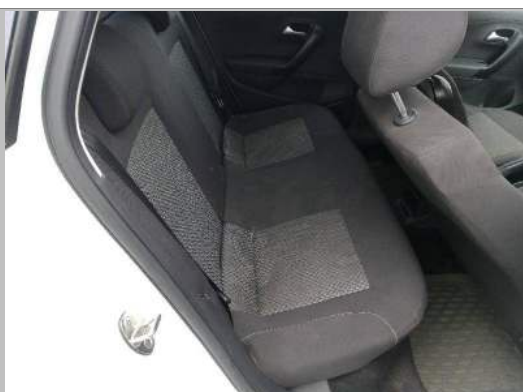
| Seat Rear Dirty | Repair |

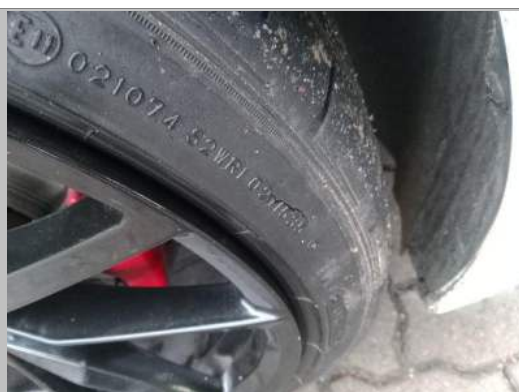
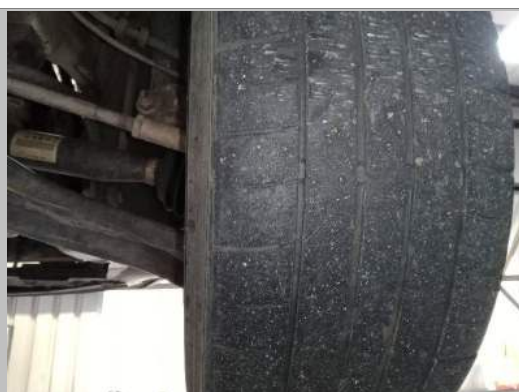
| Tyre Front Right Damaged | Replace |

| | Size | Load/Speed Index | Manufacture | Model | Type* | Production Date | Tread Depth (mm) |
|---|---|---|---|---|---|---|---|
| Front Right | 205/40 R17 | 84W | Dunlop | Direzza | V | 4721 | 0 mm |

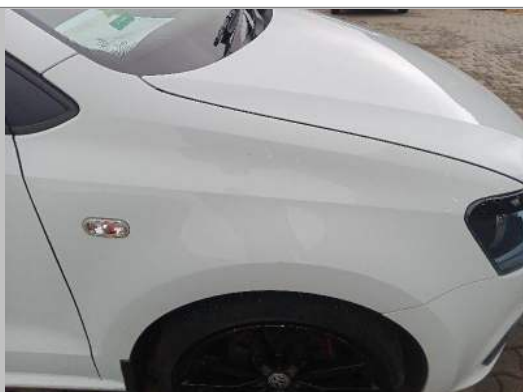
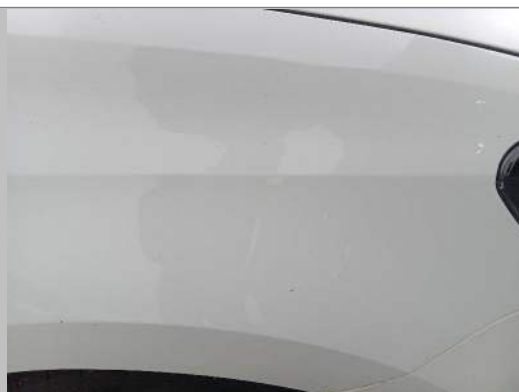
| Front Fender Right Paintwork • Chipmarks | Repair |

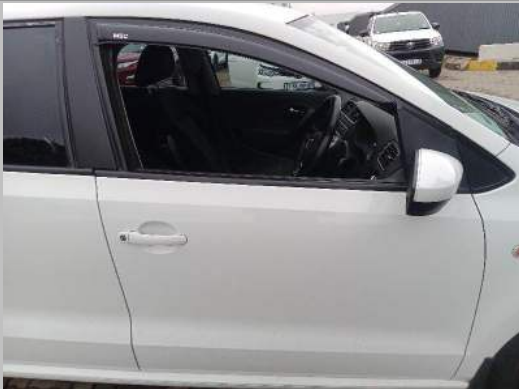
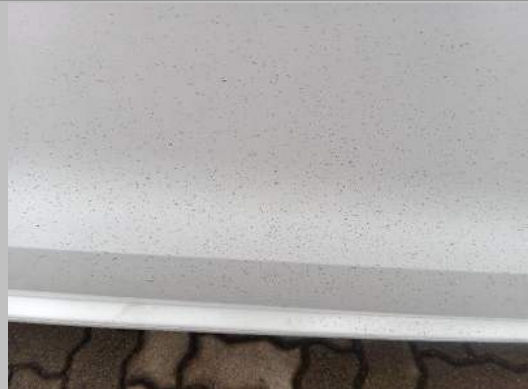
| Door Front Right Defective | Repair |

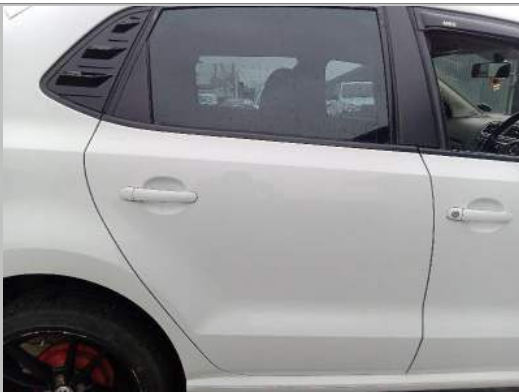
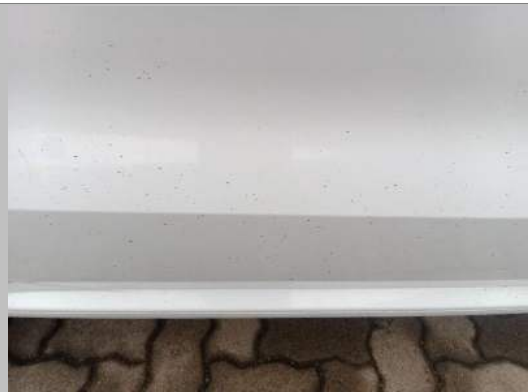
| Door Rear Right Paintwork • Chipmarks | Repair |

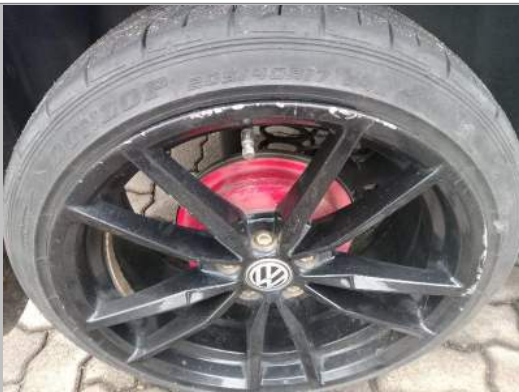
| Rim Rear Right Scratched | Repair |

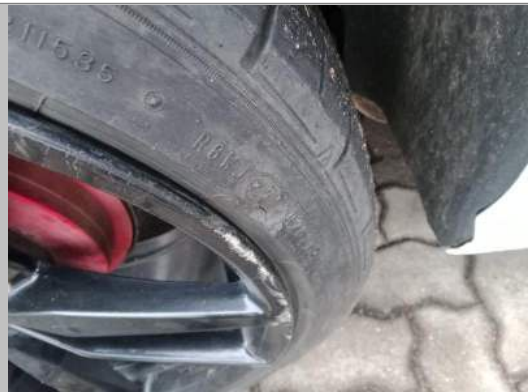
| Tyre Rear Right Damaged | Replace |

| | Size | Load/Speed Index | Manufacture | Model | Type* | Production Date | Tread Depth (mm) |
|---|---|---|---|---|---|---|---|
| Rear Right | 205/40 R17 | 84W | Dunlop | Direzza | V | 2821 | 2 mm |

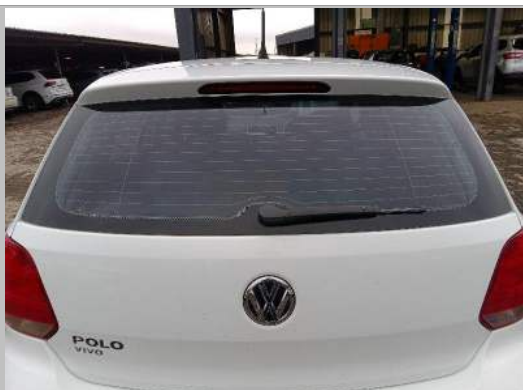
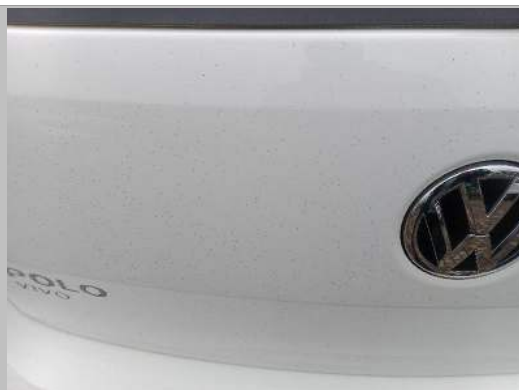
| Boot Lid / Hatch door Defective | Repair |

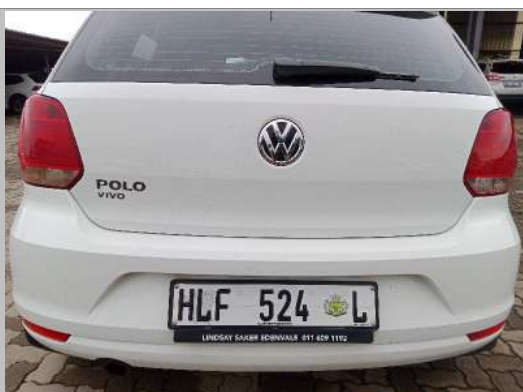
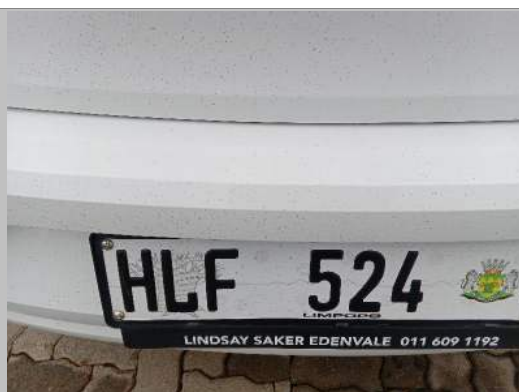
| Rear bumper Defective | Repair |

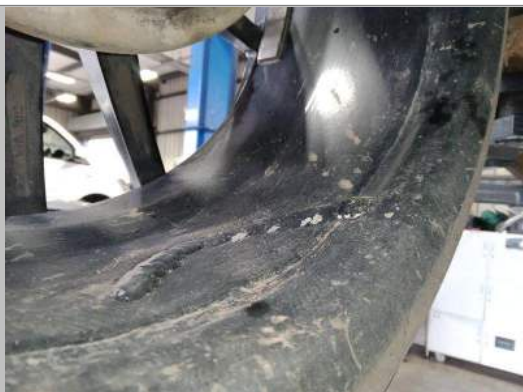
| Rim Rear Left Welded | Replace |

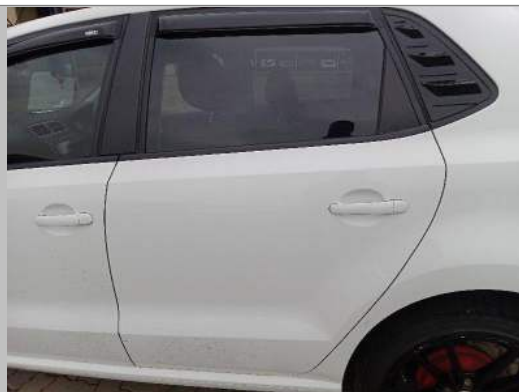
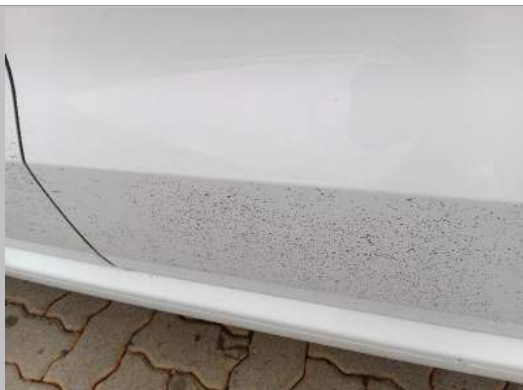
| Door Rear Left Defective | Repair |

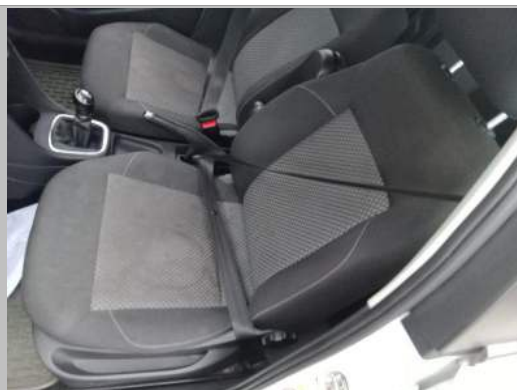
| Seat Front Left Dirty | Repair |

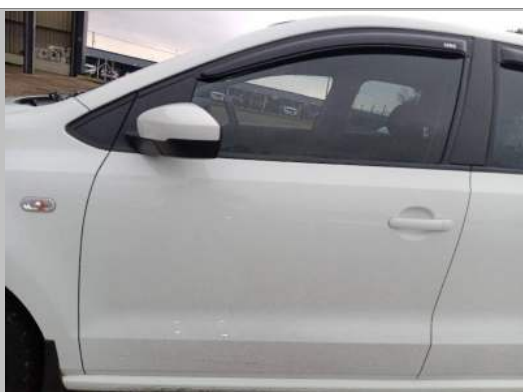
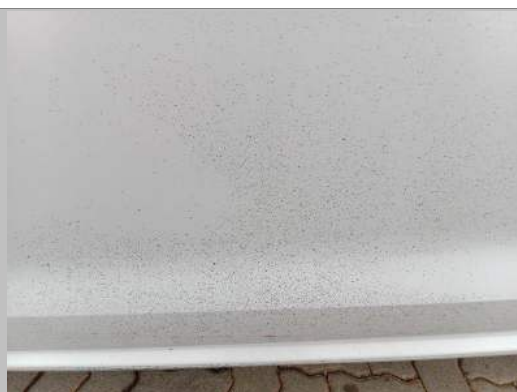
| Door Front Left Defective | Repair |

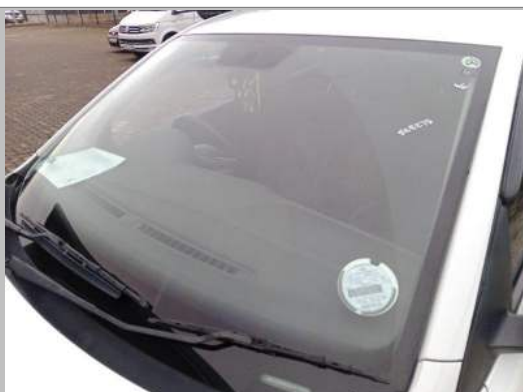
| Windscreen Cracked | Replace |

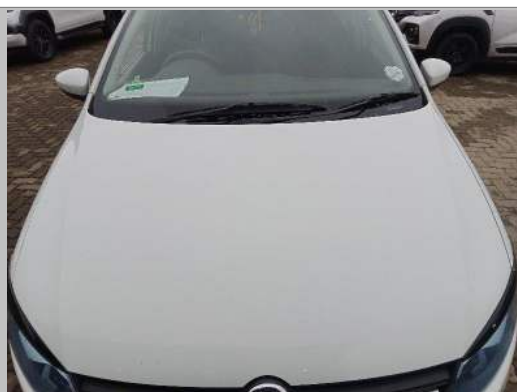
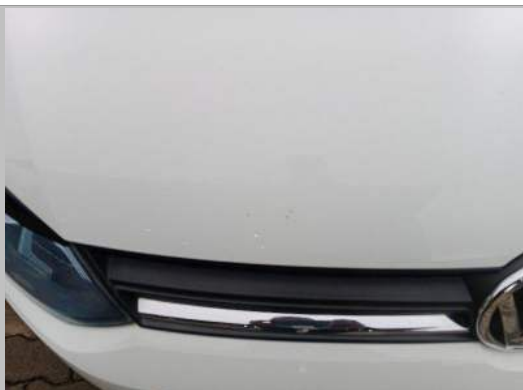
| Bonnet Paintwork • Chipmarks | Repair |

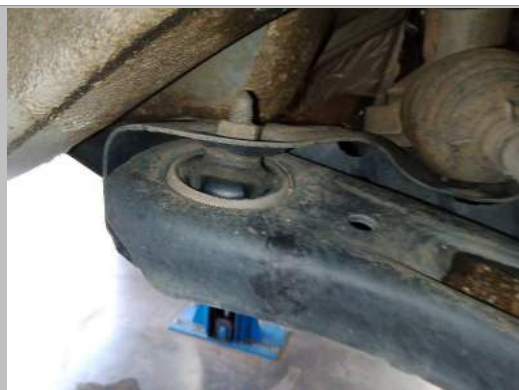
| Control Arm Bush(es) Front Axle Right Cracked | Replace |

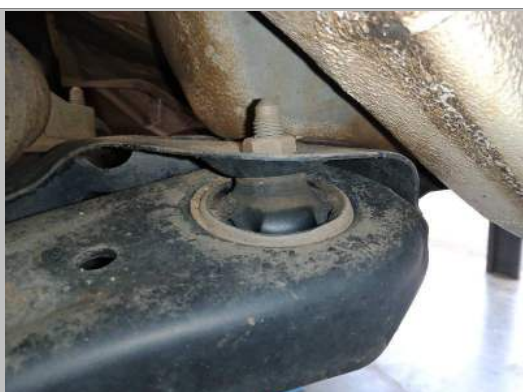
| Control Arm Bush(es) Front Axle Left Cracked | Replace |

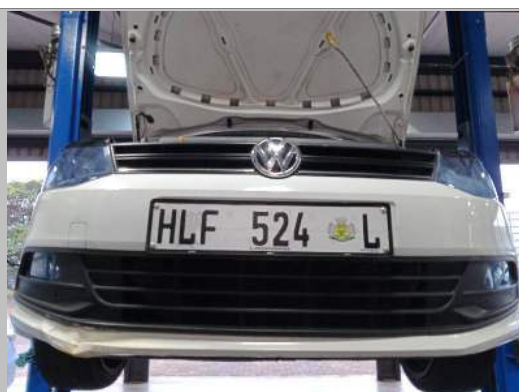
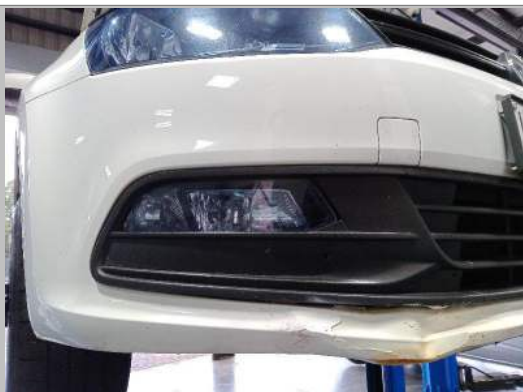
| Front Bumper Damaged | Repair |

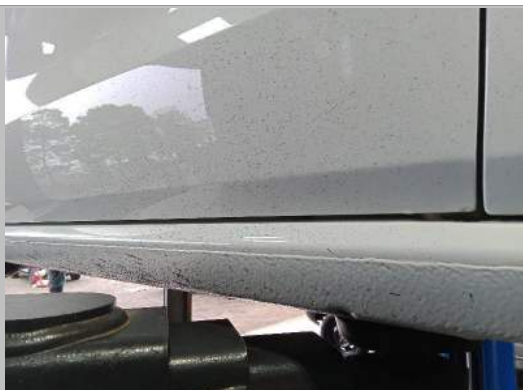
| Sill Panel Right Defective | Repair |

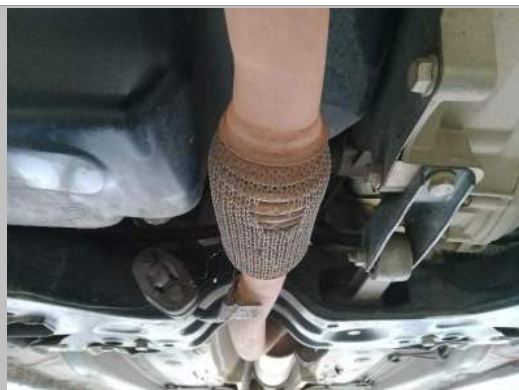
| Engine to silencer pipe Damaged | Repair |

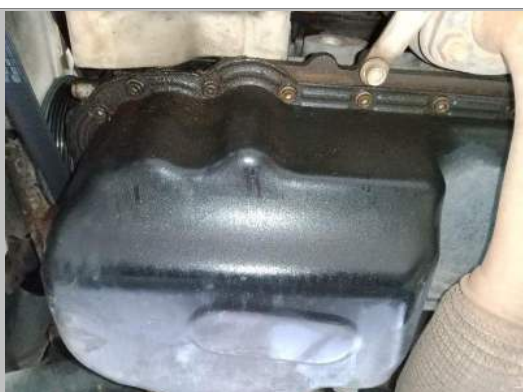
| Engine Oil Leak | Repair |

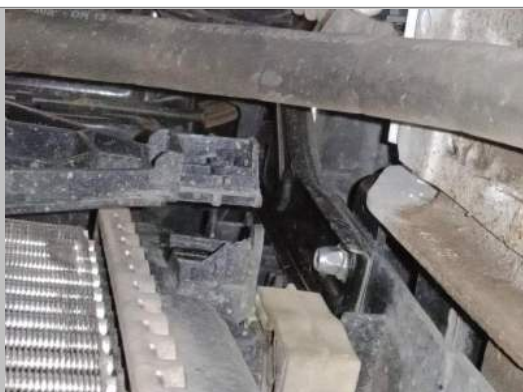
| Radiator Damaged | Repair |

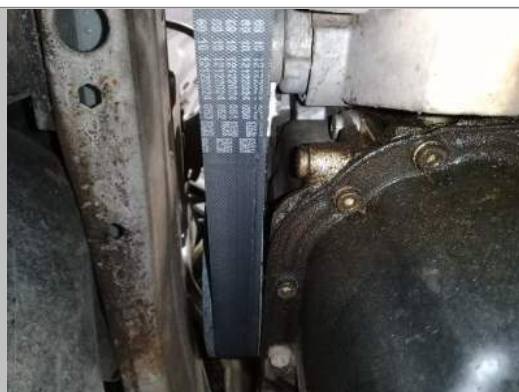
| Fan Belt Damaged | Replace |

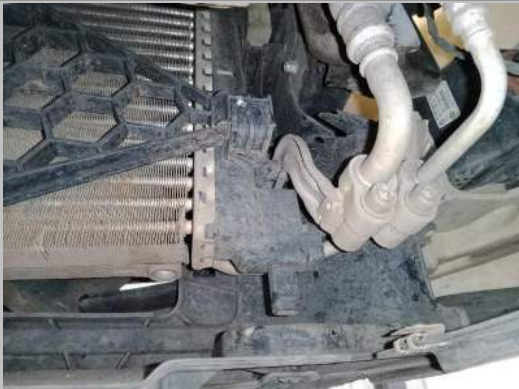
| Radiator Cradle Damaged | Replace |

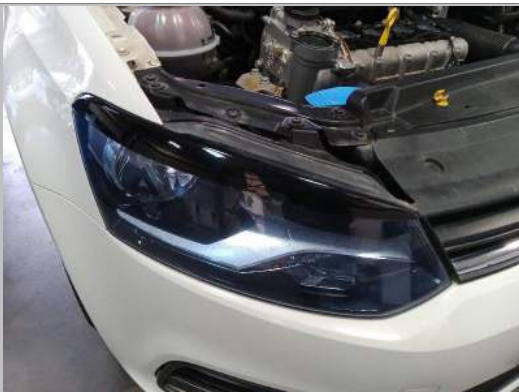
| Headlight Right Defective | Repair |

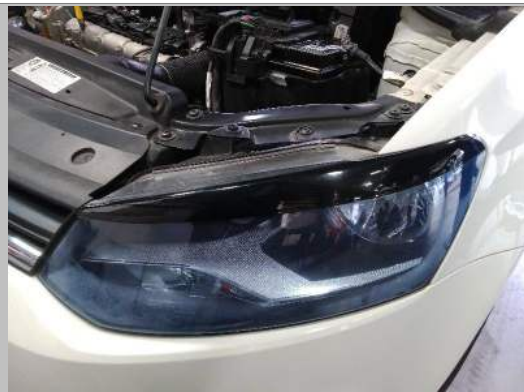
| Headlight Left Defective | Repair |
