CONDITION REPORT

Report No:  
2017302938  
DATE  
23/09/2026

MFC Auction House  
M57 Pretoria Rd, Glenmarais, KEMPTON PARK  
Gauteng

| Manufacturer | VOLKSWAGEN | Registration Number | JN18HBGP |

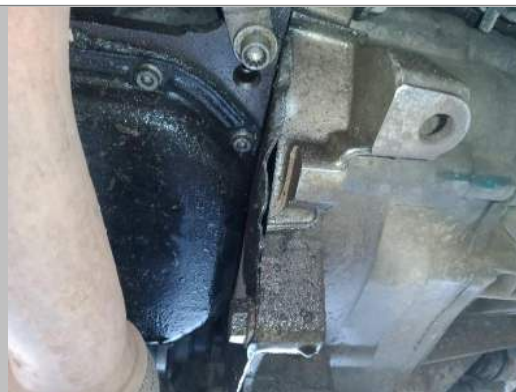
| Flywheel dust plate dented | Repair |

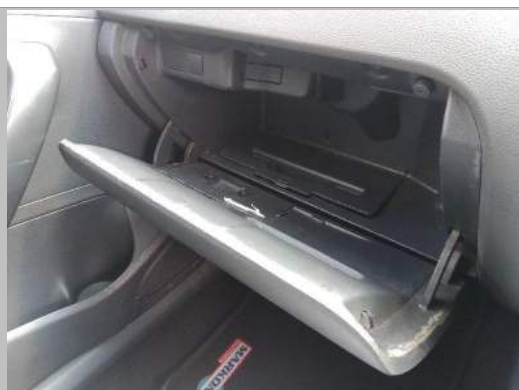
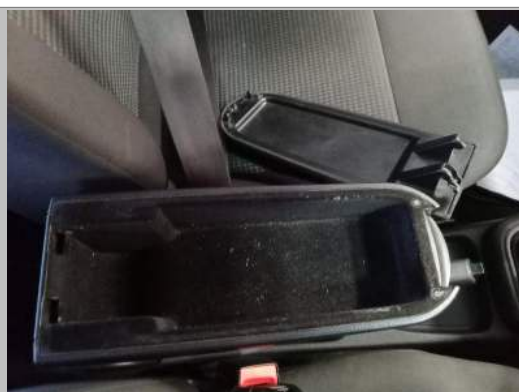
| Center Console / Cubbyhole + Lid Damaged | Replace |

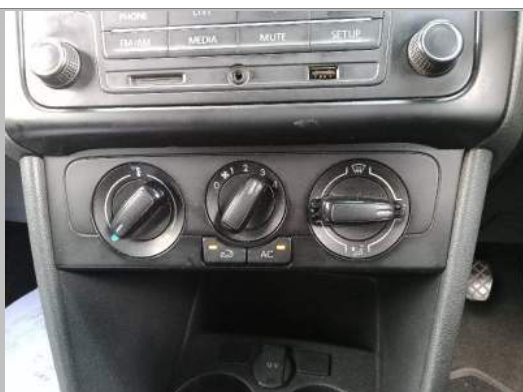
| Air Conditioner Insufficient | Replace |

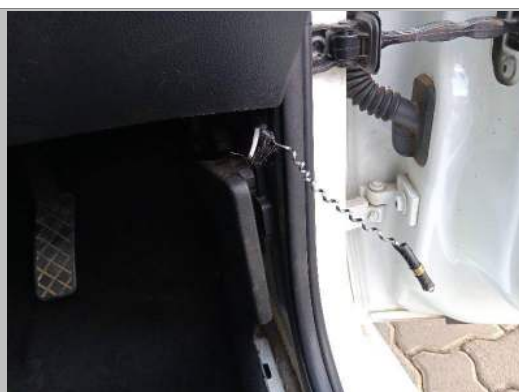
| Bonnet cable Damaged | Replace |

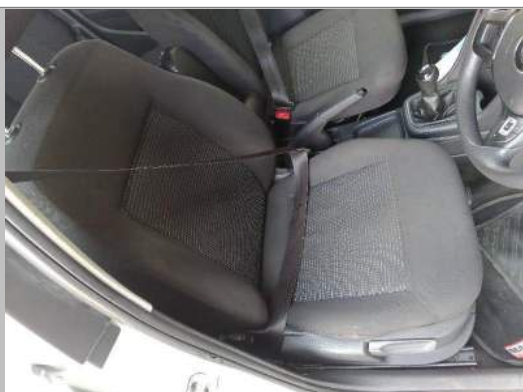
| Seat Front Right Dirty | Repair |

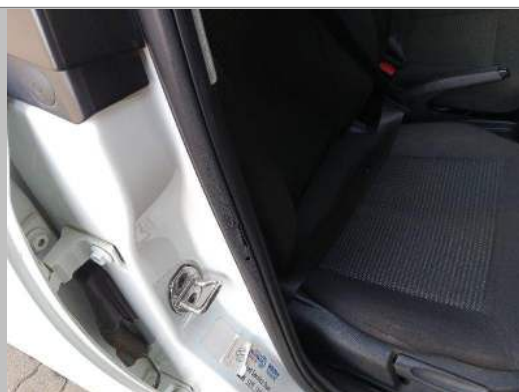
| Door Sealing Rubber Front Right Damaged | Replace |

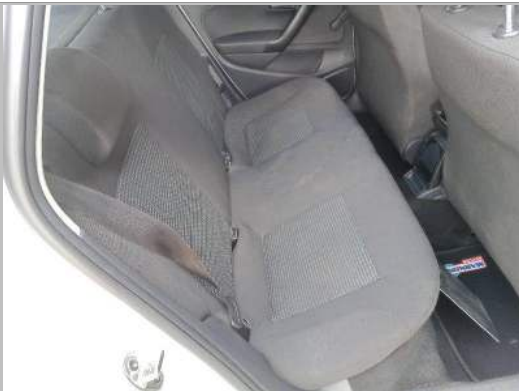
| Seat Rear Dirty | Repair |

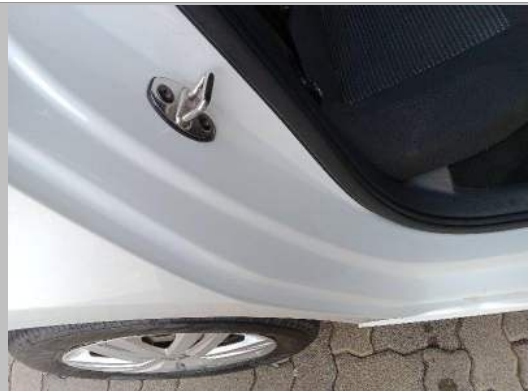
| C • Pillar Right Dented | Repair |

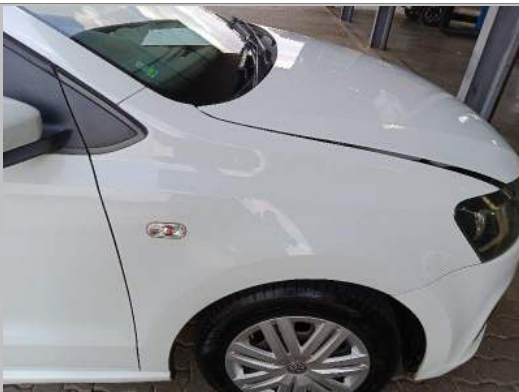
| Front Fender Right Residual Traces of Repair | Repair |

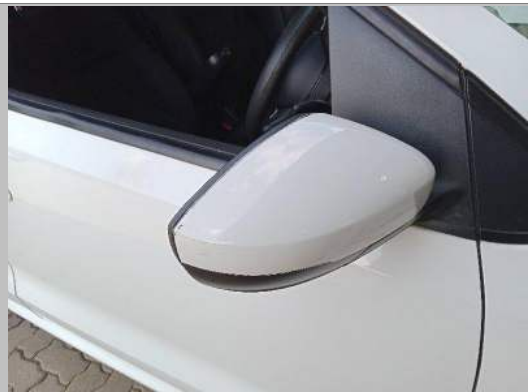
| Side Mirror Right Residual Traces of Repair | Repair |

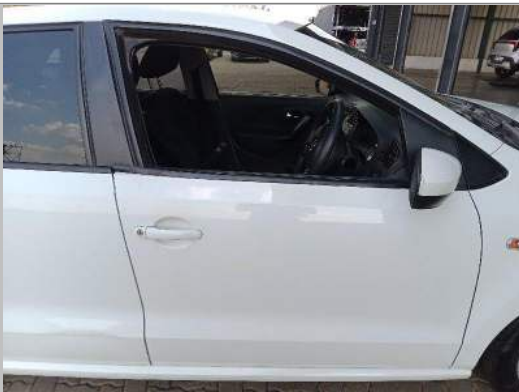
| Door Front Right Residual Traces of Repair | Repair |

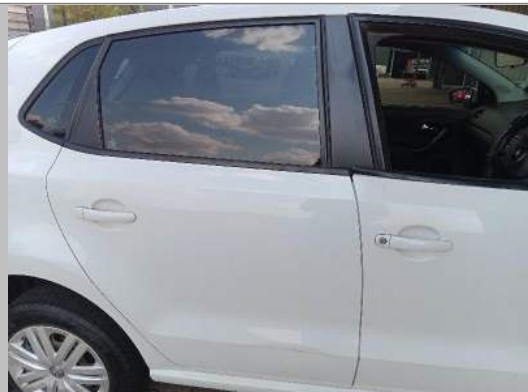
| Door Rear Right Damaged | Repair |

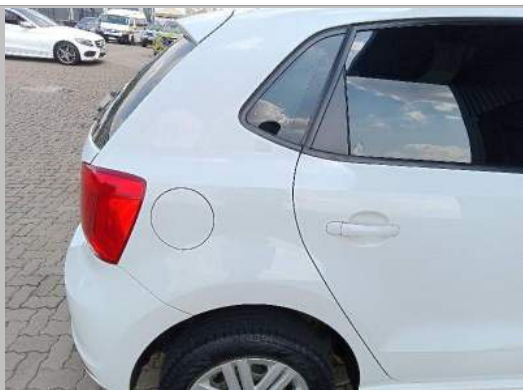
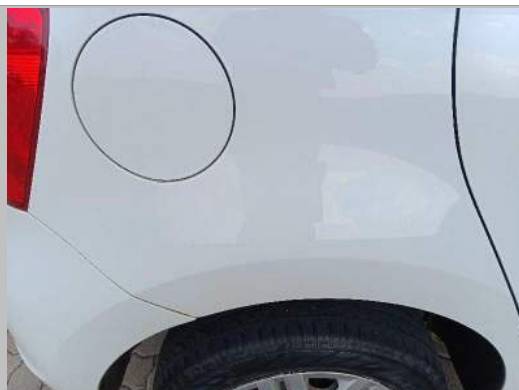
| Rear Fender Right Paintwork • Scratched | Repair |

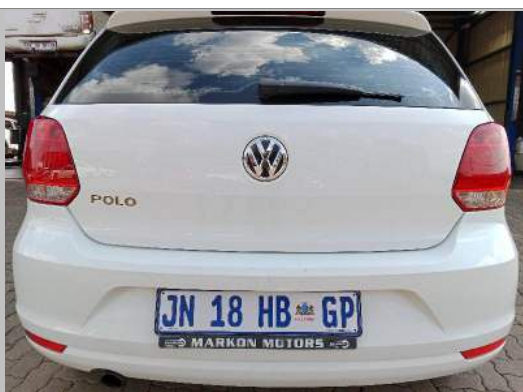
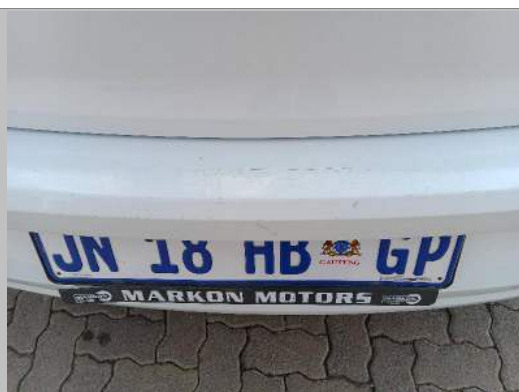
| Rear bumper Damaged | Repair |

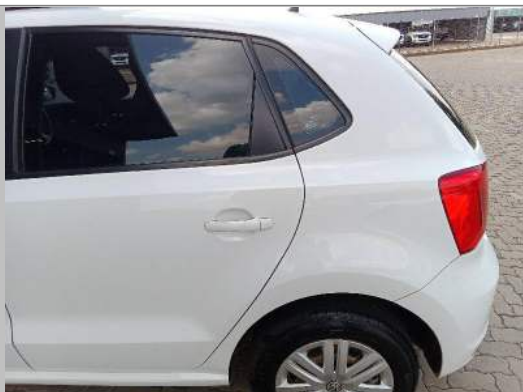
| Rear Fender Left Residual Traces of Repair | Repair |

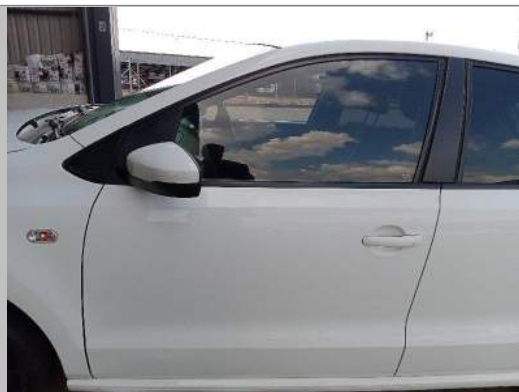
| Door Front Left Dented | Repair |

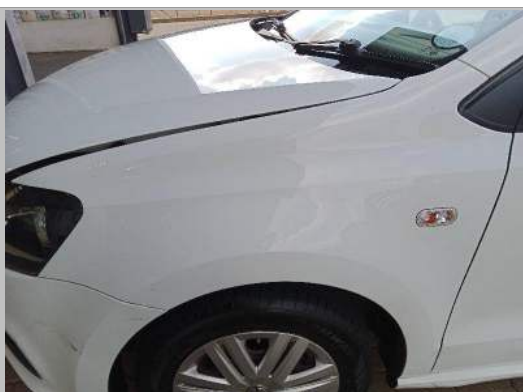
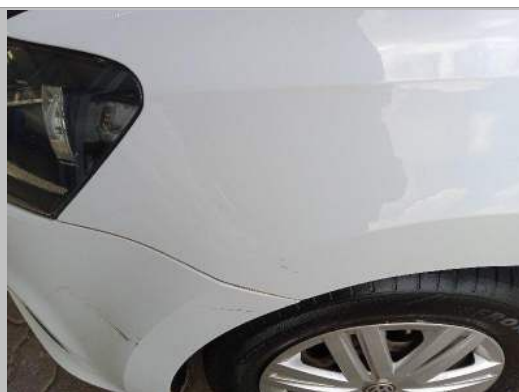
| Front Fender Left Paintwork • Scratched | Repair |

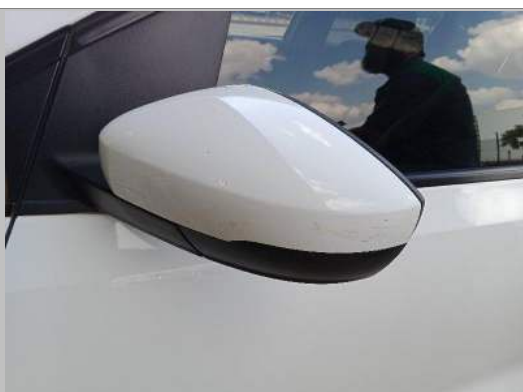
| Side Mirror Left Paintwork • Scratched | Repair |

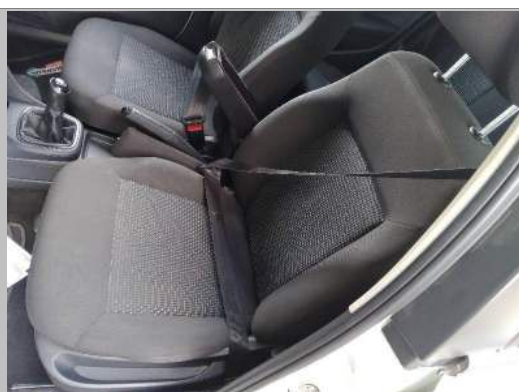
| Seat Front Left Dirty | Repair |

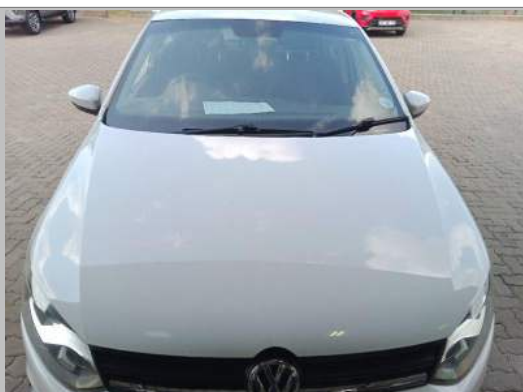
| Bonnet Residual Traces of Repair | Repair |

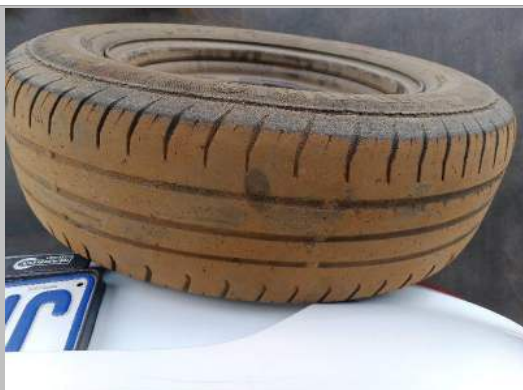
| Spare Tyre Damaged | Replace |

| | Size | Load/Speed Index | Manufacture | Model | Type* | Production Date | Tread Depth (mm) |
|---|---|---|---|---|---|---|---|
| Spare | 175/70 R14 | 84T | Continental | Contipremuim | V | 3618 | 1 mm |

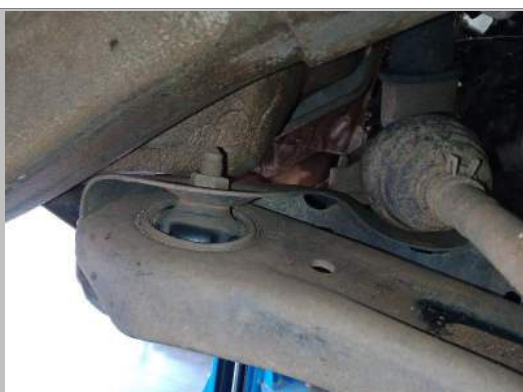
| Control Arm Bush(es) Front Axle Right Cracked | Replace |

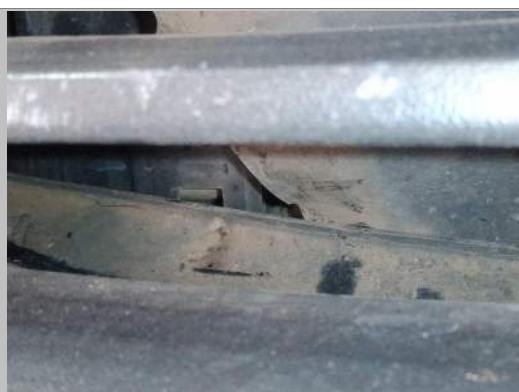
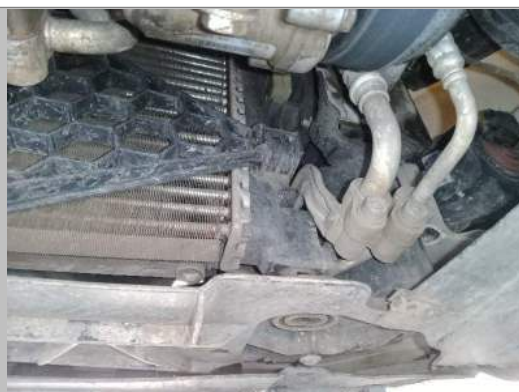
| Radiator Cradle Damaged | Repair |

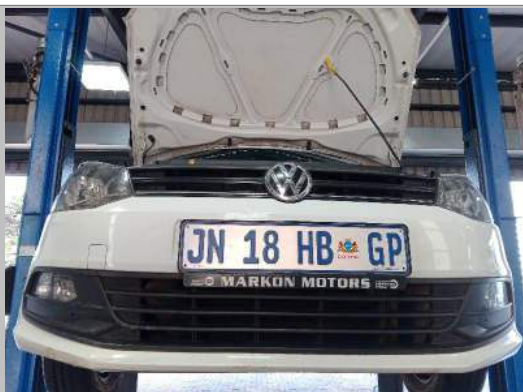
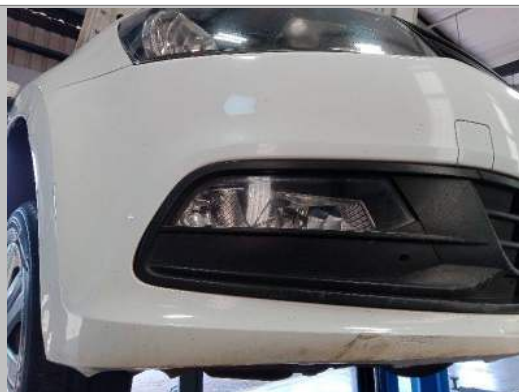
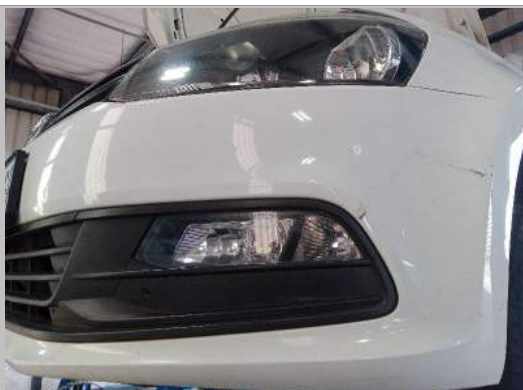
| Front Bumper Damaged | Repair |

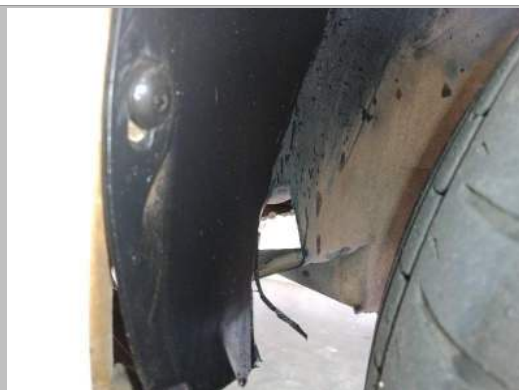
| Front Fender Left / Inner Tray Damaged | Replace |

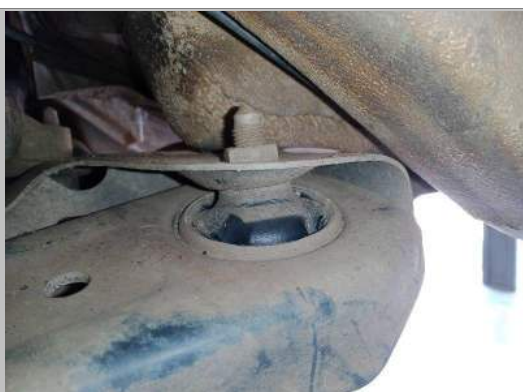
| Control Arm Bush(es) Front Axle Left Cracked | Replace |

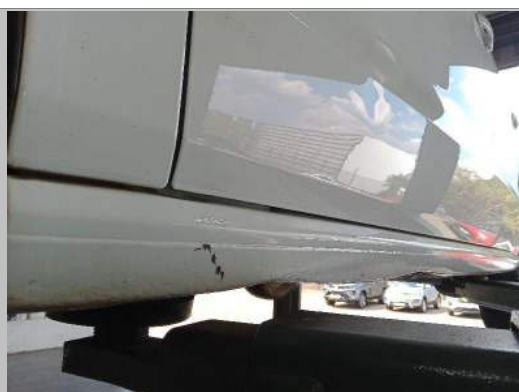
| Sill Panel Left Damaged | Repair |

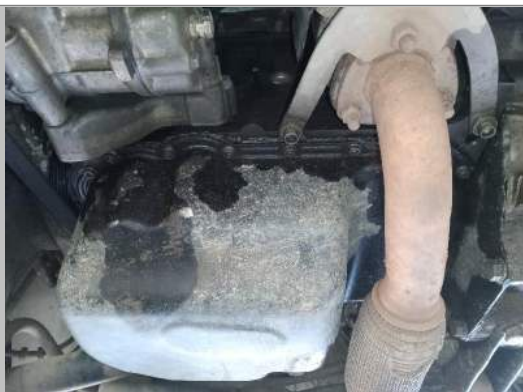
| Engine Oil Leak | Repair |
| Engine Noise Excessive | Repair |

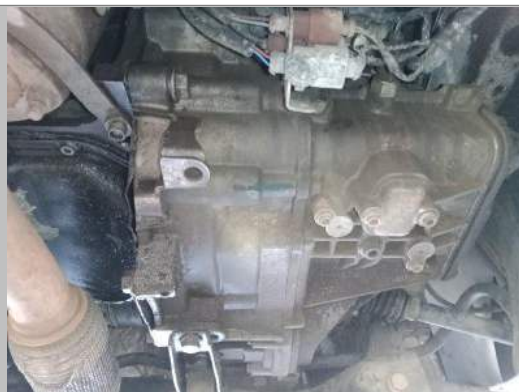
| Gearbox Oil Leak | Repair |

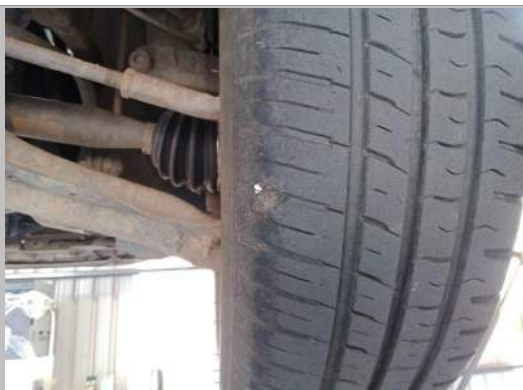
| Tyre Front Right Damaged | Replace |

| | Size | Load/Speed Index | Manufacture | Model | Type* | Production Date | Tread Depth (mm) |
|---|---|---|---|---|---|---|---|
| Front Right | 175/65 R14 | 82H | Fronway | Eco green | V | 4523 | 0 mm |

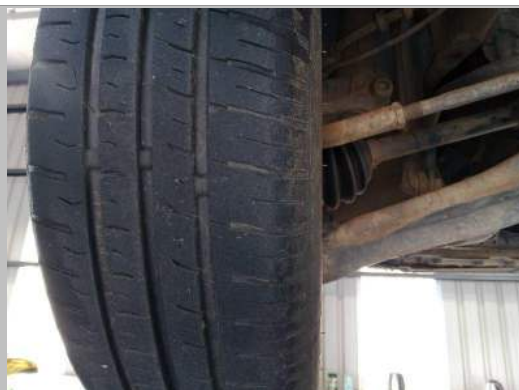
| Tyre Front Left Worn | Replace |

| | Size | Load/Speed Index | Manufacture | Model | Type* | Production Date | Tread Depth (mm) |
|---|---|---|---|---|---|---|---|
| Front Left | 175/65 R14 | 82H | Fronway | Ecogreen | V | 4523 | 0 mm |

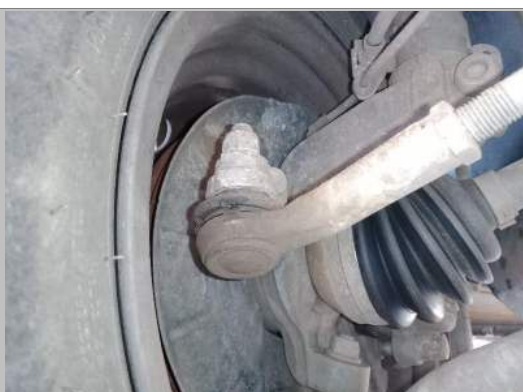
| Tie Rod End left Damaged | Replace |

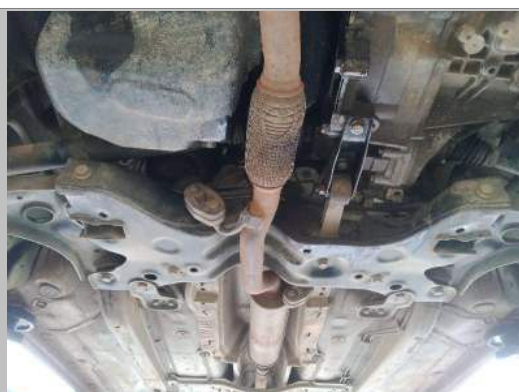
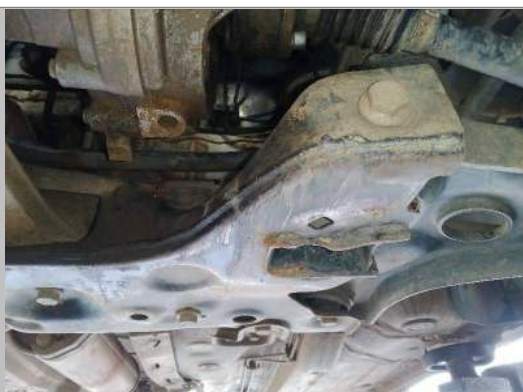
| Sub Frame Damaged | Repair |

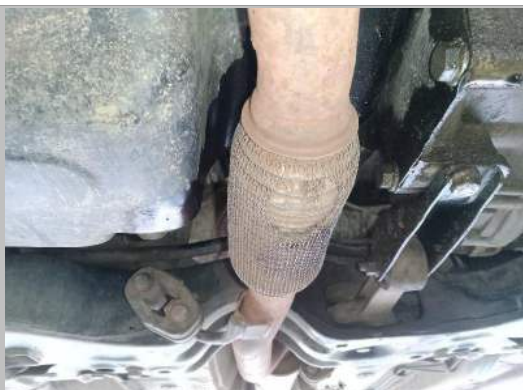
| Engine to silencer pipe Damaged | Repair |

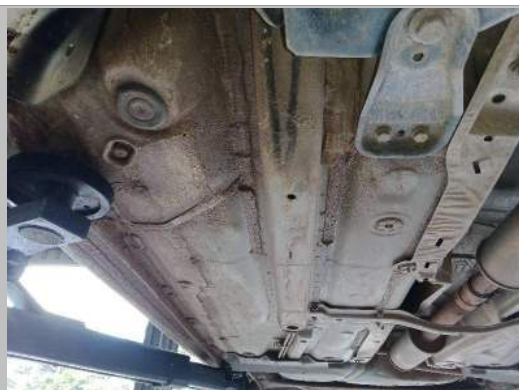
| Chassis Dented | Repair |

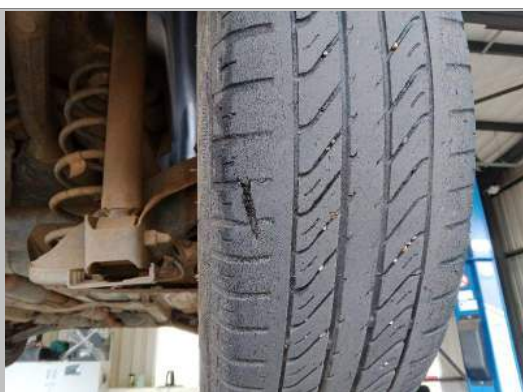
| Tyre Rear Right Damaged | Replace |

| | Size | Load/Speed Index | Manufacture | Model | Type* | Production Date | Tread Depth (mm) |
|---|---|---|---|---|---|---|---|
| Rear Right | 175/65 R14 | 82T | Dunlop | Sp-Sport | V | 4621 | 0 mm |

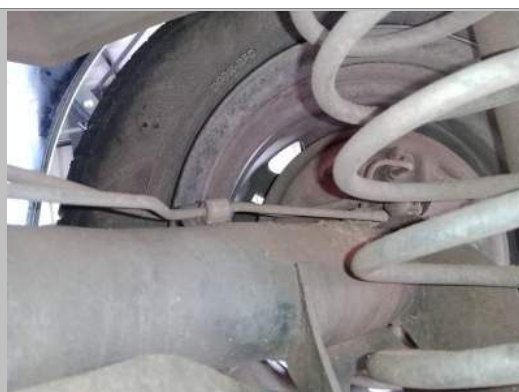
| Rear Axle Damaged | Replace |
