CONDITION REPORT

Report No: 2016255640

DATE
05/02/2024

Vehicle Type	PASSENGER VEHICLE	Registered Owner	MFC AUCTION HOUSE
Manufacturer	VOLKSWAGEN	Registration Number	FMG705L
Model	POLO VIVO	Register Number	
VIN	AAVZZZ6RZMU001395	Date Of First Licensing	
Engine Number		Last COR	
Doors	5	License Expiry Date	31/07/2024
Color	WHITE	Power / Displacement	
Year Model		Paint Finish	TWO COAT UNI
Km Reading	102,879 KM	Fuel	PETROL
Cab / Body Type	HATCHBACK	Transmission	MANUAL

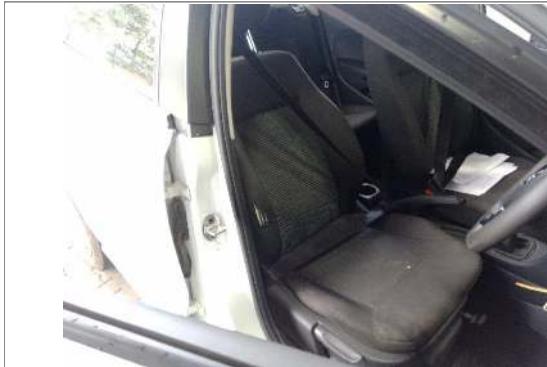
Damage	Repair Way
Engine Oil Sweat	Repair
Headlight Right Scratched	Repair
Seat Front Left Dirty	Repair
Seat Front Right Damaged	Repair
Seat Rear Dirty	Repair
Interior Mirror Loose / Excessive Play	Replace
Hood Lining Defective	Repair
Door Handle Rear Right Defective	Repair
Door Sealing Rubber Front Right Damaged	Replace
Parcel Tray Damaged	Replace
Steering Wheel Trim Defective	Repair
Number Plate Rear Dented	Repair
Front Bumper Damaged	Repair
Bonnet Paintwork • Chipmarks	Repair
Front Fender Left Paintwork • Scratched	Repair
Front Fender Right Dented	Repair
Rear Fender Left Paintwork • Scratched	Repair
Rear Fender Right Damaged	Repair
Door Front Left Damaged	Repair
Door Front Right Dented	Repair
Door Rear Left Damaged	Repair
Door Rear Right Damaged	Repair
Boot Lid / Hatch door Paintwork • Scratched	Repair
Rear bumper Paintwork • Scratched	Repair
Inner Boot Floor Pan and Spare Wheel Well Paintwork • Scratched	Repair

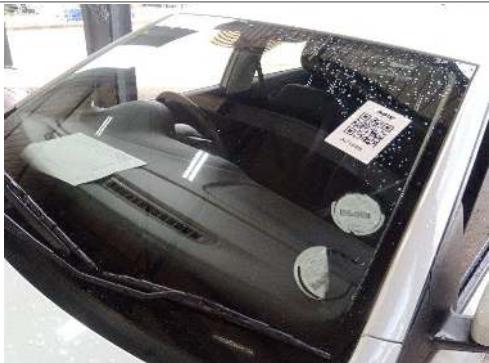
Damage	Repair Way
Windscreen Cracked	Replace
Brake disc 1. Axle right Defective	Replace
Service Brake Performance Rear Axle Left / Right	Repair
Difference out of legal range	Repair
Parking Brake Performance Left / Right Difference out of legal range	Repair
Stabilizer Mounting Front Left Defective	Replace
Control Arm Bush(es) Front Axle Left Cracked	Replace
Control Arm Bush(es) Front Axle Right Cracked	Replace
Tyre Rear Left Worn	Replace
Tyre Rear Right Damaged	Replace
Chassis Scratched	Repair
Sub Frame Dented	Repair
Engine to silencer pipe Defective	Repair
Belly plates Defective	Repair
Gearbox Oil Leak	Repair
CV Joint(s) Front Right (inner/outer) Defective	Repair
Radiator Cradle Damaged	Replace

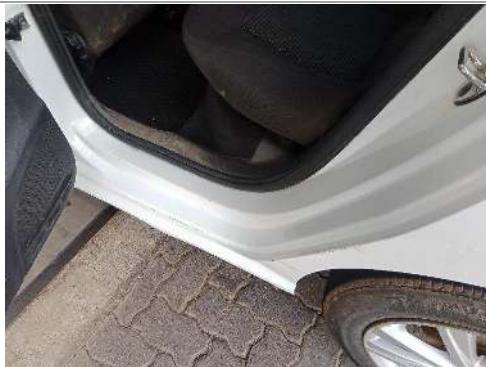
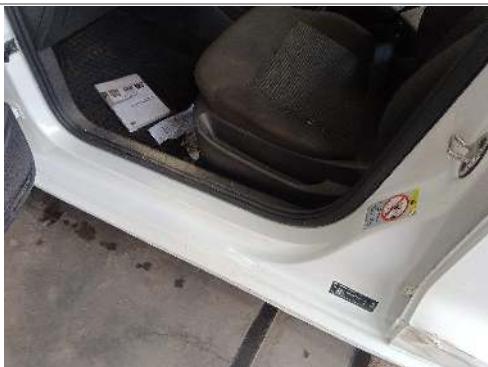
Sill Panel Left Paintwork • Scratched	Repair
Rocker Panel Left Damaged	Repair
Rocker Panel Right Damaged	Repair

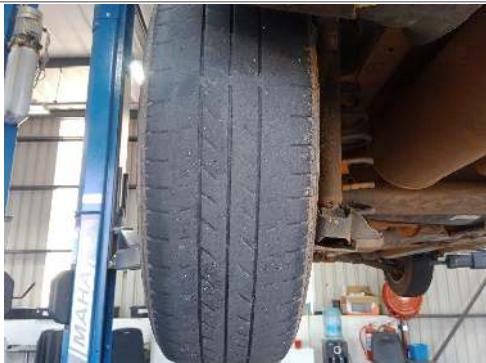
Tyre Rear Left

Size	Load/Speed Index	Manufacture	Model	Type*	Production Date	Tread Depth (mm)
Front Left	185/65 R15	88H	Bridgestone	B250	V	3419	1 mm
Front Right	185/65 R15	88H	Bridgestone	B250	V	3319	2 mm
Rear Left	185/65 R15	88H	Bridgestone	B250	V	3419	0 mm
Rear Right	185/60 R15	88H	Firestone	Touring	V	4222	0 mm
