## CONDITION REPORT

Report No:  
2017287377  
DATE  
20/08/2026

| Manufacturer | VOLKSWAGEN | Registration Number | JX57BDGP |
| Model | POLO VIVO 1.4 55KW TRENDLINE 5-DR [2020-2022] | Register Number | |

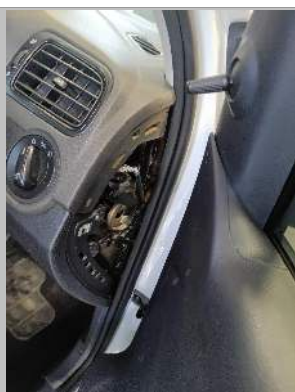
Sider cover missing

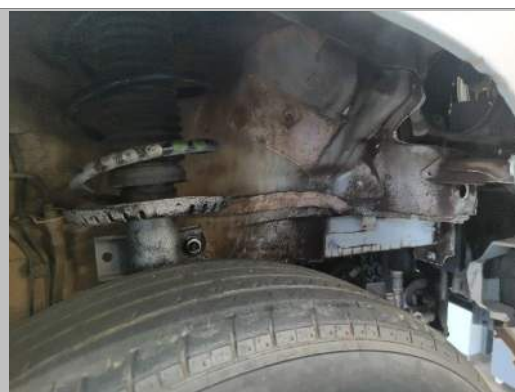
R/F fender liner missing

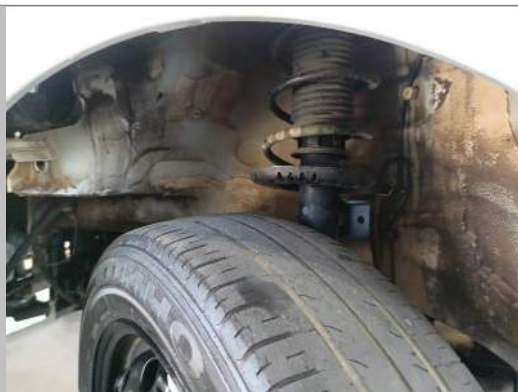
L/F fender liner missing

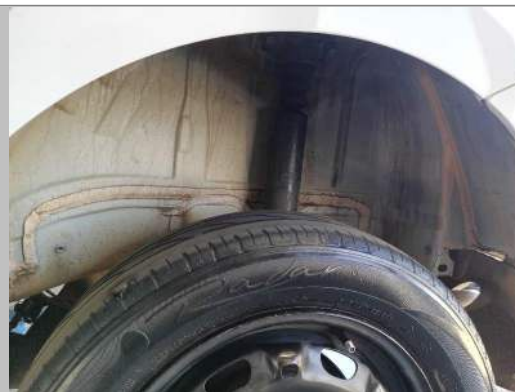
L/R fender liner missing

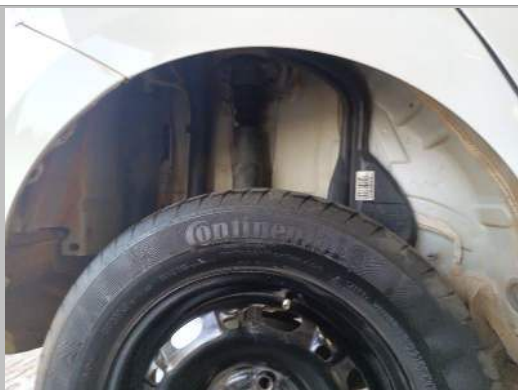
R/R fender liner missing

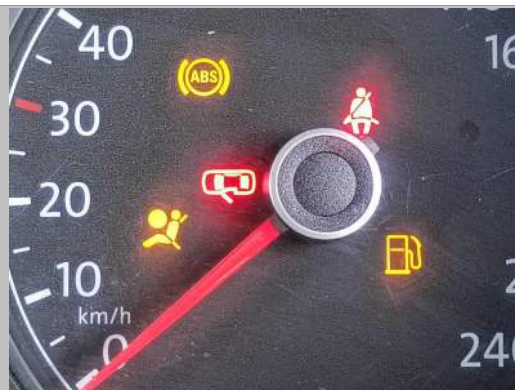
| Damage | Repair Way |
|---|---|
| Warning lights illuminated | Repair |

Warning lights illuminated

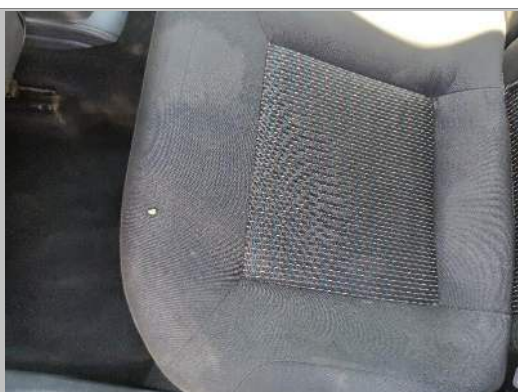
| Damage | Repair Way |
|---|---|
| Seat Rear Torn / Cut | Repair |

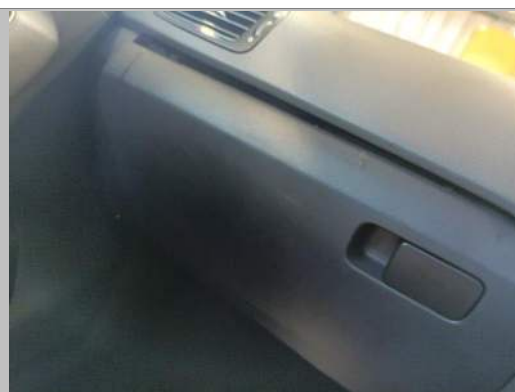
| Damage | Repair Way |
|---|---|
| Center Console / Cubbyhole + Lid Damaged | Repair |

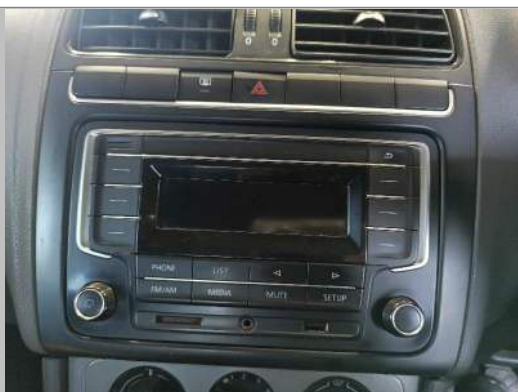
| Damage | Repair Way |
|---|---|
| Radio/CD/USB Defective | Repair |

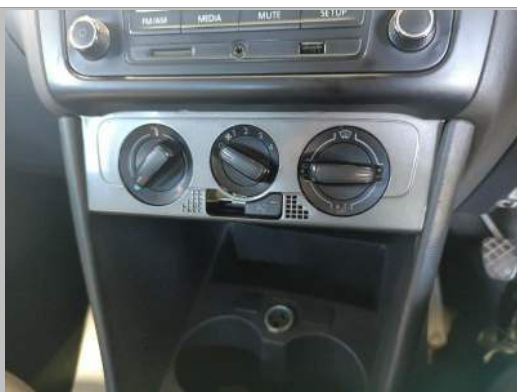
| Damage | Repair Way |
|---|---|
| Air Conditioner Insufficient | Repair |

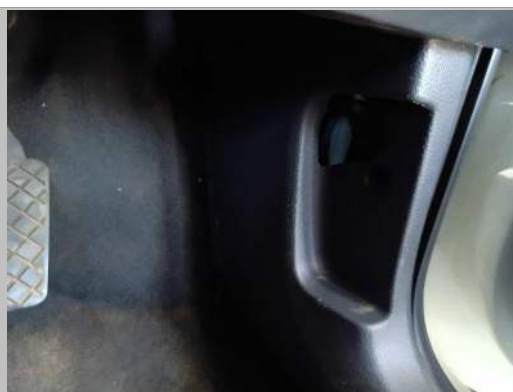
| Damage | Repair Way |
|---|---|
| Bonnet cable Missing | Repair |

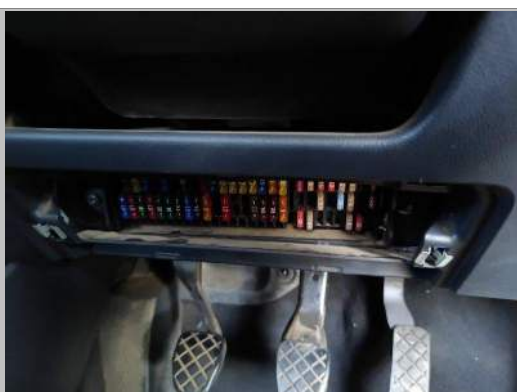
| Damage | Repair Way |
|---|---|
| Fuse box and fuses Defective | Repair |

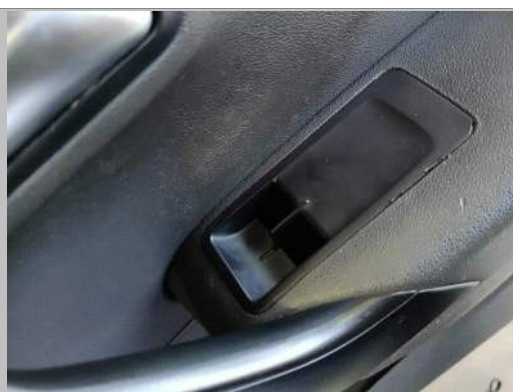
| Damage | Repair Way |
|---|---|
| Switch Electrical Window Winder front right Missing | Replace |

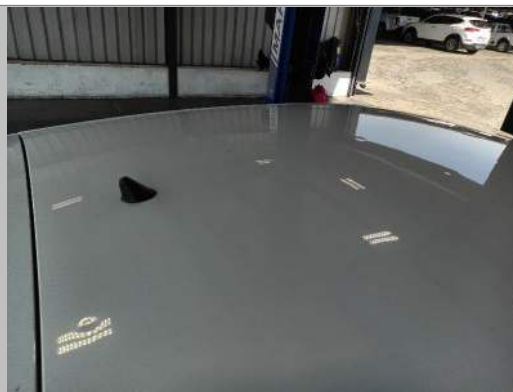
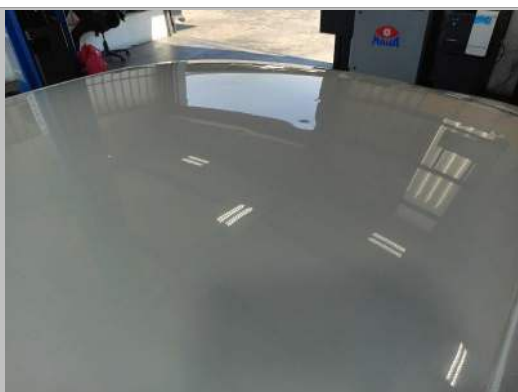
| Damage | Repair Way |
|---|---|
| Roof Dented | Repair |

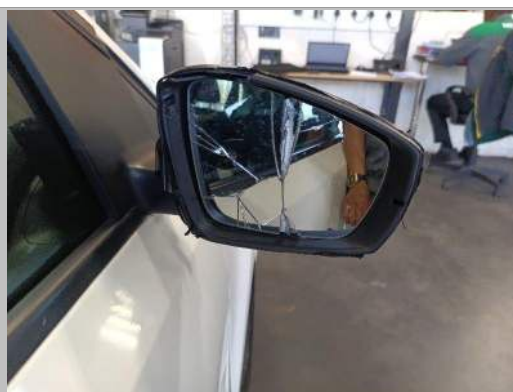
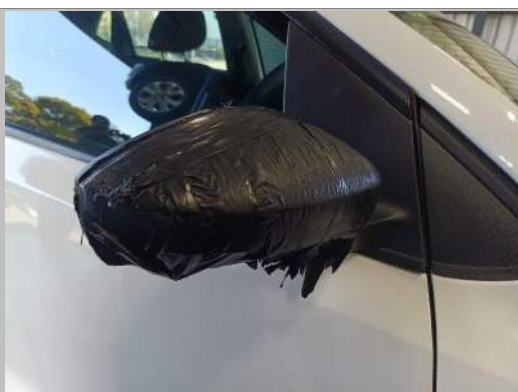
| Damage | Repair Way |
|---|---|
| Side Mirror Right Damaged | Replace |

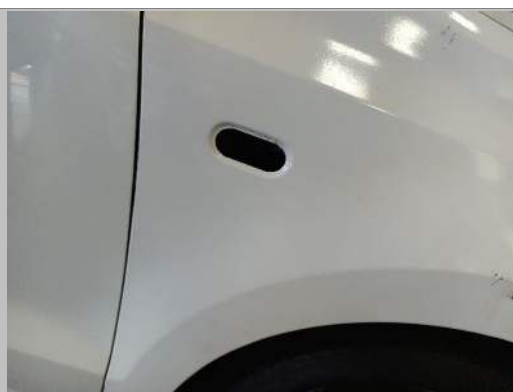
| Damage | Repair Way |
|---|---|
| Indicator Light Front Right Missing | Replace |

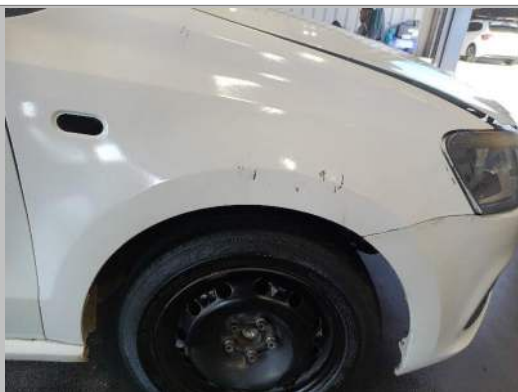
| Damage | Repair Way |
|---|---|
| Front Fender Right Residual Traces of Repair | Repair |

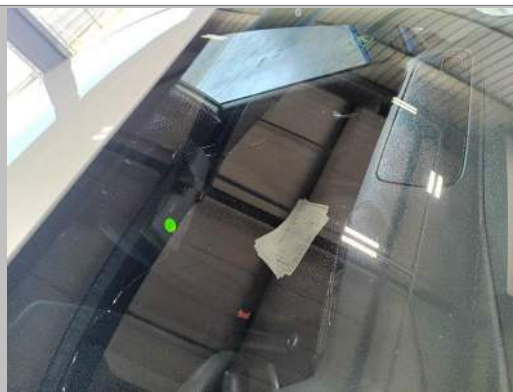
| Damage | Repair Way |
|---|---|
| Windscreen Cracked | Replace |

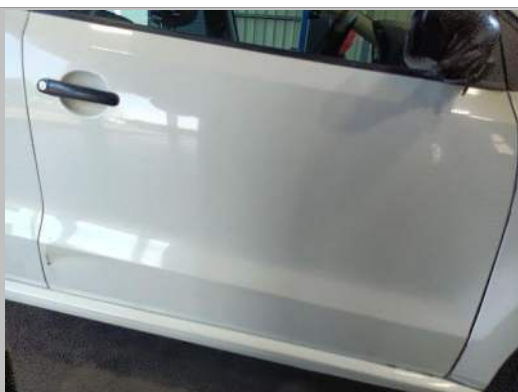
| Damage | Repair Way |
|---|---|
| Door Rear Right Dented | Repair |

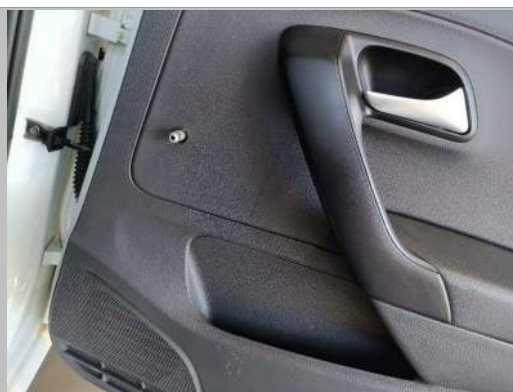
| Damage | Repair Way |
|---|---|
| Window Winder rear right Missing | Replace |

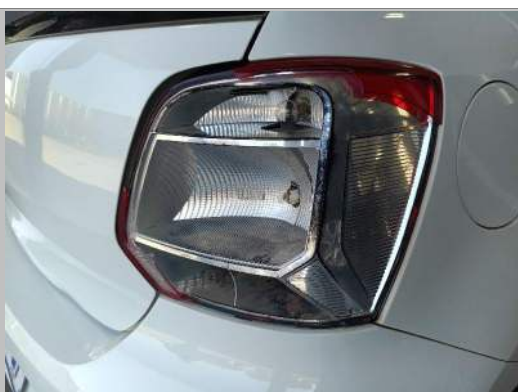
| Damage | Repair Way |
|---|---|
| Tail Light Right Damaged | Replace |

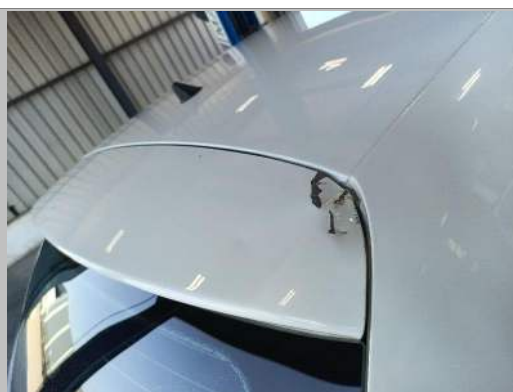
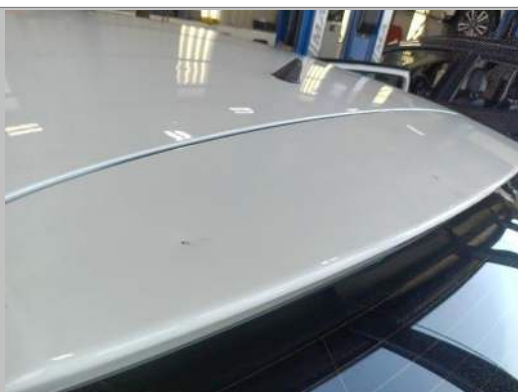
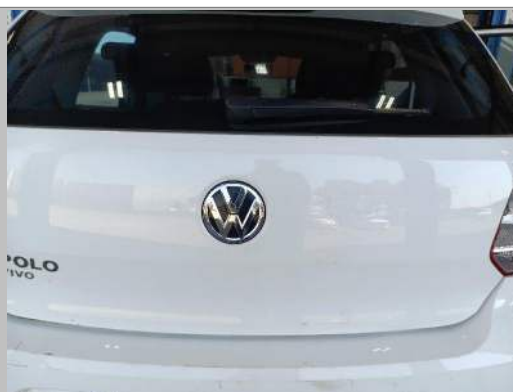
| Damage | Repair Way |
|---|---|
| Boot Lid / Hatch door Dented | Repair |

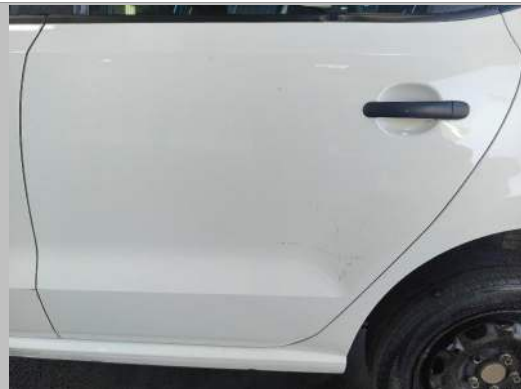
| Damage | Repair Way |
|---|---|
| Door Rear Left Paintwork • Scratched | Repair |

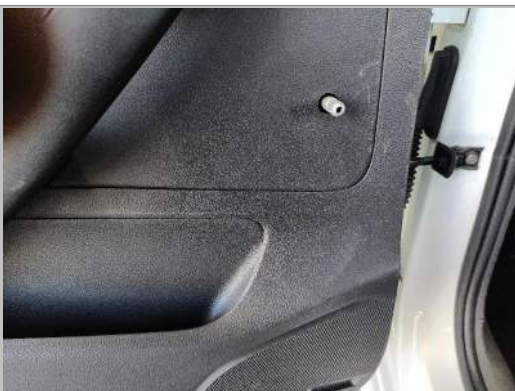
| Damage | Repair Way |
|---|---|
| Window Winder rear left Missing | Replace |

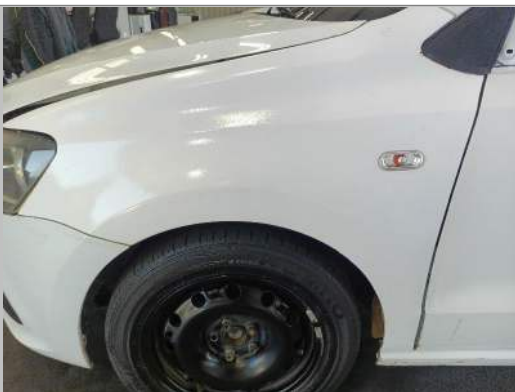
| Damage | Repair Way |
|---|---|
| Front Fender Left Residual Traces of Repair | Repair |

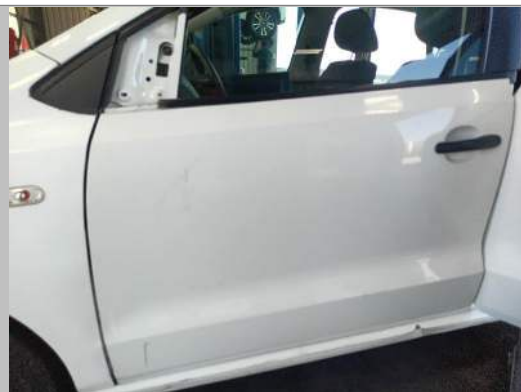
| Damage | Repair Way |
|---|---|
| Door Front Left Paintwork • Scratched | Repair |

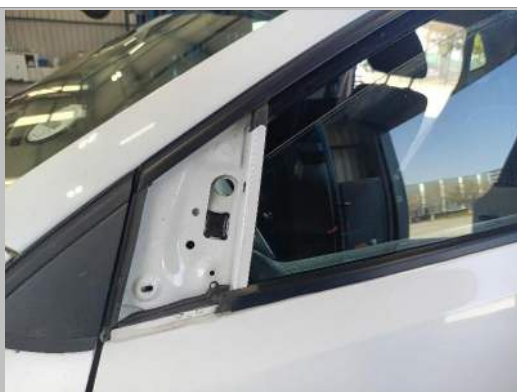
| Damage | Repair Way |
|---|---|
| Side Mirror Left Damaged | Replace |

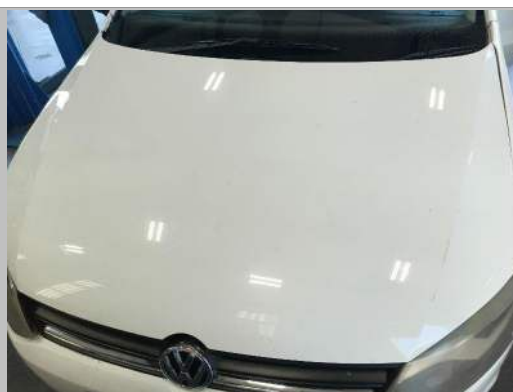
| Damage | Repair Way |
|---|---|
| Bonnet Paintwork • Scratched | Repair |

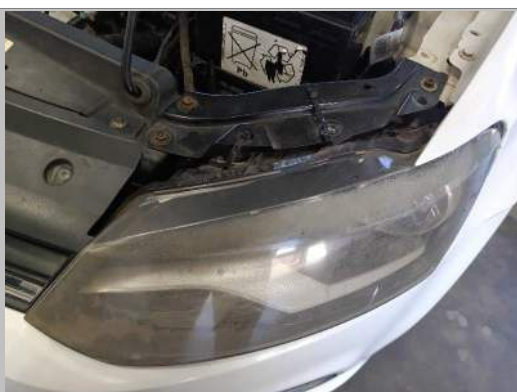
| Damage | Repair Way |
|---|---|
| Headlight Left Damaged | Replace |

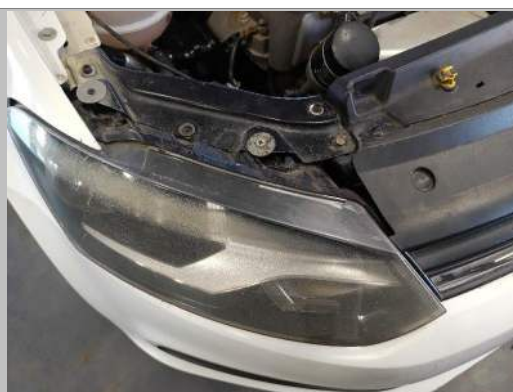
| Damage | Repair Way |
|---|---|
| Headlight Right Damaged | Replace |

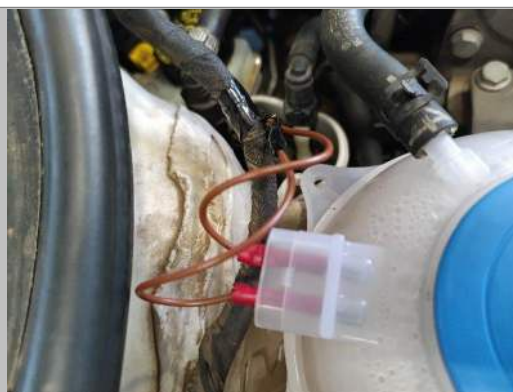
| Damage | Repair Way |
|---|---|
| Engine Wiring Defective | Repair |

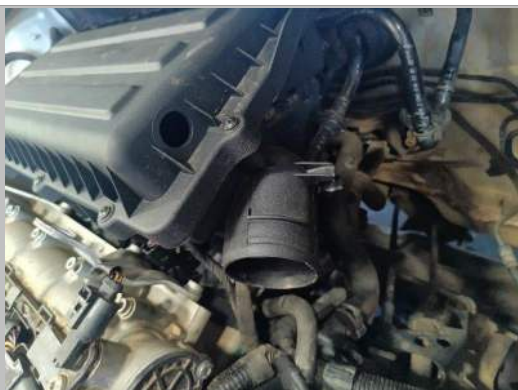
| Damage | Repair Way |
|---|---|
| Air cleaner Defective | Repair |

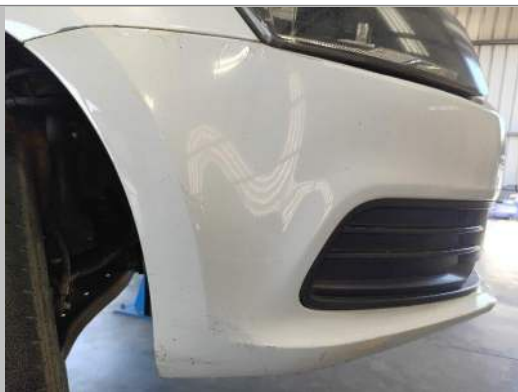
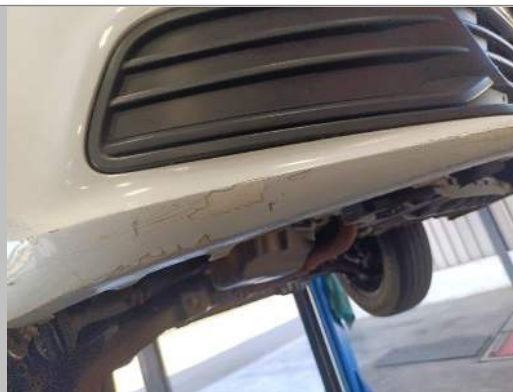
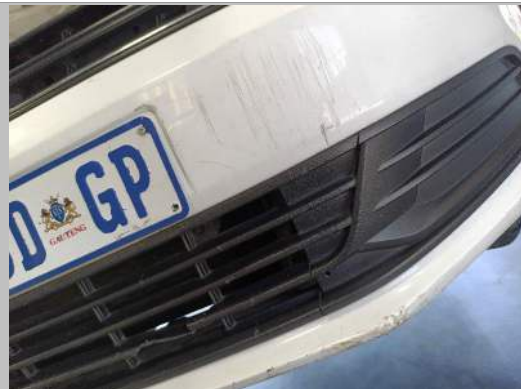
| Damage | Repair Way |
|---|---|
| Front Bumper Paintwork • Scratched | Repair |

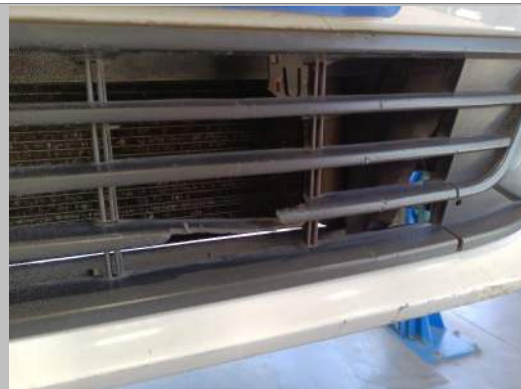
| Damage | Repair Way |
|---|---|
| Grill Damaged | Replace |

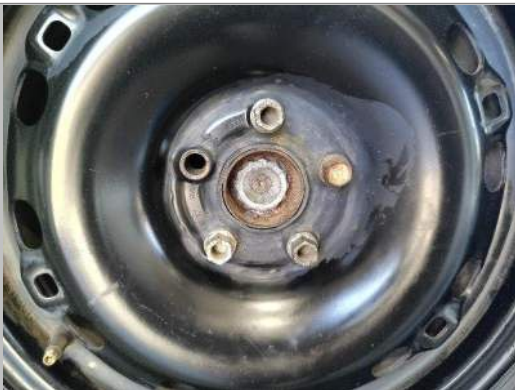
| Damage | Repair Way |
|---|---|
| Bolt(s) / Nut(s) Front Wheel Left Missing | Replace |

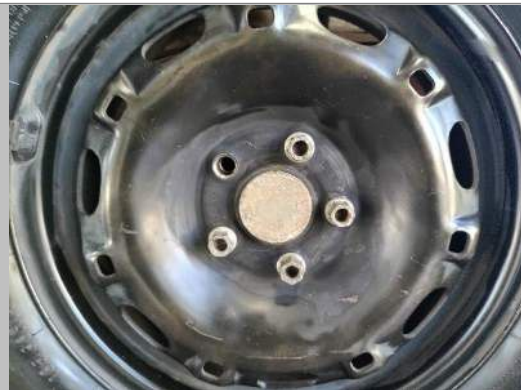
| Damage | Repair Way |
|---|---|
| Bolt(s) / Nut(s) Rear Wheel Left Missing | Replace |

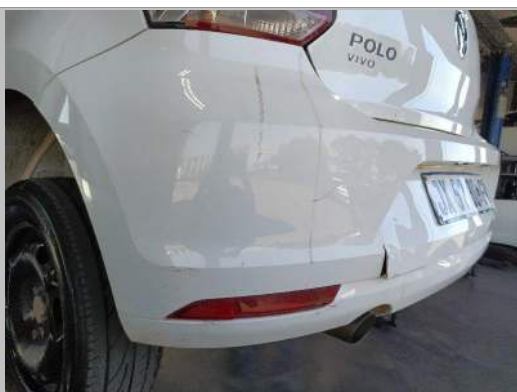
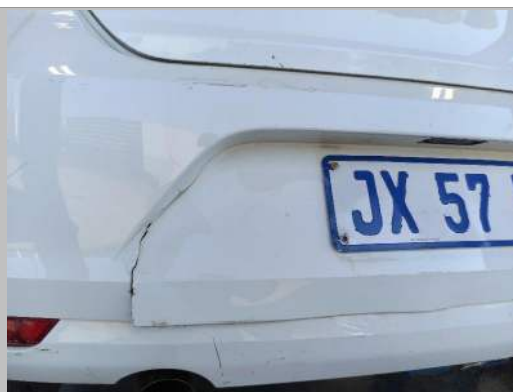
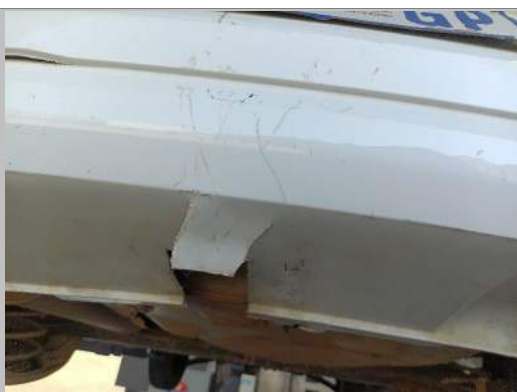
| Damage | Repair Way |
|---|---|
| Rear bumper Damaged | Repair |

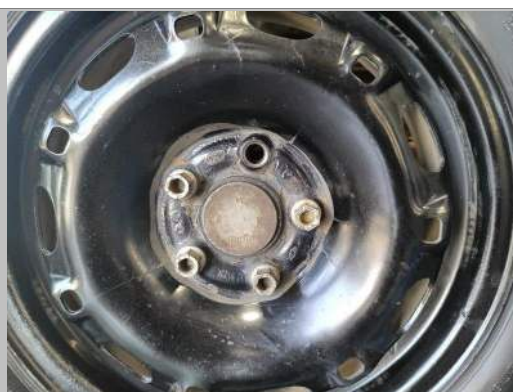
| Damage | Repair Way |
|---|---|
| Bolt(s) / Nut(s) Rear Wheel Right Missing | Replace |

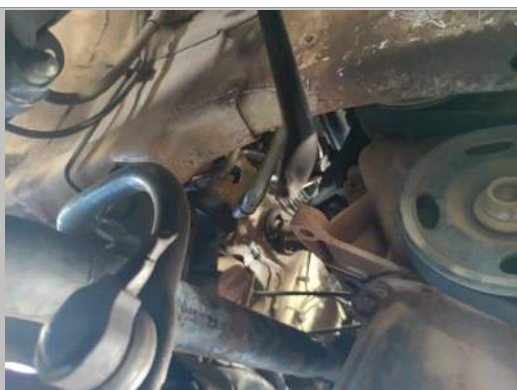
| Damage | Repair Way |
|---|---|
| Stabilizer Mounting Front Right Damaged | Replace |

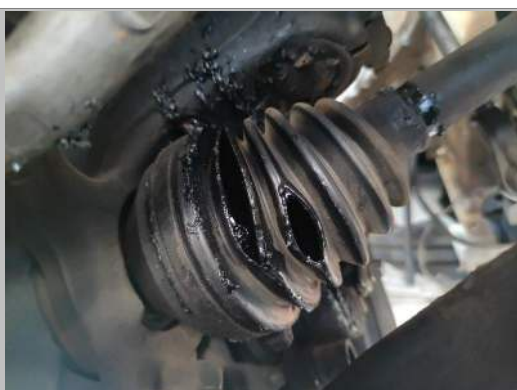
| Damage | Repair Way |
|---|---|
| CV Joint(s) Boot(s) Front Left (inner/outer) Damaged | Replace |

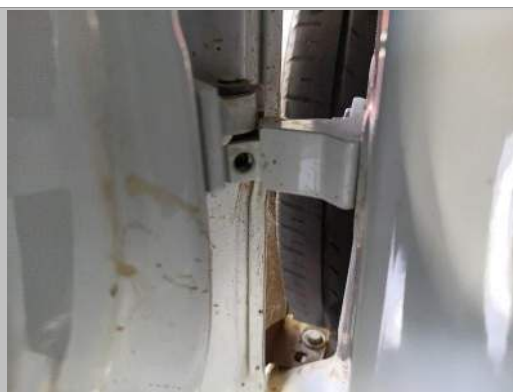
| Damage | Repair Way |
|---|---|
| Door Hinges Front Left Defective | Replace |

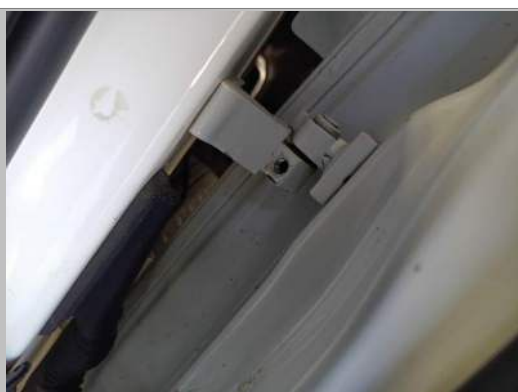
| Damage | Repair Way |
|---|---|
| Door Hinges Front Right Defective | Replace |

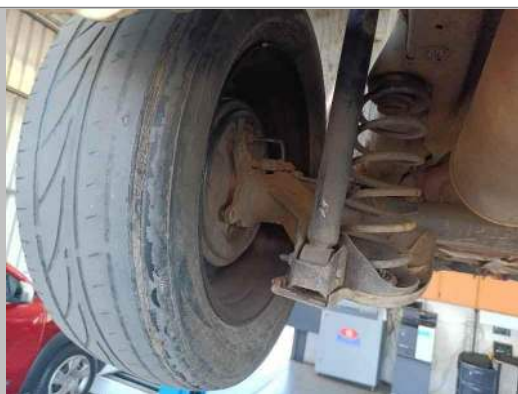
| Damage | Repair Way |
|---|---|
| Tyre Rear Left Worn | Replace |

| | Size | Load/Speed Index | Manufacture | Model | Type* | Production Date | Tread Depth (mm) |
|---|---|---|---|---|---|---|---|
| Rear Left | 185/60R14 | 86H | Radar | RPX | V | 1420 | 0 mm |
