MFC Auction House  
M57 Pretoria Rd, Glenmarais, KEMPTON PARK  
Gauteng

## Assignment

| Manufacturer | VOLKSWAGEN | Registration Number | KTC357NW |
| Model | POLO VIVO | Register Number | |

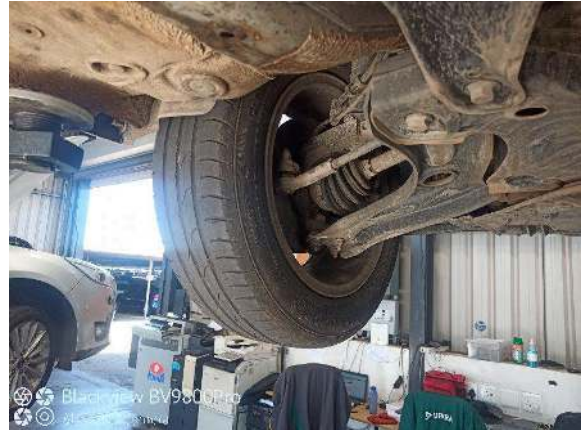
LF TYRE TREAD

| | Size | Load/Speed Index | Manufacture | Model | Type* | Production Date | Tread Depth (mm) |
|---|---|---|---|---|---|---|---|
| Front Left | 185/60R15 | 84H | Continental | Contact | V | 2622 | 2 mm |

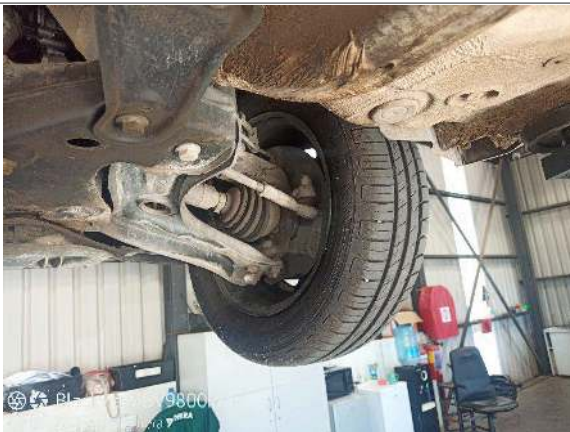
RF TYRE TREAD

| | Size | Load/Speed Index | Manufacture | Model | Type* | Production Date | Tread Depth (mm) |
|---|---|---|---|---|---|---|---|
| Front Right | 185/60R14 | 82H | Goodyear | Efficientgri | V | 1522 | 4 mm |

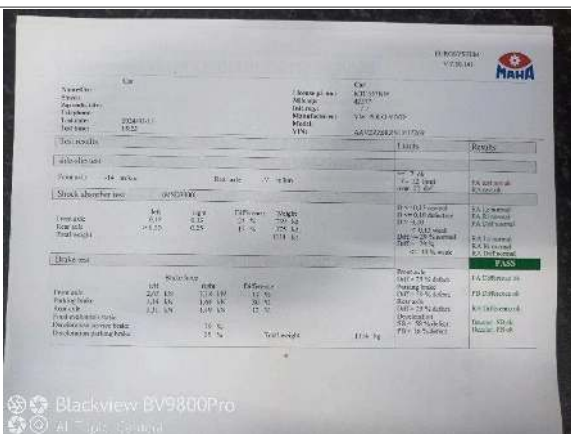
SHOCK &amp; BRAKE REPORT

| | Left | Right | Axle Weight [KG] | Deceleration [m/s <sup>2</sup> ] |
|---|---|---|---|---|
| Front | 2.6 | 3.1 | - | |
| Rear | 1.3 | 1.4 | - | |
| Emergency / Parking | 1.1 | 1.6 | - | |

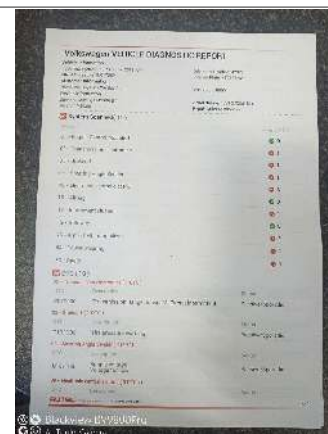
DIAGNOSTIC REPORT PAGE 1

During the diagnostic no active error messages were detected. (See also attached Diagnostic Report. For more information regarding the Fault Codes (DTC) and the recommended rectifications please contact the workshops of the vehicle manufacture).

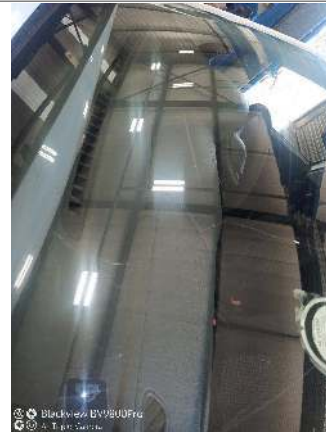
| Damage | Repair Way |
|---|---|
| Windscreen Cracked | Replace |

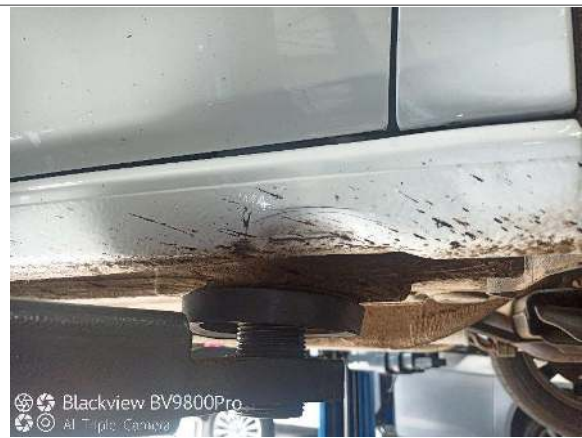
| Damage | Repair Way |
|---|---|
| Sill Panel Right Dented | Repair |
