CONDITION REPORT

Report No:  
2017303131  
DATE  
25/09/2026

| Manufacturer | VOLKSWAGEN | Registration Number | KTZ298NW |
| Model | POLO VIVO 1.4 63KW COMFORTLINE 5-DR [2022-2024] | Register Number | |

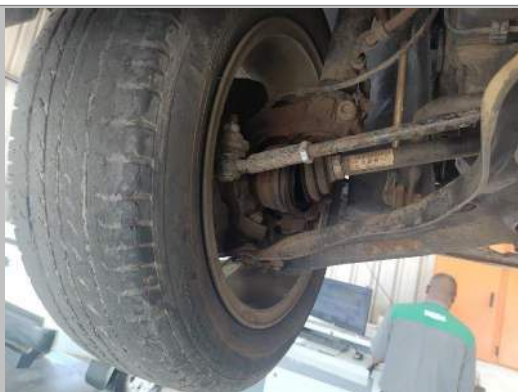
LF TYRE TREAD

| | Size | Load/Speed Index | Manufacture | Model | Type* | Production Date | Tread Depth (mm) |
|---|---|---|---|---|---|---|---|
| Front Left | 185/60R15 | 84H | Michelin | Energy | V | 0617 | 0 mm |

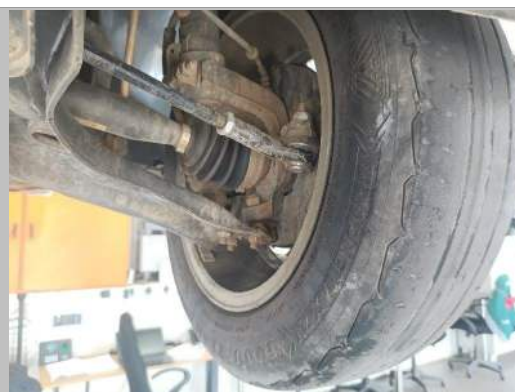
RF TYRE TREAD

| | Size | Load/Speed Index | Manufacture | Model | Type* | Production Date | Tread Depth (mm) |
|---|---|---|---|---|---|---|---|
| Front Right | 185/65R15 | 88H | Goodyear | Triplemax | V | | 0 mm |

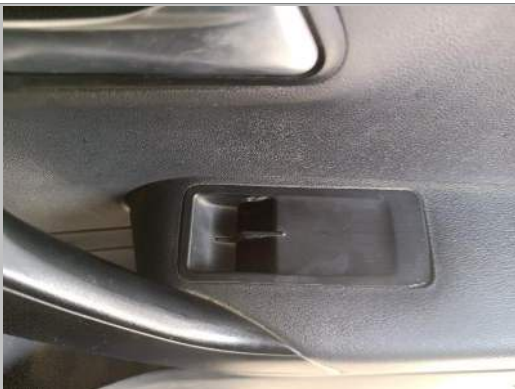
| Damage | Repair Way |
|---|---|
| Switch Electrical Window Winder front right Missing | Replace |

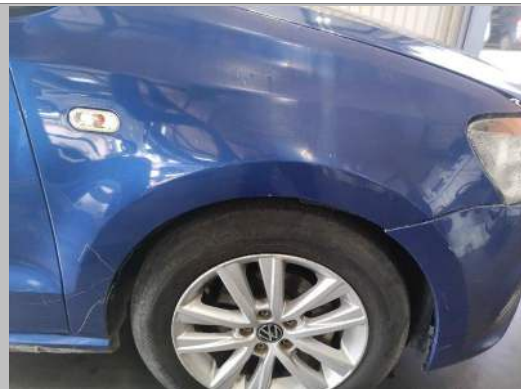
| Damage | Repair Way |
|---|---|
| Front Fender Right Residual Traces of Repair | Repair |

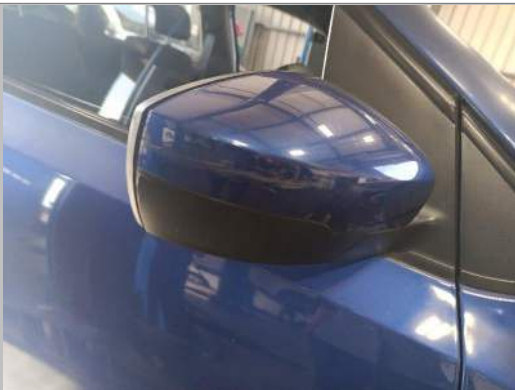
| Damage | Repair Way |
|---|---|
| Side Mirror Right Paintwork • Scratched | Repair |

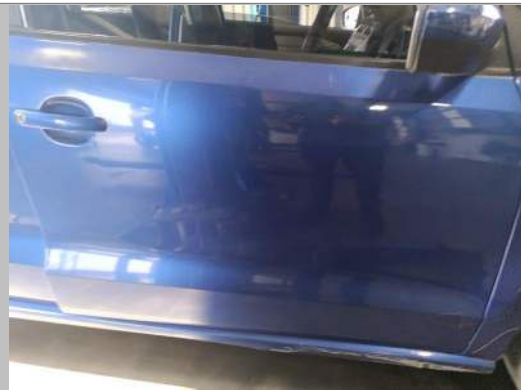
| Damage | Repair Way |
|---|---|
| Door Front Right Residual Traces of Repair | Repair |

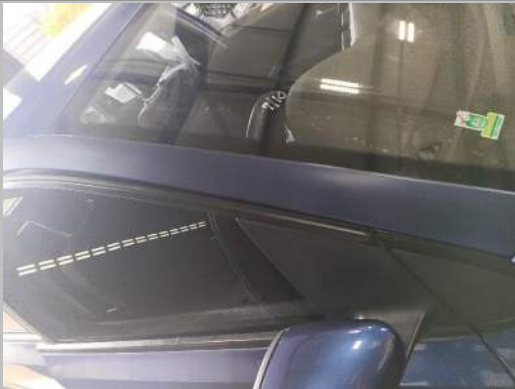
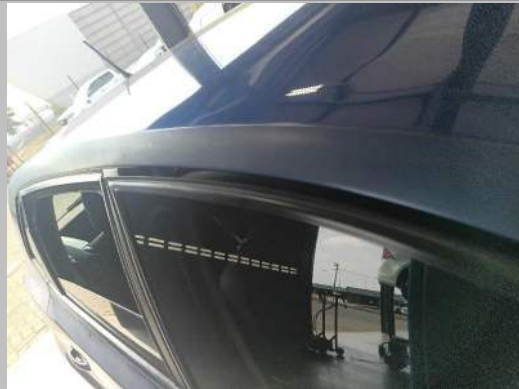
| Damage | Repair Way |
|---|---|
| A • Pillar Right Residual Traces of Repair | Repair |

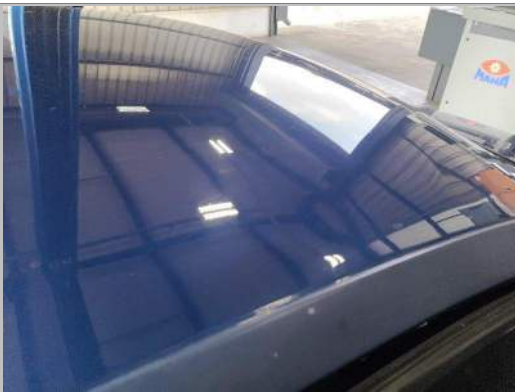
| Damage | Repair Way |
|---|---|
| Roof Dented | Repair |

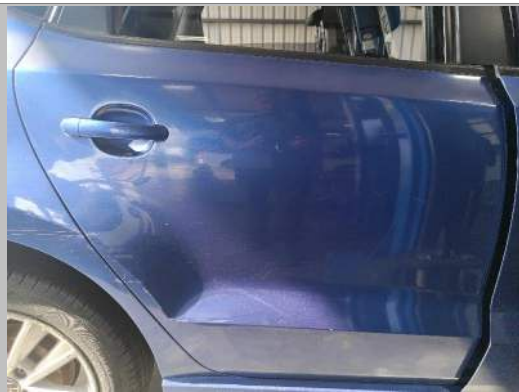
| Damage | Repair Way |
|---|---|
| Door Rear Right Residual Traces of Repair | Repair |

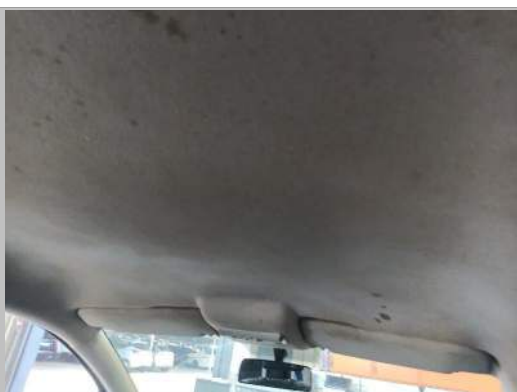
| Damage | Repair Way |
|---|---|
| Hood Lining Dirty | Repair |

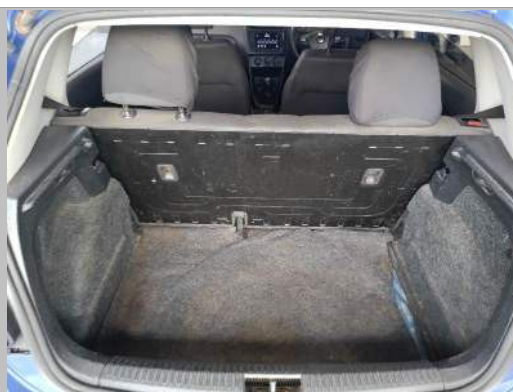
| Damage | Repair Way |
|---|---|
| Parcel Tray Missing | Replace |

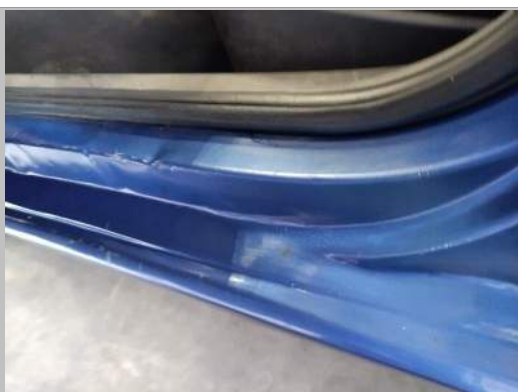
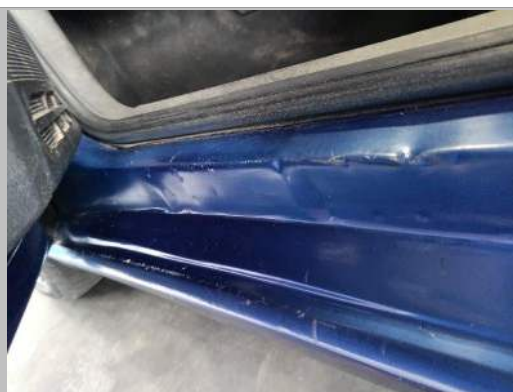
| Damage | Repair Way |
|---|---|
| Sill Panel Left Residual Traces of Repair | Repair |

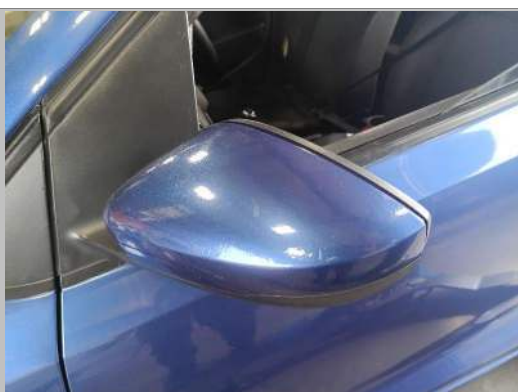
| Damage | Repair Way |
|---|---|
| Side Mirror Left Residual Traces of Repair | Repair |

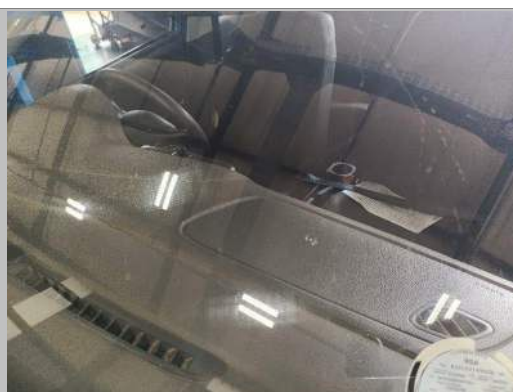
| Damage | Repair Way |
|---|---|
| Windscreen Chipped | Replace |

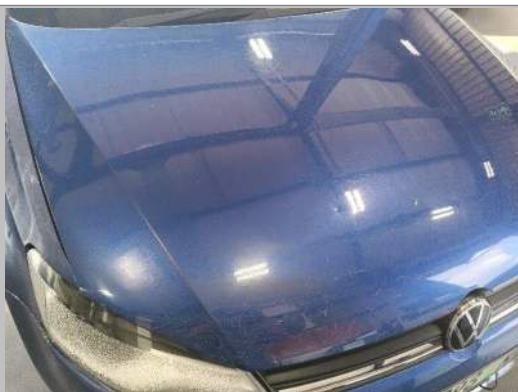
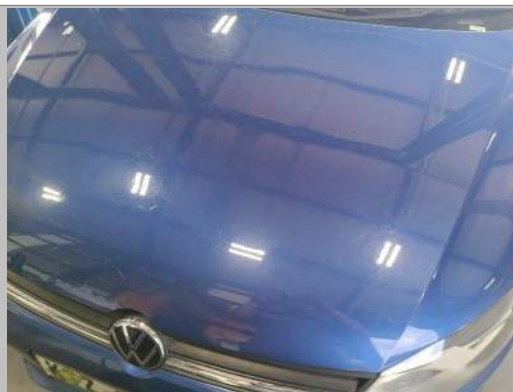
| Damage | Repair Way |
|---|---|
| Bonnet Paintwork • Scratched | Repair |

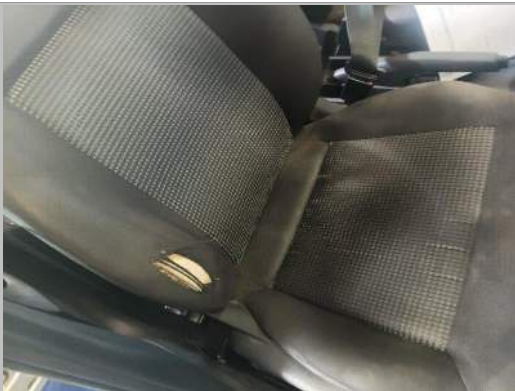
| Damage | Repair Way |
|---|---|
| Seat Front Right Torn / Cut | Repair |

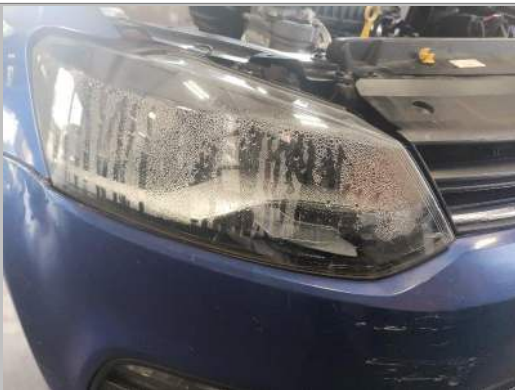
| Damage | Repair Way |
|---|---|
| Headlight Right Damaged | Replace |

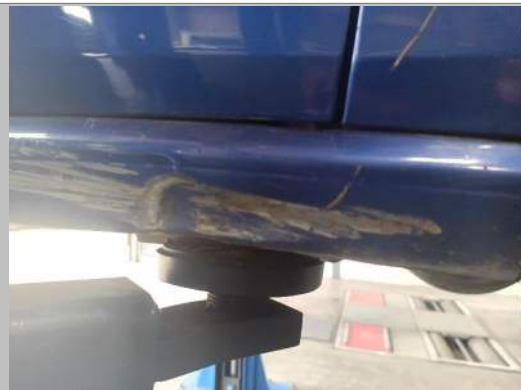
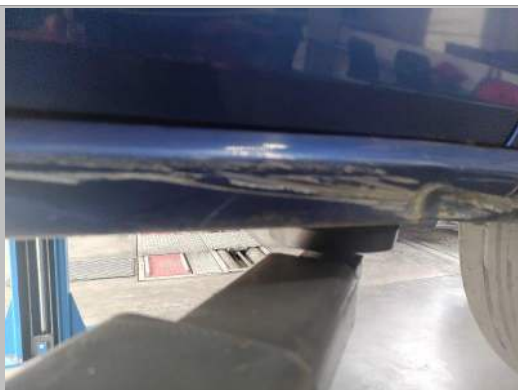
| Damage | Repair Way |
|---|---|
| Sill Panel Right Dented | Repair |

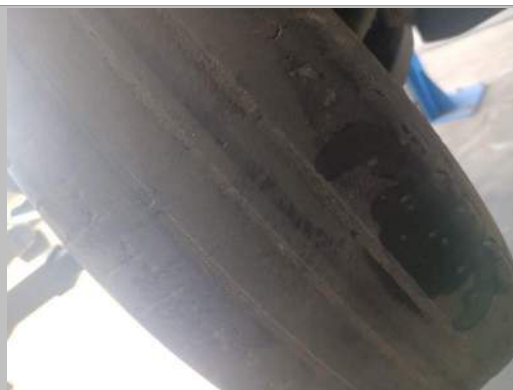
| Damage | Repair Way |
|---|---|
| Tyre Front Right Smooth | Replace |

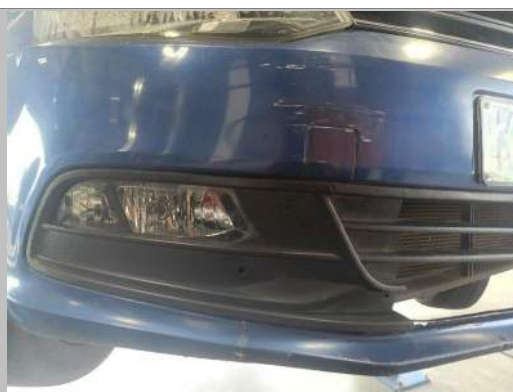
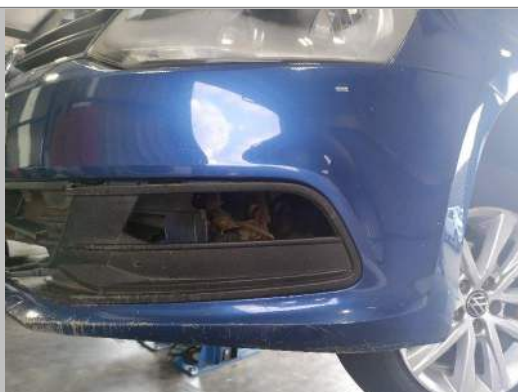
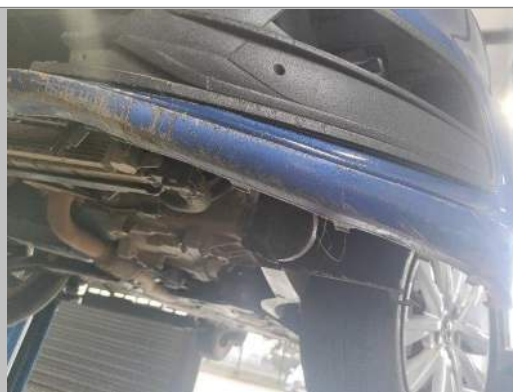
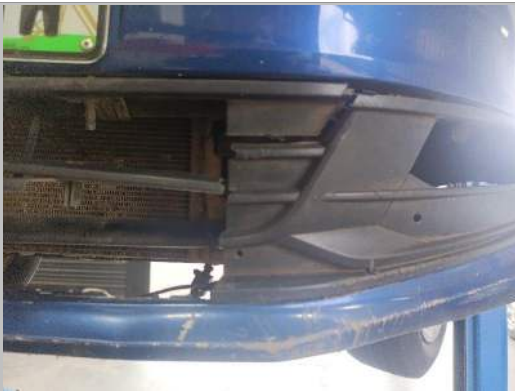
| Damage | Repair Way |
|---|---|
| Front Bumper Paintwork • Scratched | Repair |

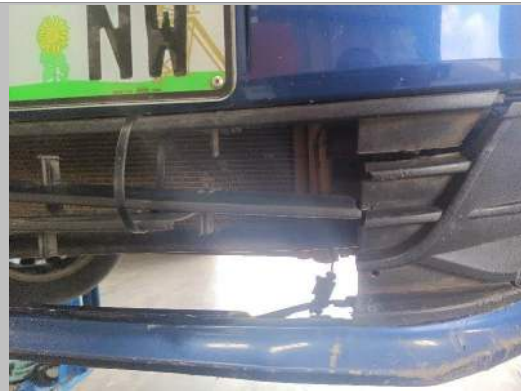
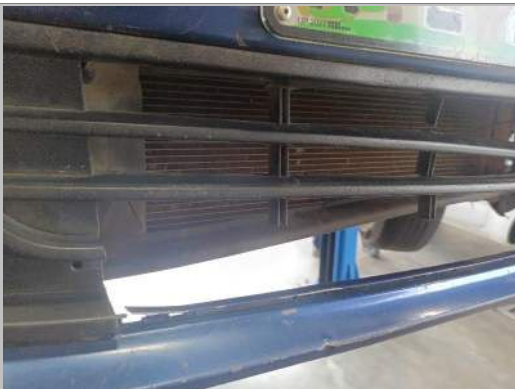
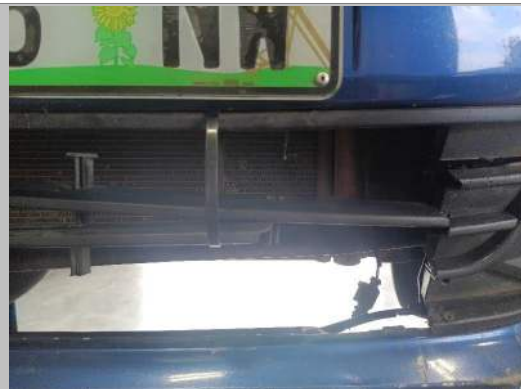
| Damage | Repair Way |
|---|---|
| Grill Damaged | Replace |

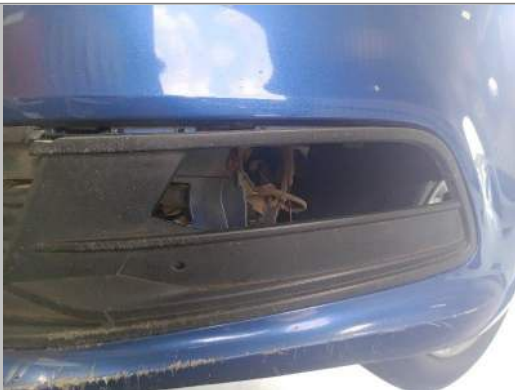
| Damage | Repair Way |
|---|---|
| Fog Light Front Left Missing | Replace |

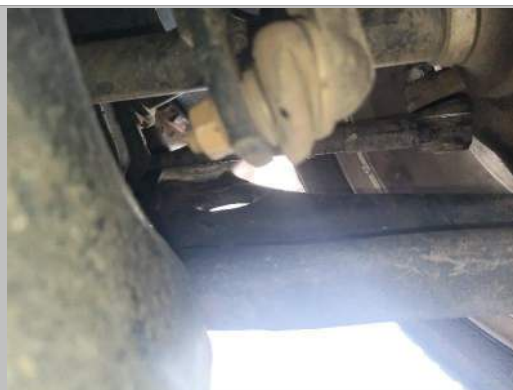
| Damage | Repair Way |
|---|---|
| Stabilizer Mounting Front Left Damaged | Replace |

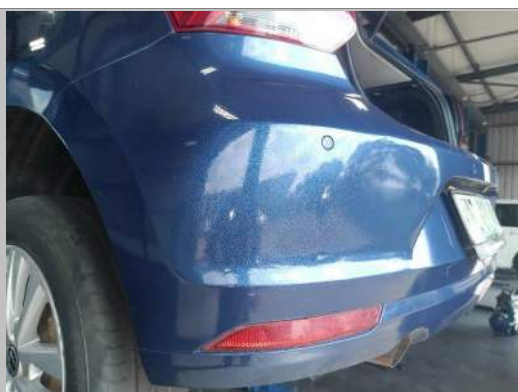
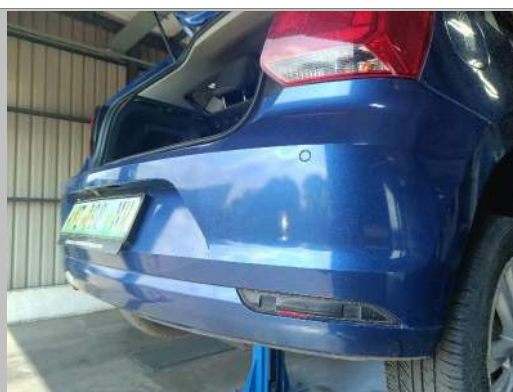
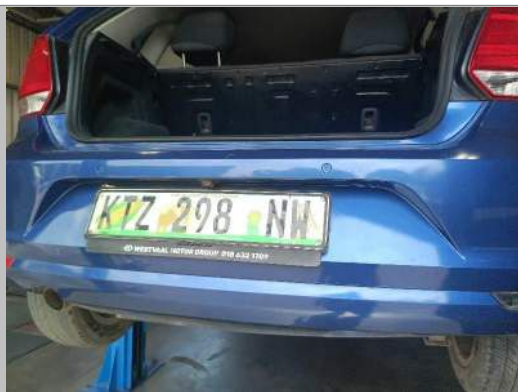
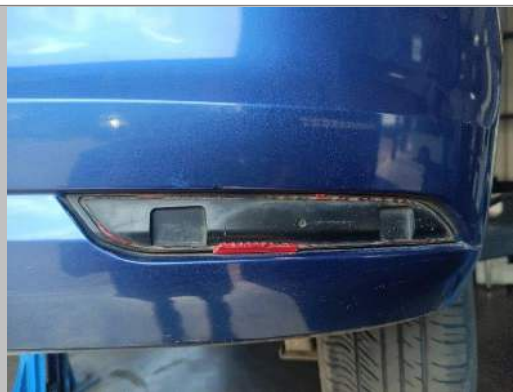
| Damage | Repair Way |
|---|---|
| Rear bumper Residual Traces of Repair | Replace |

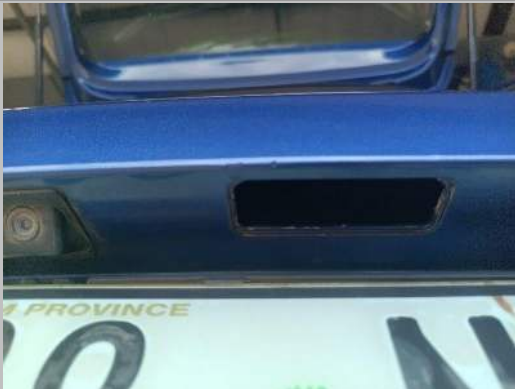
| Damage | Repair Way |
|---|---|
| Number Plate Light Right Missing | Replace |

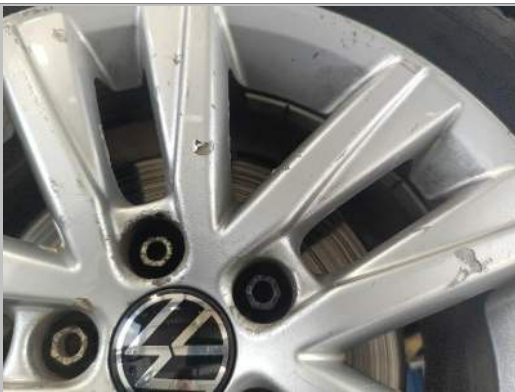
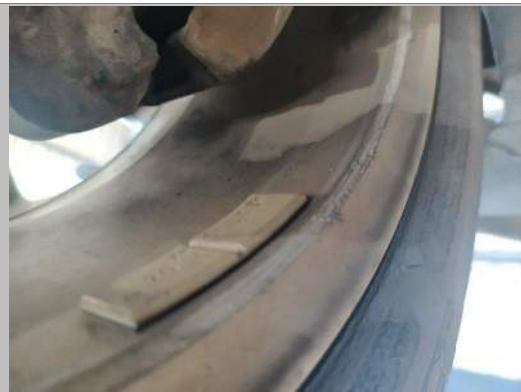
| Damage | Repair Way |
|---|---|
| Rim Front Left Scratched | Repair |

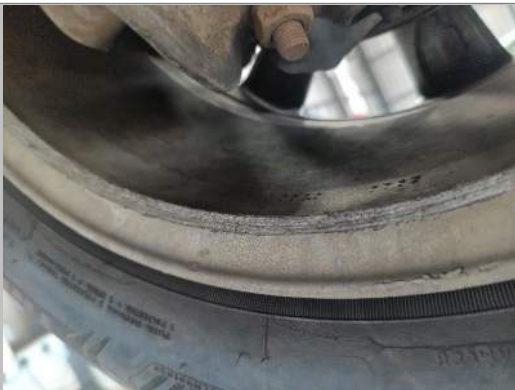
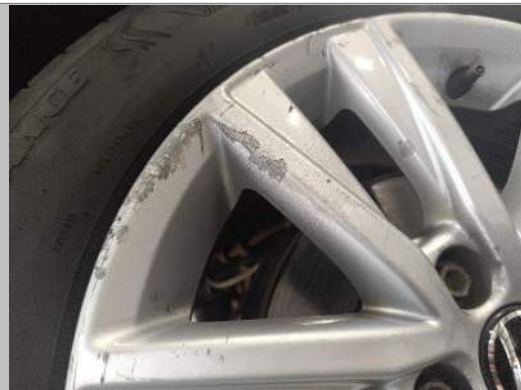
| Damage | Repair Way |
|---|---|
| Rim Front Right Scratched | Repair |

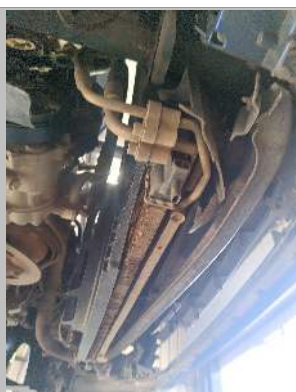
| Damage | Repair Way |
|---|---|
| Radiator Cross Member Damaged | Repair |

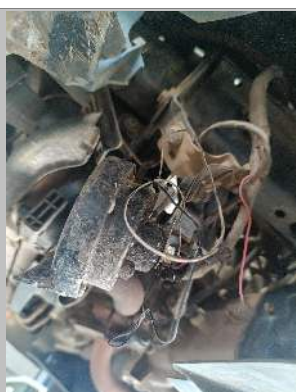
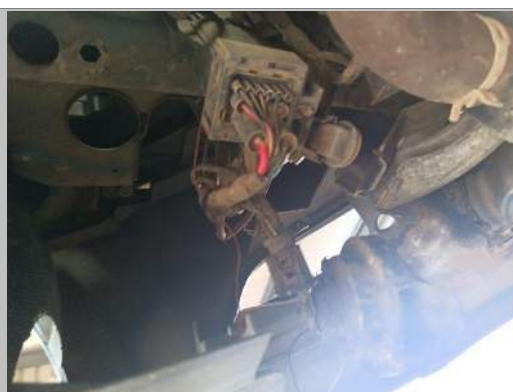
| Damage | Repair Way |
|---|---|
| Engine Wiring Defective | Repair |
