CONDITION REPORT

Report No: 2016842116

MFC Auction House  
M57 Pretoria Rd, Glenmarais, KEMPTON PARK  
Gauteng

Vehicle Type	PASSENGER VEHICLE	Registered Owner	
Manufacturer	VOLKSWAGEN	Registration Number	KX33LXGP
Model	POLO VIVO 1.4 63KW COMFORTLINE 5-DR [2022-2024]	Register Number	
VIN	AAVZZZ6RZPU002991	Date Of First Licensing	
Engine Number		Last COR	
Doors	5	License Expiry Date	30/11/2025
Color	WHITE	Power / Displacement	
Year Model	2022	Paint Finish	C - COMMON
Km Reading	76,488 KM	Fuel	PETROL
Cab / Body Type	HATCHBACK	Transmission	MANUAL

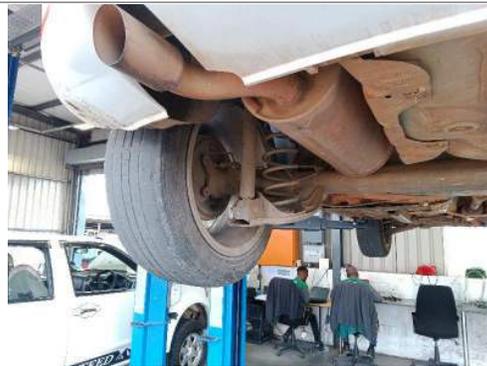
LR TYRE TREAD

Size	Load/Speed Index	Manufacture	Model	Type*	Production Date	Tread Depth (mm)
Front Left	195/55R16	91V	Continental	Contact	V	0322	3 mm
Front Right	195/55R16	91V	Continental	Contact	V	3822	3 mm
Rear Left	195/55R16	87V	Hilo	Genesys	V	4020	0 mm
Rear Right	195/55R16	91V	Continental	Contact	V	3722	3 mm
Spare	175/70R14	84T	Firestone	Touring	V	0000	2 mm

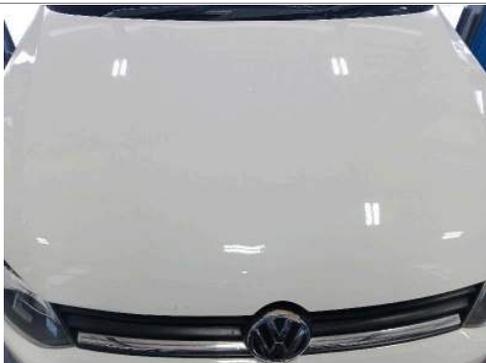
Damage	Repair Way
Tail Light Left Damaged	Replace
Dim Light Left Malfunction	Repair
Fog Light Front Right Malfunction	Repair
Front Bumper Paintwork • Scratched	Repair
Bonnet Paintwork • Pitmarks	Repair
Front Fender Right Dented	Repair
Rear Fender Left Paintwork • Scratched	Repair
Rear Fender Right Dented	Repair
Door Front Left Paintwork • Scratched	Repair
Door Front Right Paintwork • Scratched	Repair
Door Rear Left Paintwork • Scratched	Repair
Door Rear Right Paintwork • Scratched	Repair
Rear bumper Paintwork • Scratched	Repair
Roof Paintwork • Pitmarks	Repair
Windscreen Cracked	Repair
Parking Brake Performance Left / Right Difference out of legal range	Repair
Tyre Rear Left Smooth	Repair
Windscreen washers not working	Repair

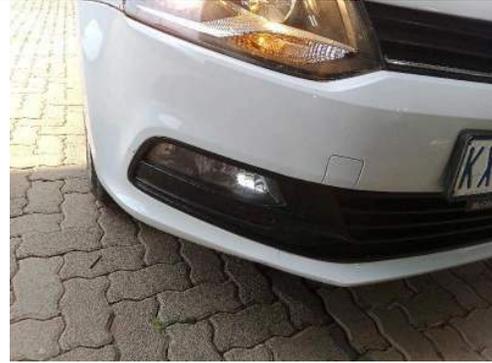
Fog Light Front Right

No	System	Code	Description	Status
1	PASSIVE/SPORADIC	U140000	SUPPLY VOLTAGE VOLTAGE TOO LOW	
2	ACTIVE/STATIC	03429:011	ACTIVATION OF RIGHT CORNERING LIGHT- OPEN CIRCUIT
