CONDITION REPORT

Report No:  
2016961522  
DATE  
29/07/2025

| Manufacturer | VOLKSWAGEN | Registration Number | HBD705L |
| Model | POLO VIVO 1.4 63KW COMFORTLINE 5-DR [2022-2024] | Register Number | |

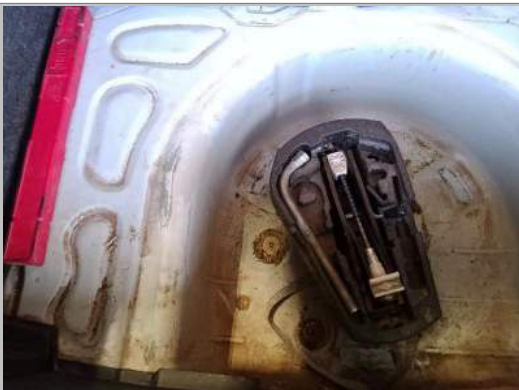
Spare wheel Accessories

| Damage | Repair Way |
|---|---|
| Tyres and rims | Spare wheel missing |

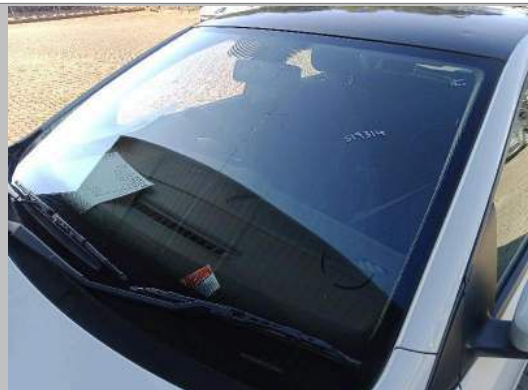
LICENSE DISC

| Damage | Repair Way |
|---|---|
| Body and Exterior | Vehicle license disk missing |

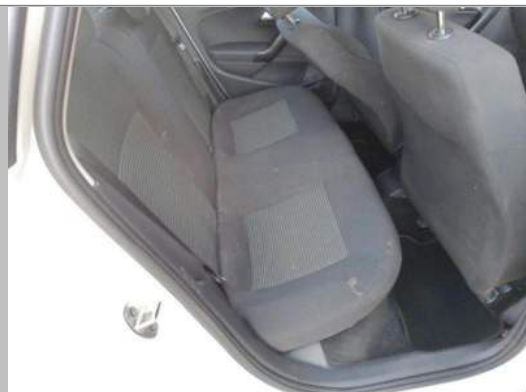
| Damage | Repair Way |
|---|---|
| Seat Rear Dirty | Repair |

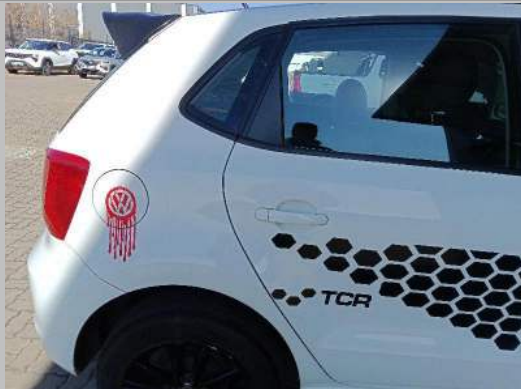
| Damage | Repair Way |
|---|---|
| Rear Fender Right Paintwork • Chipmarks | Repair |

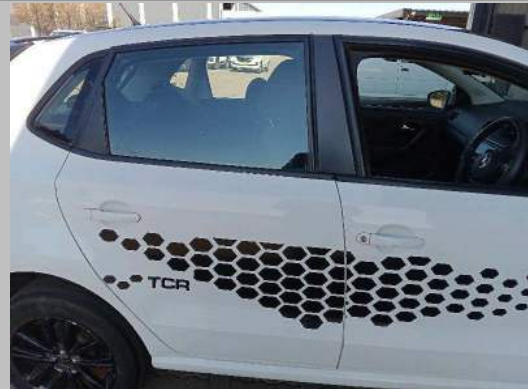
| Damage | Repair Way |
|---|---|
| Door Rear Right Paintwork • Scratched | Repair |

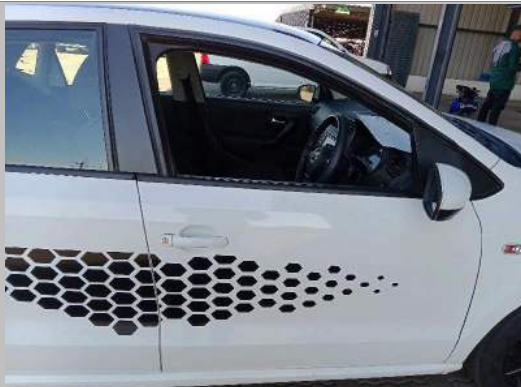
| Damage | Repair Way |
|---|---|
| Door Front Right Paintwork • Scratched | Repair |

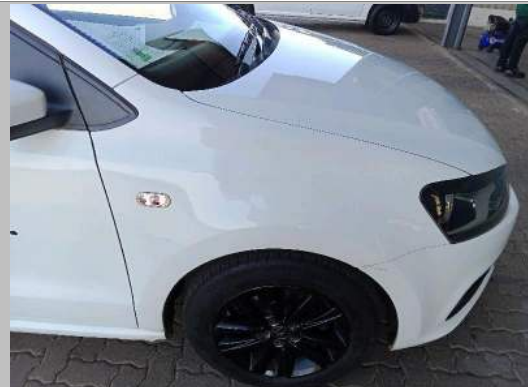
| Damage | Repair Way |
|---|---|
| Front Fender Right Damaged | Repair |

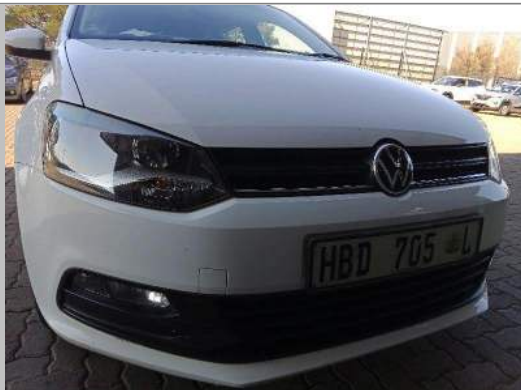
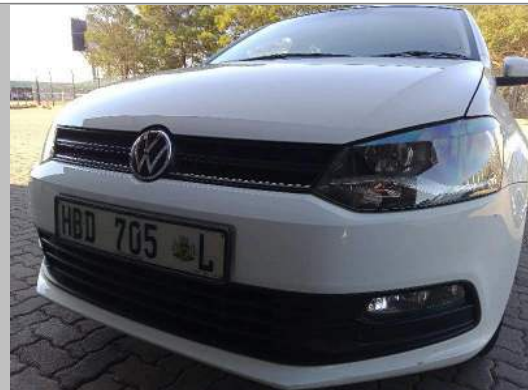
| Damage | Repair Way |
|---|---|
| Front Bumper Damaged | Repair |

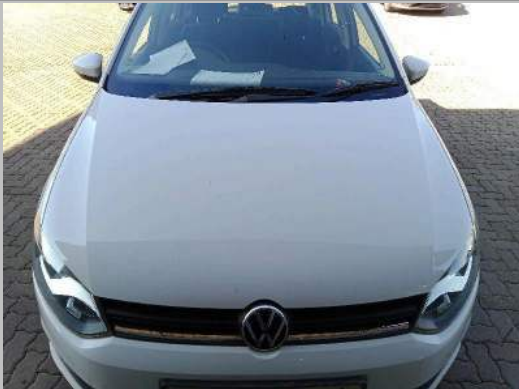
| Damage | Repair Way |
|---|---|
| Bonnet Paintwork • Scratched | Repair |

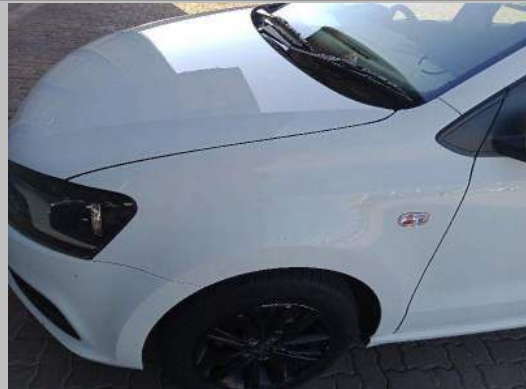
| Damage | Repair Way |
|---|---|
| Front Fender Left Damaged | Repair |

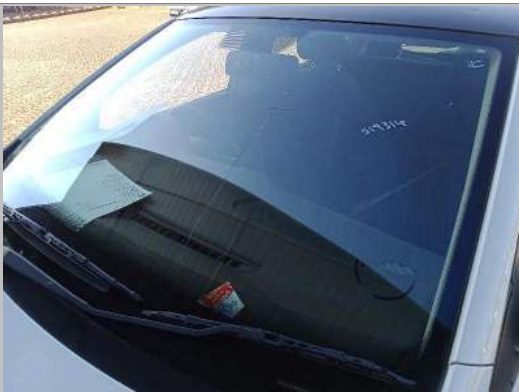
| Damage | Repair Way |
|---|---|
| Windscreen Cracked | Replace |

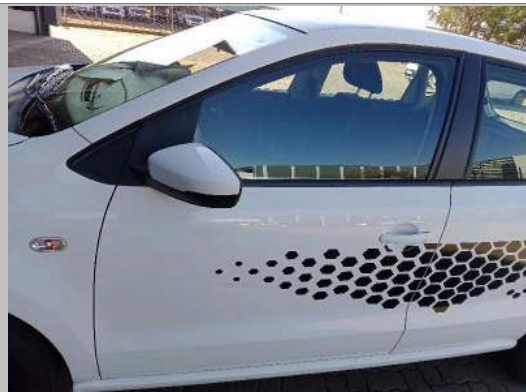
| Damage | Repair Way |
|---|---|
| Door Front Left Paintwork • Scratched | Repair |

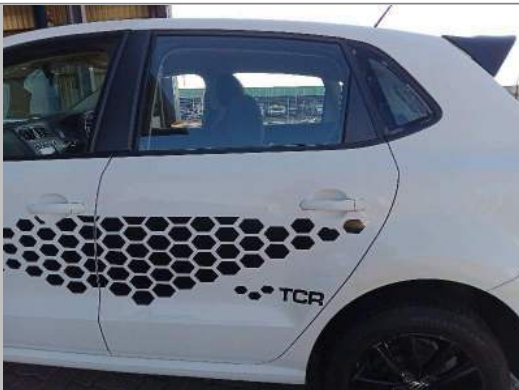
| Damage | Repair Way |
|---|---|
| Door Rear Left Damaged | Repair |

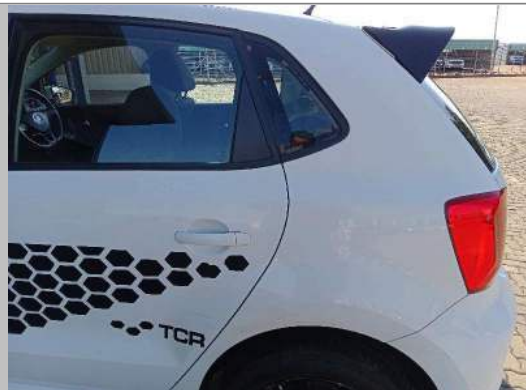
| Damage | Repair Way |
|---|---|
| Rear Fender Left Damaged | Repair |

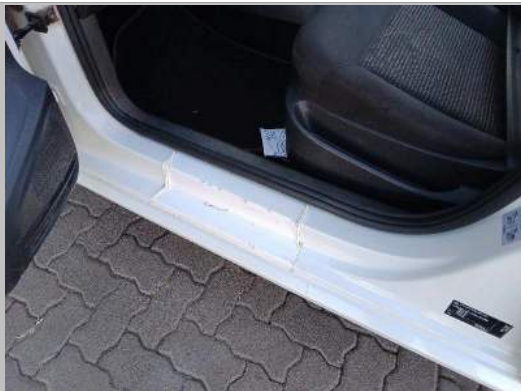
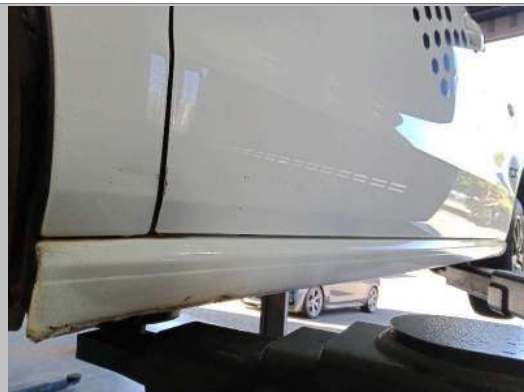
| Damage | Repair Way |
|---|---|
| Sill Panel Left Damaged | Repair |

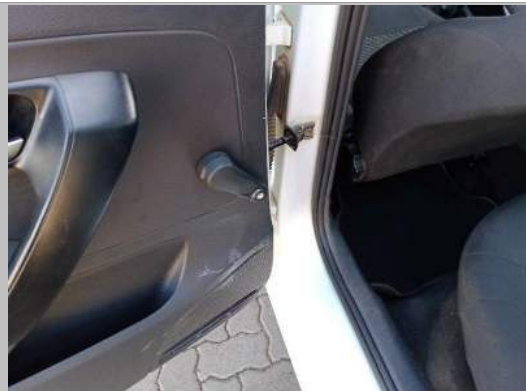
| Damage | Repair Way |
|---|---|
| Window Winder rear left Damaged | Replace |

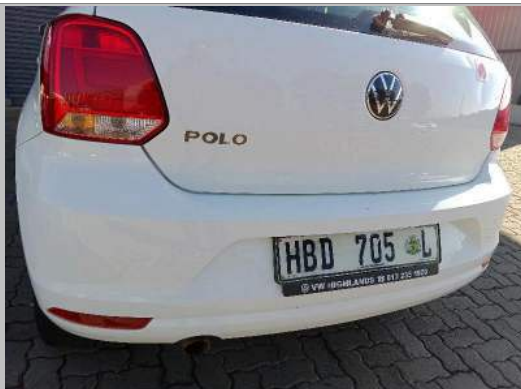
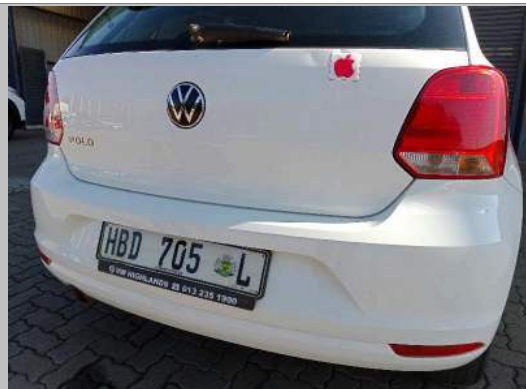
| Damage | Repair Way |
|---|---|
| Rear bumper Paintwork • Scratched | Repair |

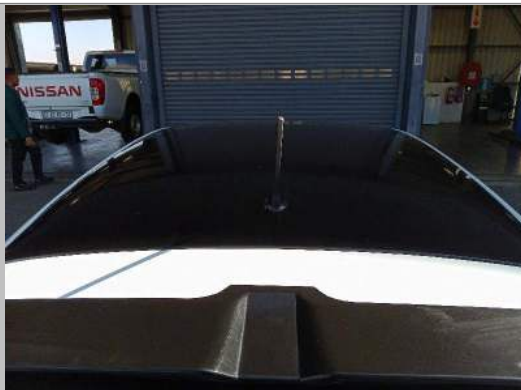
| Damage | Repair Way |
|---|---|
| Roof Dented | Repair |

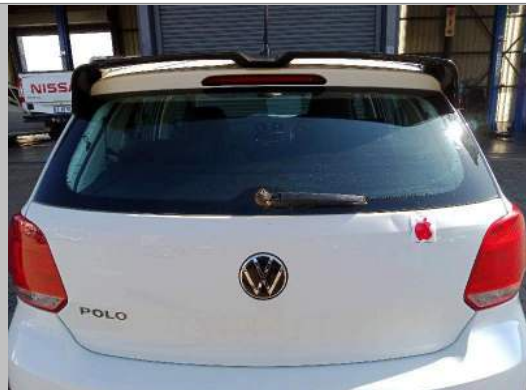
| Damage | Repair Way |
|---|---|
| Boot Lid / Hatch door Dented | Repair |

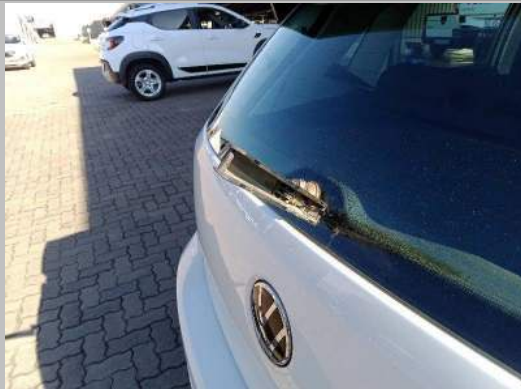
| Damage | Repair Way |
|---|---|
| Windscreen Wiper Missing | Replace |

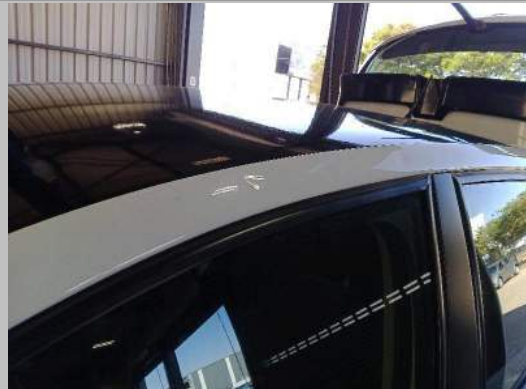
| Damage | Repair Way |
|---|---|
| B • Pillar Left Damaged | Repair |

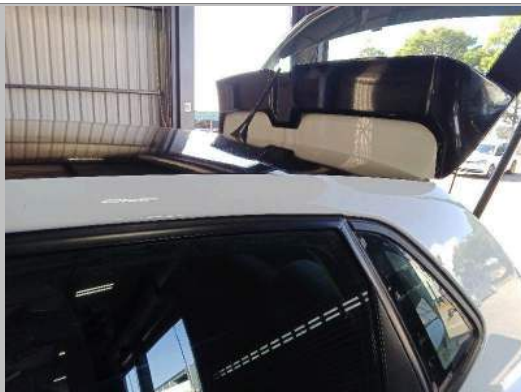
| Damage | Repair Way |
|---|---|
| C • Pillar Left Dented | Repair |

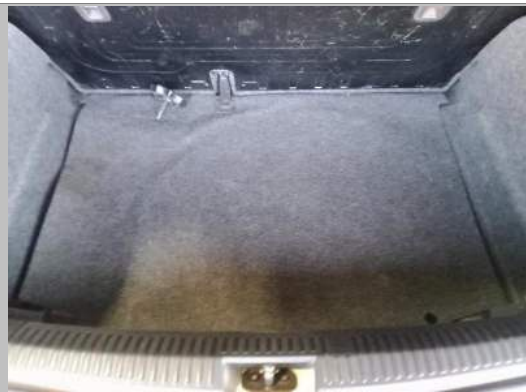
| Damage | Repair Way |
|---|---|
| Boot Carpet Damaged | Repair |

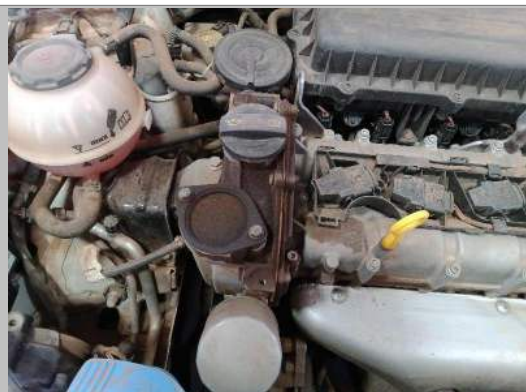
| Damage | Repair Way |
|---|---|
| Engine Oil Sweat | Repair |

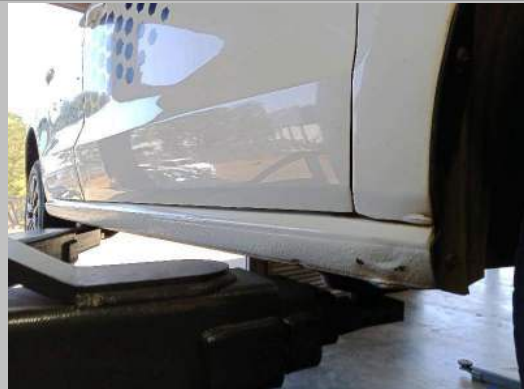
| Damage | Repair Way |
|---|---|
| Sill Panel Right Damaged | Repair |

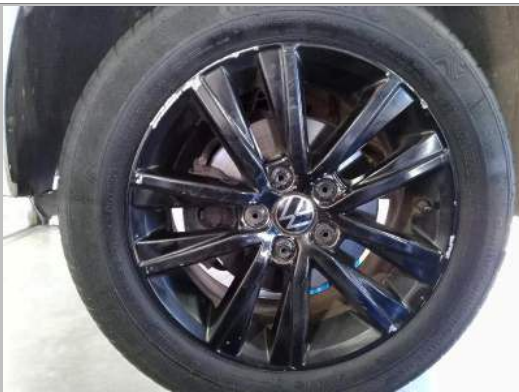
| Damage | Repair Way |
|---|---|
| Rim Front Left Scratched | Repair |

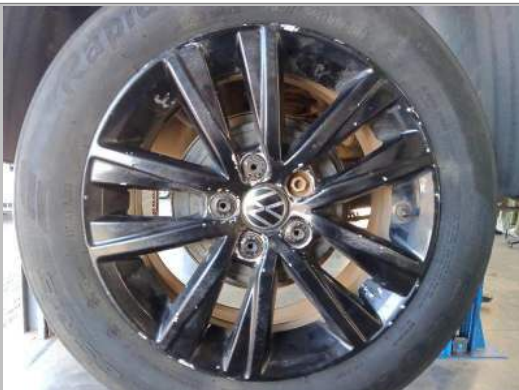
| Damage | Repair Way |
|---|---|
| Rim Rear Right Scratched | Repair |

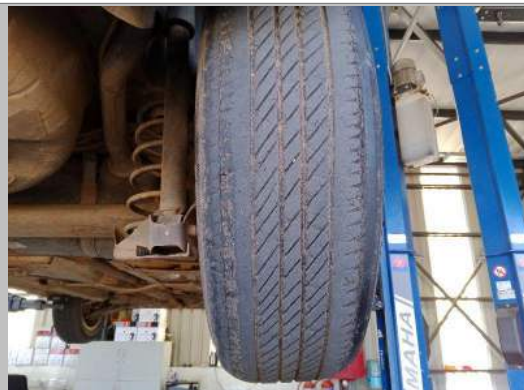
| Damage | Repair Way |
|---|---|
| Tyre Rear Right Damaged | Replace |

| | Size | Load/Speed Index | Manufacture | Model | Type* | Production Date | Tread Depth (mm) |
|---|---|---|---|---|---|---|---|
| Rear Right | 185/65 R15 | 88H | Rapid | Eco809 | V | 3121 | 0 mm |

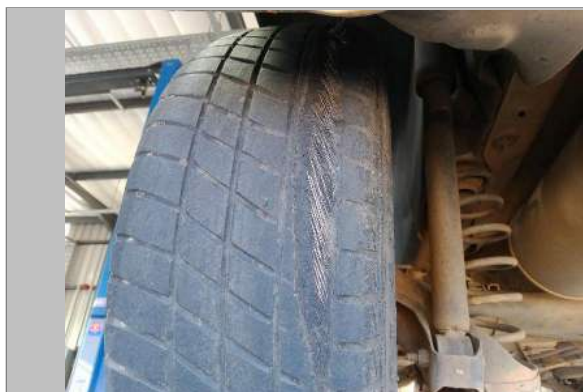
| Damage | Repair Way |
|---|---|
| Tyre Rear Left Damaged | Replace |

| | Size | Load/Speed Index | Manufacture | Model | Type* | Production Date | Tread Depth (mm) |
|---|---|---|---|---|---|---|---|
| Rear Left | 185/65 R15 | 92T | Barum | Brillantis | V | 0714 | 0 mm |
