MFC Auction House  
M57 Pretoria Rd, Glenmarais, KEMPTON PARK  
Gauteng

## Assignment

| Manufacturer | VOLKSWAGEN | Registration Number | FN55CLGP |
| Model | POLO VIVO 1.4 TRENDLINE 5-DR TIPTRONIC [2011-2015] | Register Number | |

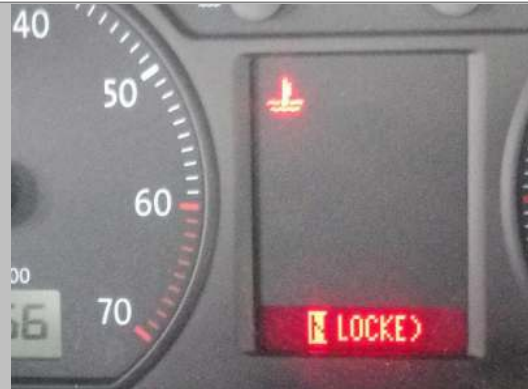
Water light illuminated

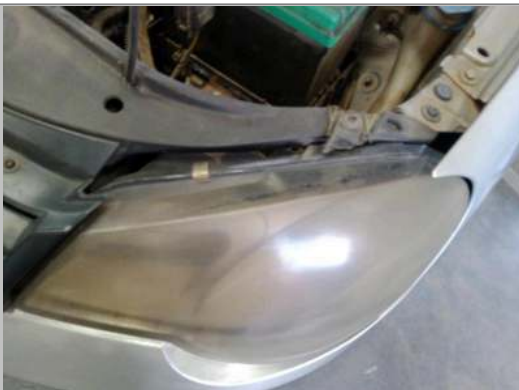
| Damage | Repair Way |
|---|---|
| Both front headlights clips broken, headlights are | Replace |

L/F headlight is loose

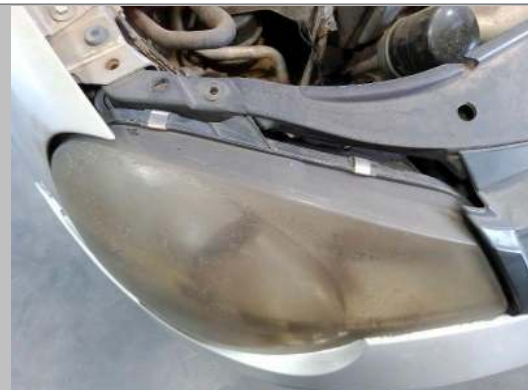
R/F headlight is loose

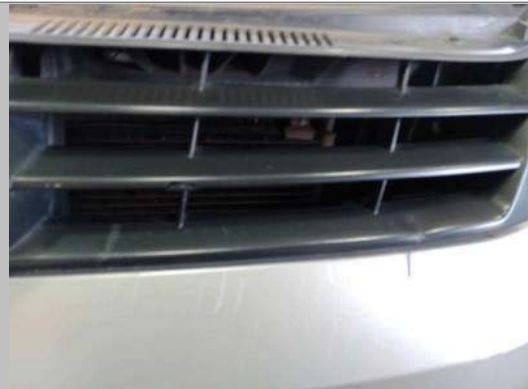
| | Damage | Repair Way |
|---|---|---|
| | Grill Damaged | Replace |

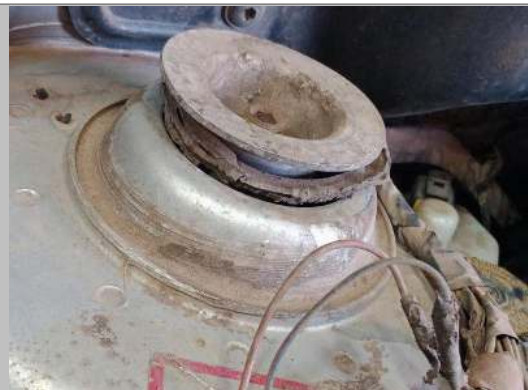
| | Damage | Repair Way |
|---|---|---|
| | Shock Absorber Mounting Front Right Damaged | Replace |

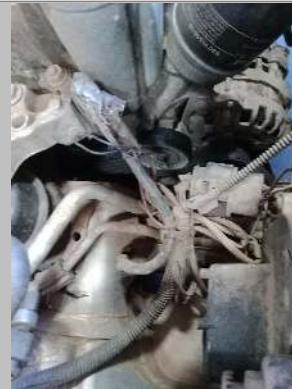
| | Damage | Repair Way |
|---|---|---|
| | Engine Wiring Defective | Repair |

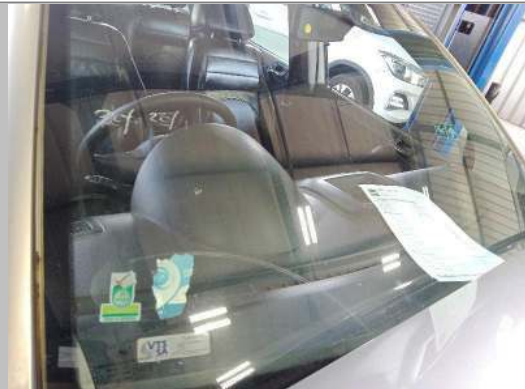
| | Damage | Repair Way |
|---|---|---|
| | Windscreen Chipped | Replace |

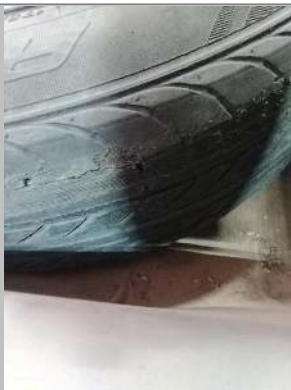
| | Damage | Repair Way |
|---|---|---|
| | Spare Tyre Excessive Wear & Tear | Replace |

| | Size | Load/Speed Index | Manufacture | Model | Type* | Production Date | Tread Depth (mm) |
|---|---|---|---|---|---|---|---|
| Spare | 175/65R14 | 82H | Apollo | Alnac | V | 0000 | 0 mm |

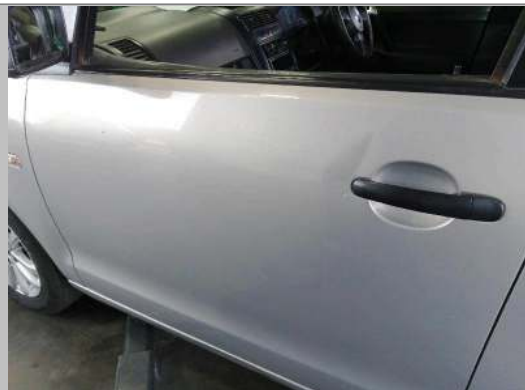
| | Damage | Repair Way |
|---|---|---|
| | Door Front Left Dented | Repair |

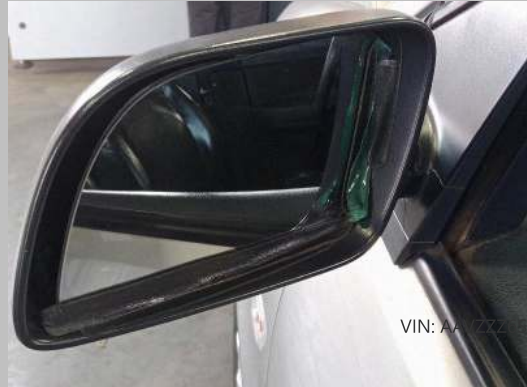
| | Damage | Repair Way |
|---|---|---|
| | Side Mirror Left Damaged | Replace |

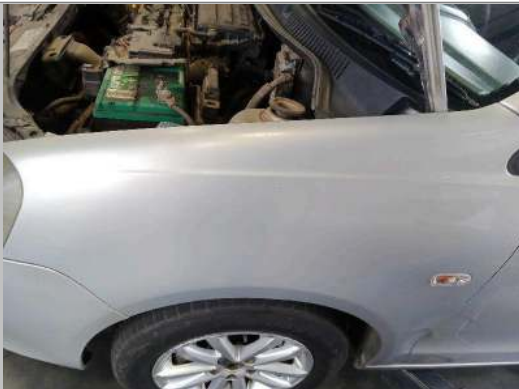
| | Damage | Repair Way |
|---|---|---|
| | Front Fender Left Paintwork • Dull | Repair |

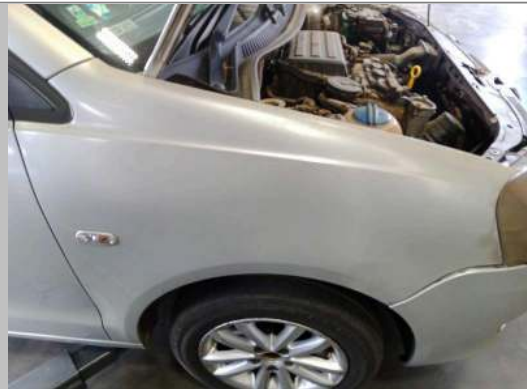
| | Damage | Repair Way |
|---|---|---|
| | Front Fender Right Paintwork • Dull | Repair |

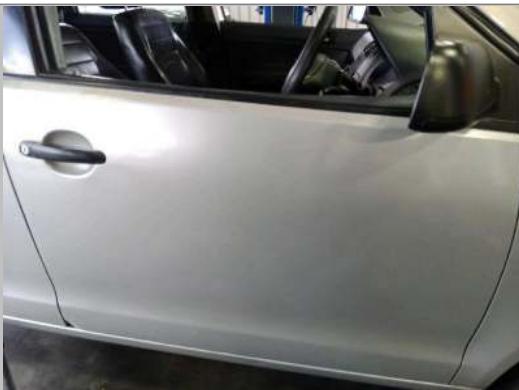
| | Damage | Repair Way |
|---|---|---|
| | Door Front Right Residual Traces of Repair | Repair |

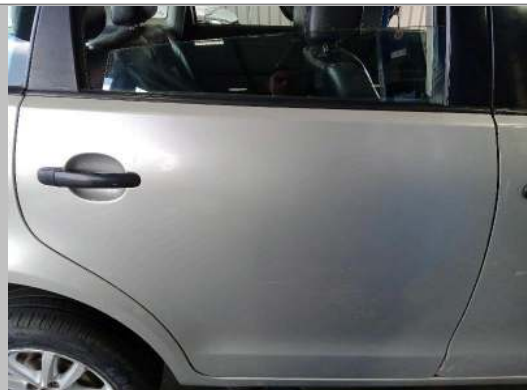
| | Damage | Repair Way |
|---|---|---|
| | Door Rear Right Residual Traces of Repair | Repair |

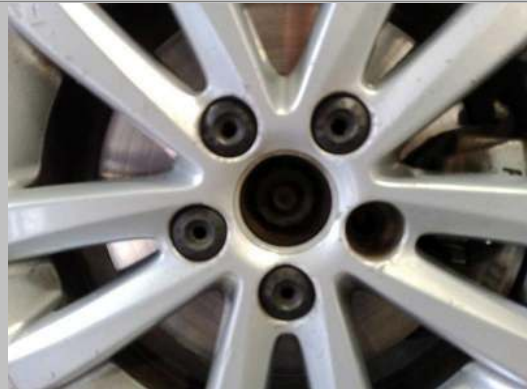
| | Damage | Repair Way |
|---|---|---|
| | Bolt(s) / Nut(s) Front Wheel Right Missing | Replace |

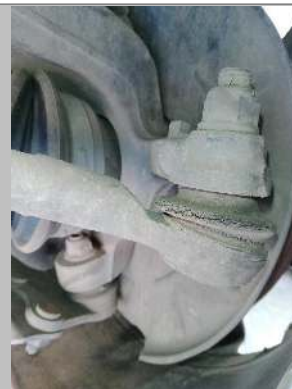
| | Damage | Repair Way |
|---|---|---|
| | Tie Rod End right Cracked | Replace |

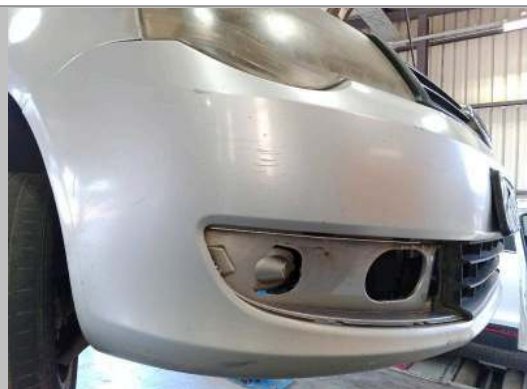
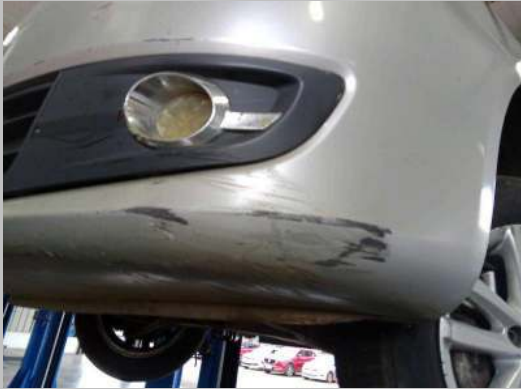
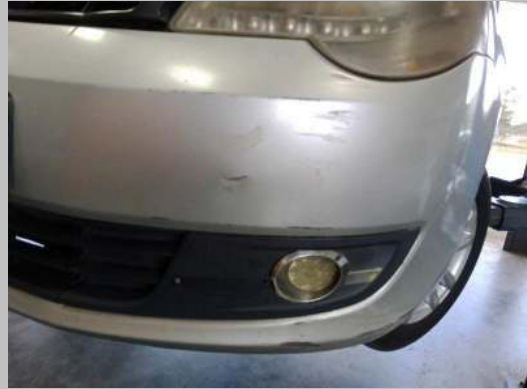
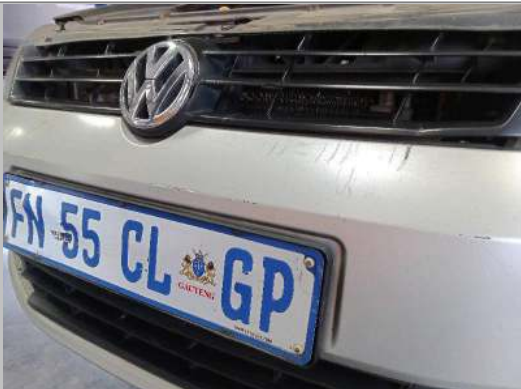
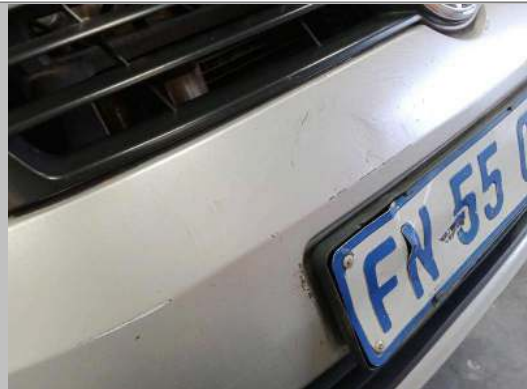
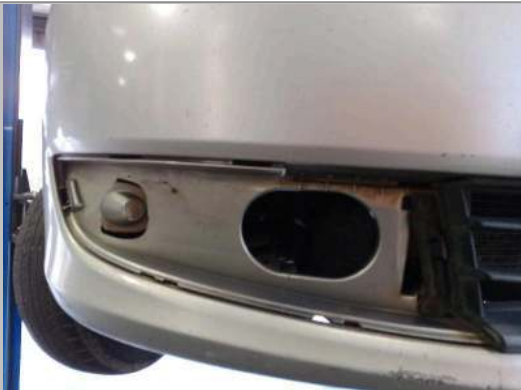
| | Damage | Repair Way |
|---|---|---|
| | Front Bumper Paintwork • Scratched | Repair |

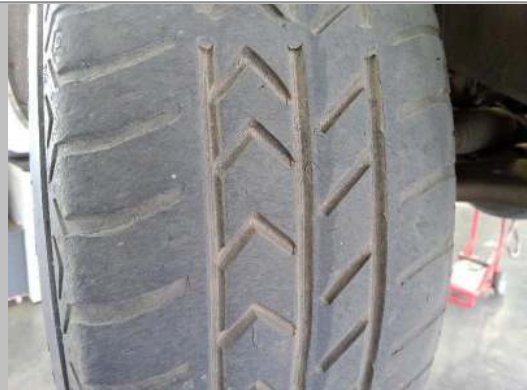
| | Damage | Repair Way |
|---|---|---|
| | Tyre Front Left Excessive Wear & Tear | Replace |

| | Size | Load/Speed Index | Manufacture | Model | Type* | Production Date | Tread Depth (mm) |
|---|---|---|---|---|---|---|---|
| Front Left | 185/65R14 | 86T | General | Altimax | V | 5020 | 1 mm |

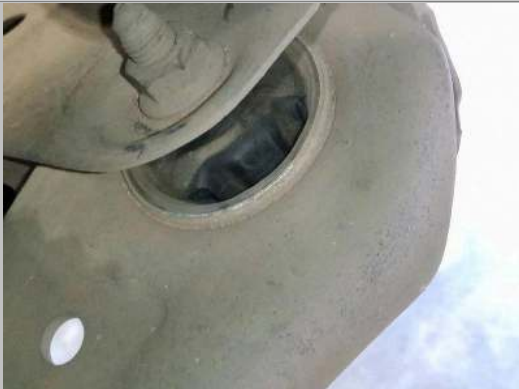
| | Damage | Repair Way |
|---|---|---|
| | Control Arm Bush(es) Front Axle Left Cracked | Replace |

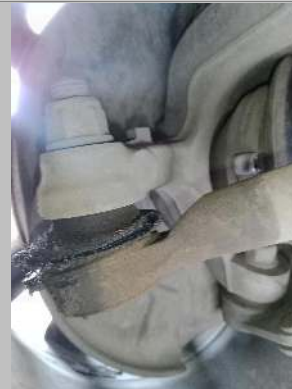
| | Damage | Repair Way |
|---|---|---|
| | Tie Rod End left Damaged | Replace |

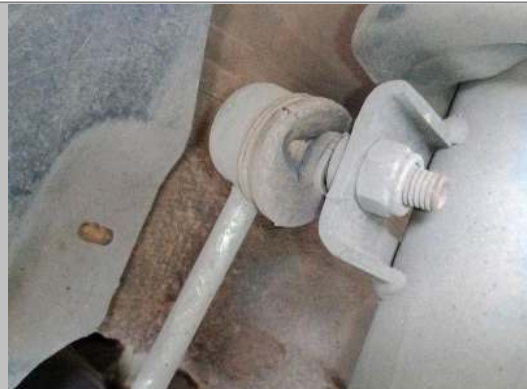
| | Damage | Repair Way |
|---|---|---|
| | Stabilizer Mounting Front Left Damaged | Replace |

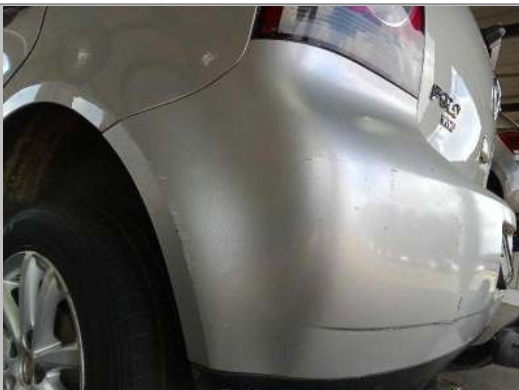
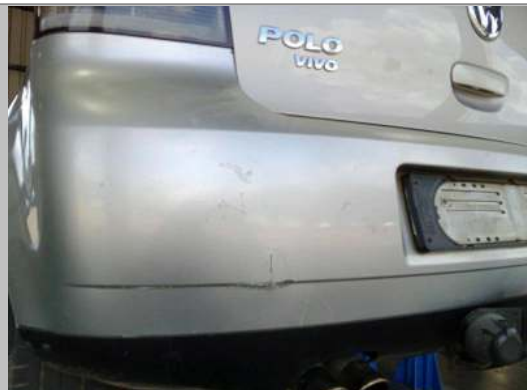
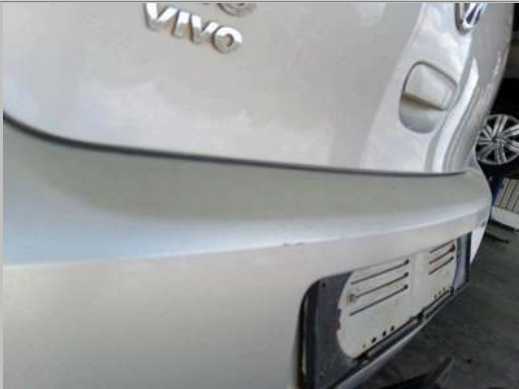
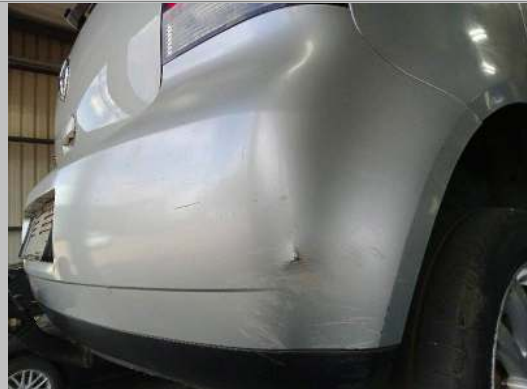
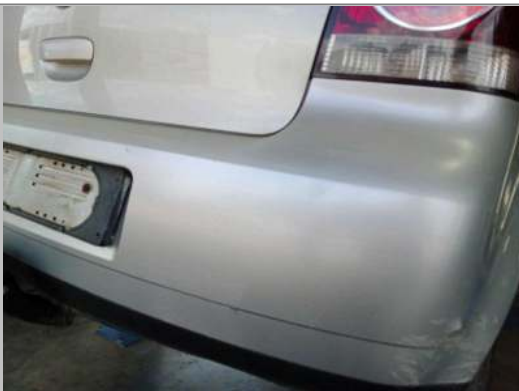
| | Damage | Repair Way |
|---|---|---|
| | Rear bumper Residual Traces of Repair | Repair |

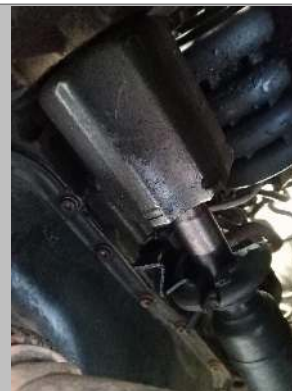
| Damage | Repair Way |
|---|---|
| CV Joint(s) Boot(s) Front Right (inner/outer) Damaged | Replace |

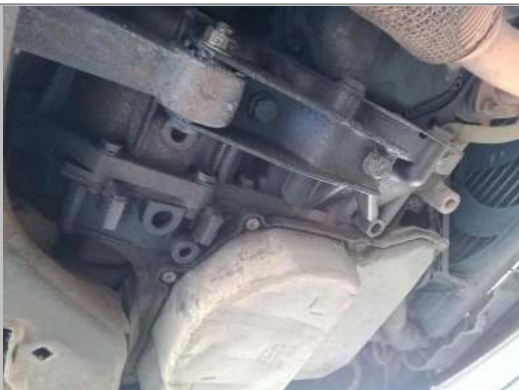
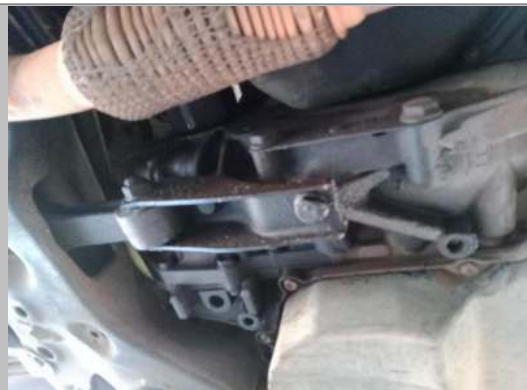
| Damage | Repair Way |
|---|---|
| Gearbox Oil Leak | Repair |

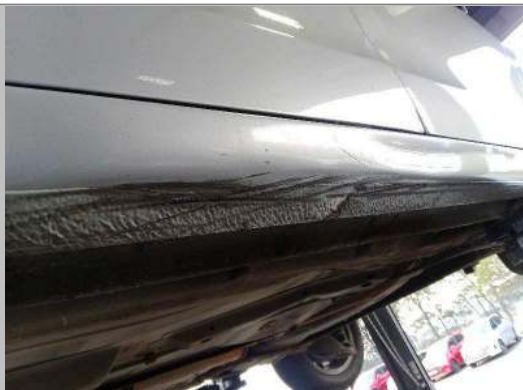
| | Damage | Repair Way |
|---|---|---|
| | Sill Panel Left Damaged | Repair |

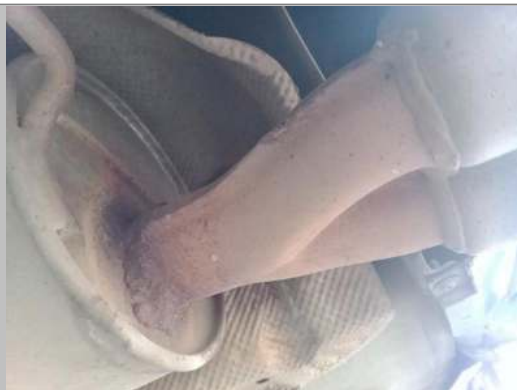
| Damage | Repair Way |
|---|---|
| Engine to silencer pipe Welded | Replace |

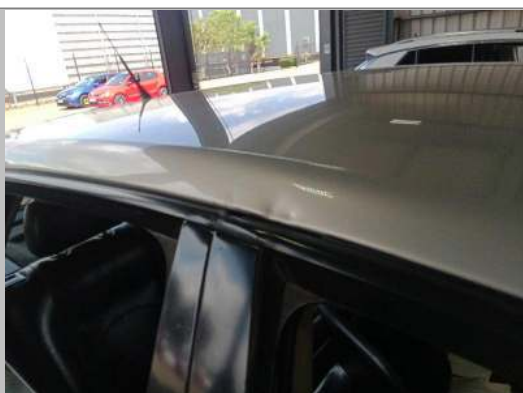
| | Damage | Repair Way |
|---|---|---|
| | A • Pillar Right Dented | Repair |

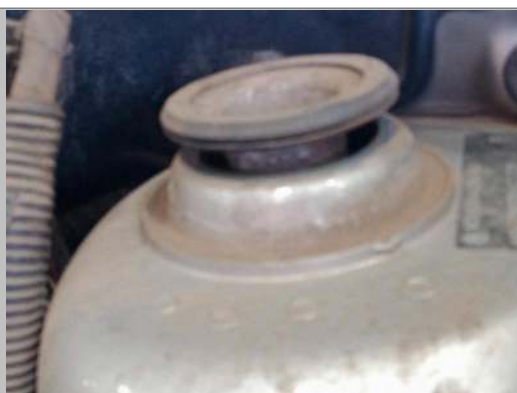
| | Damage | Repair Way |
|---|---|---|
| | Shock Absorber Mounting Front Left Damaged | Replace |

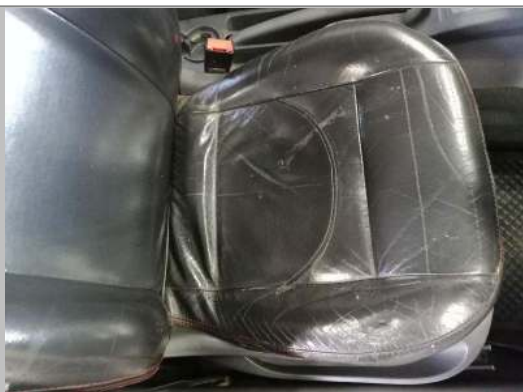
| | Damage | Repair Way |
|---|---|---|
| | Seat Front Right Torn / Cut | Repair |
