## CONDITION REPORT

Report No: 2016866298

| Manufacturer | VOLKSWAGEN | Registration Number | DP39DMGP |
| Model | POLO VIVO GP 1.6 GT 5-DR [2014-2016] | Register Number | |

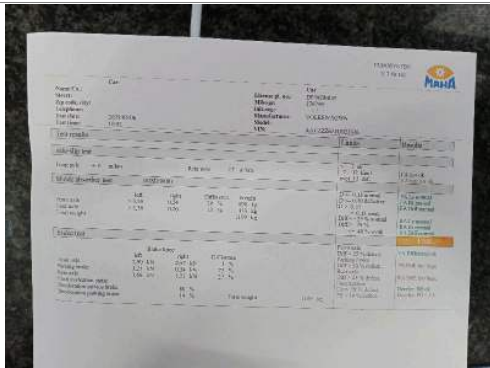
Shock and brake report

| Damage | Repair Way |
|---|---|
| Parking Brake Performance Left / Right Difference out of legal range | Repair |

| | Left | Right | | |
|---|---|---|---|---|
| Emergency / Parking | 1.2 | 0.3 | - | |

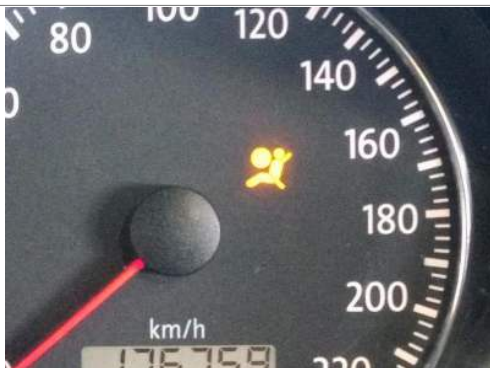
Airbag warning lights illumina

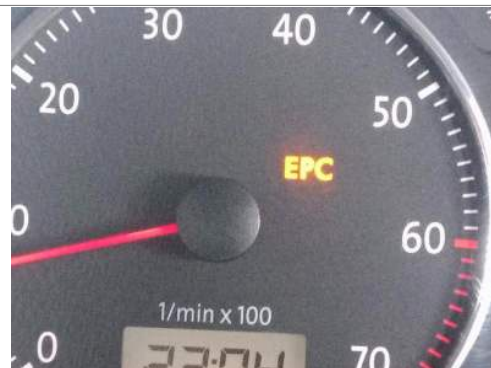
| Damage | Repair Way |
|---|---|
| Warning lights illuminated on cluster | Repair |

Warning lights illuminated

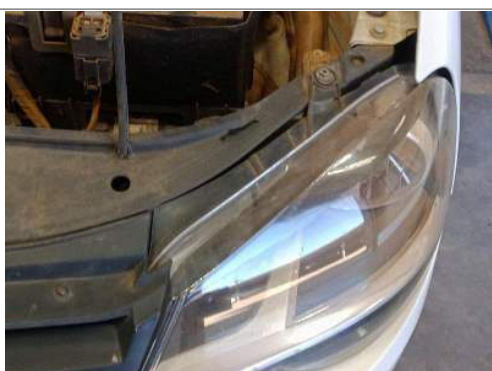
L/F headlight clips broken

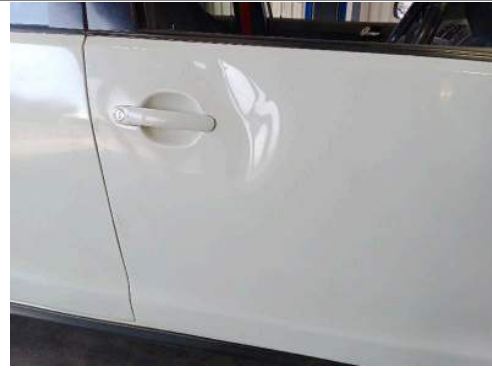
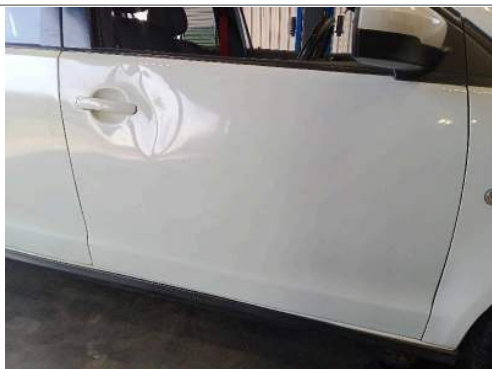
| Damage | Repair Way |
|---|---|
| Door Front Right Dented | Repair |

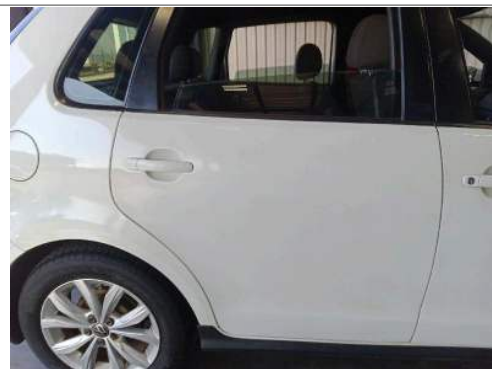
| Damage | Repair Way |
|---|---|
| Door Rear Right Residual Traces of Repair | Repair |

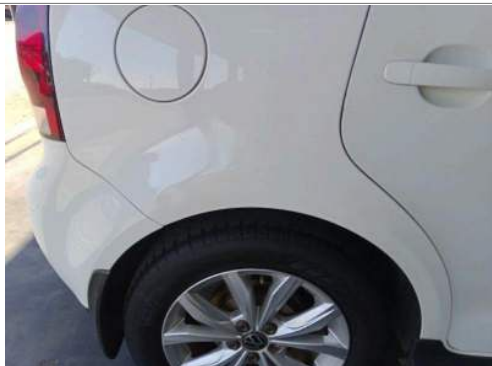
| Damage | Repair Way |
|---|---|
| C • Pillar Right Dented | Repair |

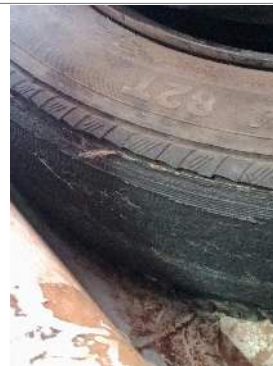
| Damage | Repair Way |
|---|---|
| Spare Tyre Excessive Wear & Tear | Replace |

| | Size | Load/Speed Index | Manufacture | Model | Type* | Production Date | Tread Depth (mm) |
|---|---|---|---|---|---|---|---|
| Spare | 175/65R14 | 82T | Continental | Control | V | 0000 | 0 mm |

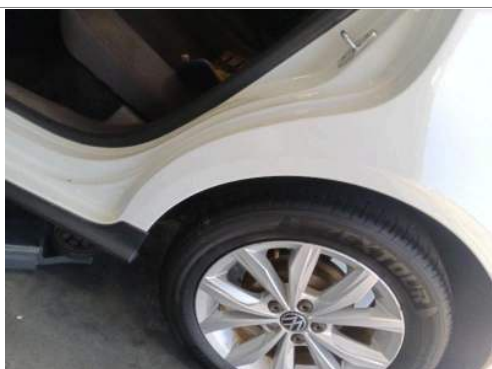
| Damage | Repair Way |
|---|---|
| C • Pillar Left Paintwork • Scratched | Repair |

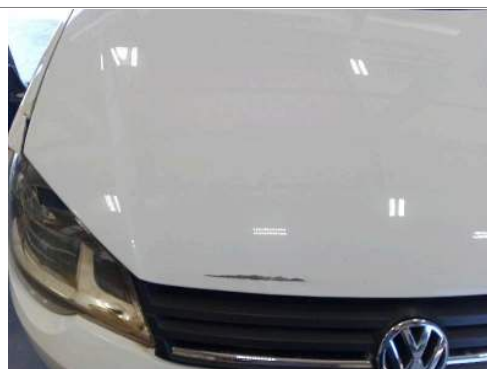
| Damage | Repair Way |
|---|---|
| Bonnet Damaged | Repair |

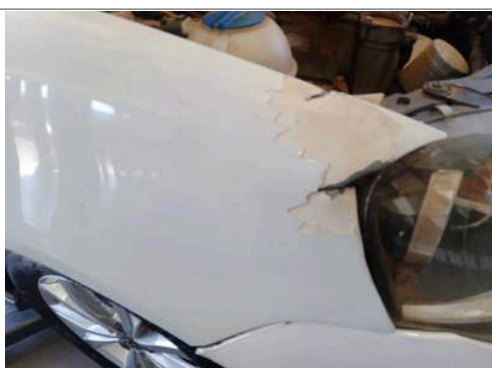
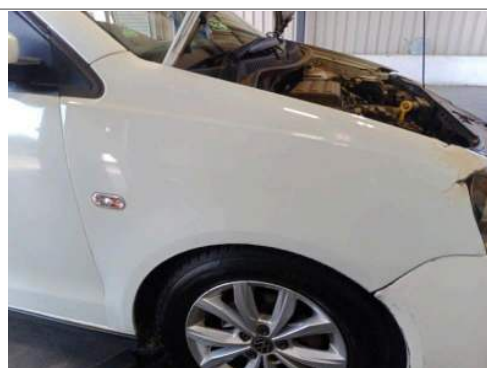
| Damage | Repair Way |
|---|---|
| Front Fender Right Residual Traces of Repair | Repair |

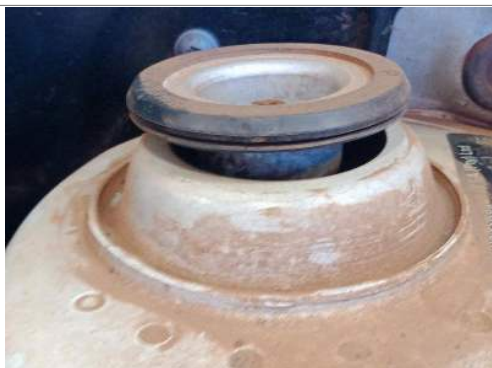
| Damage | Repair Way |
|---|---|
| Shock Absorber Mounting Front Left Damaged | Replace |

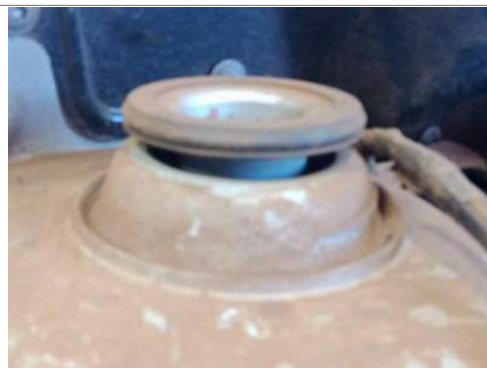
| Damage | Repair Way |
|---|---|
| Shock Absorber Mounting Front Right Damaged | Replace |

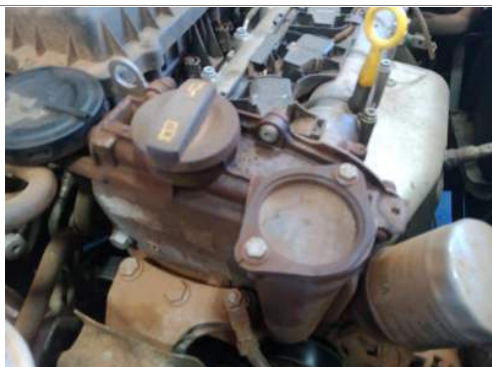
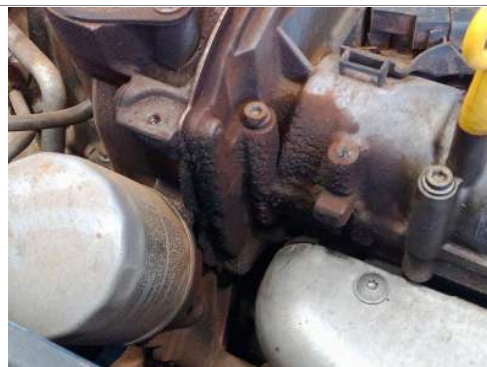
| Damage | Repair Way |
|---|---|
| Engine Oil Leak | Repair |

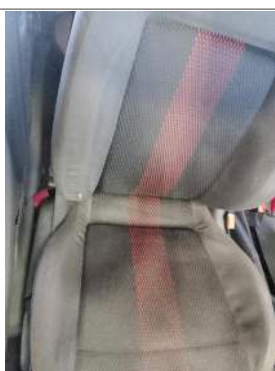
| Damage | Repair Way |
|---|---|
| Seat Front Right Torn / Cut | Repair |

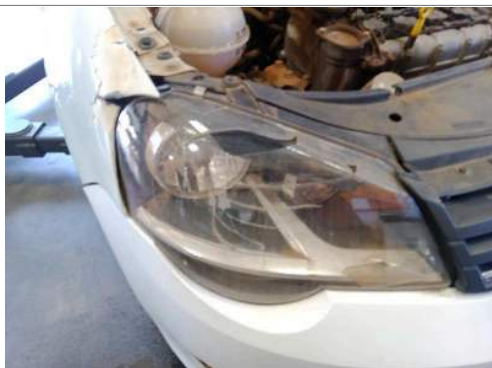
| Damage | Repair Way |
|---|---|
| Headlight Right Damaged | Replace |

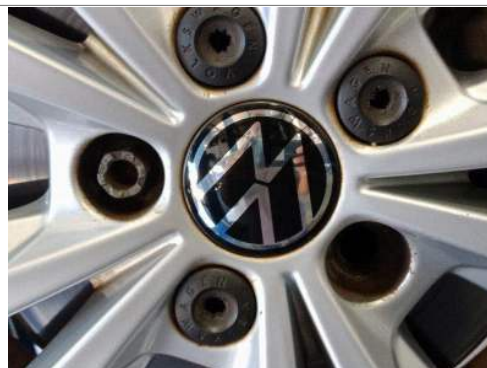
| Damage | Repair Way |
|---|---|
| Bolt(s) / Nut(s) Front Wheel Right Missing | Replace |

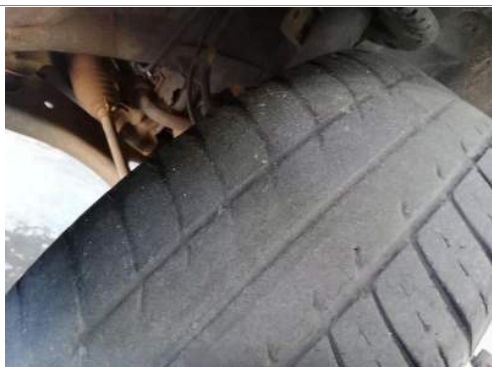
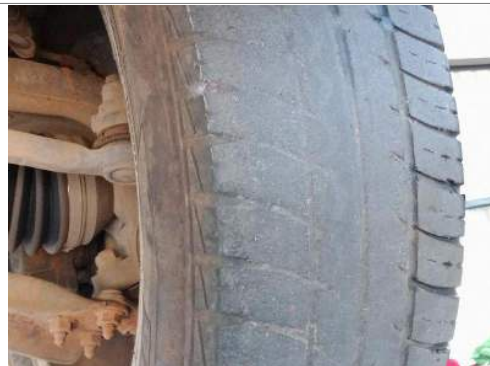
| Damage | Repair Way |
|---|---|
| Tyre Front Right Smooth | Replace |

| | Size | Load/Speed Index | Manufacture | Model | Type* | Production Date | Tread Depth (mm) |
|---|---|---|---|---|---|---|---|
| Front Right | 185/65R15 | 92T | Barum | Brillantis | V | 0000 | 0 mm |

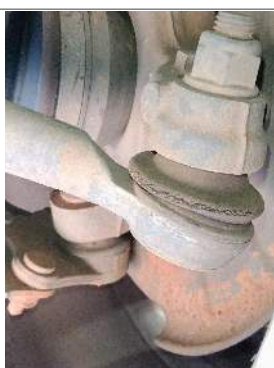
| Damage | Repair Way |
|---|---|
| Tie Rod End right Cracked | Replace |

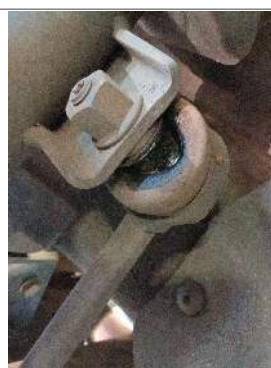
| Damage | Repair Way |
|---|---|
| Stabilizer Mounting Front Right Damaged | Replace |

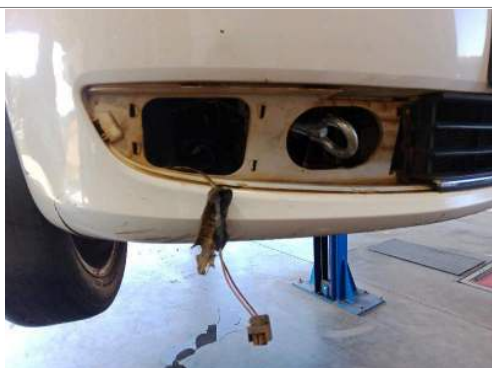
| Damage | Repair Way |
|---|---|
| Fog Light Front Right Missing | Replace |

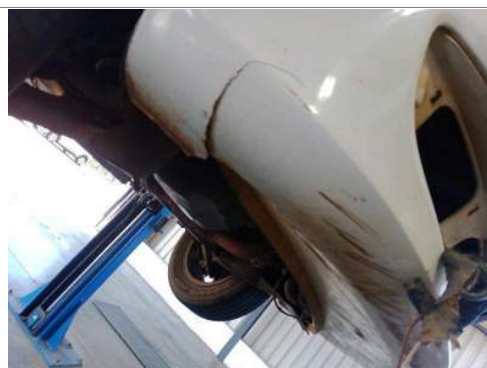
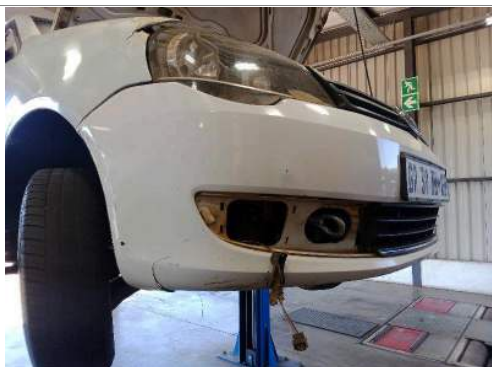
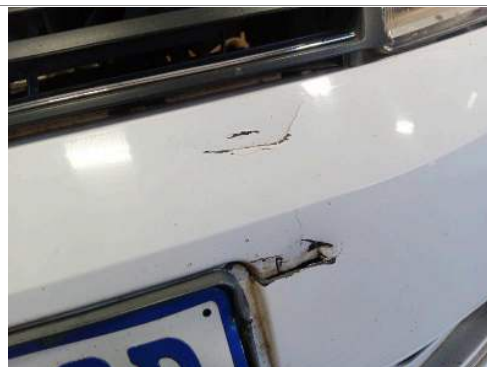
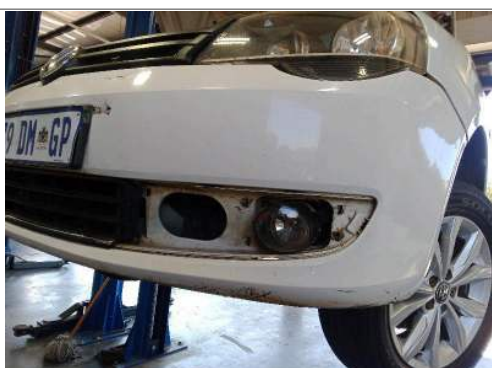
| Damage | Repair Way |
|---|---|
| Front Bumper Damaged | Repair |

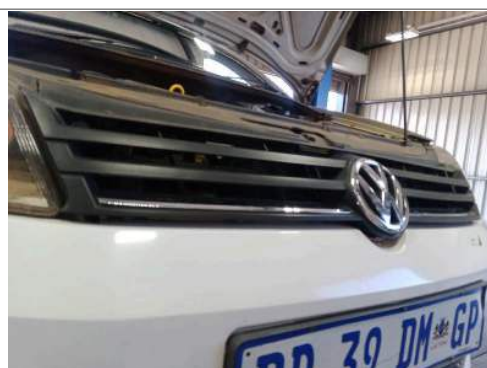
| Damage | Repair Way |
|---|---|
| Grill Damaged | Replace |

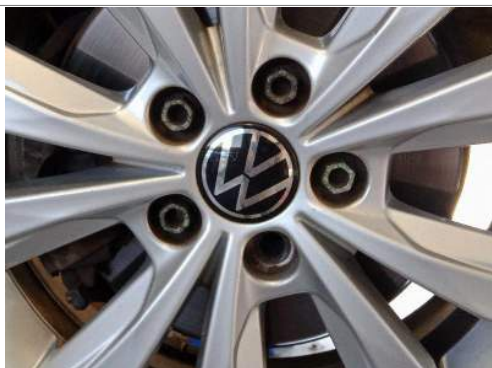
| Damage | Repair Way |
|---|---|
| Bolt(s) / Nut(s) Front Wheel Left Missing | Replace |

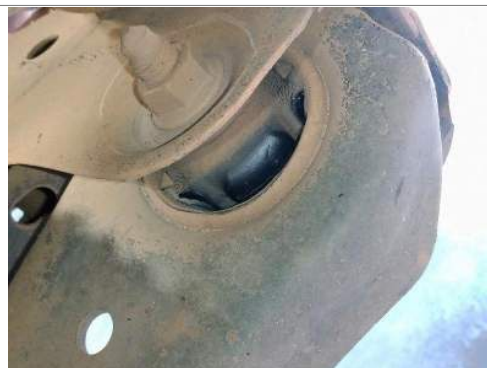
| Damage | Repair Way |
|---|---|
| Control Arm Bush(es) Front Axle Left Cracked | Replace |

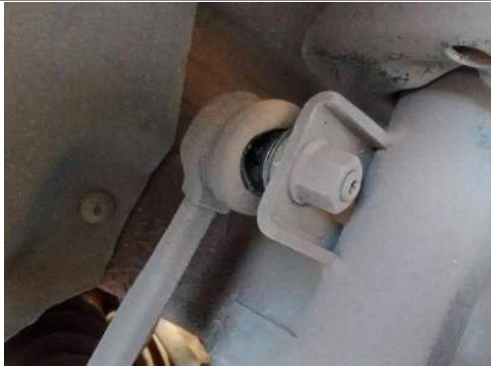
| Damage | Repair Way |
|---|---|
| Stabilizer Mounting Front Left Damaged | Replace |

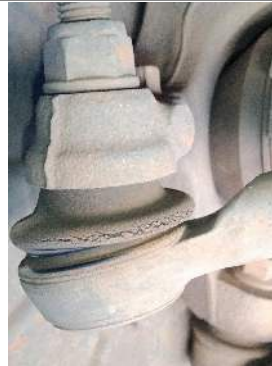
| Damage | Repair Way |
|---|---|
| Tie Rod End left Cracked | Replace |

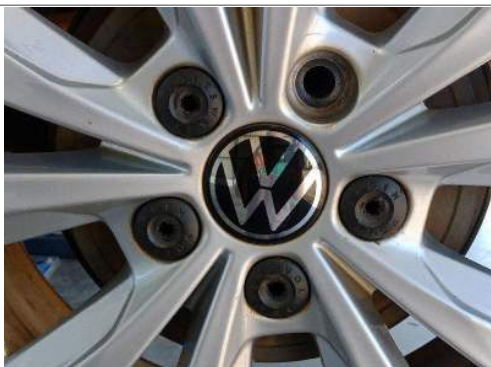
| Damage | Repair Way |
|---|---|
| Bolt(s) / Nut(s) Rear Wheel Left Missing | Replace |

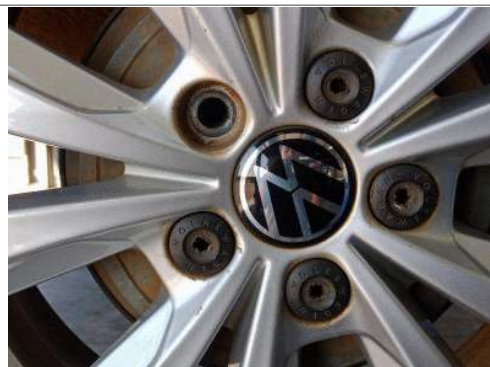
| Damage | Repair Way |
|---|---|
| Bolt(s) / Nut(s) Rear Wheel Right Missing | Replace |

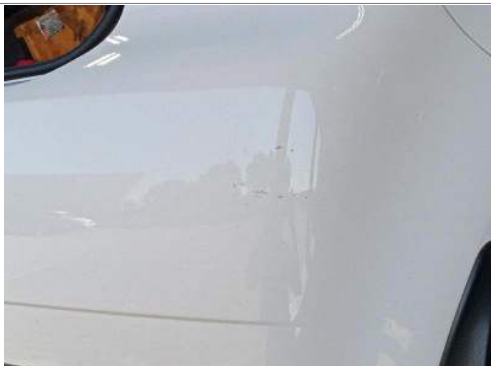
| Damage | Repair Way |
|---|---|
| Rear bumper Paintwork • Scratched | Repair |

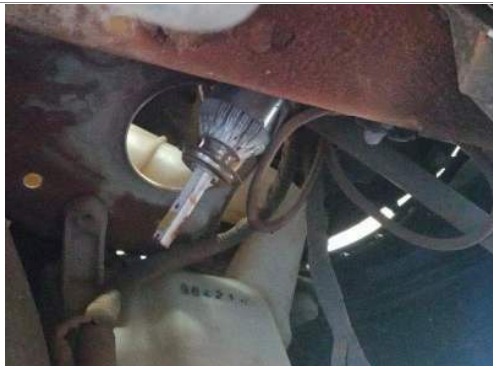
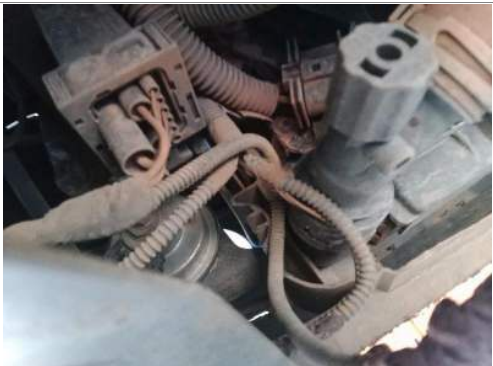
| Damage | Repair Way |
|---|---|
| Engine Wiring Defective | Repair |

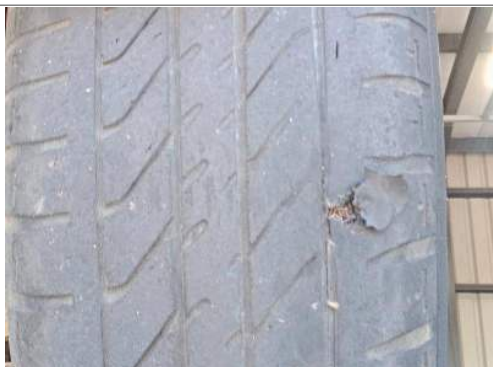
| Damage | Repair Way |
|---|---|
| Tyre Rear Right Excessive Wear & Tear | Replace |

| | Size | Load/Speed Index | Manufacture | Model | Type* | Production Date | Tread Depth (mm) |
|---|---|---|---|---|---|---|---|
| Rear Right | 185/65R15 | 92H | Dunlop | Sport | V | 0000 | 0 mm |

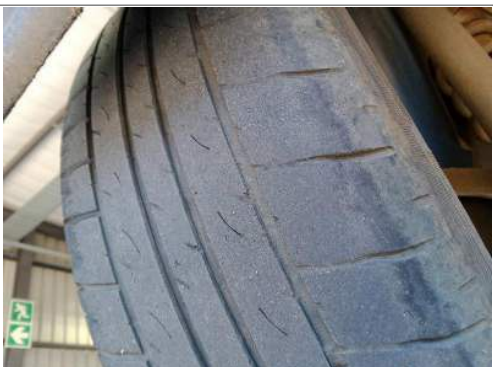
| Damage | Repair Way |
|---|---|
| Tyre Rear Left Excessive Wear & Tear | Replace |

| | Size | Load/Speed Index | Manufacture | Model | Type* | Production Date | Tread Depth (mm) |
|---|---|---|---|---|---|---|---|
| Rear Left | 185/60R15 | 84H | Zextour | Comfort | V | 0123 | 1 mm |
