## CONDITION REPORT

2016961534

| Manufacturer | VOLKSWAGEN | Registration Number | LF03GKGP |
| Model | POLO VIVO SEDAN GP 1.4 TRENDLINE [2014-2017] | Register Number | |

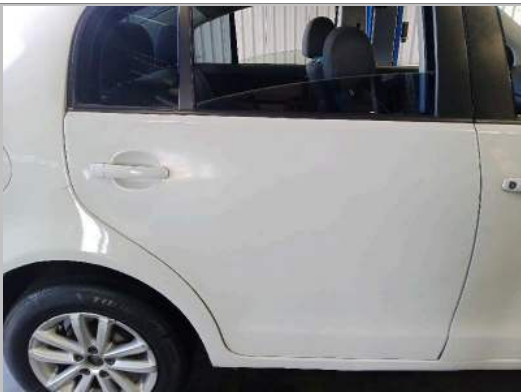
| Door Rear Right Residual Traces of Repair | Repair |

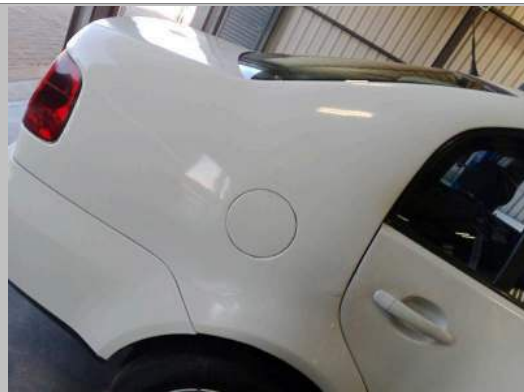
| Rear Fender Right Residual Traces of Repair | Repair |

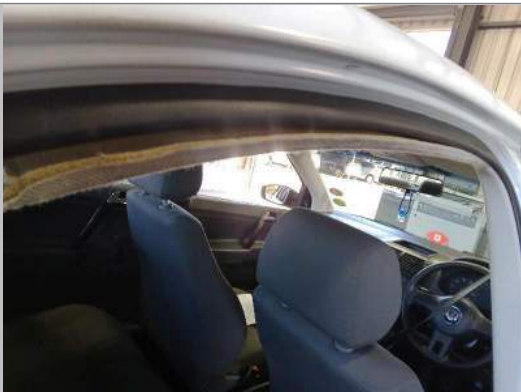
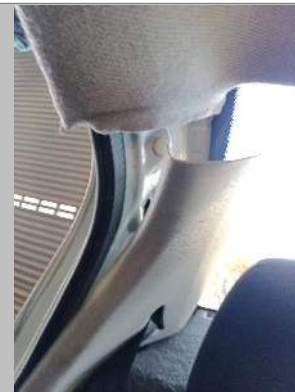
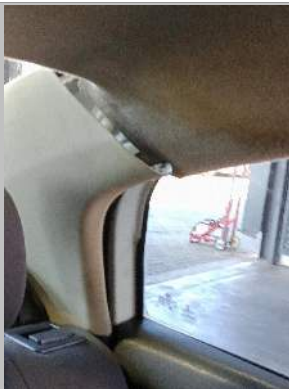
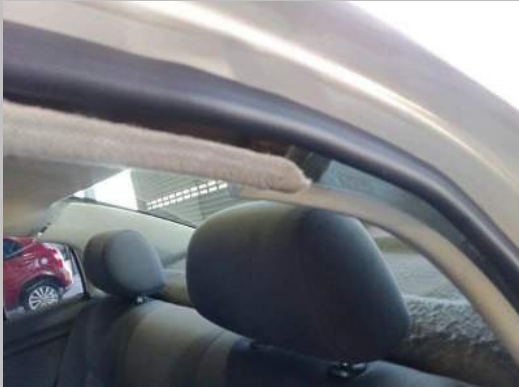
| Hood Lining Excessive Wear & Tear | Repair |

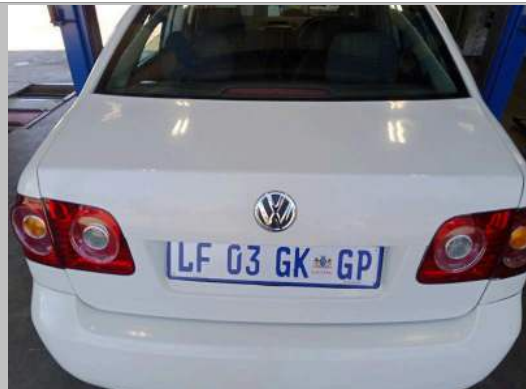
| Boot Lid / Hatch door Residual Traces of Repair | Repair |
| Bootlid does not open | Repair |

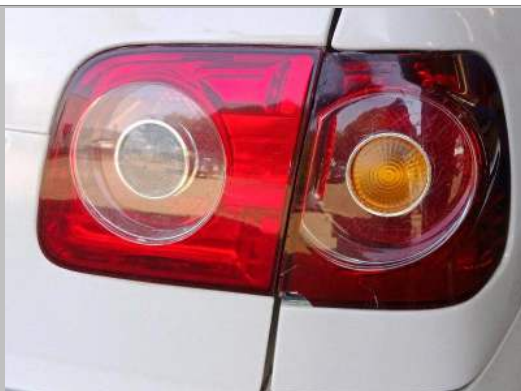
| Tail Light Right Cracked | Repair |

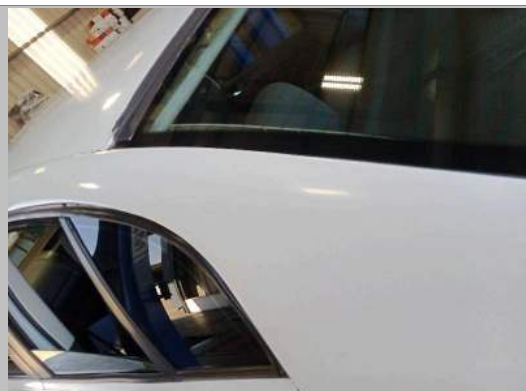
| C • Pillar Left Residual Traces of Repair | Repair |

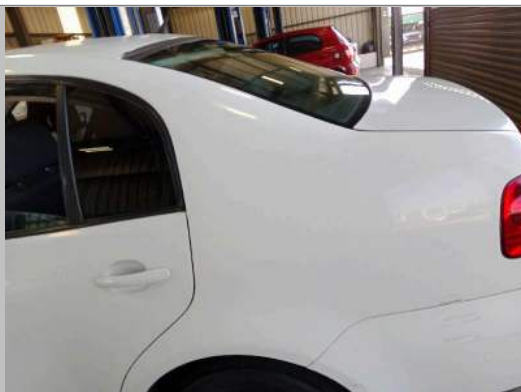
| Rear Fender Left Residual Traces of Repair | Repair |

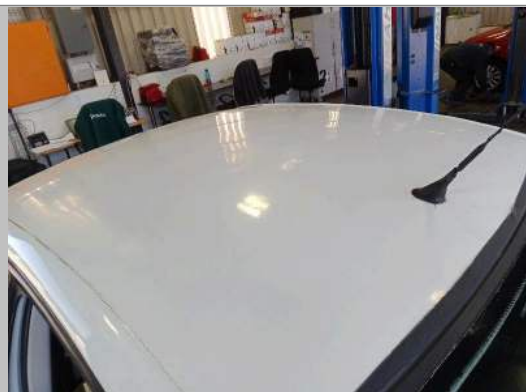
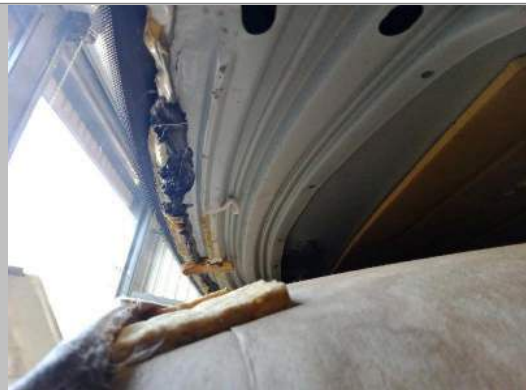
| Roof Residual Traces of Repair | Repair |

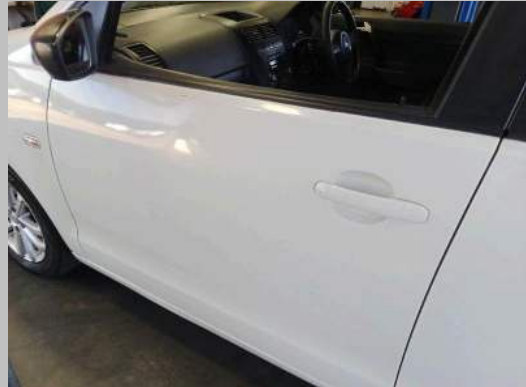
| Door Front Left Residual Traces of Repair | Repair |

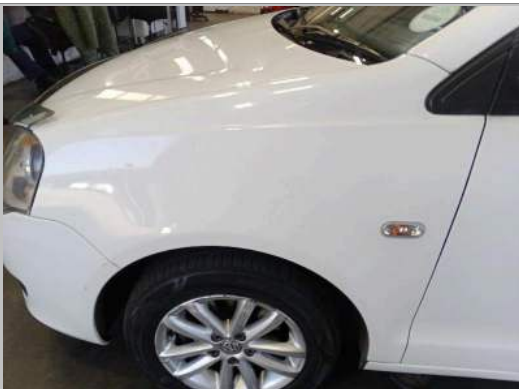
| Front Fender Left Residual Traces of Repair | Repair |

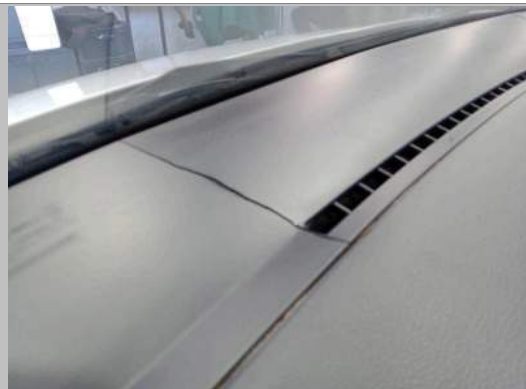
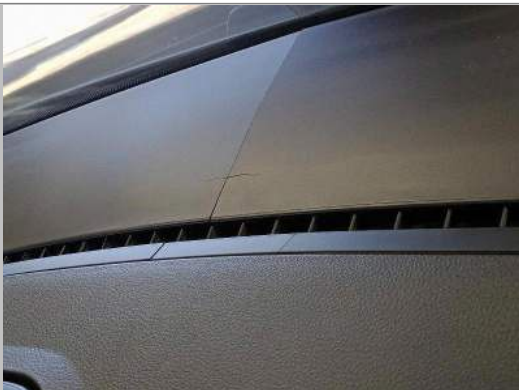
| Parcel Tray Damaged | Repair |

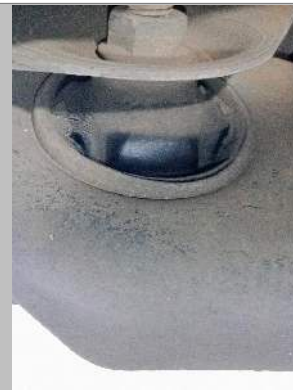
| Control Arm Bush(es) Front Axle Right Cracked | Replace |

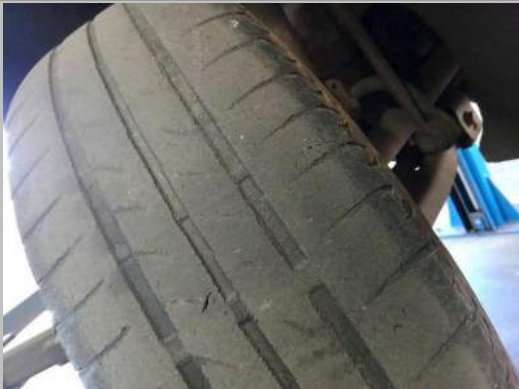
| Tyre Front Right Smooth | Replace |

| | Size | Load/Speed Index | Manufacture | Model | Type* | Production Date | Tread Depth (mm) |
|---|---|---|---|---|---|---|---|
| Front Right | 185/65R14 | 86T | Bridgestone | B250 | V | 1219 | 0 mm |

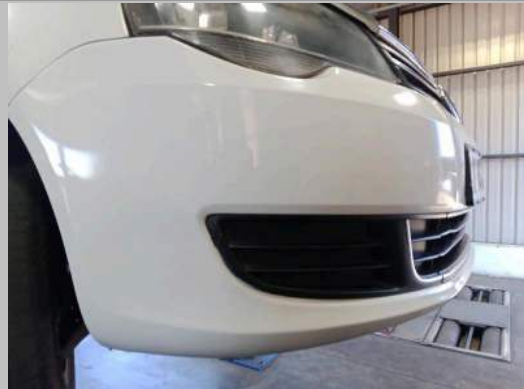
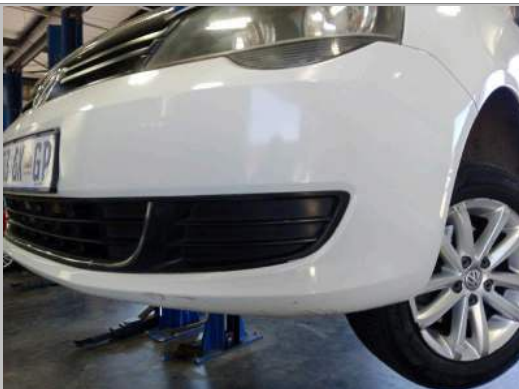
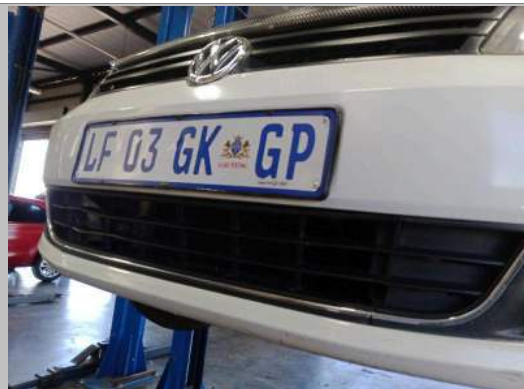
| Front Bumper Residual Traces of Repair | Repair |

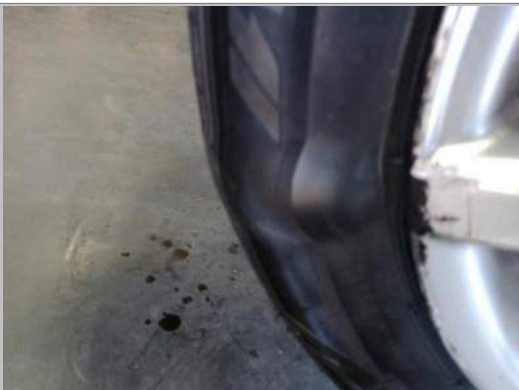
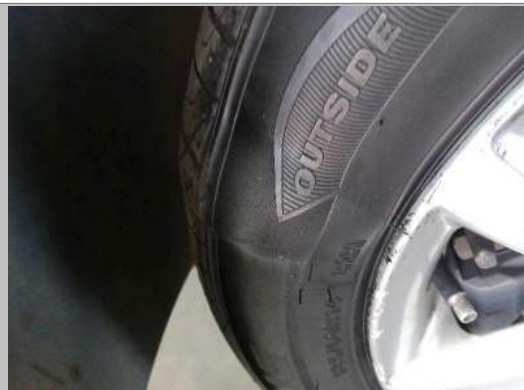
| Tyre Front Left Damaged | Replace |

| | Size | Load/Speed Index | Manufacture | Model | Type* | Production Date | Tread Depth (mm) |
|---|---|---|---|---|---|---|---|
| Front Left | 185/60R14 | 82H | Aplus | A609 | V | 0824 | 2 mm |

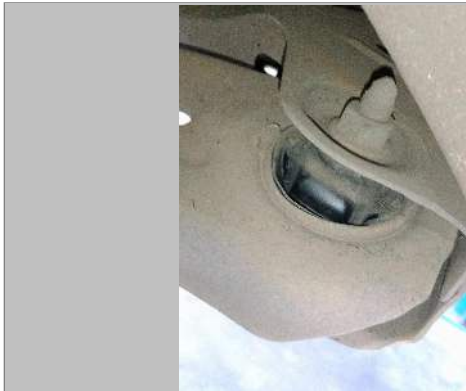
| Control Arm Bush(es) Front Axle Left Cracked | Repair |

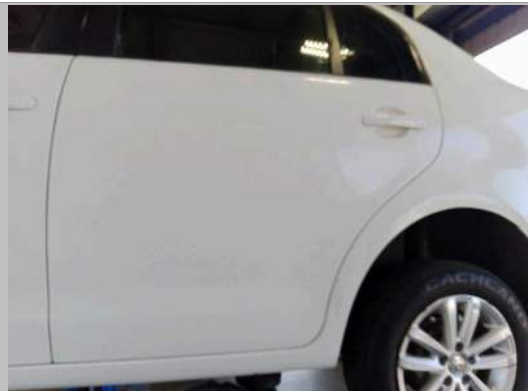
| Door Rear Left Residual Traces of Repair | Repair |

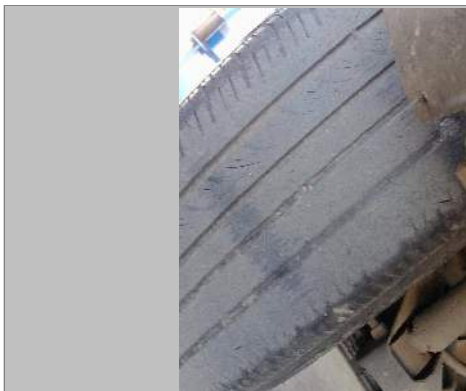
| Tyre Rear Left Smooth | Replace |

| | Size | Load/Speed Index | Manufacture | Model | Type* | Production Date | Tread Depth (mm) |
|---|---|---|---|---|---|---|---|
| Rear Left | 175/65R14 | 82T | Cachland | CH | V | 0000 | 0 mm |

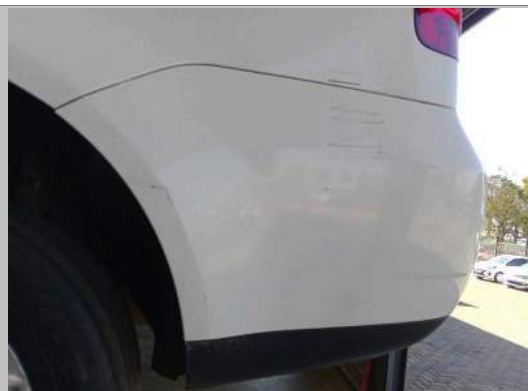
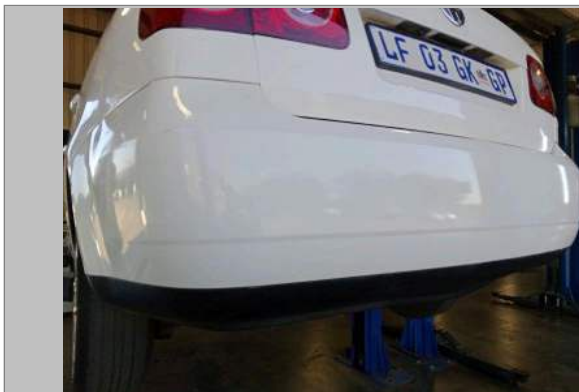
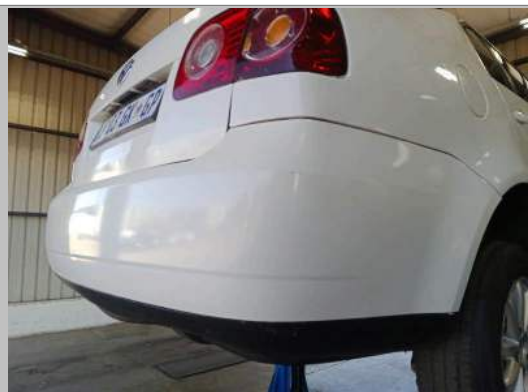
| Rear bumper Residual Traces of Repair | Repair |

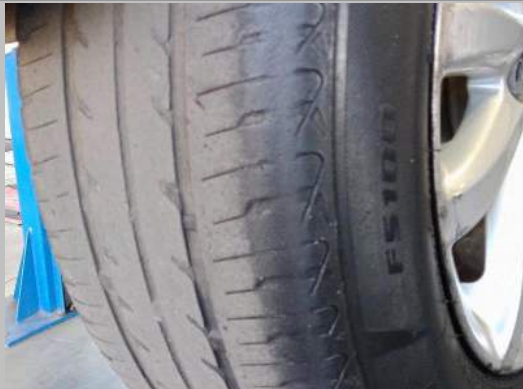
| Tyre Rear Right Smooth | Replace |

| | Size | Load/Speed Index | Manufacture | Model | Type* | Production Date | Tread Depth (mm) |
|---|---|---|---|---|---|---|---|
| Rear Right | 185/65R14 | 86H | Bridgestone | Touring | V | 0000 | 0 mm |

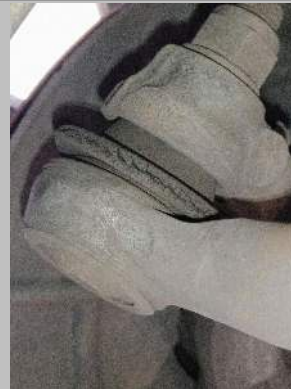
| Tie Rod End left Cracked | Replace |

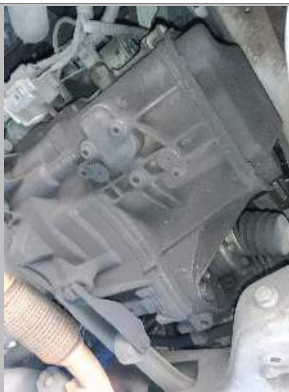
| Gearbox Oil Sweat | Repair |

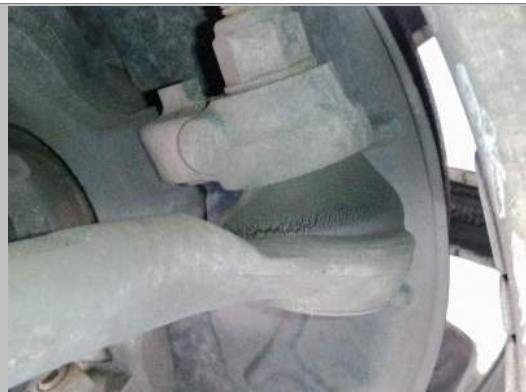
| Tie Rod End right Cracked | Replace |

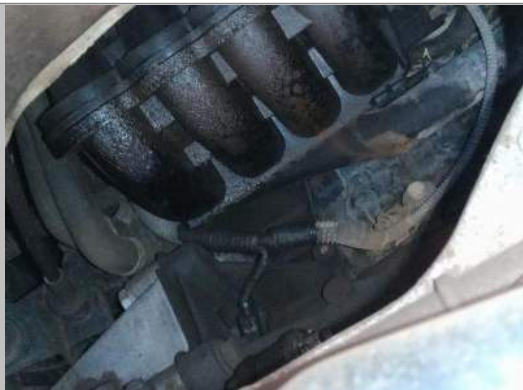
| Engine Oil Leak | Repair |

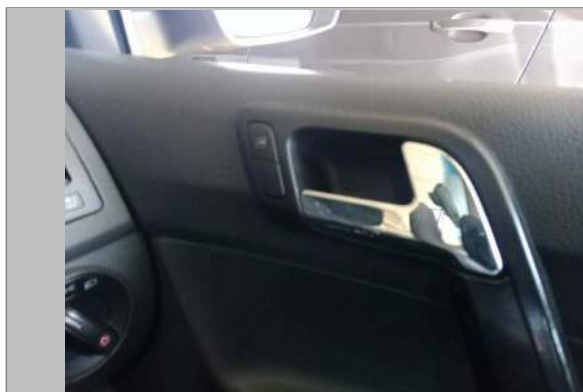
| Switch Electrical Window Winder front right Damaged | Repair |
| Driver electric window not working | Repair |
