## CONDITION REPORT

2017304204

MFC Auction House  
M57 Pretoria Rd, Glenmarais, KEMPTON PARK  
Gauteng

| Model | POLO VIVO GP 1.4 55KW CONCEPTLINE 5-DR [2016-2018] | Register Number | |

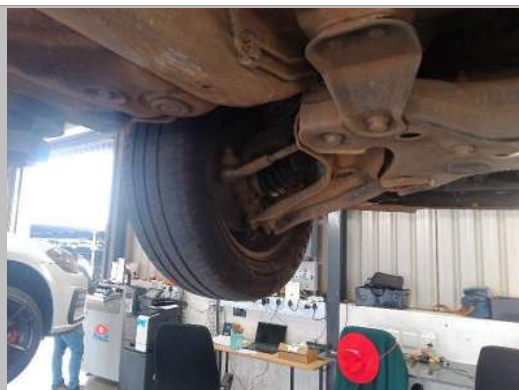
LF TYRE TREAD

| | Size | Load/Speed Index | Manufacture | Model | Type* | Production Date | Tread Depth (mm) |
|---|---|---|---|---|---|---|---|
| Front Left | 185/60R14 | 82H | Goodyear | Efficient gr | V | 0424 | 3 mm |

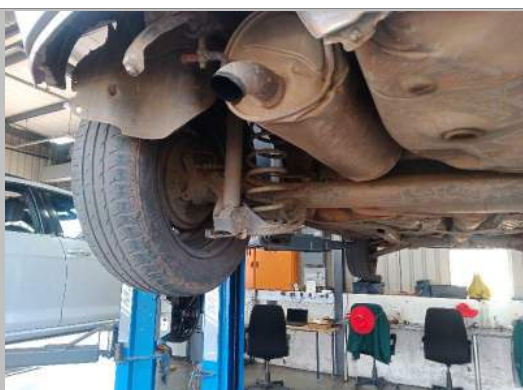
LR TYRE TREAD

| | Size | Load/Speed Index | Manufacture | Model | Type* | Production Date | Tread Depth (mm) |
|---|---|---|---|---|---|---|---|
| Rear Left | 175/65R14 | 82H | Continental | Contact | V | 0811 | 2 mm |

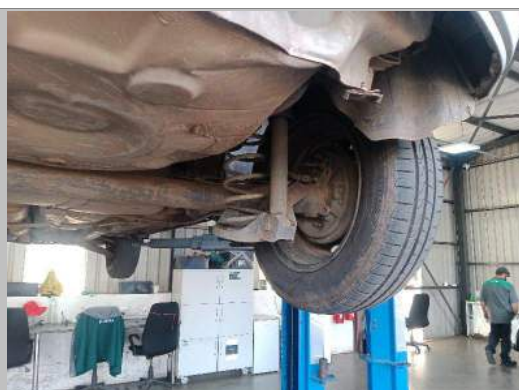
RR TYRE TREAD

| | Size | Load/Speed Index | Manufacture | Model | Type* | Production Date | Tread Depth (mm) |
|---|---|---|---|---|---|---|---|
| Rear Right | 165/70R14 | 82H | Hankook | Kinergy | V | 3423 | 3 mm |

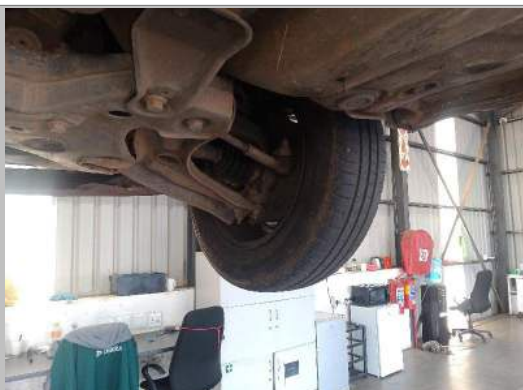
RF TYRE TREAD

| | Size | Load/Speed Index | Manufacture | Model | Type* | Production Date | Tread Depth (mm) |
|---|---|---|---|---|---|---|---|
| Front Right | 165/70R14 | 81T | Hankook | Kinergy | V | 3423 | 3 mm |

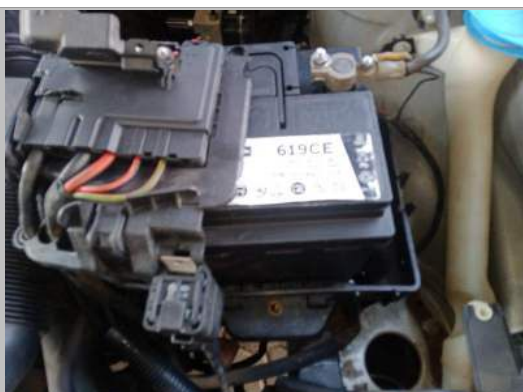
| Battery loose | Repair |

Battery loose

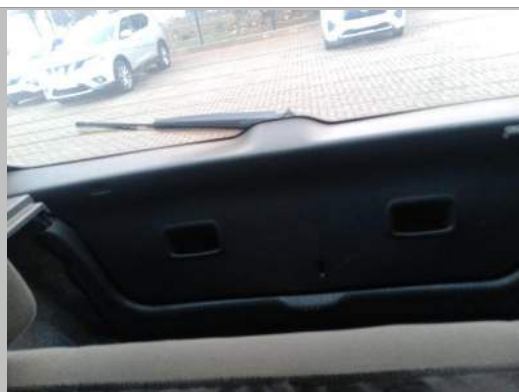
| Parcel Tray Missing | Replace |

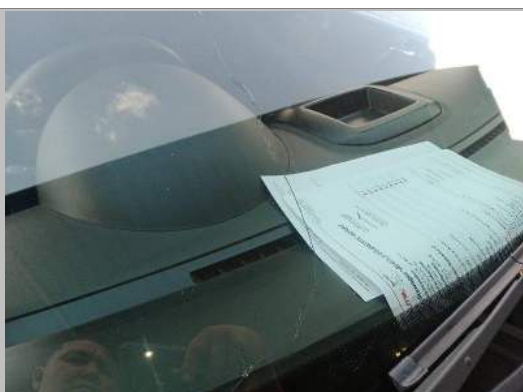
| Windscreen Cracked | Replace |

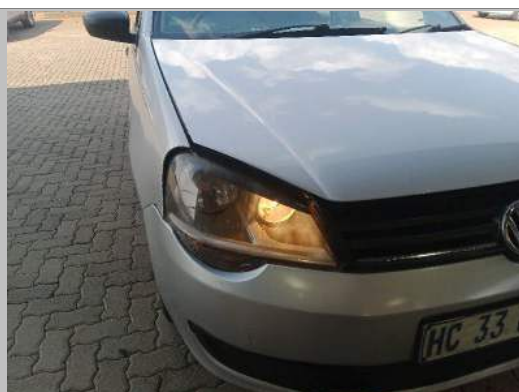
| Dim Light Right Malfunction | Repair |

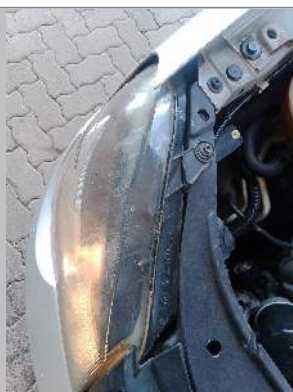
| Headlight Right Damaged | Repair |

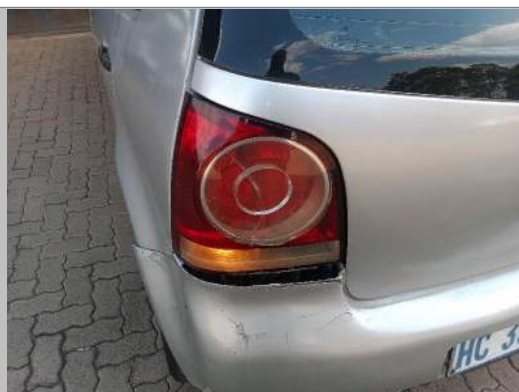
| Tail Light Left Cracked | Replace |

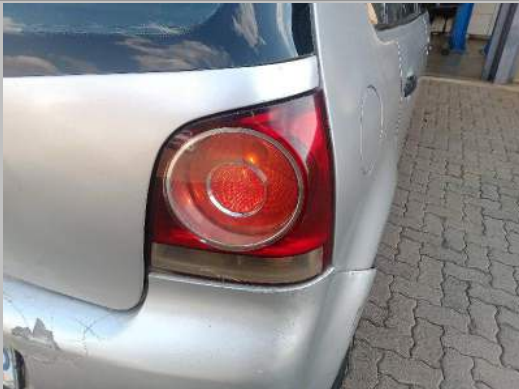
| Tail Light Right Cracked | Replace |

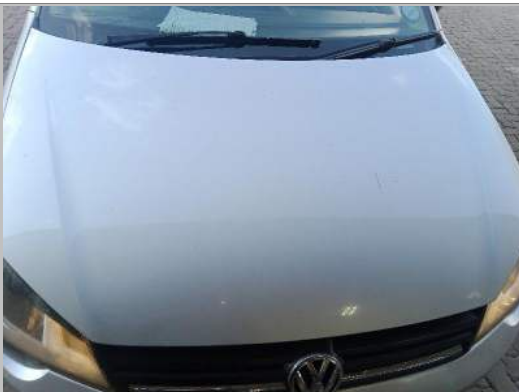
| Bonnet Paintwork • Scratched | Repair |

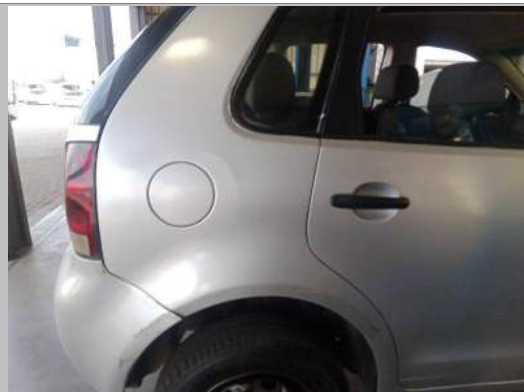
| Rear Fender Right Paintwork • Scratched | Repair |

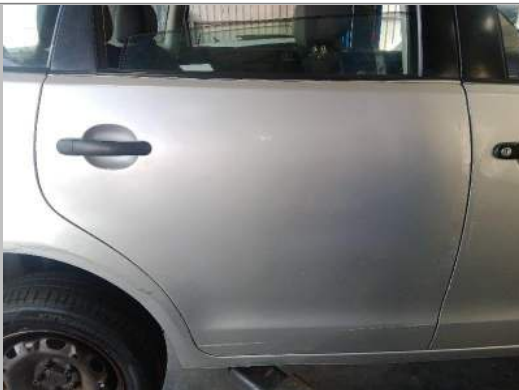
| Door Rear Right Paintwork • Scratched | Repair |

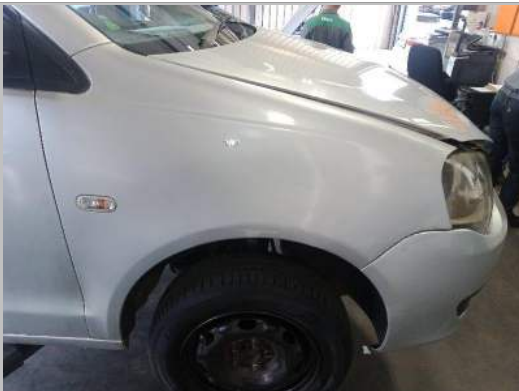
| Front Fender Right Residual Traces of Repair | Repair |

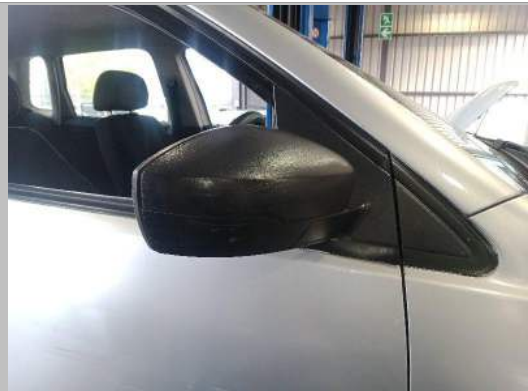
| Side Mirror Right Paintwork • Scratched | Repair |

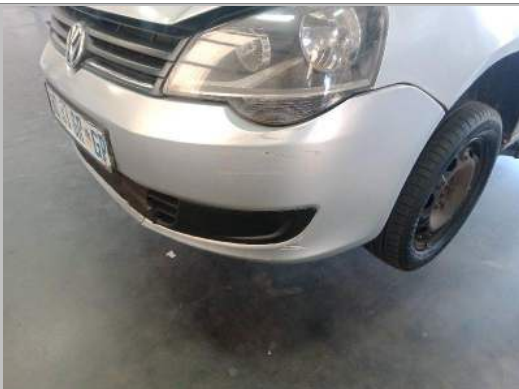
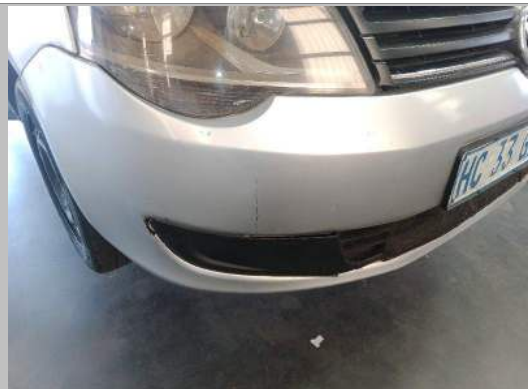
| Front Bumper Paintwork • Scratched | Repair |

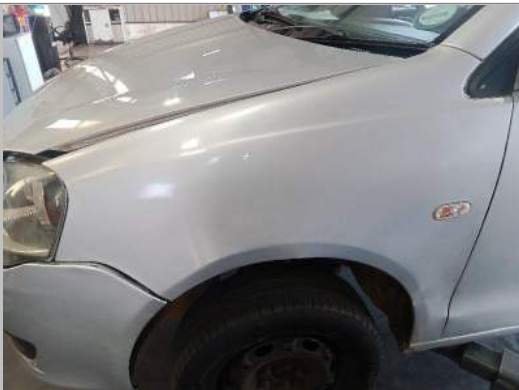
| Front Fender Left Residual Traces of Repair | Repair |

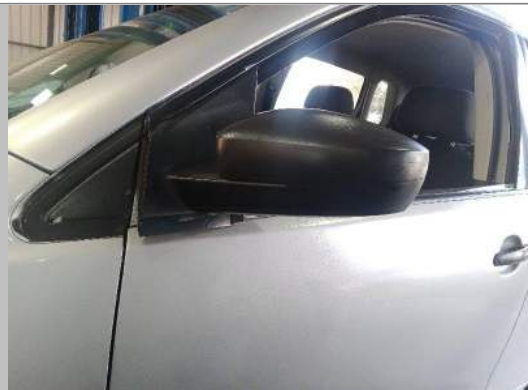
| Side Mirror Left Damaged | Repair |

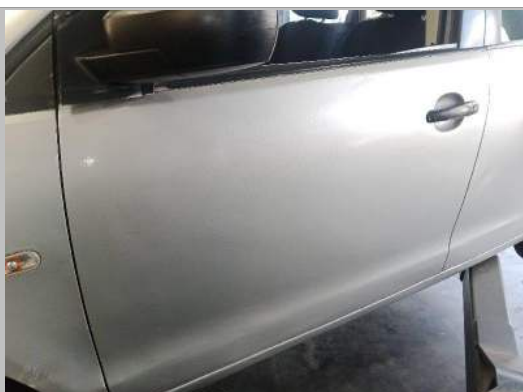
| Door Front Left Residual Traces of Repair | Repair |

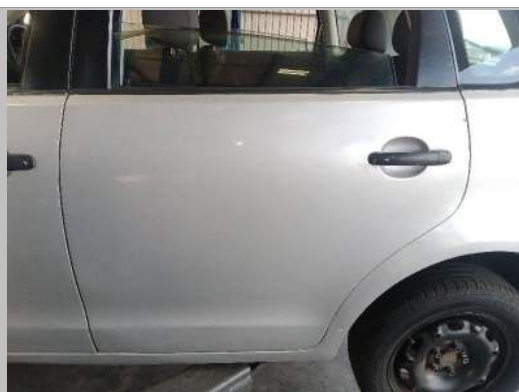
| Door Rear Left Residual Traces of Repair | Repair |

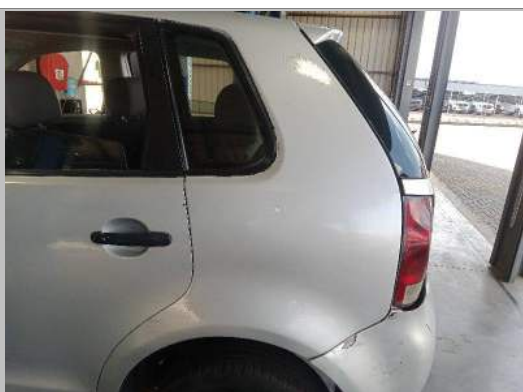
| Rear Fender Left Residual Traces of Repair | Repair |

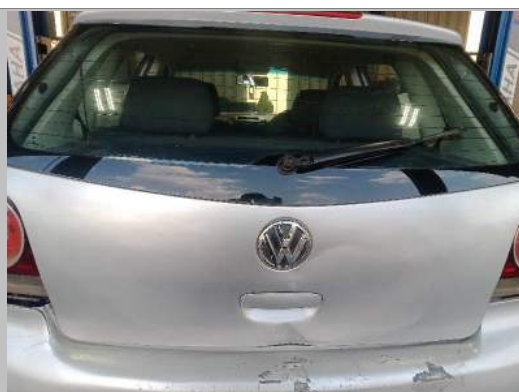
| Boot Lid / Hatch door Dented | Repair |

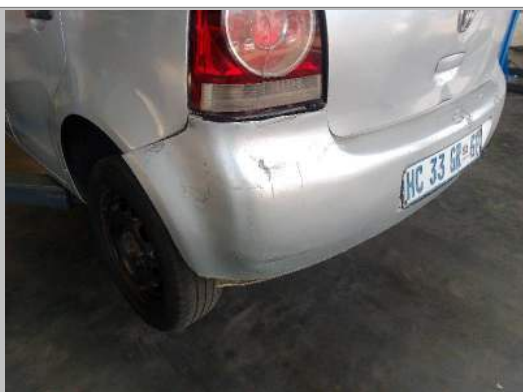
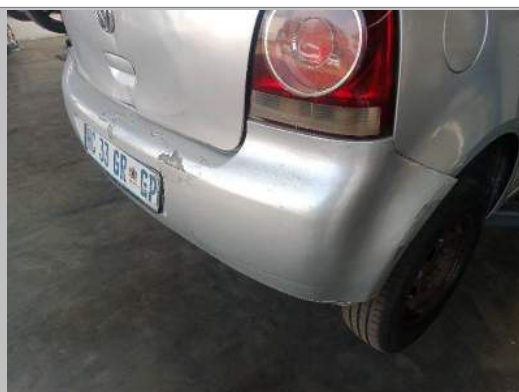
| Rear bumper Damaged | Repair |

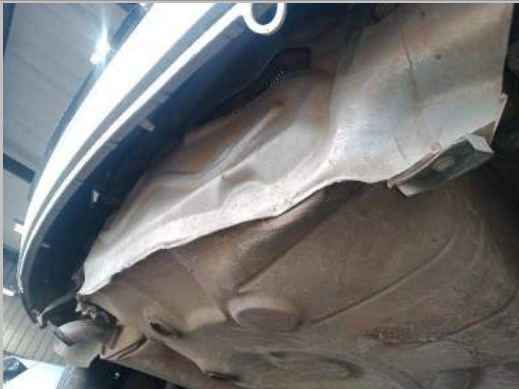
| Inner Boot Floor Pan and Spare Wheel Well Dented | Repair |

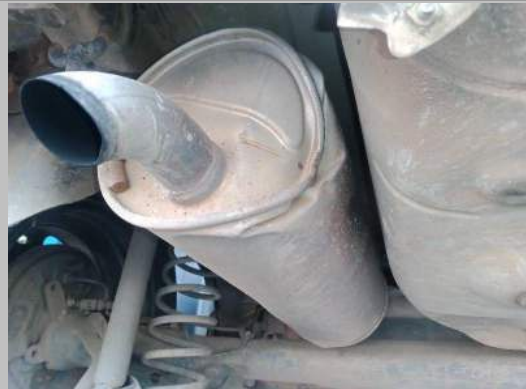
| Silencer Defective | Repair |

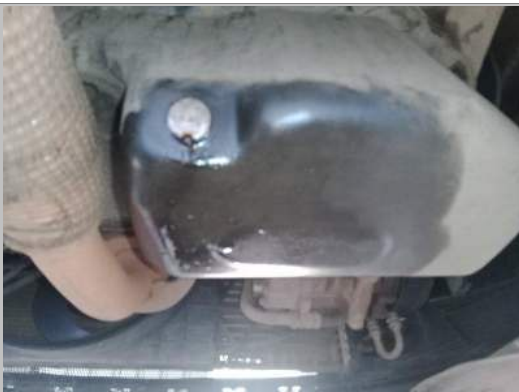
| Engine Oil Leak | Repair |

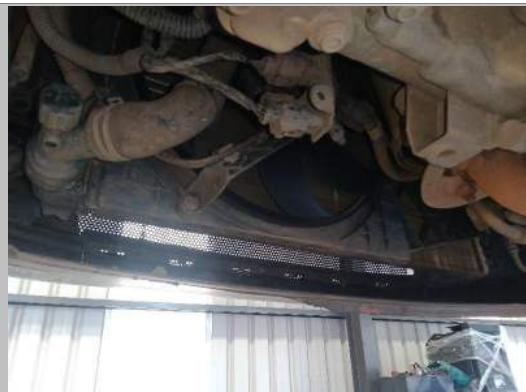
| Radiator Cradle Missing | Replace |

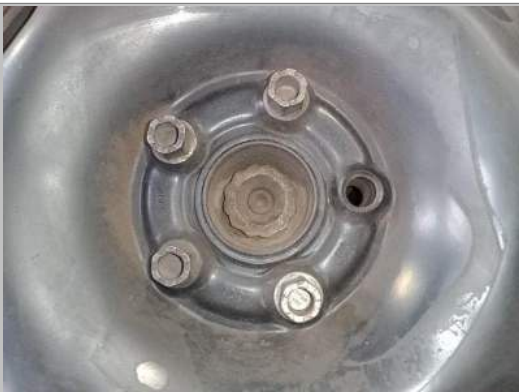
| Bolt(s) / Nut(s) Front Wheel Right Missing | Replace |
