## CONDITION REPORT

Report No: 2016843982

MFC Auction House  
M57 Pretoria Rd, Glenmarais, KEMPTON PARK  
Gauteng

| Manufacturer | VOLKSWAGEN | Registration Number | FVZ841L |

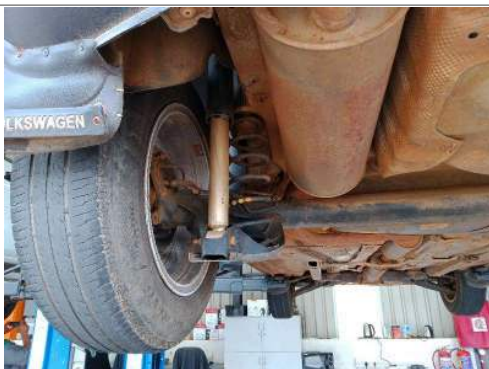
LF TYRE TREAD

| | Size | Load/Speed Index | Manufacture | Model | Type* | Production Date | Tread Depth (mm) |
|---|---|---|---|---|---|---|---|
| Front Left | 175/65 R14 | 82H | Apollo | Acelere | V | 5011 | 1 mm |

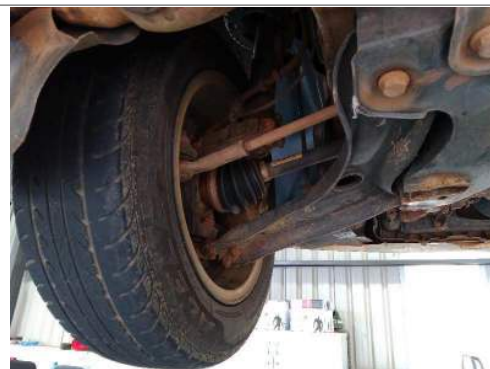
RF TYRE TREAD

| | Size | Load/Speed Index | Manufacture | Model | Type* | Production Date | Tread Depth (mm) |
|---|---|---|---|---|---|---|---|
| Front Right | 175/65 R14 | 82H | Apollo | Acelere | V | 4711 | 1 mm |

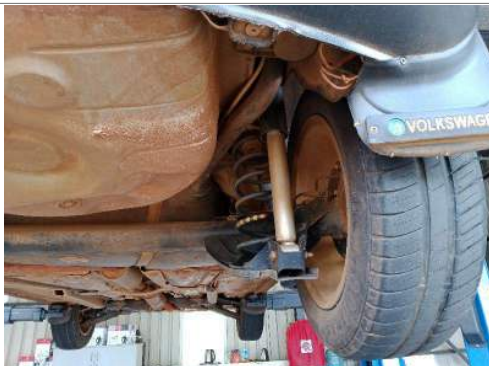
LR TYRE TREAD

| | Size | Load/Speed Index | Manufacture | Model | Type* | Production Date | Tread Depth (mm) |
|---|---|---|---|---|---|---|---|
| Rear Left | 175/70 R14 | 84T | Firestone | Touring | V | 3421 | 0 mm |

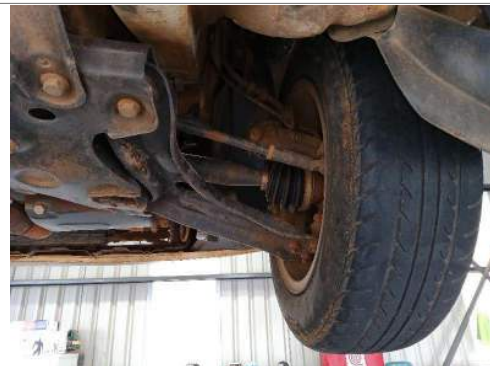
RR TYRE TREAD

| | Size | Load/Speed Index | Manufacture | Model | Type* | Production Date | Tread Depth (mm) |
|---|---|---|---|---|---|---|---|
| Rear Right | 175/65 R14 | 82H | Goodyear | Efficient | V | 1722 | 3 mm |

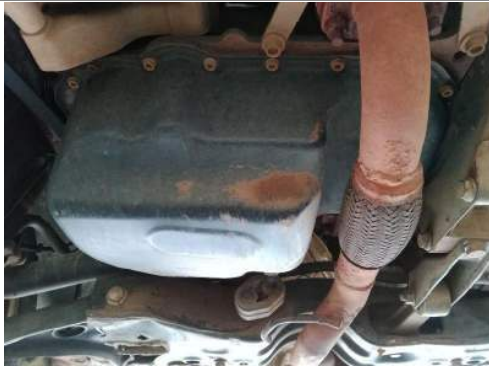
| Damage | Repair Way |
|---|---|
| Engine | Engine oil sump dented |

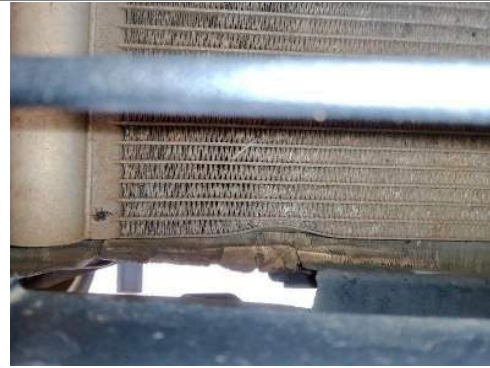
| Damage | Repair Way |
|---|---|
| Engine | Aircon condenser dented |

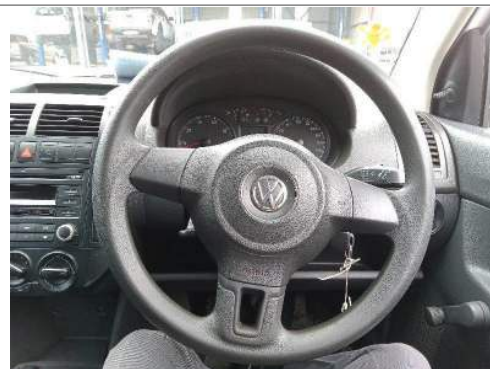
| Damage | Repair Way |
|---|---|
| Steering Wheel Trim Defective | Repair |

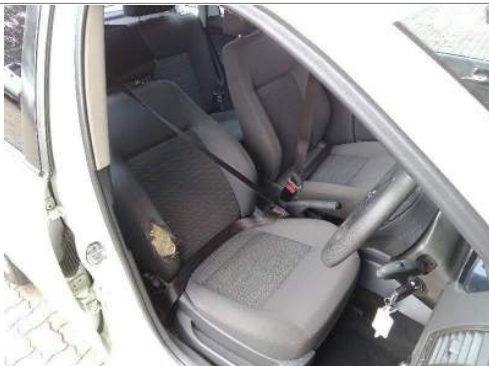
| Damage | Repair Way |
|---|---|
| Seat Front Right Damaged | Repair |

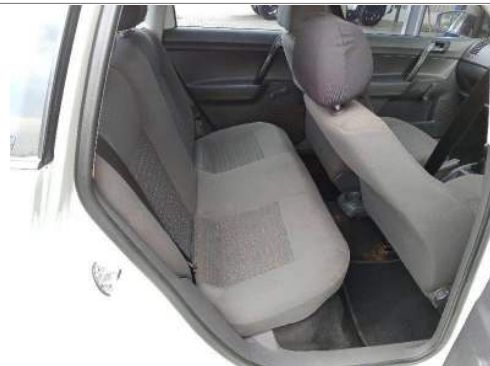
| Damage | Repair Way |
|---|---|
| Seat Rear Dirty | Repair |

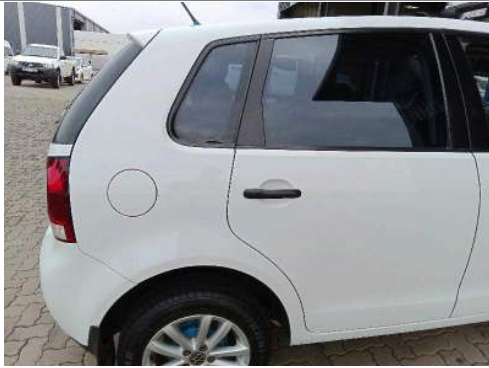
| Damage | Repair Way |
|---|---|
| Rear Fender Right Paintwork • Scratched | Repair |

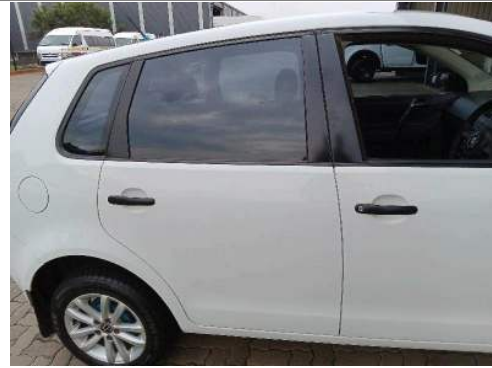
| Damage | Repair Way |
|---|---|
| Door Rear Right Paintwork • Scratched | Repair |

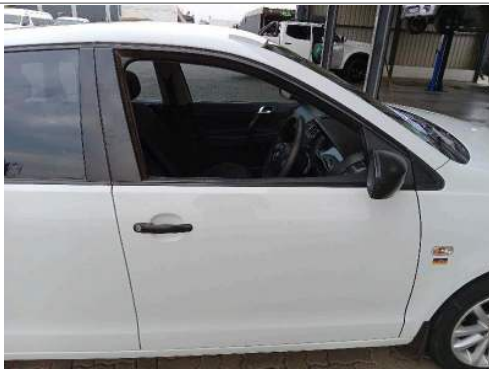
| Damage | Repair Way |
|---|---|
| Door Front Right Paintwork • Scratched | Repair |

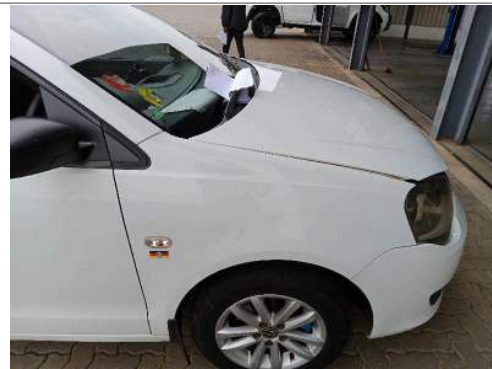
| Damage | Repair Way |
|---|---|
| Front Fender Right Damaged | Repair |

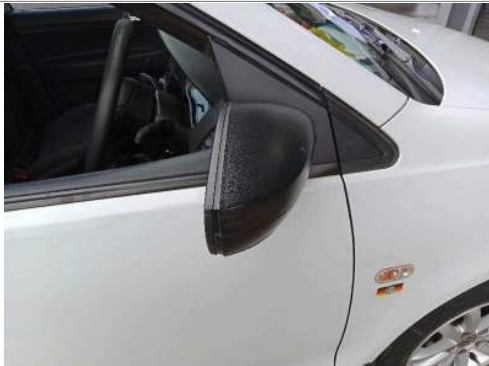
| Damage | Repair Way |
|---|---|
| Side Mirror Right Paintwork • Scratched | Repair |

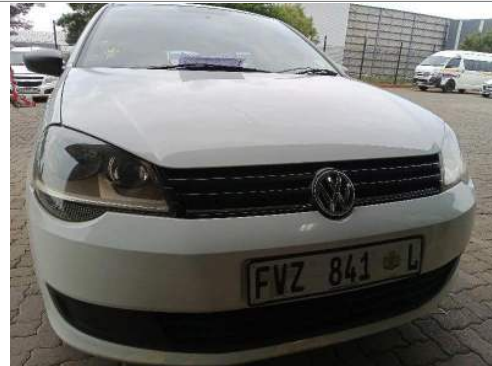
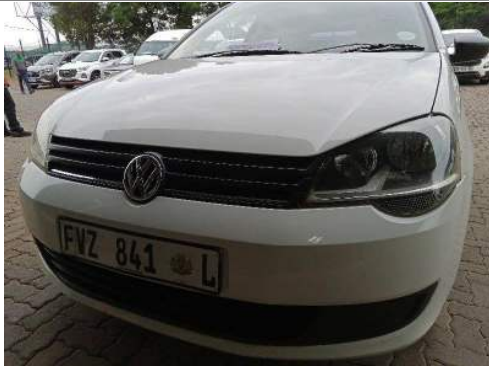
| Damage | Repair Way |
|---|---|
| Front Bumper Damaged | Repair |

| Damage | Repair Way |
|---|---|
| Body and Exterior | Signs of impact damage to front of vehicle. |

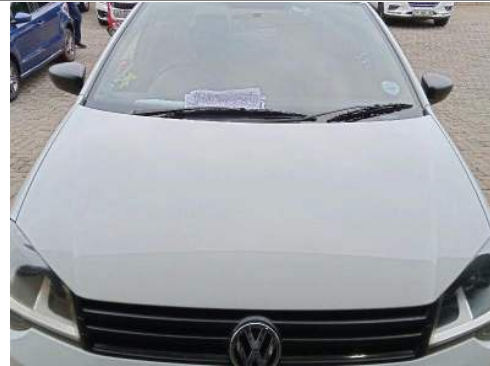
| Damage | Repair Way |
|---|---|
| Bonnet Paintwork • Scratched | Repair |

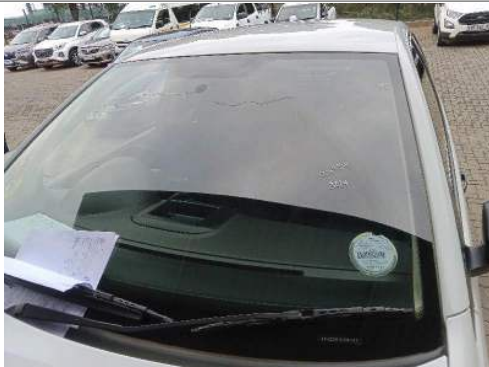
| Damage | Repair Way |
|---|---|
| Windscreen Cracked | Replace |

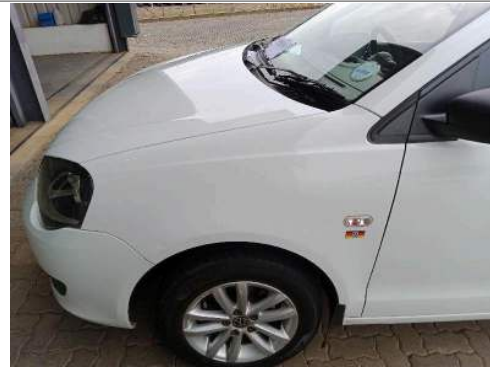
| Damage | Repair Way |
|---|---|
| Front Fender Left Damaged | Repair |

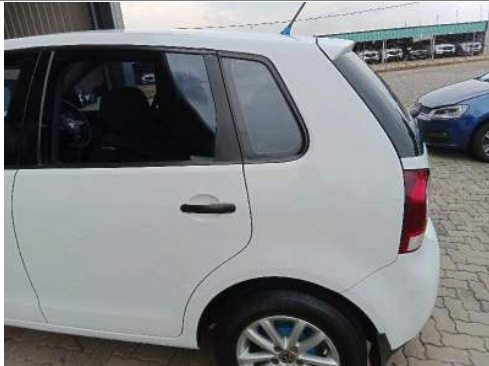
| Damage | Repair Way |
|---|---|
| Rear Fender Left Dented | Repair |

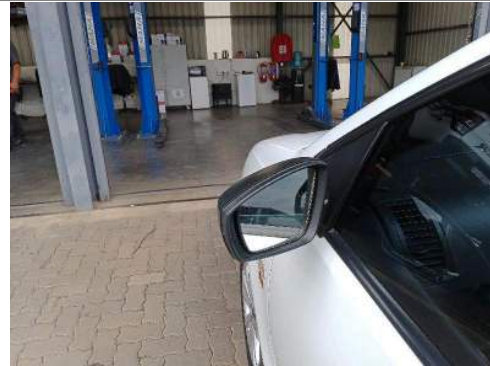
| Damage | Repair Way |
|---|---|
| Side Mirror Left Residual Traces of Repair | Replace |

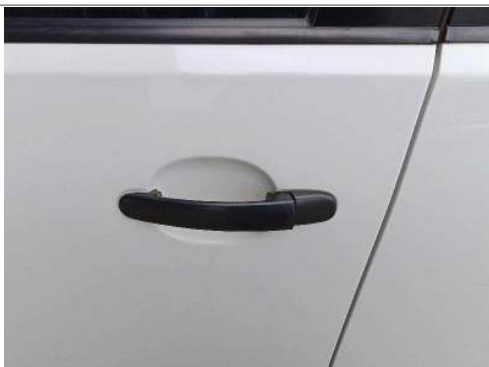
| Damage | Repair Way |
|---|---|
| Door Handle Front Left Defective | Replace |

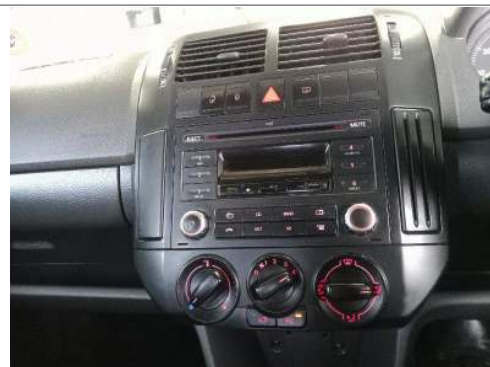
| Damage | Repair Way |
|---|---|
| Air Conditioner Insufficient | Replace |

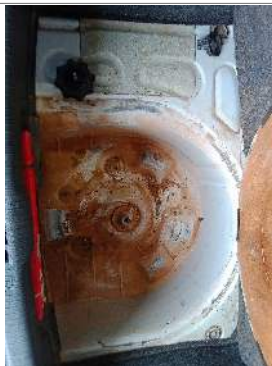
| Damage | Repair Way |
|---|---|
| Inner Boot Floor Pan and Spare Wheel Well Damaged | Repair |

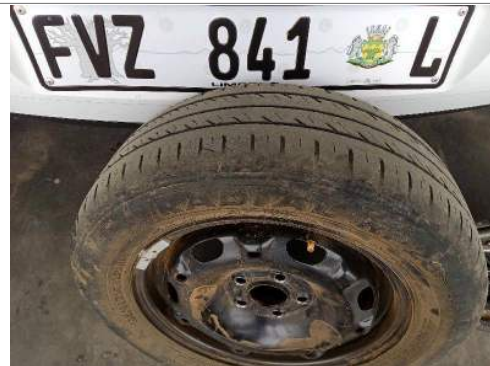
| Damage | Repair Way |
|---|---|
| Spare Tyre Worn | Replace |

| | Size | Load/Speed Index | Manufacture | Model | Type* | Production Date | Tread Depth (mm) |
|---|---|---|---|---|---|---|---|
| Spare | 185/60 R14 | 82H | Goodride | Radial | V | | 0 mm |

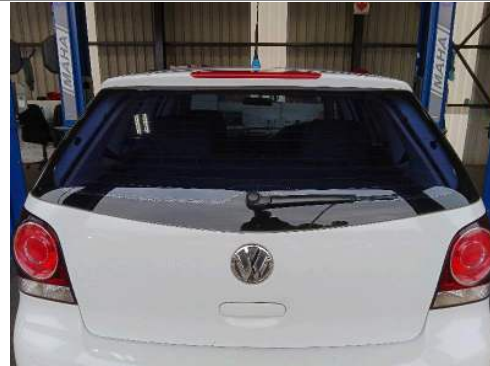
| Damage | Repair Way |
|---|---|
| Boot Lid / Hatch door Paintwork • Scratched | Repair |

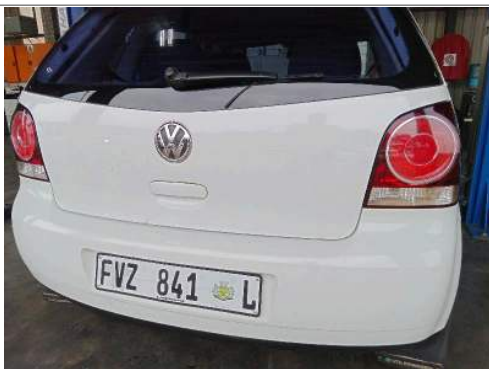
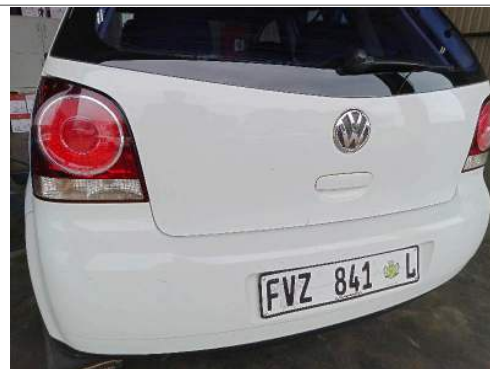
| Damage | Repair Way |
|---|---|
| Rear bumper Paintwork • Scratched | Repair |

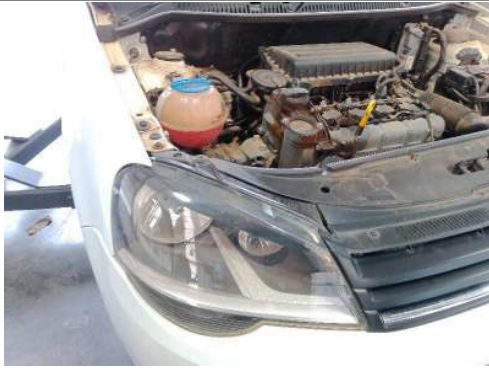
| Damage | Repair Way |
|---|---|
| Headlight Right Defective | Repair |

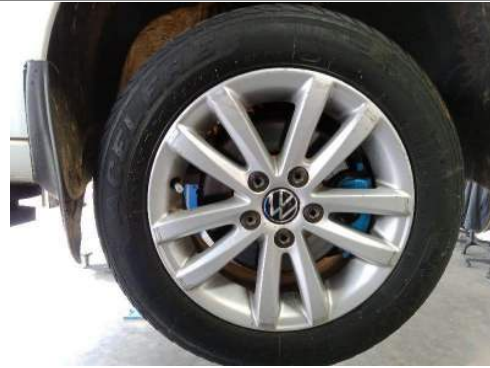
| Damage | Repair Way |
|---|---|
| Rim Front Right Scratched | Repair |

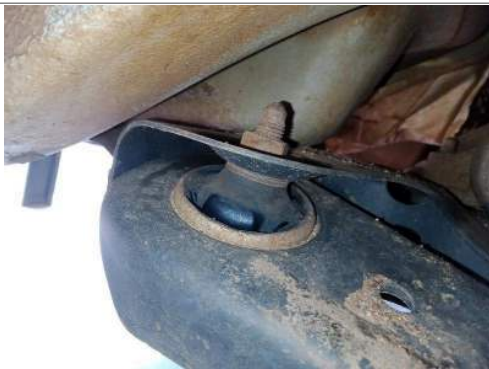
| Damage | Repair Way |
|---|---|
| Control Arm Bush(es) Front Axle Right Cracked | Replace |

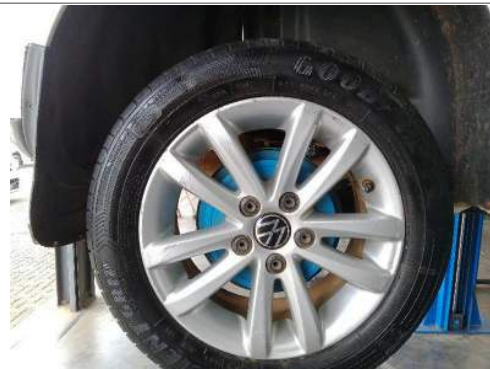
| Damage | Repair Way |
|---|---|
| Rim Rear Right Scratched | Repair |

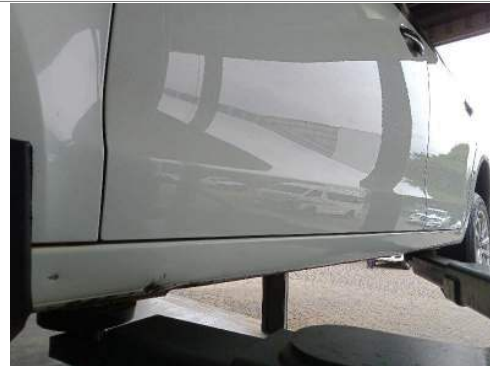
| Damage | Repair Way |
|---|---|
| Sill Panel Left Dented | Repair |

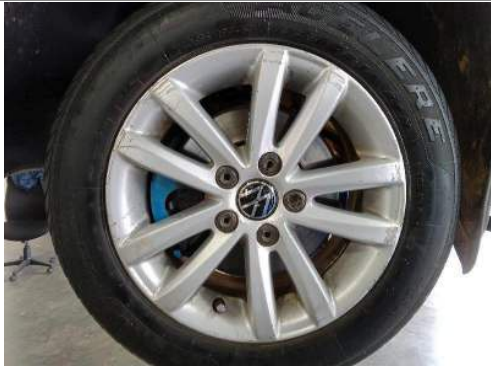
| Damage | Repair Way |
|---|---|
| Rim Front Left Scratched | Repair |

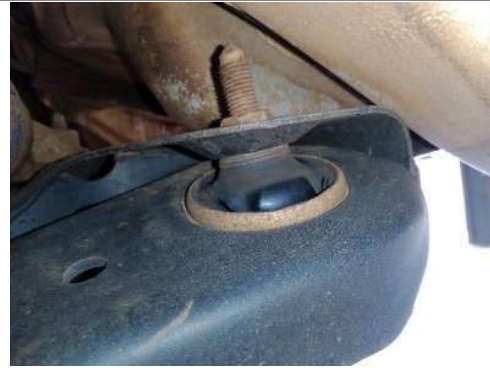
| Damage | Repair Way |
|---|---|
| Control Arm Bush(es) Front Axle Left Cracked | Replace |

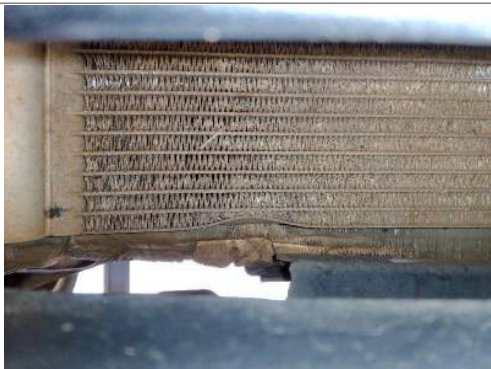
| Damage | Repair Way |
|---|---|
| Radiator Damaged | Replace |

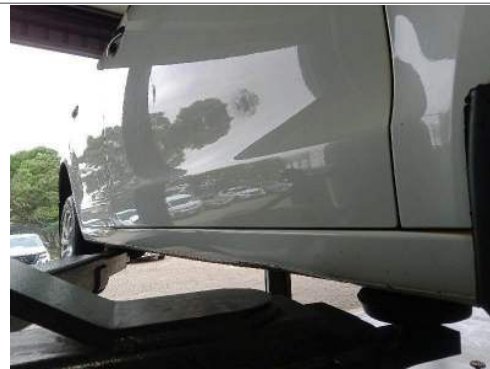
| Damage | Repair Way |
|---|---|
| Sill Panel Right Dented | Repair |

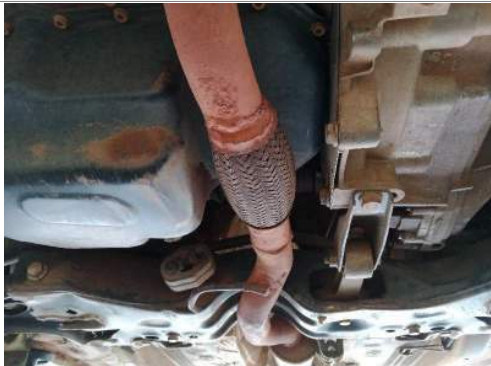
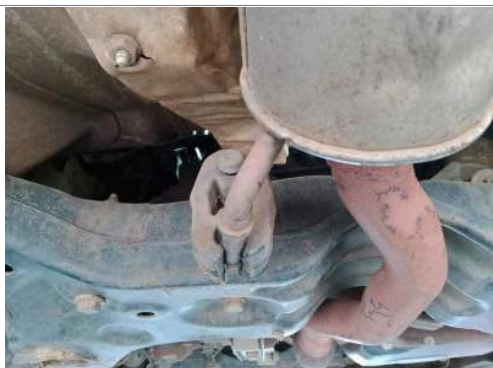
| Damage | Repair Way |
|---|---|
| Engine to silencer pipe Welded | Replace |

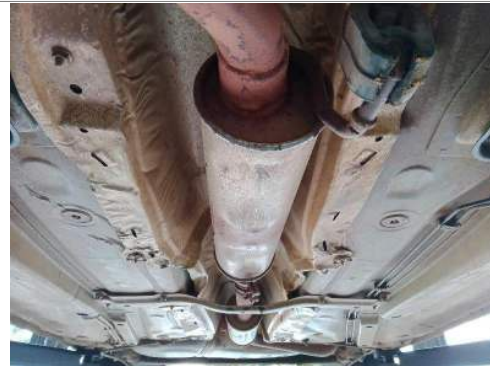
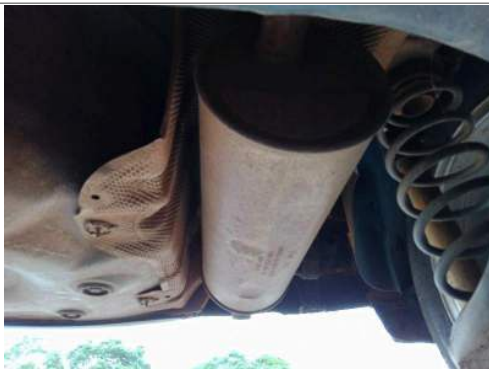
| Damage | Repair Way |
|---|---|
| Silencer Damaged | Replace |

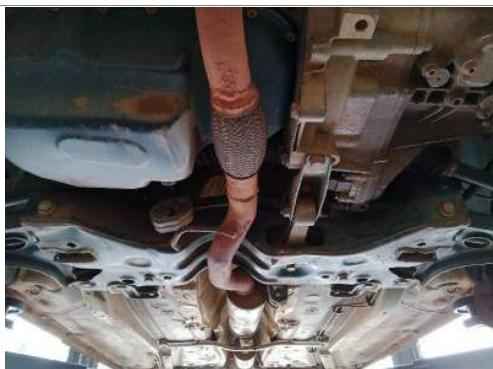
| Damage | Repair Way |
|---|---|
| Sub Frame Damaged | Replace |

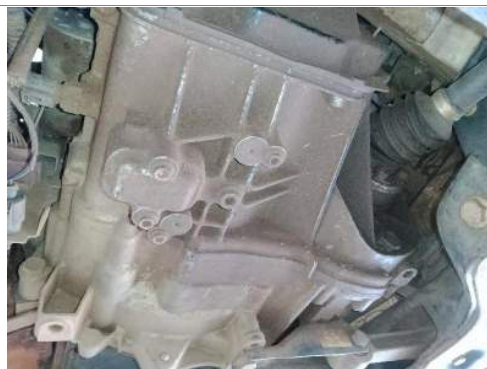
| Damage | Repair Way |
|---|---|
| Gearbox Oil Sweat | Repair |

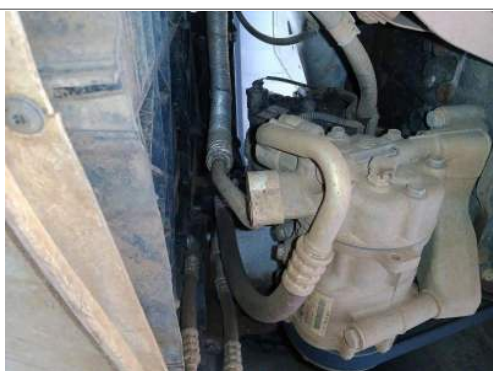
| Damage | Repair Way |
|---|---|
| Air conditioner pipes Damaged | Repair |

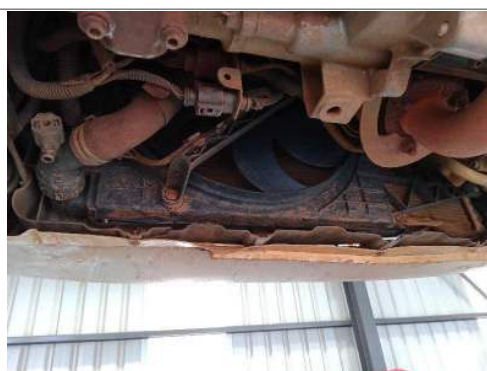
| Damage | Repair Way |
|---|---|
| Radiator Cradle Damaged | Replace |

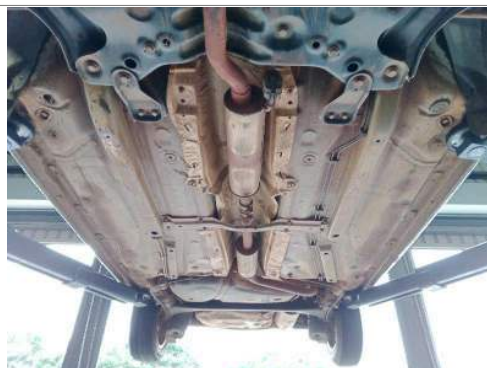
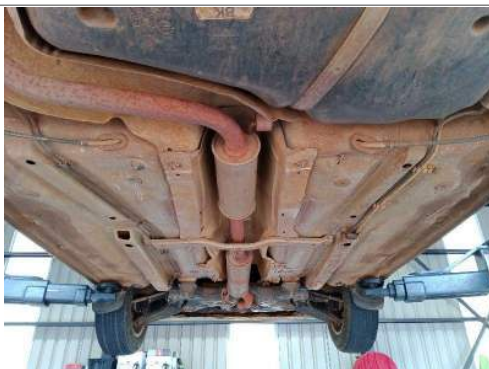
| Damage | Repair Way |
|---|---|
| Chassis Damaged | Repair |

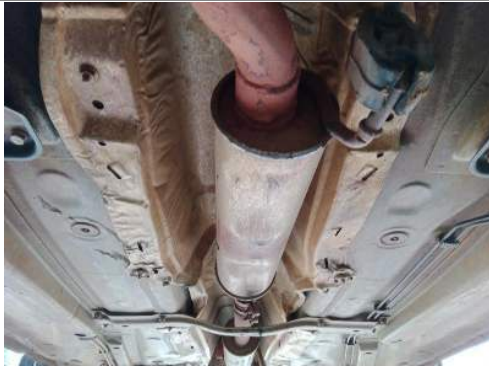
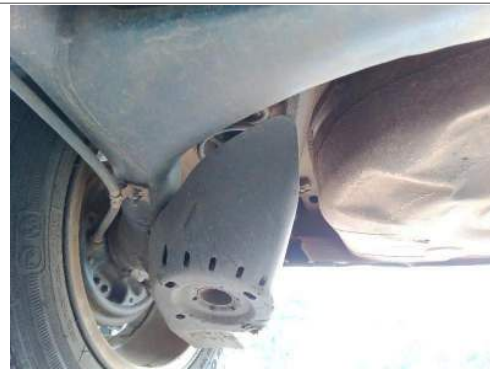
| Damage | Repair Way |
|---|---|
| Belly plates Damaged | Repair |

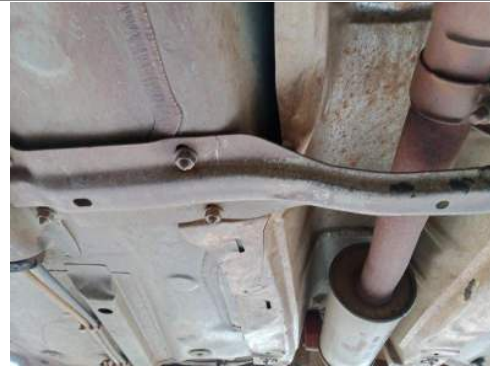
| Damage | Repair Way |
|---|---|
| Cross Member Rear Right Dented | Repair |

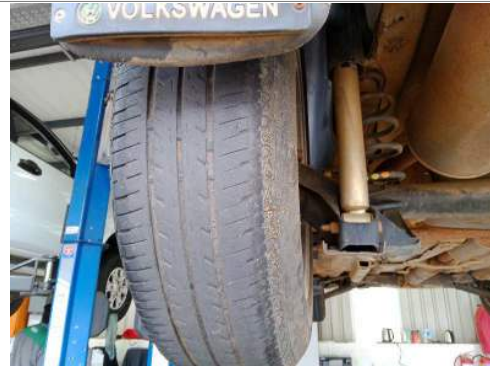
| Damage | Repair Way |
|---|---|
| Tyre Rear Left Worn | Replace |
| Tyres and rims | Rear left and right tyre sizes different |

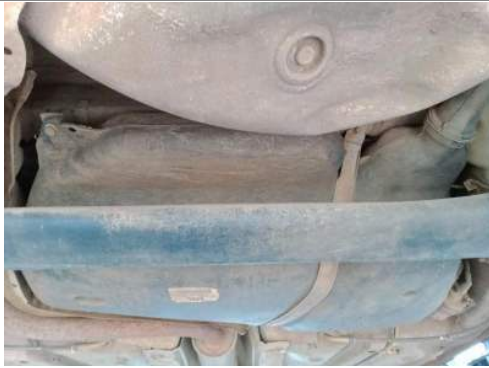
| Damage | Repair Way |
|---|---|
| Fuel Tank Defective | Repair |

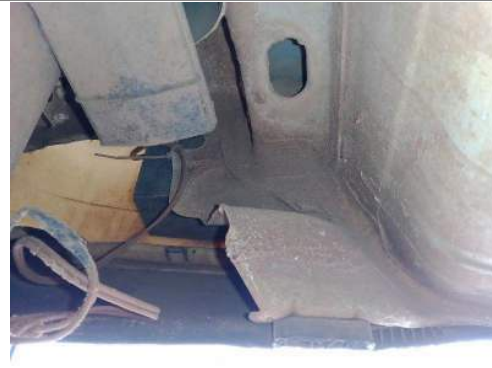
| Damage | Repair Way |
|---|---|
| Rear Fender Right / Inner Tray Dented | Repair |
