## CONDITION REPORT

Report No:  
2017302479  
DATE  
23/09/2026

| Manufacturer | VOLKSWAGEN | Registration Number | HR50VXGP |
| Model | POLO 1.0 TSI 70KW TRENDLINE 5-DR [2018-2020] | Register Number | |

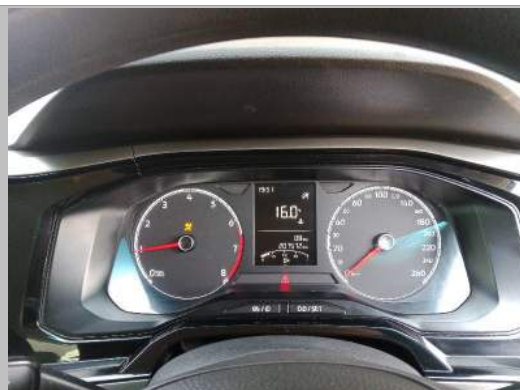
DASHBOARD (W/ ENGINE RUNNING)

| Damage | Repair Way |
|---|---|
| Warning lights illuminated on dashboard | Repair |

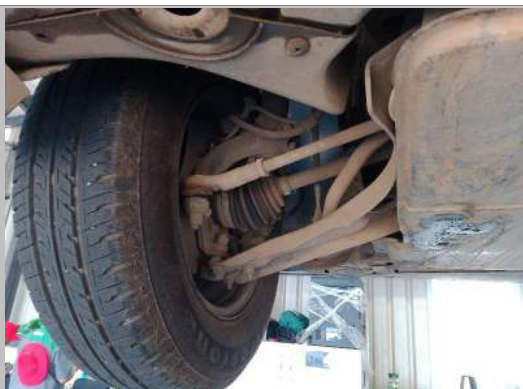
LF TYRE TREAD

| | Size | Load/Speed Index | Manufacture | Model | Type* | Production Date | Tread Depth (mm) |
|---|---|---|---|---|---|---|---|
| Front Left | 185/70 R14 | 88T | Firestone | Touring | V | 1823 | 3 mm |

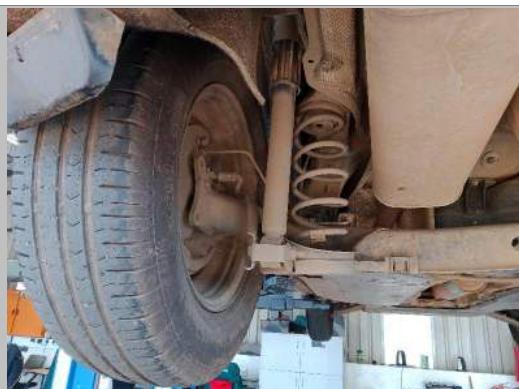
LR TYRE TREAD

| | Size | Load/Speed Index | Manufacture | Model | Type* | Production Date | Tread Depth (mm) |
|---|---|---|---|---|---|---|---|
| Rear Left | 185/70 R14 | 88H | Continental | Contipremuim | V | 2424 | 4 mm |

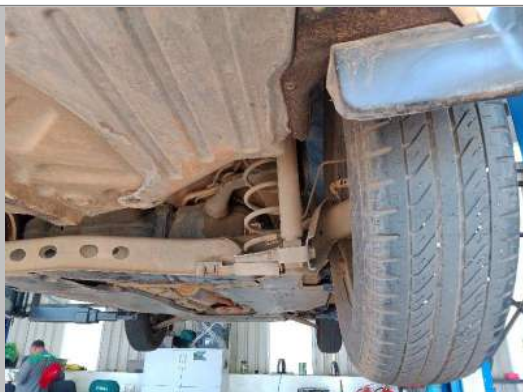
RR TYRE TREAD

| | Size | Load/Speed Index | Manufacture | Model | Type* | Production Date | Tread Depth (mm) |
|---|---|---|---|---|---|---|---|
| Rear Right | 185/70 R14 | 88T | Dunlop | Sp-Sport | V | 4023 | 2 mm |

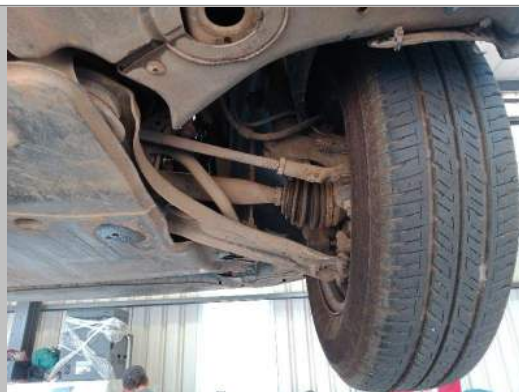
RF TYRE TREAD

| | Size | Load/Speed Index | Manufacture | Model | Type* | Production Date | Tread Depth (mm) |
|---|---|---|---|---|---|---|---|
| Front Right | 185/70 R14 | 88T | Firestone | Touring | V | 4923 | 4 mm |

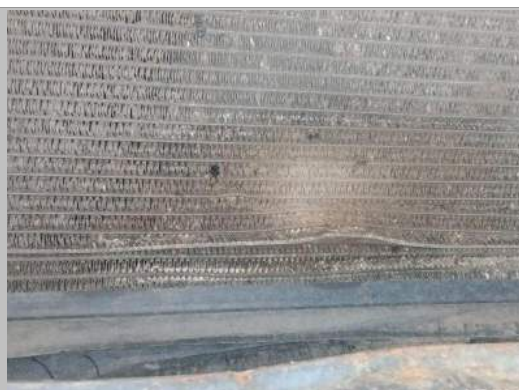
| Damage | Repair Way |
|---|---|
| Aircon condenser dented | Repair |

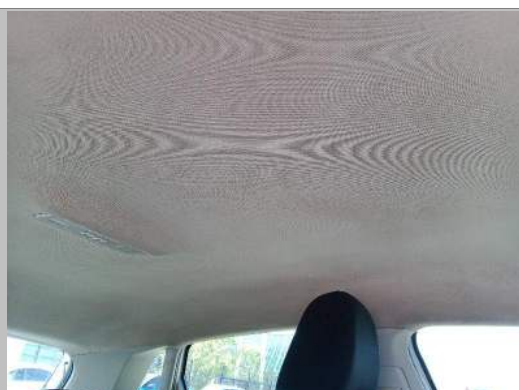
| Damage | Repair Way |
|---|---|
| Hood Lining Dirty | Repair |

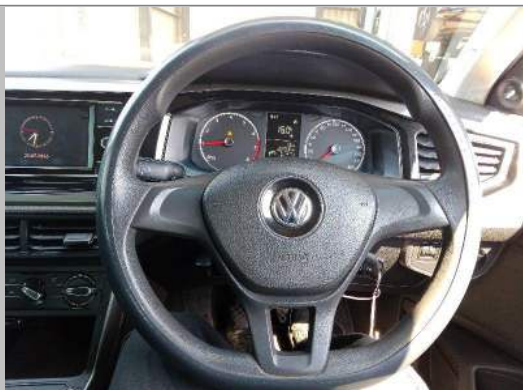
| Damage | Repair Way |
|---|---|
| Steering Wheel Trim Excessive Wear & Tear | Repair |

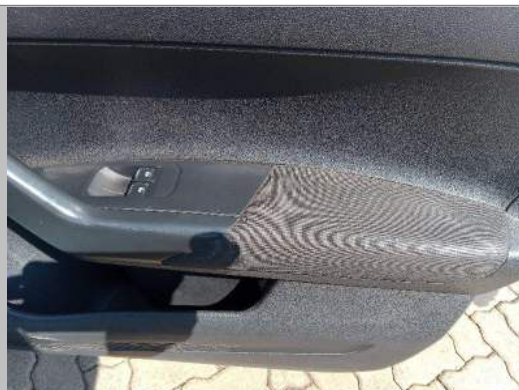
| Damage | Repair Way |
|---|---|
| Door Panel Front Right Damaged | Repair |

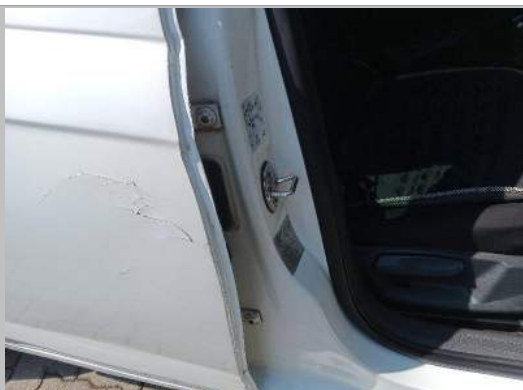
| Damage | Repair Way |
|---|---|
| B • Pillar Right Residual Traces of Repair | Repair |

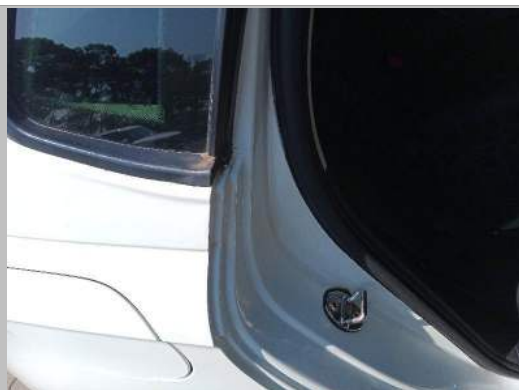
| Damage | Repair Way |
|---|---|
| C • Pillar Right Residual Traces of Repair | Repair |

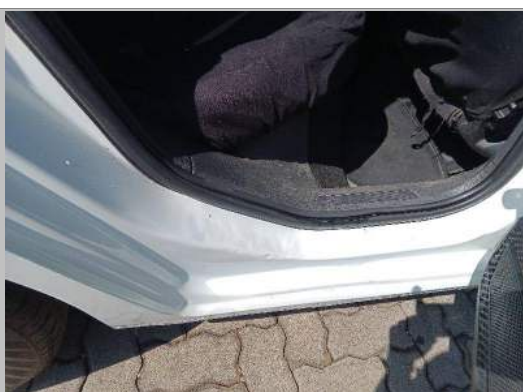
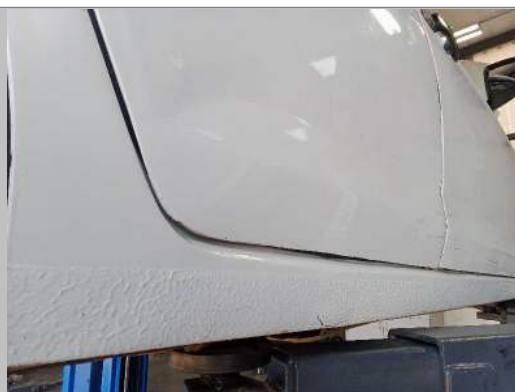
| Damage | Repair Way |
|---|---|
| Sill Panel Right Damaged | Repair |

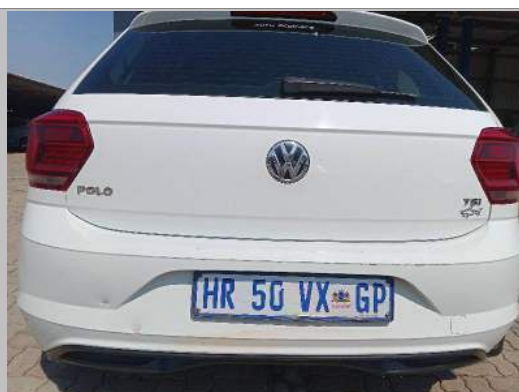
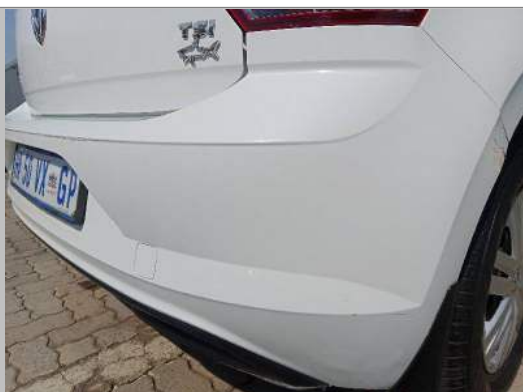
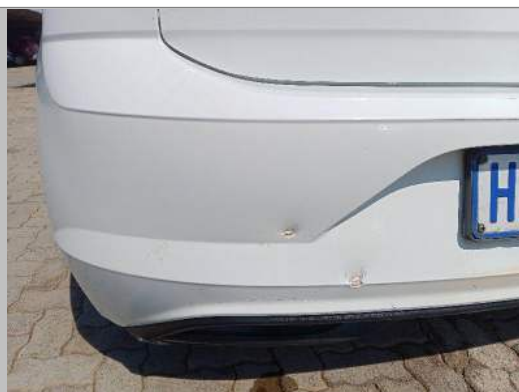
| Damage | Repair Way |
|---|---|
| Rear bumper Damaged | Repair |

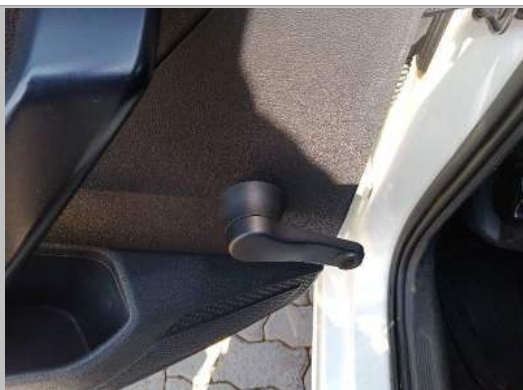
| Damage | Repair Way |
|---|---|
| Window Winder rear left Defective | Repair |

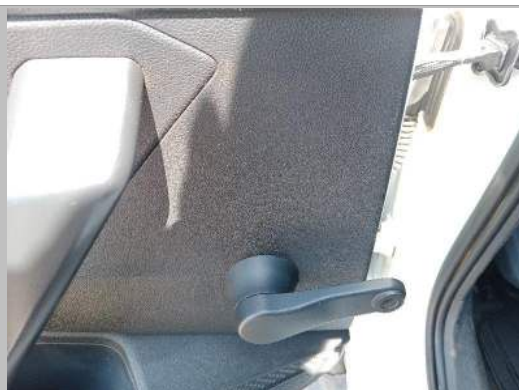
| Damage | Repair Way |
|---|---|
| Door Panel Rear Left Damaged | Repair |

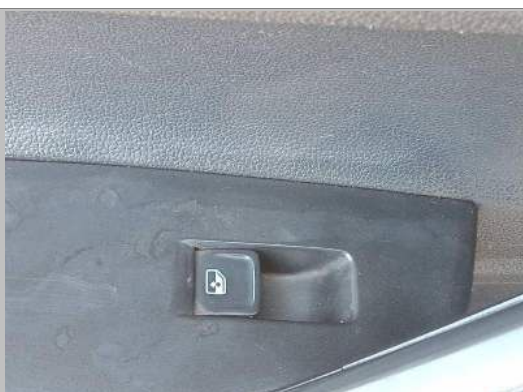
| Damage | Repair Way |
|---|---|
| Switch Electrical Window Winder front left Damaged | Replace |

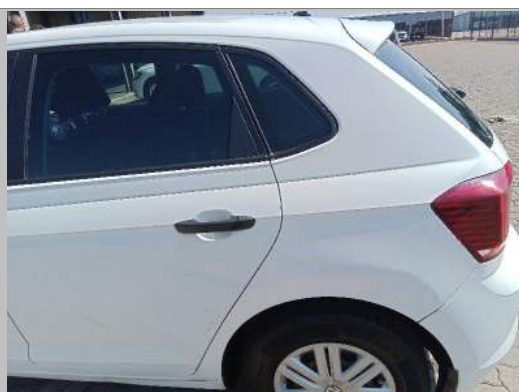
| Damage | Repair Way |
|---|---|
| Rear Fender Left Residual Traces of Repair | Repair |

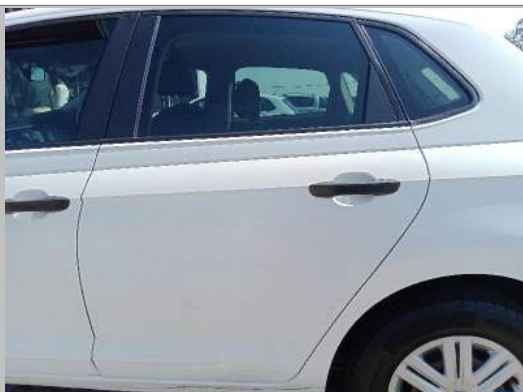
| Damage | Repair Way |
|---|---|
| Door Rear Left Damaged | Repair |

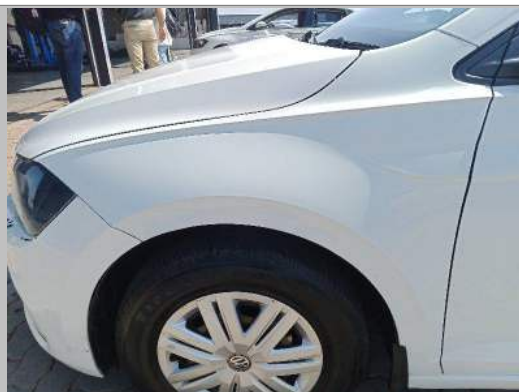
| Damage | Repair Way |
|---|---|
| Front Fender Left Residual Traces of Repair | Repair |

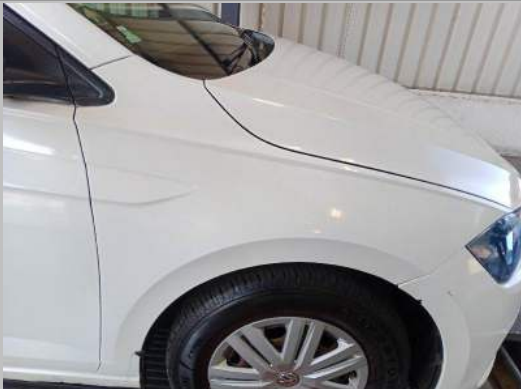
| Damage | Repair Way |
|---|---|
| Front Fender Right Residual Traces of Repair | Repair |

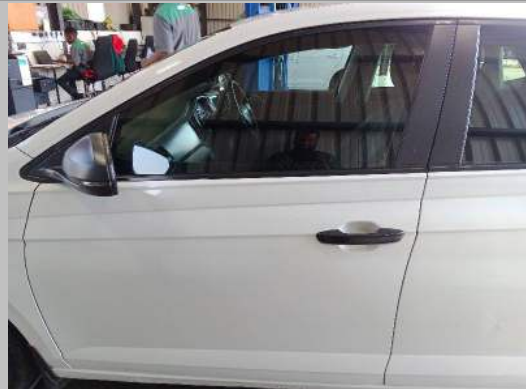
| Damage | Repair Way |
|---|---|
| Door Front Left Residual Traces of Repair | Repair |

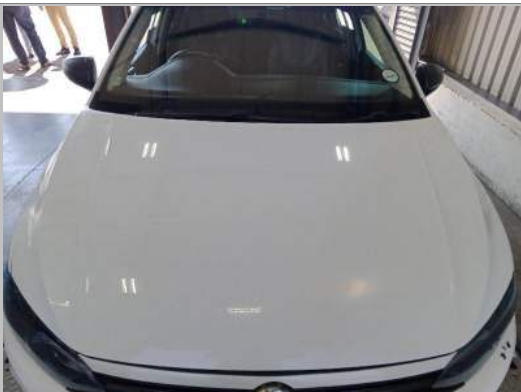
| Damage | Repair Way |
|---|---|
| Bonnet Residual Traces of Repair | Repair |

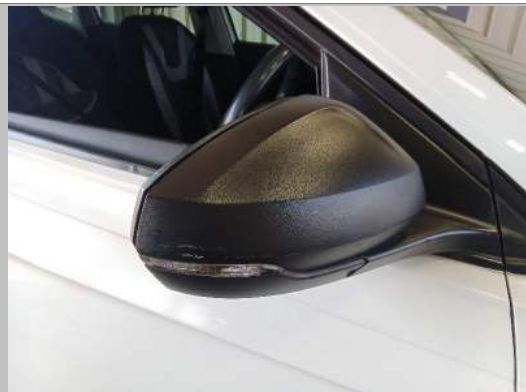
| Damage | Repair Way |
|---|---|
| Side Mirror Right Paintwork • Scratched | Repair |

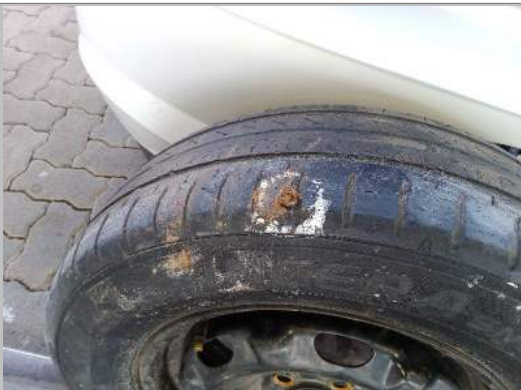
| Damage | Repair Way |
|---|---|
| Spare Tyre Damaged | Replace |

| | Size | Load/Speed Index | Manufacture | Model | Type* | Production Date | Tread Depth (mm) |
|---|---|---|---|---|---|---|---|
| Spare | 185/70 R14 | 88H | Falken | Sincera | V | 1618 | 1 mm |

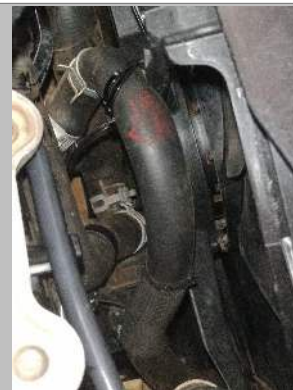
| Damage | Repair Way |
|---|---|
| Hoses Defective | Replace |

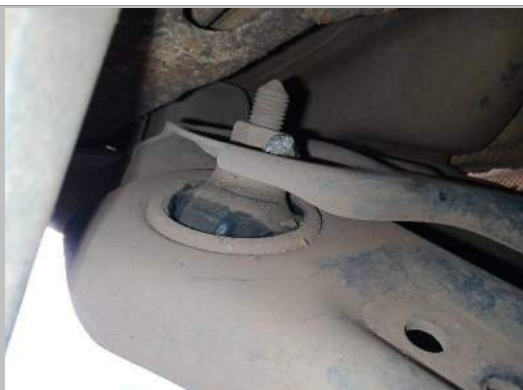
| Damage | Repair Way |
|---|---|
| Control Arm Bush(es) Front Axle Right Cracked | Replace |

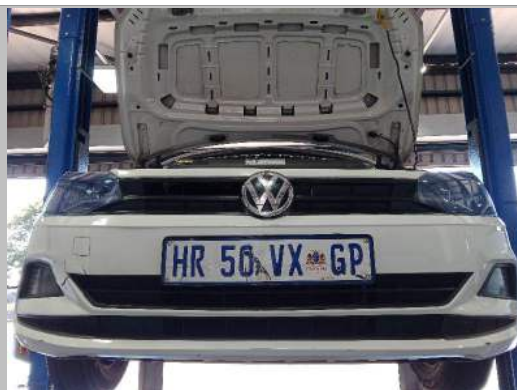
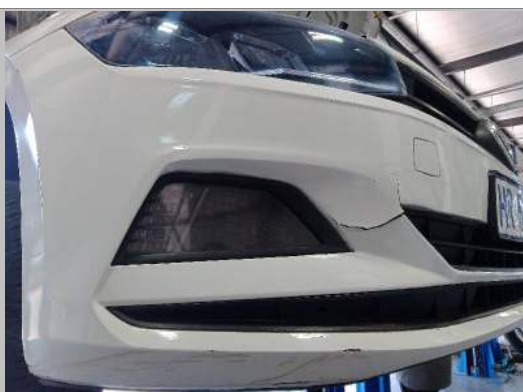
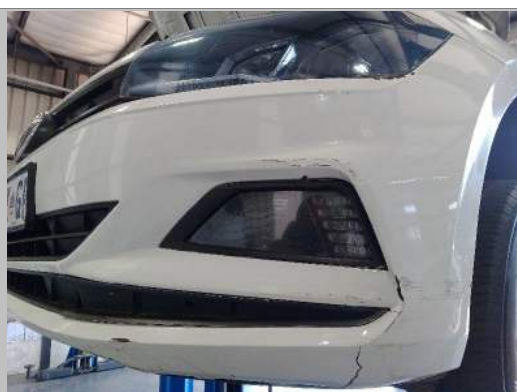
| Damage | Repair Way |
|---|---|
| Front Bumper Damaged | Replace |

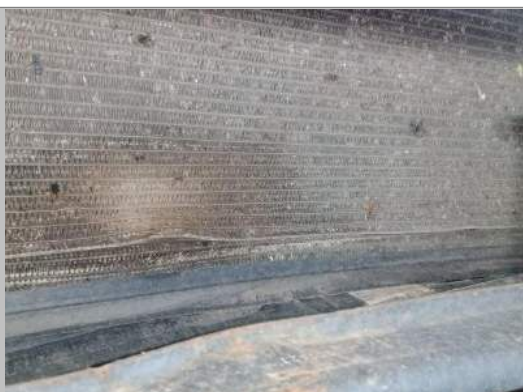
| Damage | Repair Way |
|---|---|
| Radiator Cradle Damaged | Replace |

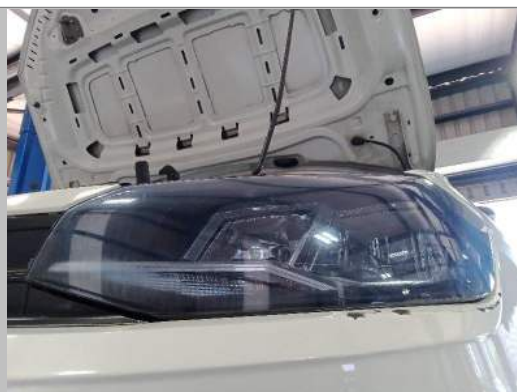
| Damage | Repair Way |
|---|---|
| Headlight Left Defective | Replace |

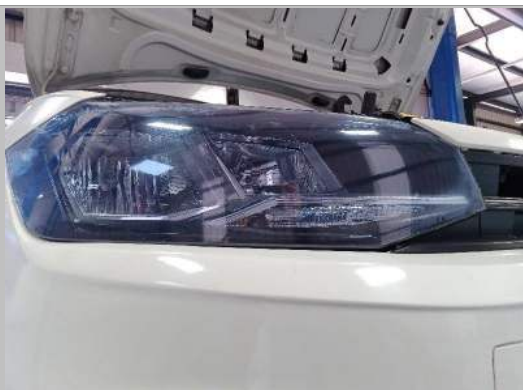
| Damage | Repair Way |
|---|---|
| Headlight Right Defective | Replace |

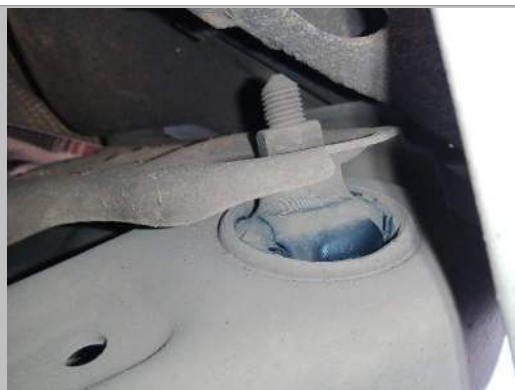
| Damage | Repair Way |
|---|---|
| Control Arm Bush(es) Front Axle Left Cracked | Replace |

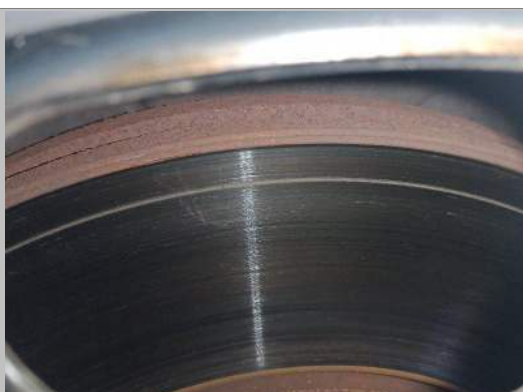
| Damage | Repair Way |
|---|---|
| Brake disc 1. Axle left Excessive Wear & Tear | Replace |

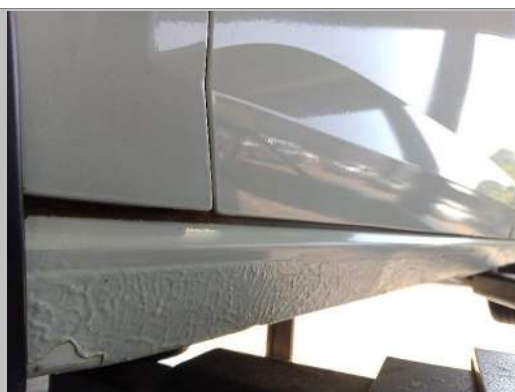
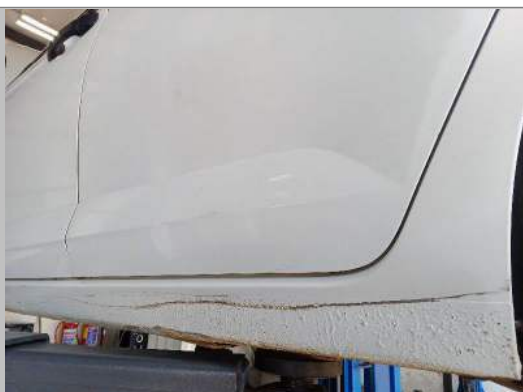
| Damage | Repair Way |
|---|---|
| Sill Panel Left Damaged | Repair |

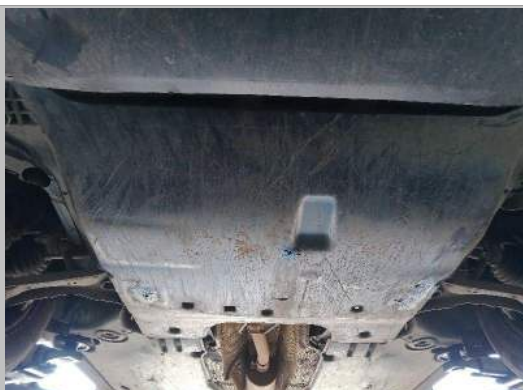
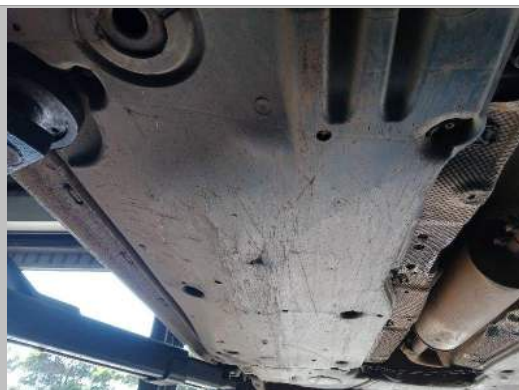
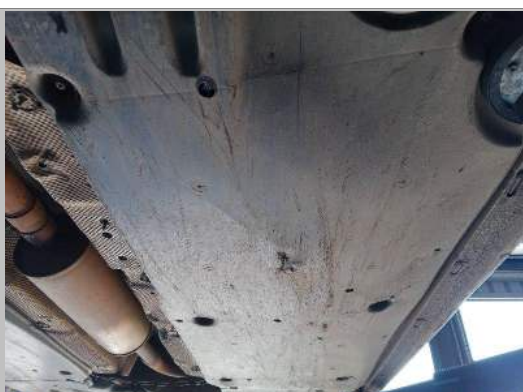
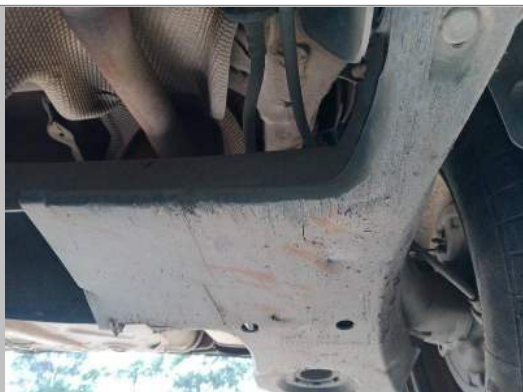
| Damage | Repair Way |
|---|---|
| Belly plates Damaged | Replace |

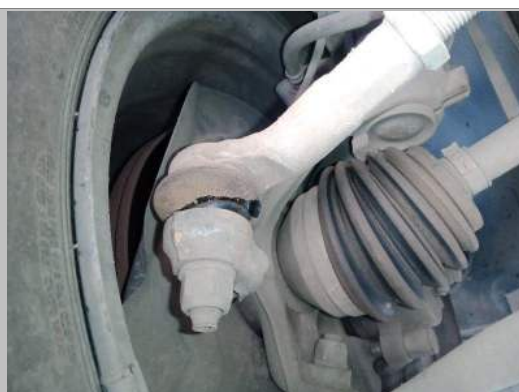
| Damage | Repair Way |
|---|---|
| Tie Rod End left Damaged | Replace |

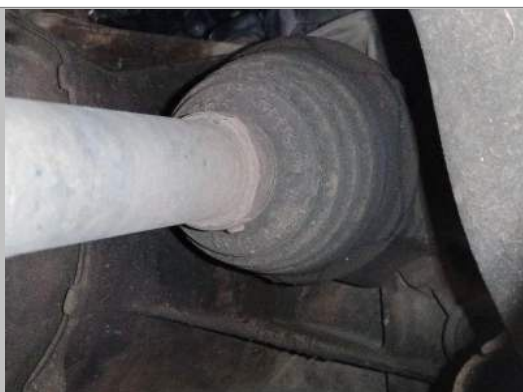
| Damage | Repair Way |
|---|---|
| CV Joint(s) Boot(s) Front Left (inner/outer) Damaged | Replace |

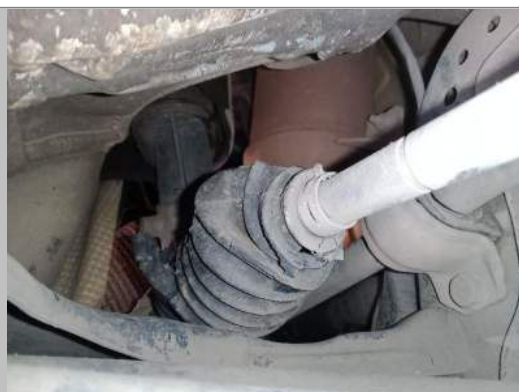
| Damage | Repair Way |
|---|---|
| Steering Rack Boot Right Damaged | Replace |

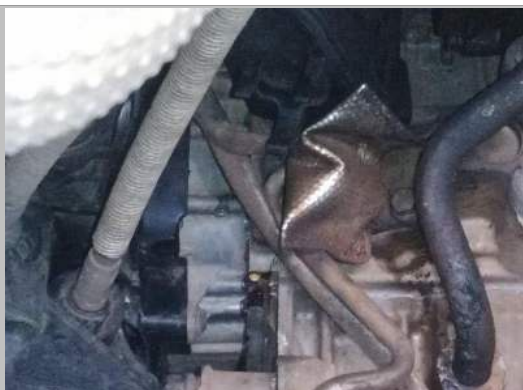
| Damage | Repair Way |
|---|---|
| Engine Water Leak | Repair |

Undercarriage: Signs of water leak on bottom of engine.Bottom of engine and gearbox fully covered.Cannot pin direction of water leak.

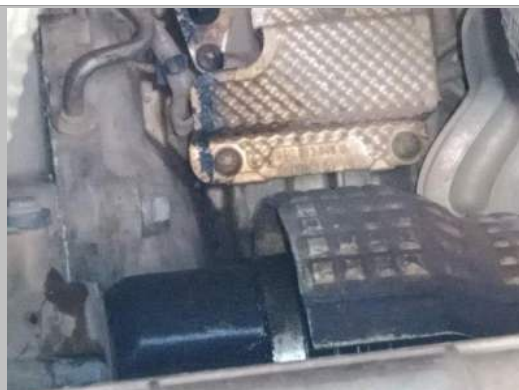
| Damage | Repair Way |
|---|---|
| CV Joint(s) Front Right (inner/outer) Defective | Repair |

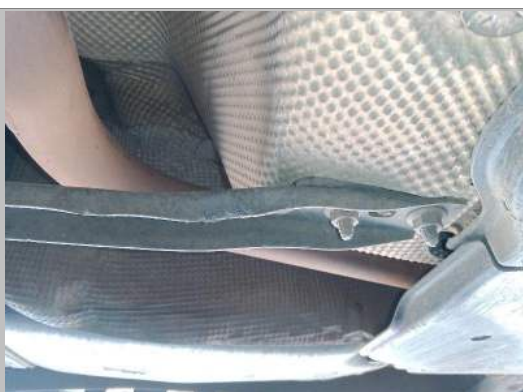
| Damage | Repair Way |
|---|---|
| Cross Member Rear Left Damaged | Repair |

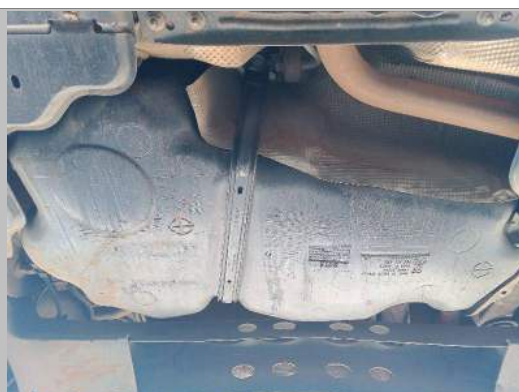
| Damage | Repair Way |
|---|---|
| Fuel Tank Damaged | Repair |

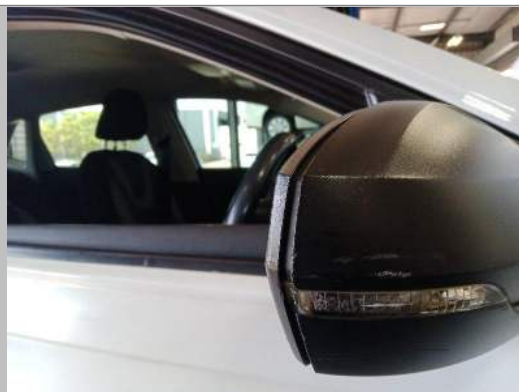
| Damage | Repair Way |
|---|---|
| Indicator Light Front Right Damaged | Replace |

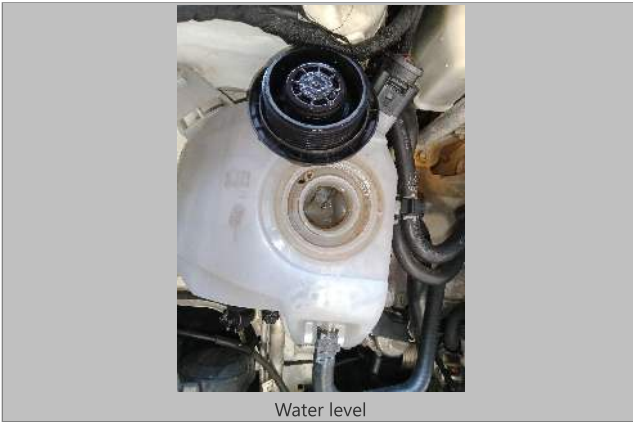
| Damage | Repair Way |
|---|---|
| Water level Insufficient | Replace |
