## CONDITION REPORT

Report No:  
2017305036  
DATE  
30/09/2026

MFC Auction House  
M57 Pretoria Rd, Glenmarais, KEMPTON PARK  
Gauteng

| Manufacturer | VOLKSWAGEN | Registration Number | KB38RTGP |

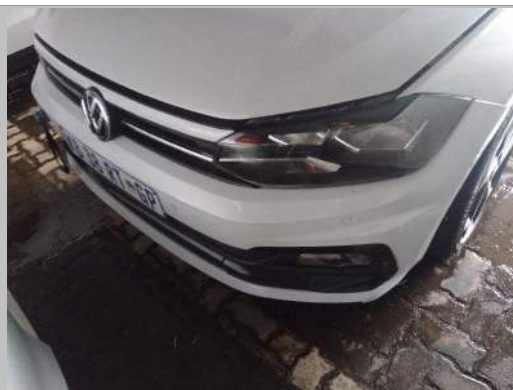
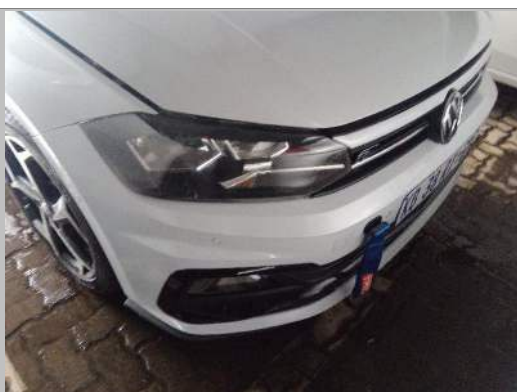
| Front Bumper Damaged | Repair |

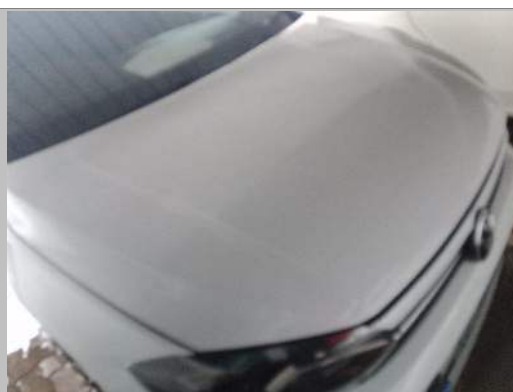
| Bonnet Residual Traces of Repair | Repair |

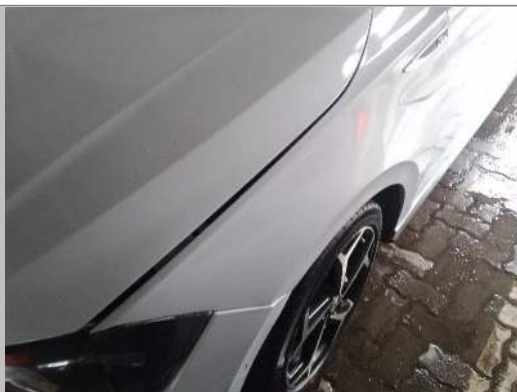
| Front Fender Left Residual Traces of Repair | Repair |

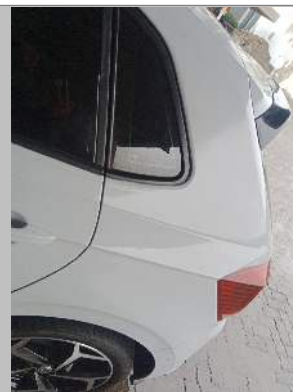
| Rear Fender Left Damaged | Repair |

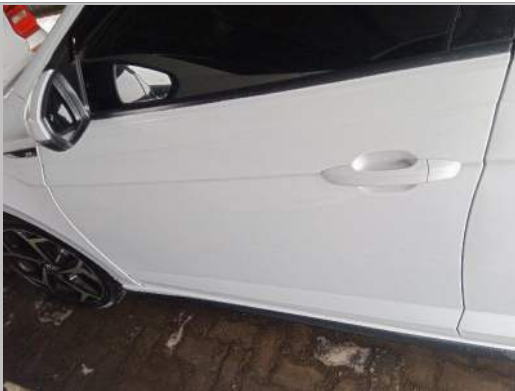
| Door Front Left Residual Traces of Repair | Repair |

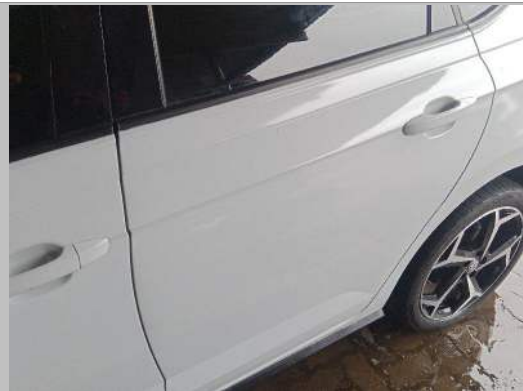
| Door Rear Left Residual Traces of Repair | Repair |

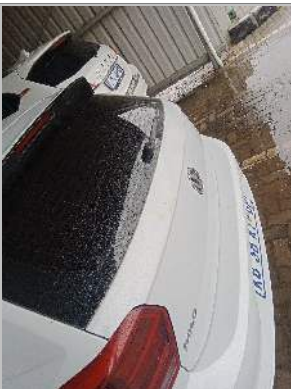
| Boot Lid / Hatch door Damaged | Repair |

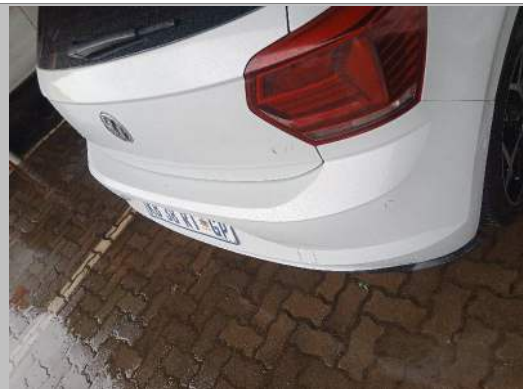
| Rear bumper Residual Traces of Repair | Repair |

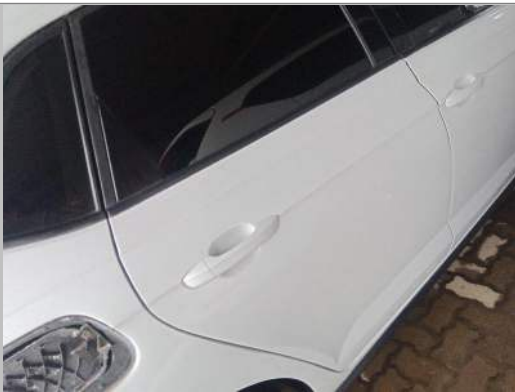
| Door Rear Right Residual Traces of Repair | Repair |

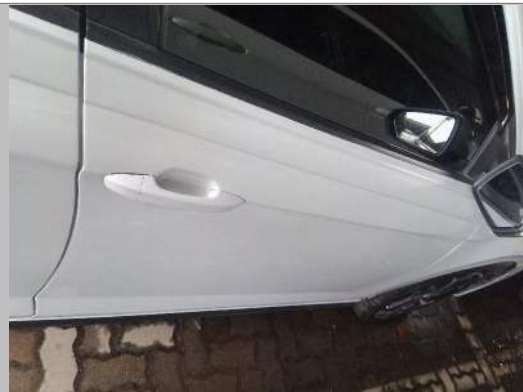
| Door Front Right Residual Traces of Repair | Repair |

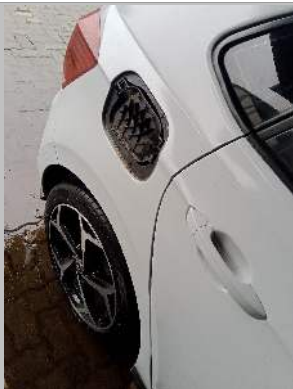
| Rear Fender Right Residual Traces of Repair | Repair |

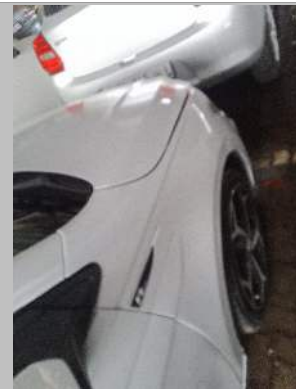
| Front Fender Right Residual Traces of Repair | Repair |

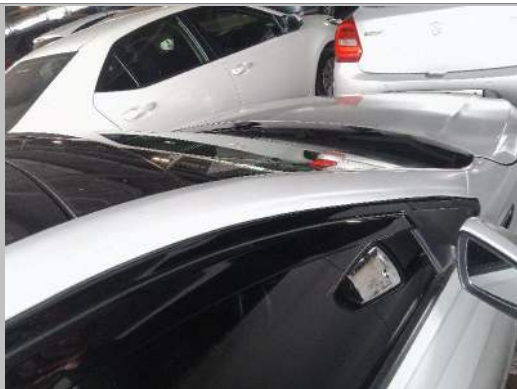
| A • Pillar Right Residual Traces of Repair | Repair |

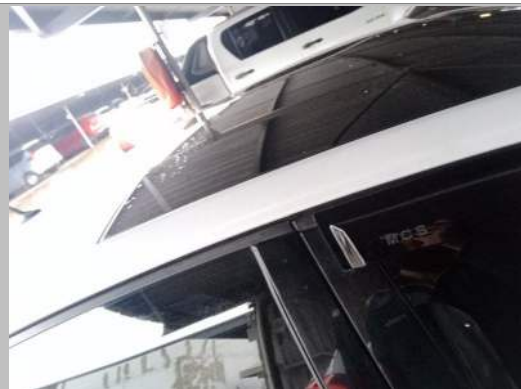
| B • Pillar Right Residual Traces of Repair | Repair |

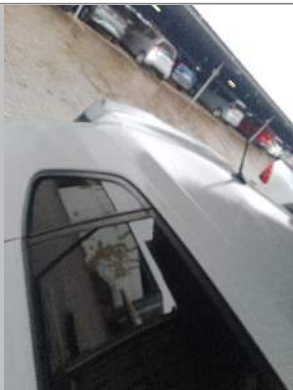
| C • Pillar Right Residual Traces of Repair | Repair |

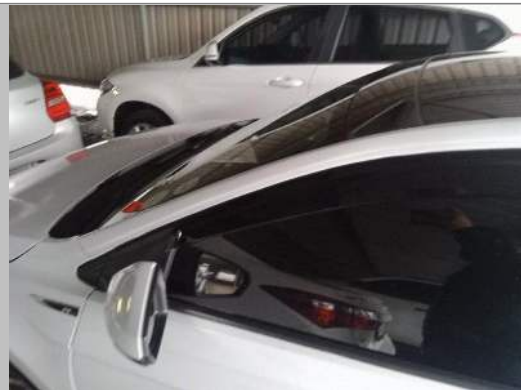
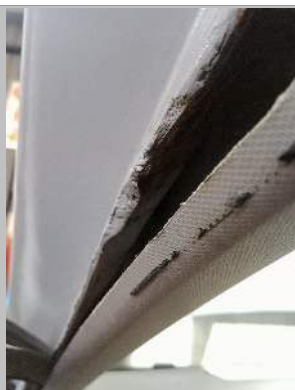
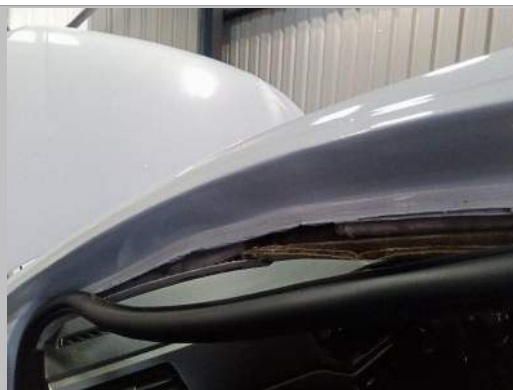
| A • Pillar Left Damaged | Repair |

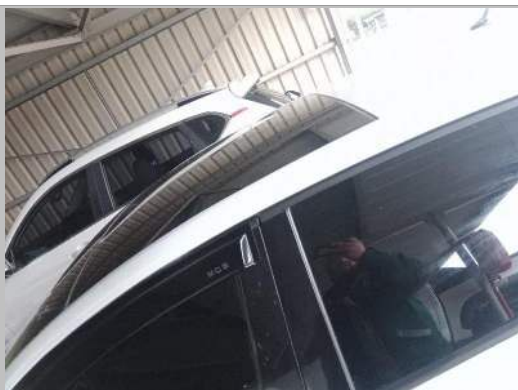
| B • Pillar Left Residual Traces of Repair | Repair |

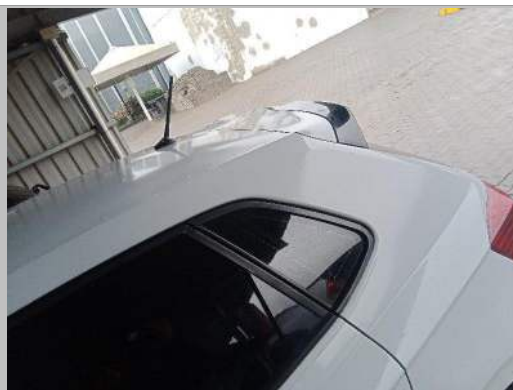
| C • Pillar Left Residual Traces of Repair | Repair |

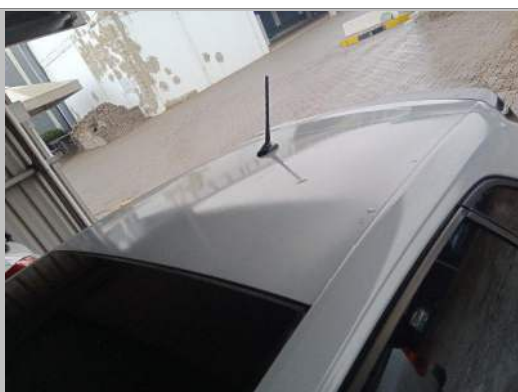
| Roof Residual Traces of Repair | Repair |

General Comments: ACCORDING TO THE AGE AND MILEAGE OF THE VEHICLE, NORMAL WEAR AND TEAR MARKS ARE VISIBLE ON THE INTERIOR, EXTERIOR, ELECTRICAL AND MECHANICAL PARTS. 62 DTC'S AT TIME OF TESTING SEE DTC REPORT. VEHICLE MIGHT BE A POSSIBLE CUT AND JOIN ON THE ROOF SECTION OF THE VEHICLE. Engine Compartment: Battery loose.

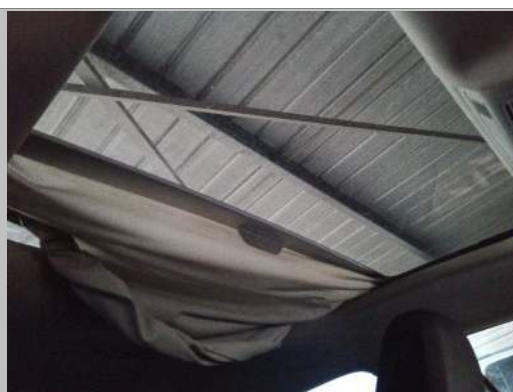
| Sun Roof Defective | Repair |

Interior: sunroof sunshader damaged.

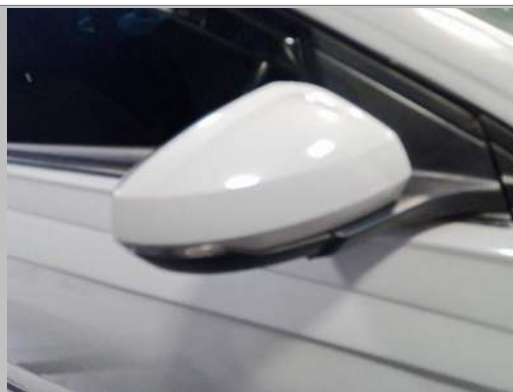
| Side Mirror Right Damaged | Replace |

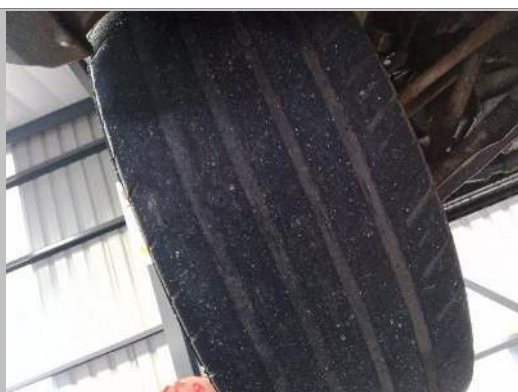
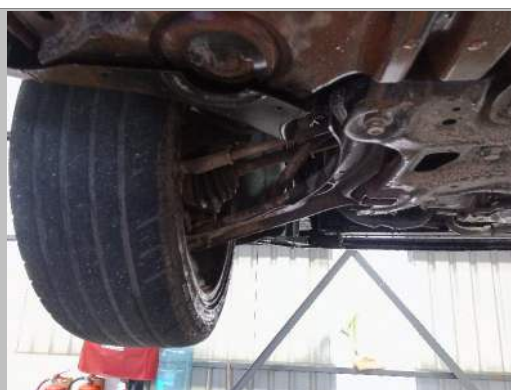
| Tyre Front Left Worn | Replace |

| | Size | Load/Speed Index | Manufacture | Model | Type* | Production Date | Tread Depth (mm) |
|---|---|---|---|---|---|---|---|
| Front Left | 215/45R17 | 91W | Ovation | Radial | V | 1921 | 0 mm |

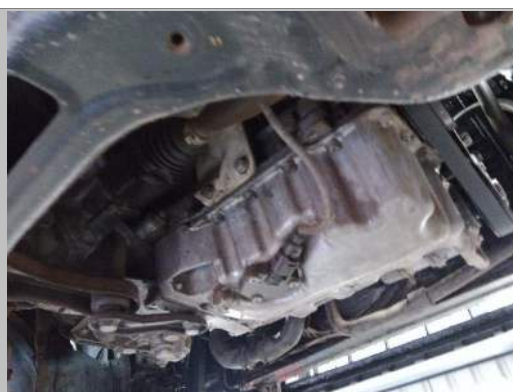
| Engine Oil Leak | Repair |

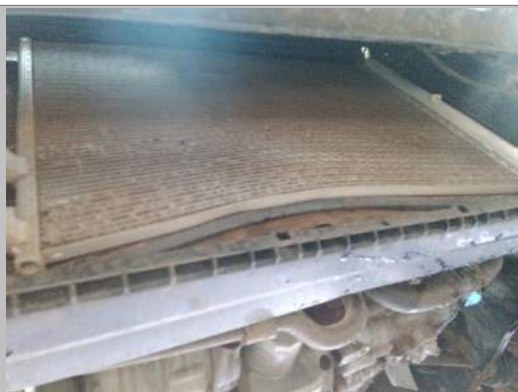
| Radiator Deformed | Replace |

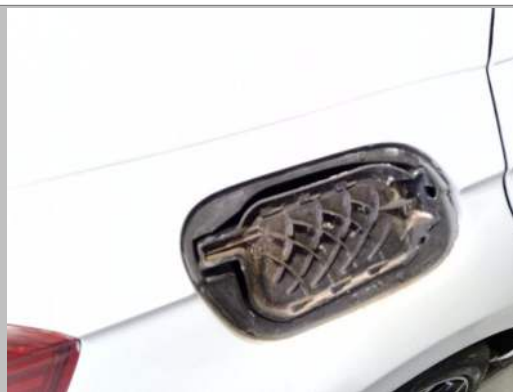
| Fuel Flap Damaged | Replace |

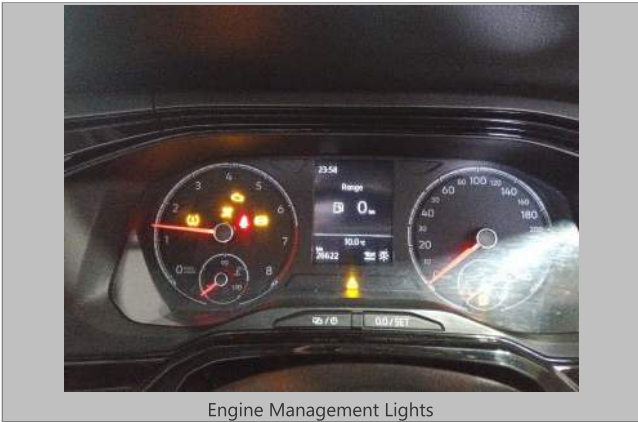
| Engine Management Lights Set | Repair |

| No | System | Code | Description | Status |
|---|---|---|---|---|
| 1 | ENGINE CONTROL MODULE 1 | P019700 | OIL TEMPERATURE SENSOR SHORT CIRCUIT TO GROUND | |
