CONDITION REPORT

Report No: 2016407562

MFC Auction House
M57 Pretoria Rd, Glenmarais, KEMPTON PARK
Gauteng

Vehicle Type	PASSENGER VEHICLE	Registered Owner	MFC AUCTION HOUSE
Manufacturer	VOLKSWAGEN	Registration Number	FMC704L
Model	POLO TSI	Register Number	
VIN	AAVZZZAWZKU082438	Date Of First Licensing	
Engine Number		Last COR	
Doors	5	License Expiry Date	31/12/2022
Color	WHITE	Power / Displacement	
Year Model		Paint Finish	TWO COAT METALLIC
Km Reading	66,128 KM	Fuel	PETROL
Cab / Body Type	HATCHBACK	Transmission	MANUAL

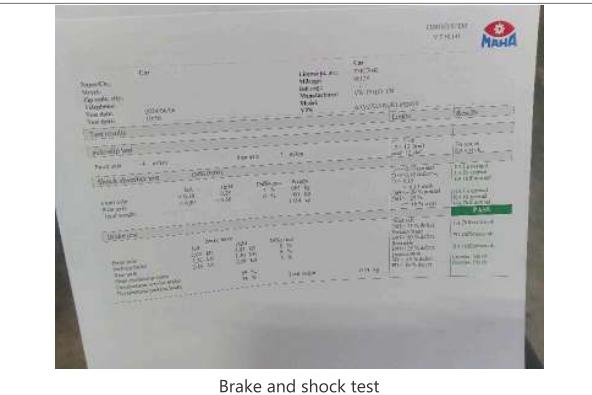
Brake and shock test

Left	Right	Axe Weight [KG]	Deceleration [m/s ²]
	Braking Force [KN]	Braking Force [KN]		
Front	2.63	2.87	-	
Rear	2.16	2.28	-	
Emergency / Parking	1.32	1.4	-

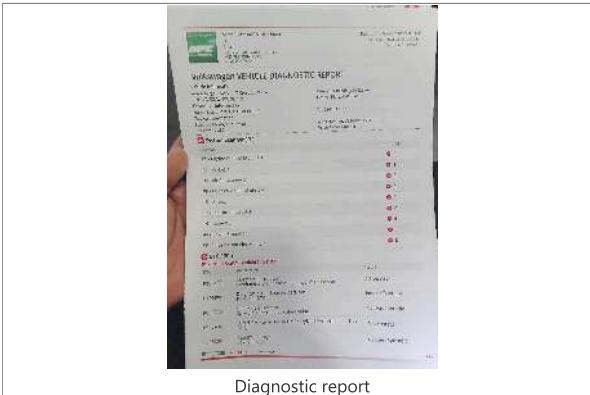
Diagnostic report

During the diagnostic no active error messages were detected. (See also attached Diagnostic Report. For more information regarding the Fault Codes (DTC) and the recommended rectifications please contact the workshops of the vehicle manufacture).

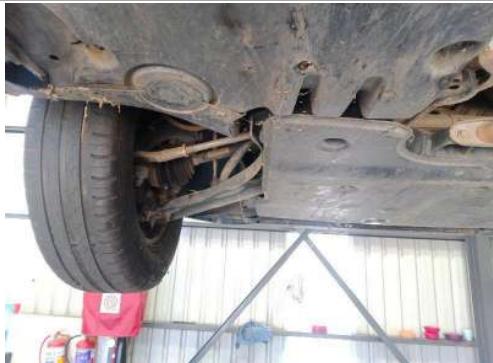
LF TYRE TREAD

Size	Load/Speed Index	Manufacture	Model	Type*	Production Date	Tread Depth (mm)
Front Left	185/70R14	88H	Falken	Radial	V	1319	2 mm
Front Right	185/70R14	88T	Dunlop	Sp	V	1820	3 mm
Rear Left	185/70R14	88T	Dunlop	Sp	V	1820	3 mm
Rear Right	185/70R14	88T	Dunlop	Radial	V	1820	3 mm

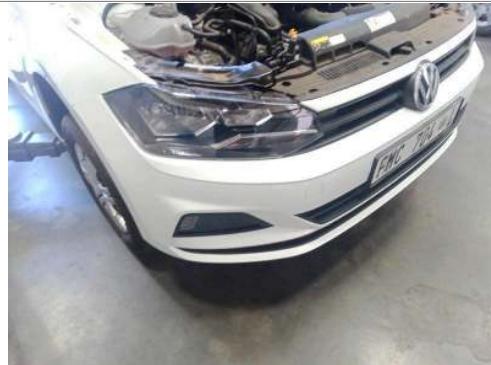
Damage	Repair Way
Engine Management Lights Set	Repair
Front Bumper Damaged	Repair
Bonnet Damaged	Repair
Front Fender Left Damaged	Repair
Rear Fender Left Damaged	Repair
Rear bumper Damaged	Repair
Body and exterior	Signs of repair work done to somebody panels.
Body and exterior	Poor alignment to somebody panels.
Undercarriage	Bottom of engine and gearbox fully cover.
