## CONDITION REPORT

Report No:  
2017304915  
DATE  
29/09/2026

| Manufacturer | VOLKSWAGEN | Registration Number | LF95JWGP |
| Model | POLO 1.0 TSI 70KW COMFORTLINE 5-DR [2019-2021] | Register Number | |

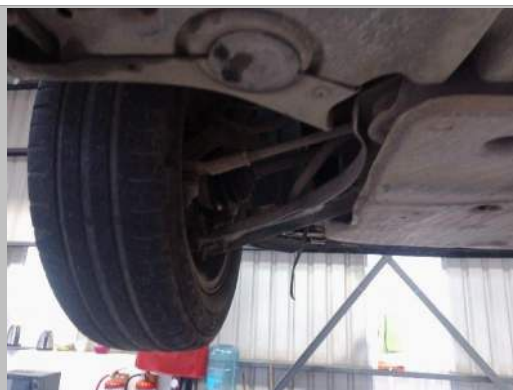
LF TYRE TREAD

| | Size | Load/Speed Index | Manufacture | Model | Type* | Production Date | Tread Depth (mm) |
|---|---|---|---|---|---|---|---|
| Front Left | 185/65R15 | 88H | Falken | Radial | V | 1719 | 2 mm |

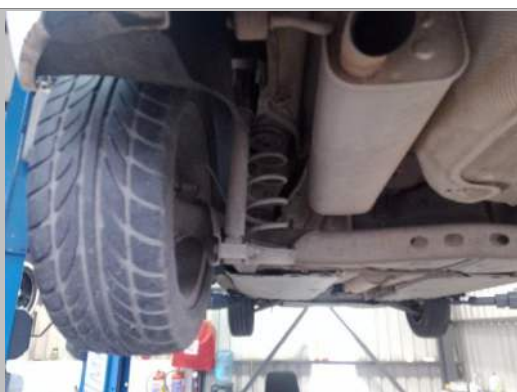
LR TYRE TREAD

| | Size | Load/Speed Index | Manufacture | Model | Type* | Production Date | Tread Depth (mm) |
|---|---|---|---|---|---|---|---|
| Rear Left | 195/50R15 | 82H | Symmetry | Radial | V | 4716 | 2 mm |

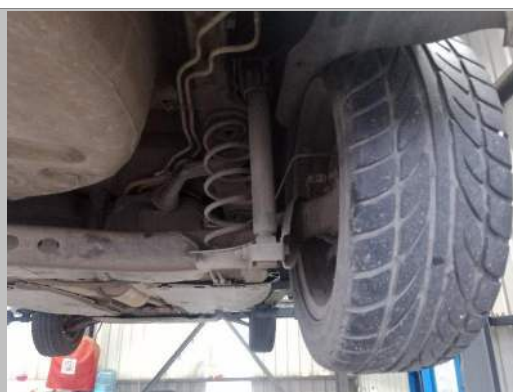
RR TYRE TREAD

| | Size | Load/Speed Index | Manufacture | Model | Type* | Production Date | Tread Depth (mm) |
|---|---|---|---|---|---|---|---|
| Rear Right | 195/50R15 | 82H | Symmetry | Radial | V | 4716 | 2 mm |

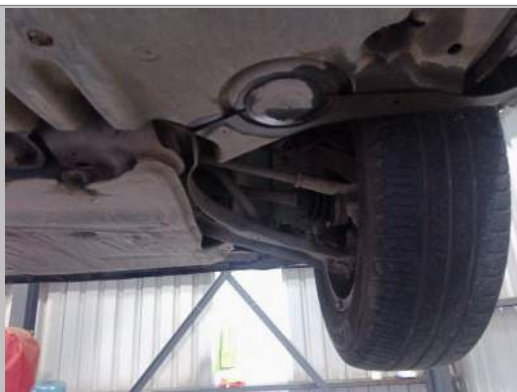
RF TYRE TREAD

| | Size | Load/Speed Index | Manufacture | Model | Type* | Production Date | Tread Depth (mm) |
|---|---|---|---|---|---|---|---|
| Front Right | 185/65R15 | 92T | Dunlop | Sp | V | 4321 | 2 mm |

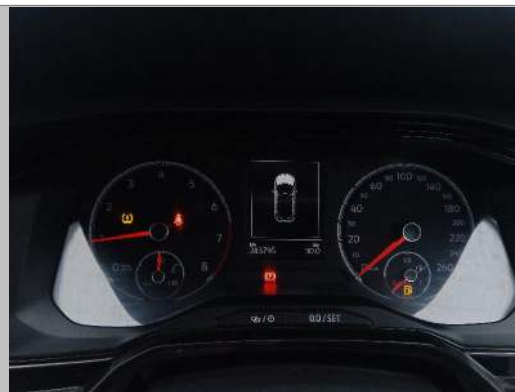
| Damage | Repair Way |
|---|---|
| Engine Management Lights Set | Repair |

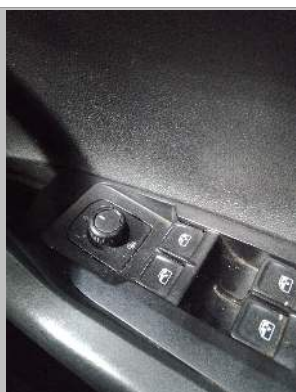
| Damage | Repair Way |
|---|---|
| Switch Electrical Window Winder front right Damaged | Repair |

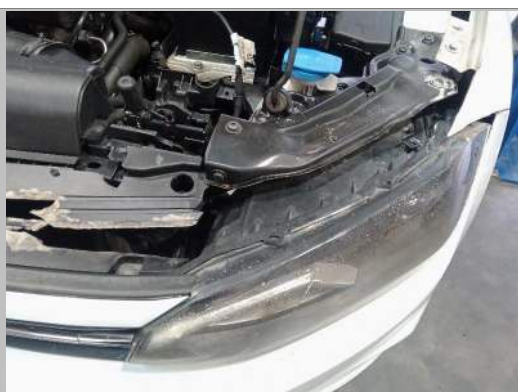
| Damage | Repair Way |
|---|---|
| Headlight Left Damaged | Repair |

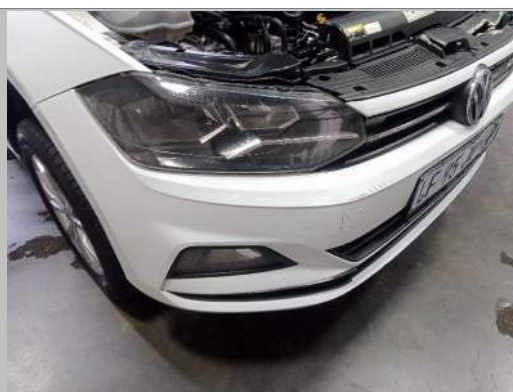
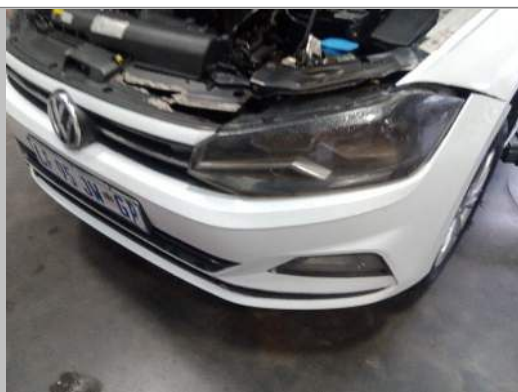
| Damage | Repair Way |
|---|---|
| Front Bumper Damaged | Repair |

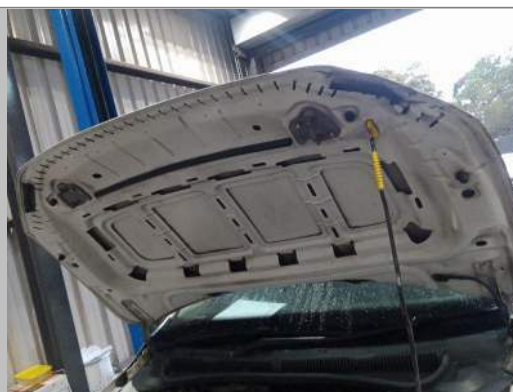
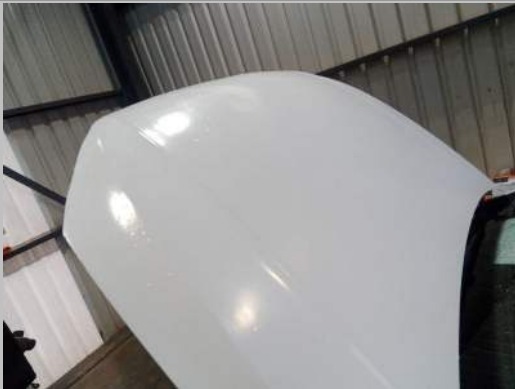
| Damage | Repair Way |
|---|---|
| Bonnet Damaged | Repair |

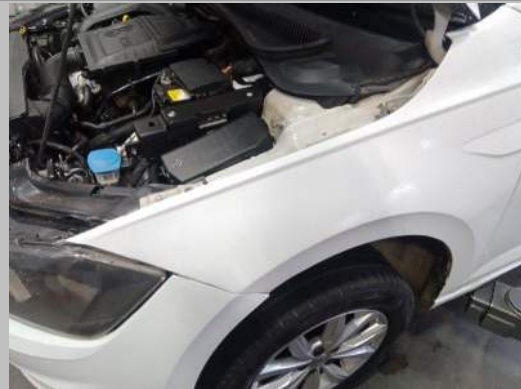
| Damage | Repair Way |
|---|---|
| Front Fender Left Damaged | Repair |

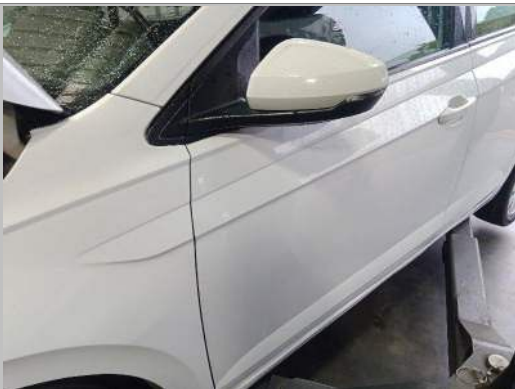
| Damage | Repair Way |
|---|---|
| Door Front Left Damaged | Repair |

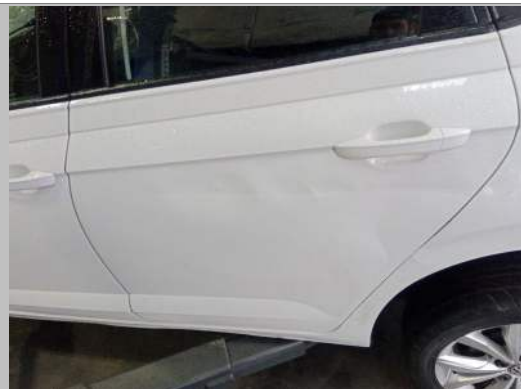
| Damage | Repair Way |
|---|---|
| Door Rear Left Damaged | Repair |

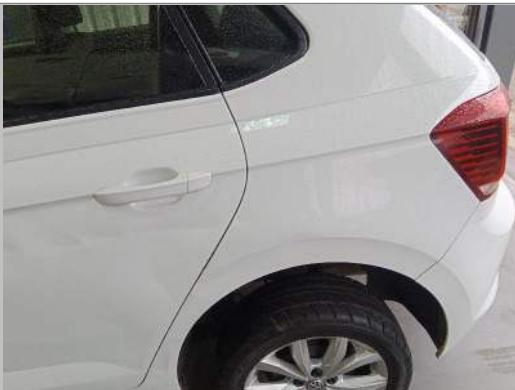
| Damage | Repair Way |
|---|---|
| Rear Fender Left Damaged | Repair |

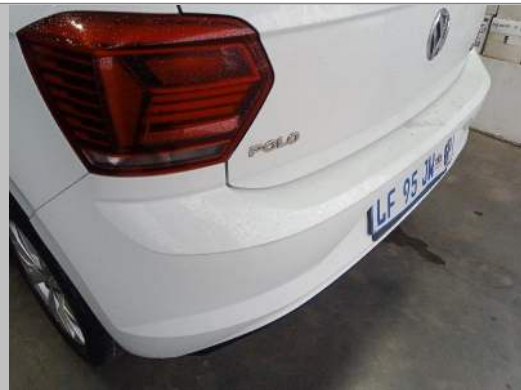
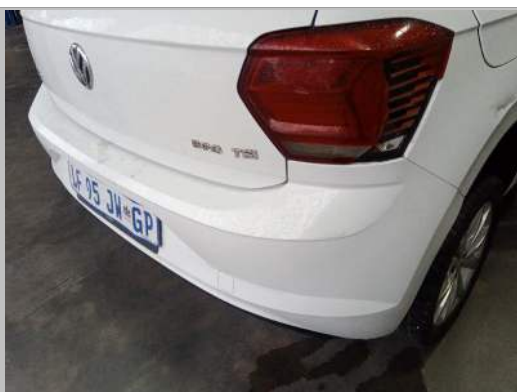
| Damage | Repair Way |
|---|---|
| Rear bumper Damaged | Repair |

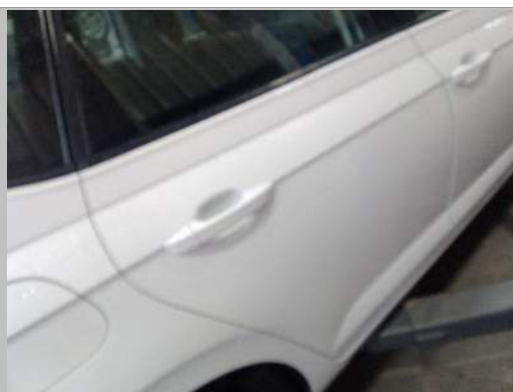
| Damage | Repair Way |
|---|---|
| Door Rear Right Damaged | Repair |

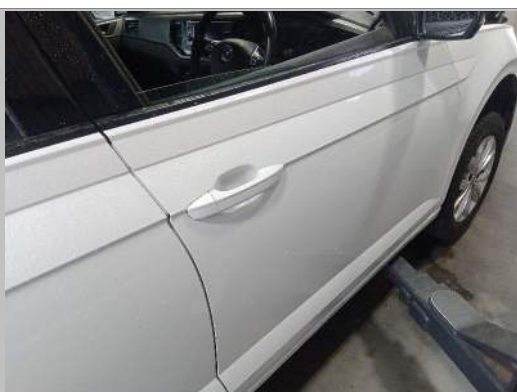
| Damage | Repair Way |
|---|---|
| Door Front Right Damaged | Repair |

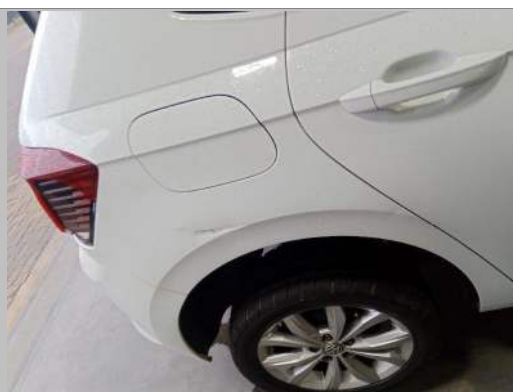
| Damage | Repair Way |
|---|---|
| Rear Fender Right Damaged | Repair |

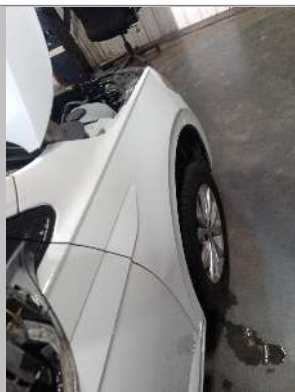
| Damage | Repair Way |
|---|---|
| Front Fender Right Damaged | Repair |

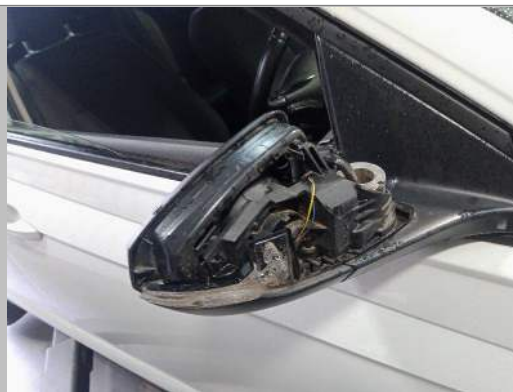
| Damage | Repair Way |
|---|---|
| Side Mirror Right Damaged | Replace |

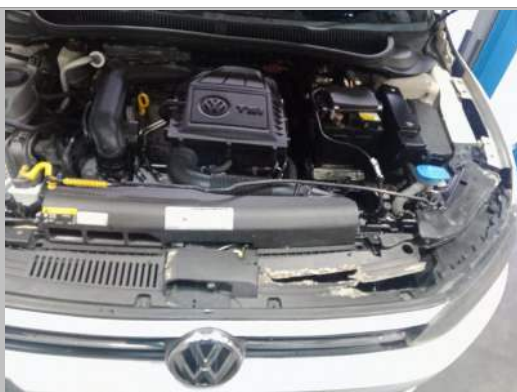
| Damage | Repair Way |
|---|---|
| Bonnet slam plate (Shock tower/ Inner tray) Damaged | Replace |

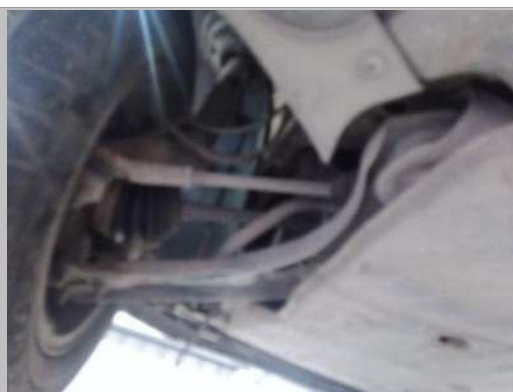
| Damage | Repair Way |
|---|---|
| Control Arm Bush(es) Front Axle Left Worn | Replace |

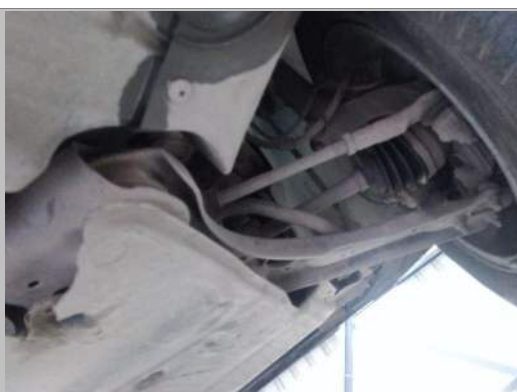
| Damage | Repair Way |
|---|---|
| Control Arm Bush(es) Front Axle Right Worn | Replace |

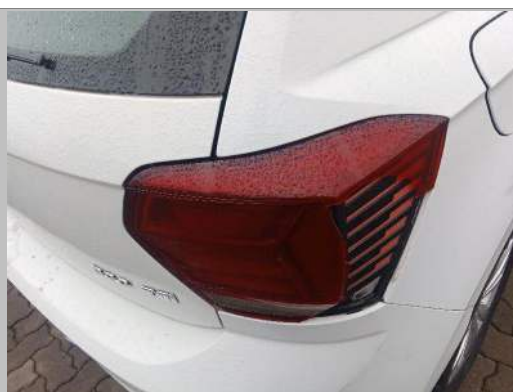
| Damage | Repair Way |
|---|---|
| Tail Light Right Damaged | Replace |
