## CONDITION REPORT

Report No: 2016379379

DATE  
15/05/2024

| Manufacturer | VOLKSWAGEN | Registration Number | JF35SXGP |

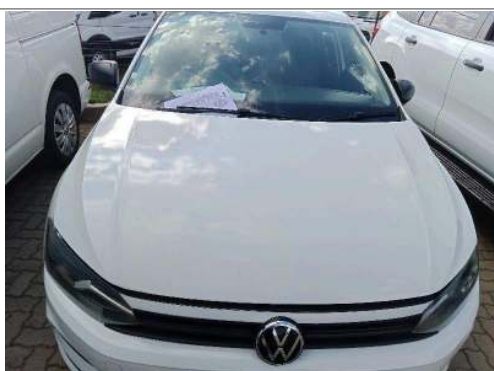
| Damage | Repair Way |
|---|---|
| Bonnet Residual Traces of Repair | Repair |

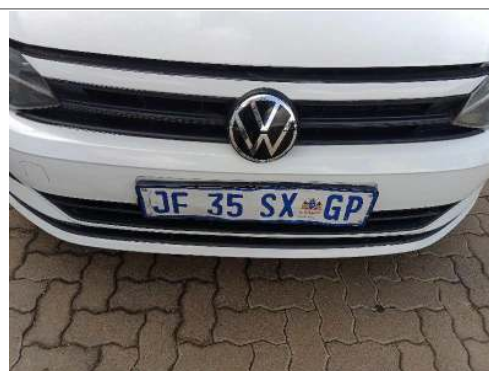
| Damage | Repair Way |
|---|---|
| Number Plate Front Damaged | Replace |

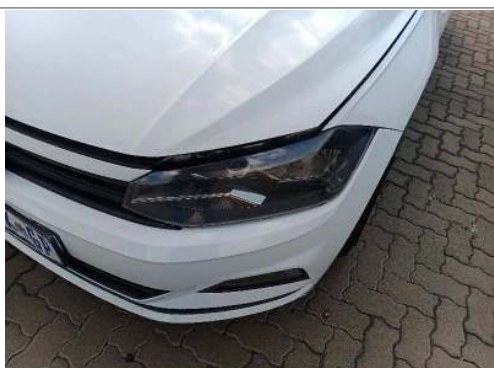
| Damage | Repair Way |
|---|---|
| Headlight Left Damaged | Replace |

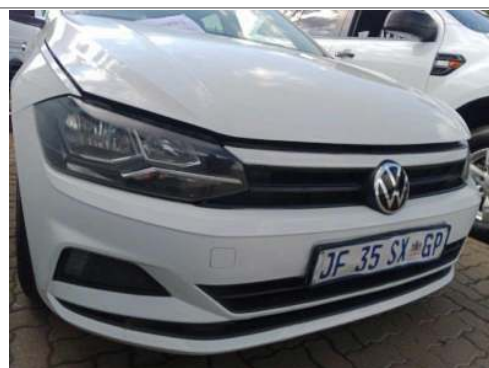
| Damage | Repair Way |
|---|---|
| Front Bumper Damaged | Replace |

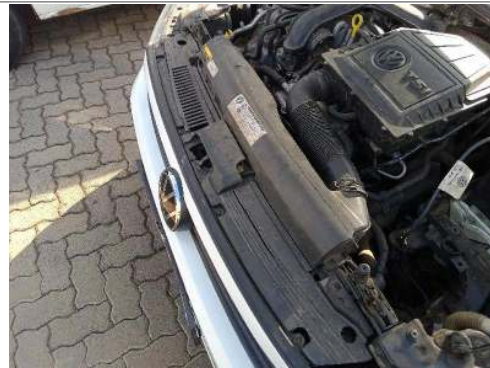
| Damage | Repair Way |
|---|---|
| Bonnet slam plate (Shock tower/ Inner tray) Damaged | Replace |

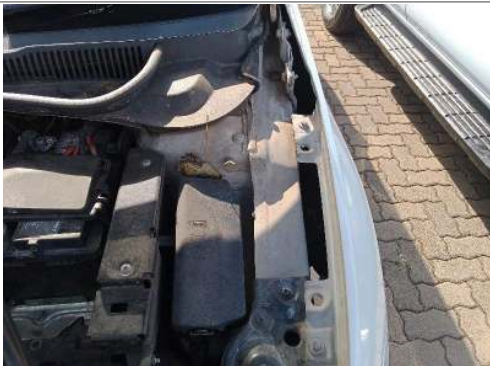
| Damage | Repair Way |
|---|---|
| Front Fender Left / Inner Tray Residual Traces of Repair | Repair |

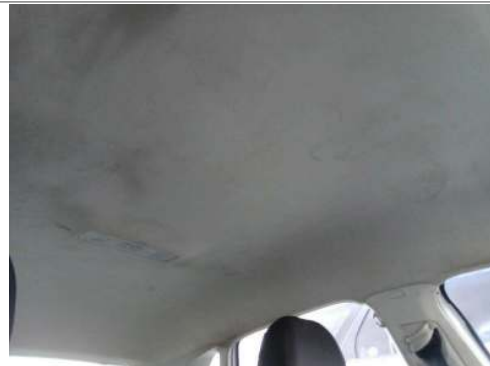
| Damage | Repair Way |
|---|---|
| Hood Lining Dirty | Repair |

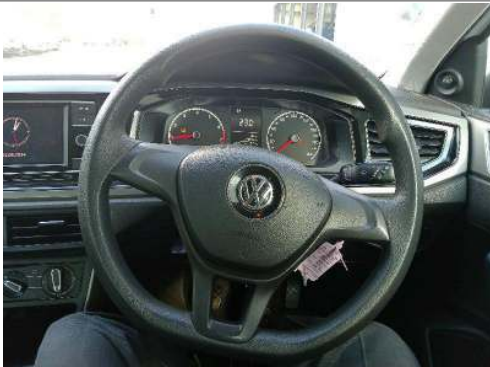
| Damage | Repair Way |
|---|---|
| Steering Wheel Trim Defective | Repair |

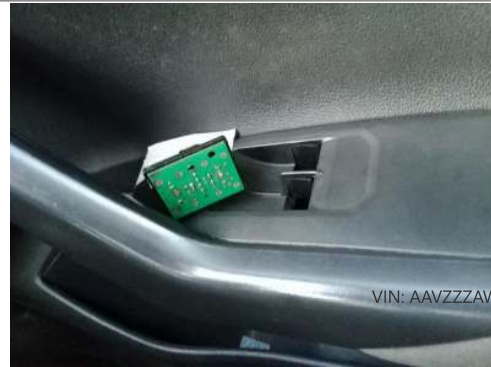
| Damage | Repair Way |
|---|---|
| Switch Electrical Window Winder front left Missing | Replace |

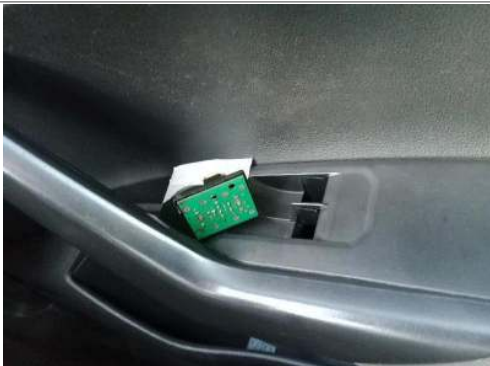
| Damage | Repair Way |
|---|---|
| Switch Electrical Window Winder front right Missing | Replace |

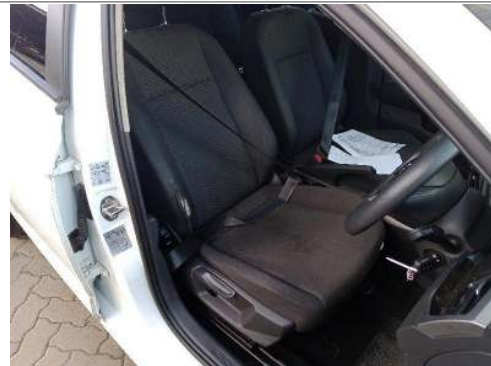
| Damage | Repair Way |
|---|---|
| Seat Front Right Damaged | Repair |

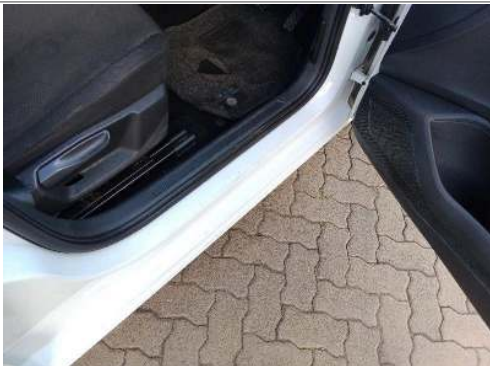
| Damage | Repair Way |
|---|---|
| Sill Panel Right Paintwork • Scratched | Repair |

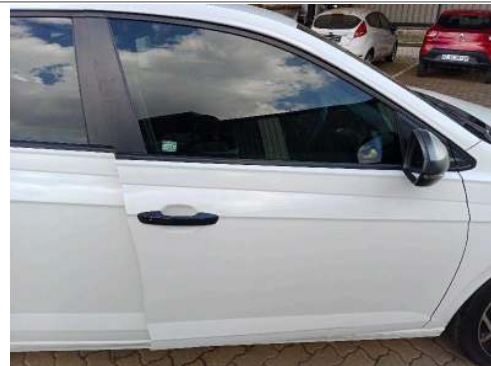
| Damage | Repair Way |
|---|---|
| Door Front Right Residual Traces of Repair | Repair |

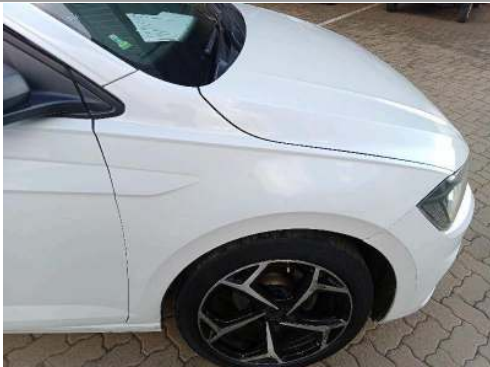
| Damage | Repair Way |
|---|---|
| Front Fender Right Residual Traces of Repair | Repair |

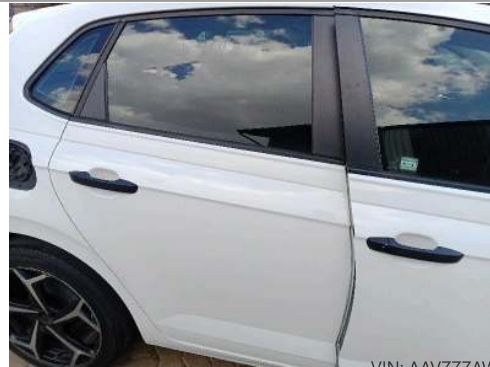
| Damage | Repair Way |
|---|---|
| Door Rear Right Residual Traces of Repair | Repair |

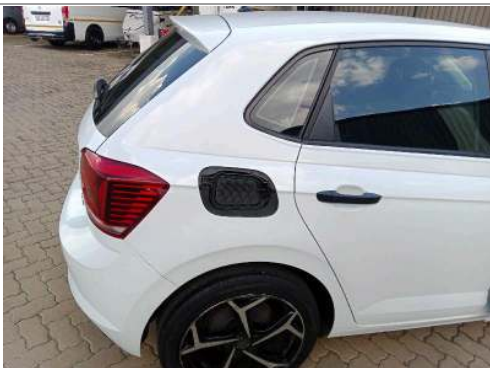
| Damage | Repair Way |
|---|---|
| Rear Fender Right Residual Traces of Repair | Repair |

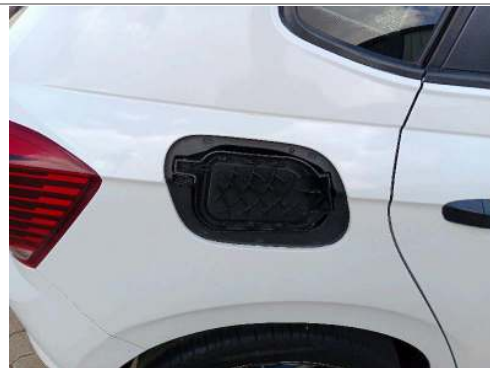
| Damage | Repair Way |
|---|---|
| Fuel Flap Damaged | Replace |

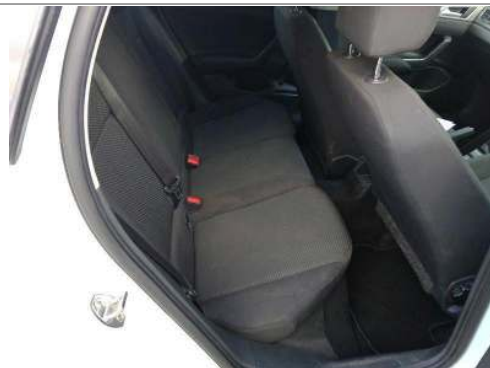
| Damage | Repair Way |
|---|---|
| Seat Rear Dirty | Repair |

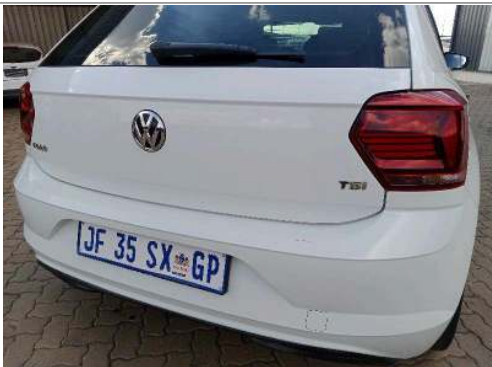
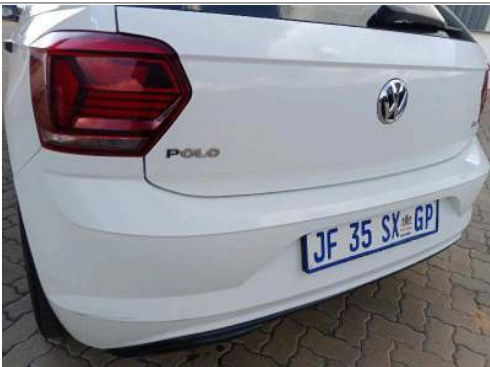
| Damage | Repair Way |
|---|---|
| Rear bumper Paintwork • Scratched | Repair |

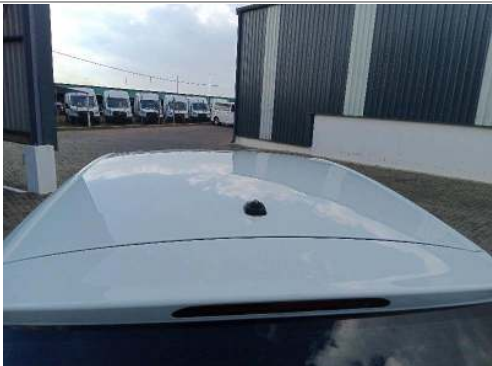
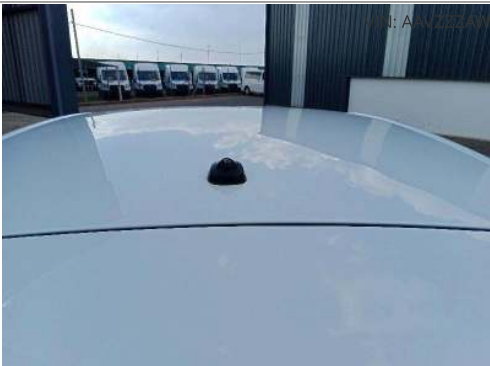
| Damage | Repair Way |
|---|---|
| Roof Dented | Repair |

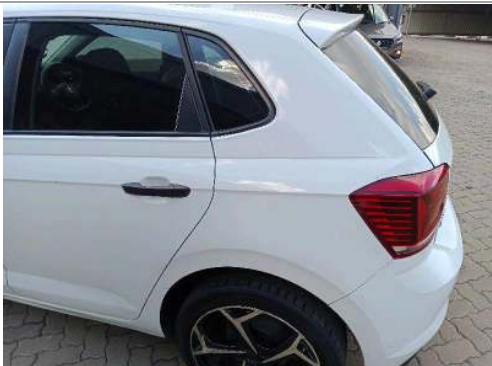
| Damage | Repair Way |
|---|---|
| Rear Fender Left Residual Traces of Repair | Repair |

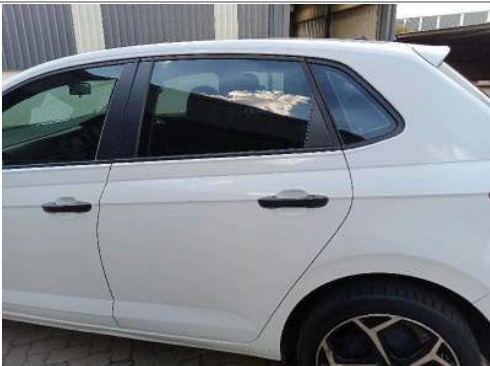
| Damage | Repair Way |
|---|---|
| Door Rear Left Residual Traces of Repair | Repair |

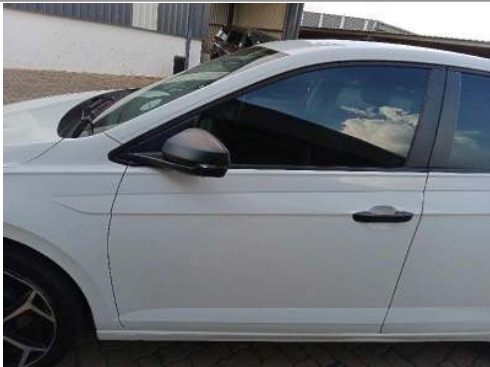
| Damage | Repair Way |
|---|---|
| Door Front Left Residual Traces of Repair | Repair |

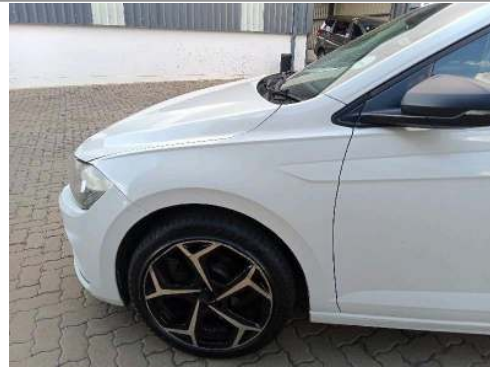
| Damage | Repair Way |
|---|---|
| Front Fender Left Residual Traces of Repair | Repair |

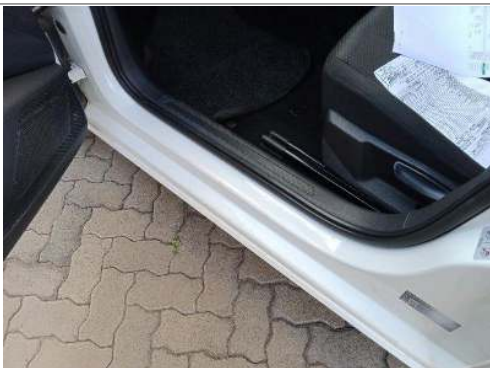
| Damage | Repair Way |
|---|---|
| Sill Panel Left Paintwork • Scratched | Repair |

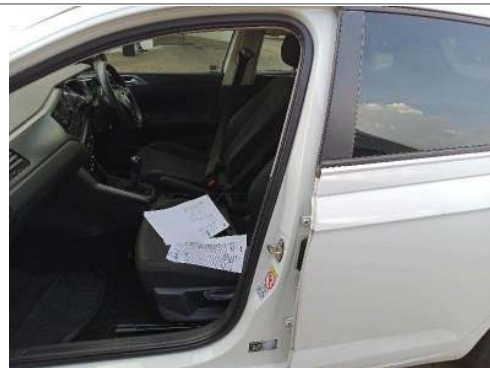
| Damage | Repair Way |
|---|---|
| B • Pillar Left Residual Traces of Repair | Repair |

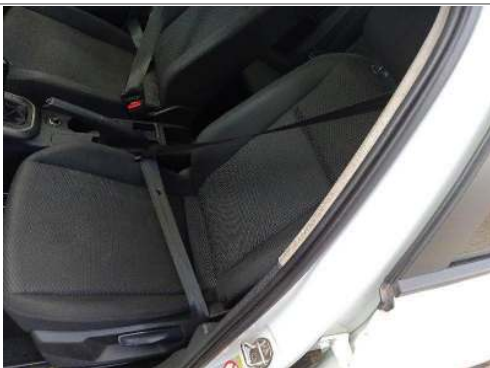
| Damage | Repair Way |
|---|---|
| Seat Front Left Dirty | Repair |

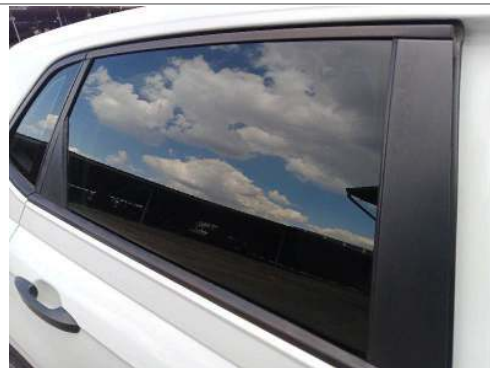
| Damage | Repair Way |
|---|---|
| Window Rear Door Right Scratched | Repair |

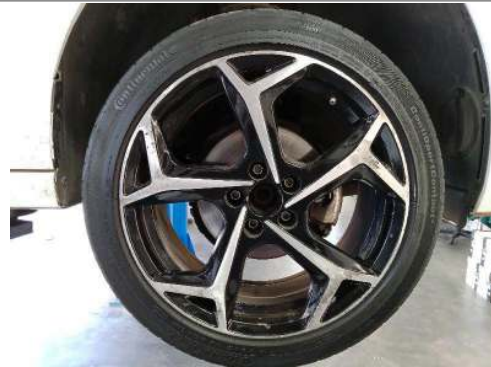
| Damage | Repair Way |
|---|---|
| Rim Front Right Scratched | Repair |

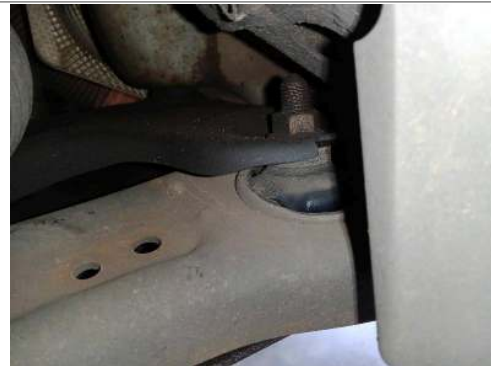
| Damage | Repair Way |
|---|---|
| Control Arm Bush(es) Front Axle Left Cracked | Replace |

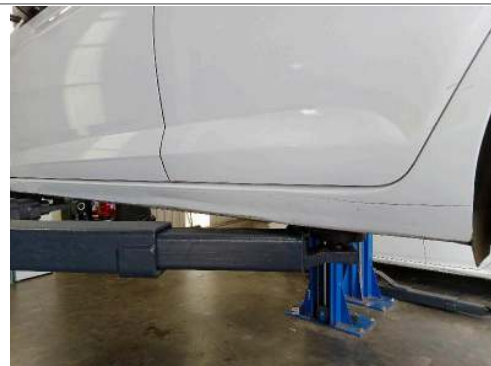
| Damage | Repair Way |
|---|---|
| Rocker Panel Left Residual Traces of Repair | Repair |

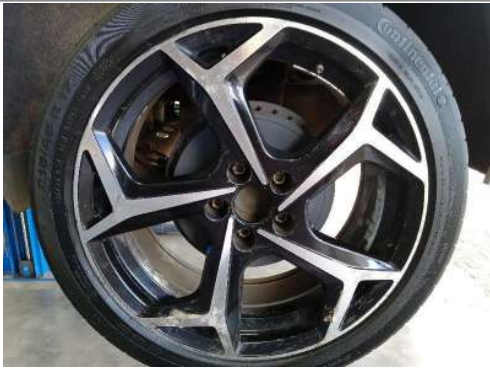
| Damage | Repair Way |
|---|---|
| Rim Rear Left Damaged | Repair |

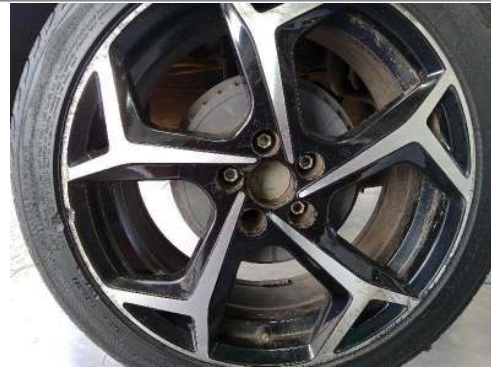
| Damage | Repair Way |
|---|---|
| Bolt(s) / Nut(s) Rear Wheel Right Missing | Replace |

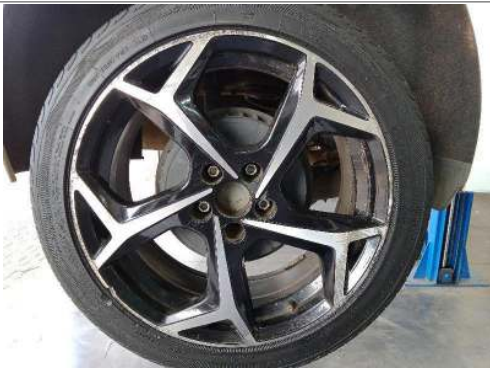
| Damage | Repair Way |
|---|---|
| Rim Rear Right Damaged | Repair |

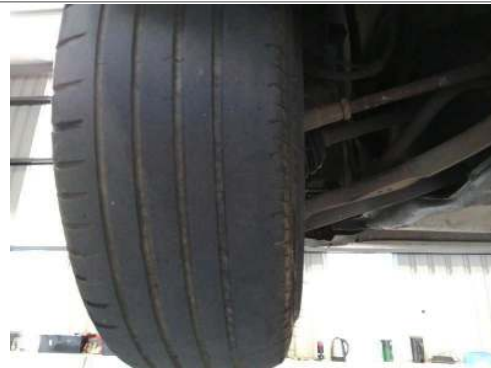
| Damage | Repair Way |
|---|---|
| Tyre Front Left Worn | Replace |

| | Size | Load/Speed Index | Manufacture | Model | Type* | Production Date | Tread Depth (mm) |
|---|---|---|---|---|---|---|---|
| Front Left | 215/45Z R17 | 91W | Accelera | PHI-R | V | 4122 | 0 mm |

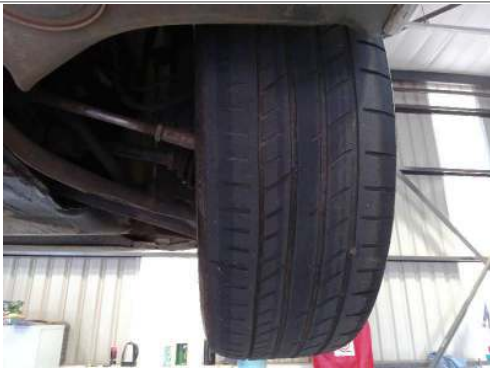
| Damage | Repair Way |
|---|---|
| Tyre Front Right Damaged | Replace |

| | Size | Load/Speed Index | Manufacture | Model | Type* | Production Date | Tread Depth (mm) |
|---|---|---|---|---|---|---|---|
| Front Right | 215/45 R17 | 91W | Continental | Contipremuim | V | 2720 | 0 mm |

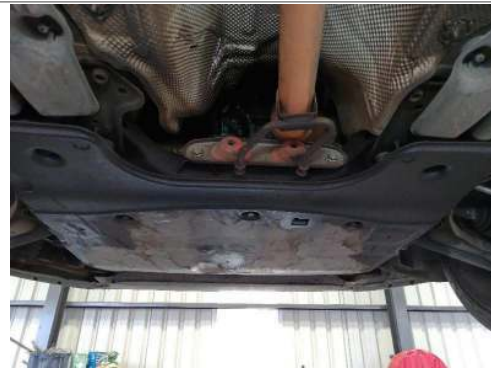
| Damage | Repair Way |
|---|---|
| Engine Oil Sweat | Repair |

| Damage | Repair Way |
|---|---|
| Engine Noise Excessive | Repair |

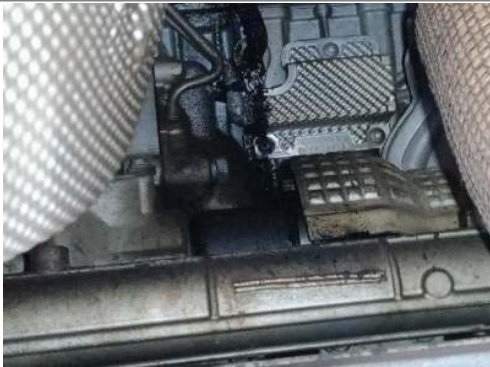
| Damage | Repair Way |
|---|---|
| CV Joint(s) Boot(s) Front Right (inner/outer) Defective | Replace |

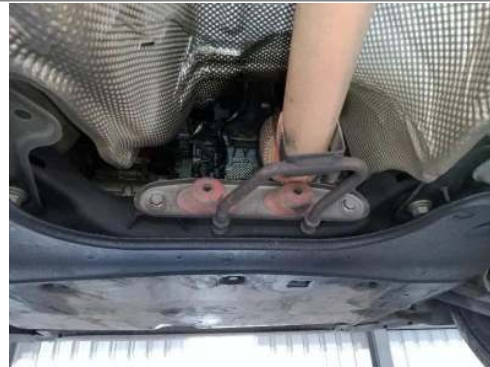
| Damage | Repair Way |
|---|---|
| Engine to silencer pipe Defective | Repair |

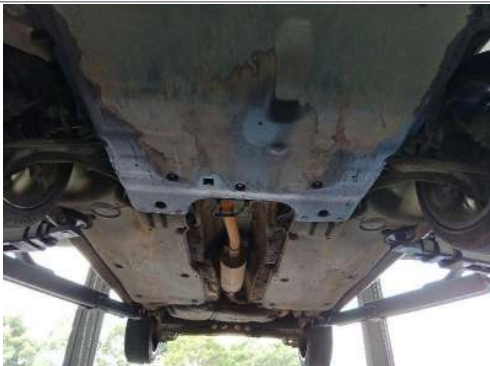
| Damage | Repair Way |
|---|---|
| Belly plates Defective | Repair |

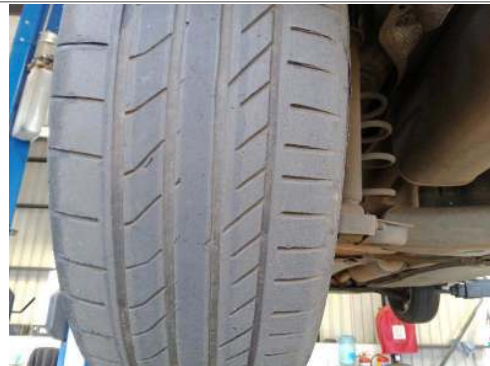
| Damage | Repair Way |
|---|---|
| Tyre Rear Left Damaged | Replace |

| | Size | Load/Speed Index | Manufacture | Model | Type* | Production Date | Tread Depth (mm) |
|---|---|---|---|---|---|---|---|
| Rear Left | 215/45 R17 | 91W | Continental | Contisport | V | 2720 | 0 mm |

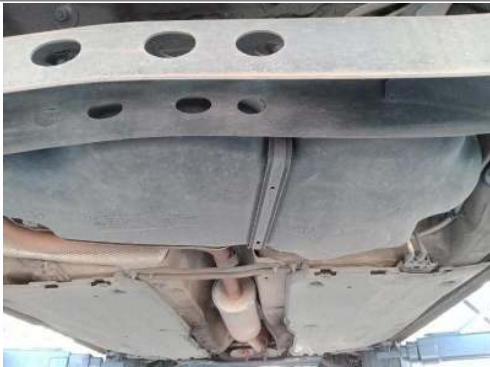
| Damage | Repair Way |
|---|---|
| Fuel Tank Defective | Repair |

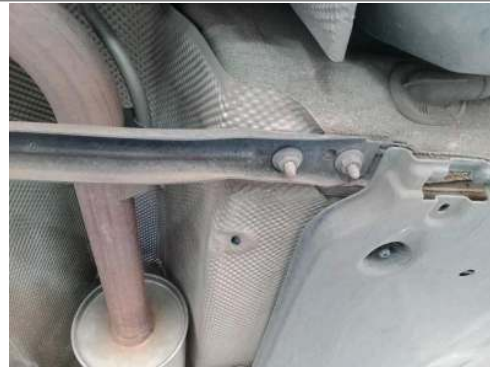
| Damage | Repair Way |
|---|---|
| Cross Member Rear Right Dented | Repair |

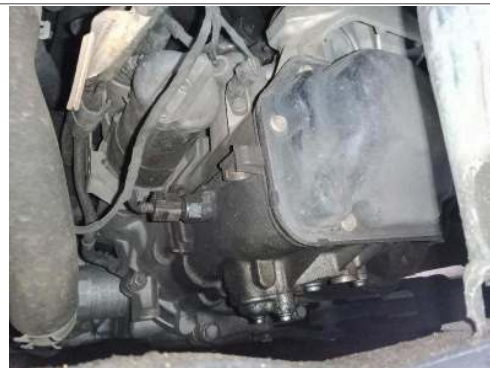
| Damage | Repair Way |
|---|---|
| Gearbox Oil Leak | Repair |

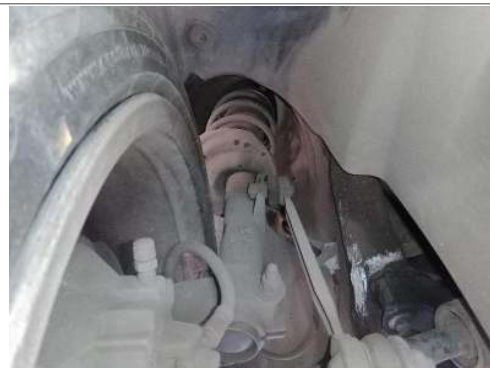
| Damage | Repair Way |
|---|---|
| Shock Absorber Front Right Defective | Replace |

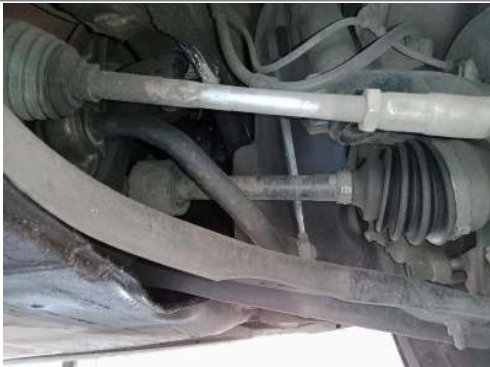
| Damage | Repair Way |
|---|---|
| Stabilizer Front Defective | Repair |

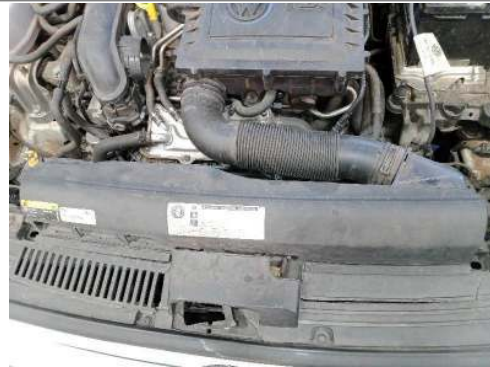
| Damage | Repair Way |
|---|---|
| Air cleaner Defective | Repair |
