CONDITION REPORT

Report No:  
2017306222  
DATE  
01/10/2026

| Manufacturer | VOLKSWAGEN | Registration Number | CXR985NC |
| Model | POLO 1.0 TSI 70KW COMFORTLINE 5-DR [2020-2022] | Register Number | |

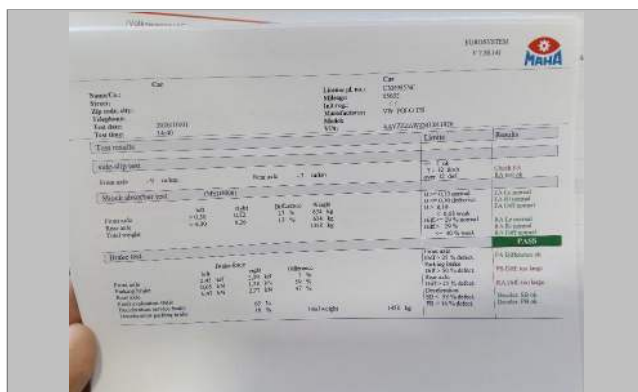
### Brake test.

| | Left | Right | | |
|---|---|---|---|---|
| Front | 2.45 | 2.29 | - | |
| Rear | 1.47 | 2.77 | - | |
| Emergency / Parking | 0.65 | 1.58 | - | |

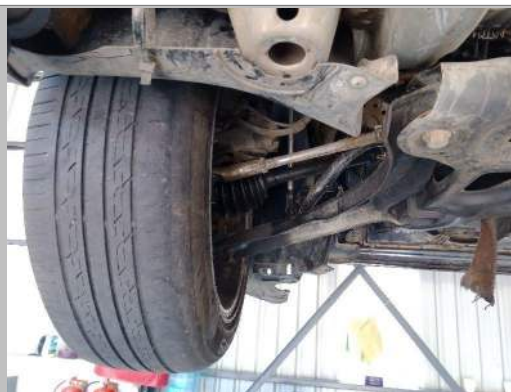
LF TYRE TREAD

| Damage | Repair Way |
|---|---|
| Tyre Front Left Worn | Replace |

| | Size | Load/Speed Index | Manufacture | Model | Type* | Production Date | Tread Depth (mm) |
|---|---|---|---|---|---|---|---|
| Front Left | 205/50R17 | 93W | Durun | Radial | V | 3823 | 0 mm |

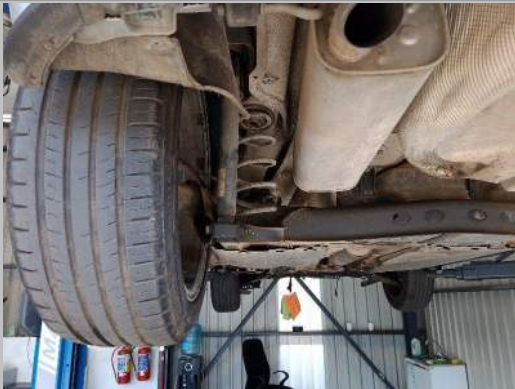
LR TYRE TREAD

| | Size | Load/Speed Index | Manufacture | Model | Type* | Production Date | Tread Depth (mm) |
|---|---|---|---|---|---|---|---|
| Rear Left | 225/45R17 | 94W | Xcent | Radial | V | 1221 | 2 mm |

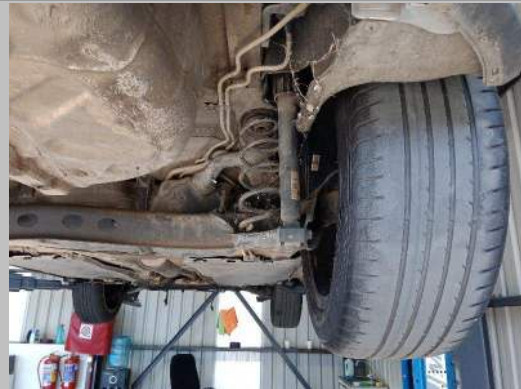
RR TYRE TREAD

| Damage | Repair Way |
|---|---|
| Tyre Rear Right Worn | Replace |

| | Size | Load/Speed Index | Manufacture | Model | Type* | Production Date | Tread Depth (mm) |
|---|---|---|---|---|---|---|---|
| Rear Right | 205/50R17 | 88V | Goodyear | Efficient | V | 3719 | 0 mm |

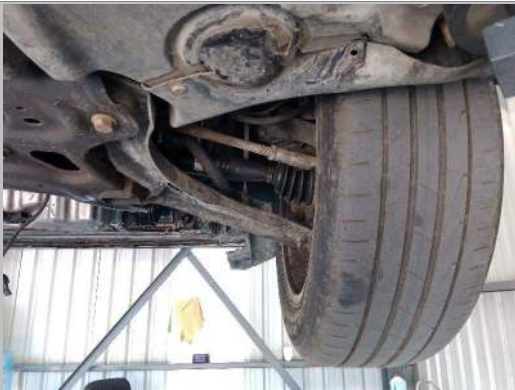
RF TYRE TREAD

| Damage | Repair Way |
|---|---|
| Tyre Front Right Worn | Replace |

| | Size | Load/Speed Index | Manufacture | Model | Type* | Production Date | Tread Depth (mm) |
|---|---|---|---|---|---|---|---|
| Front Right | 205/55R17 | 91V | Hankook | Radial | V | 4921 | 0 mm |

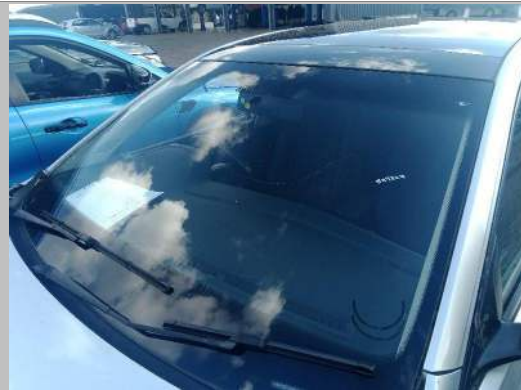
No license disc

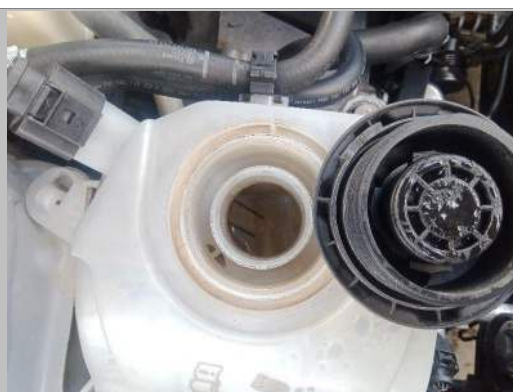
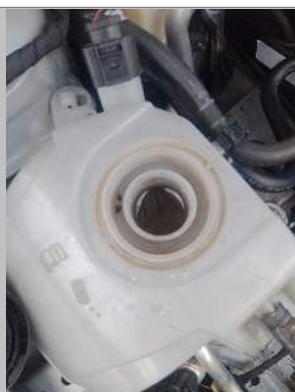
| Damage | Repair Way |
|---|---|
| Water level Insufficient | Repair |

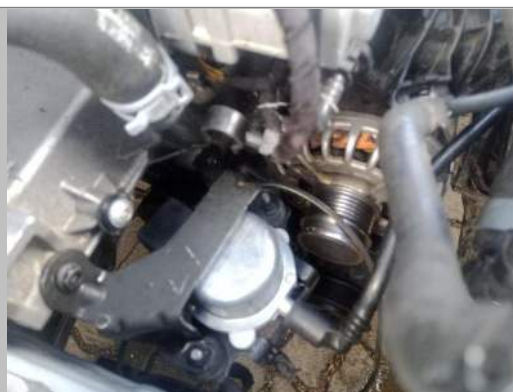
| Damage | Repair Way |
|---|---|
| Fan Belt Damaged | Replace |

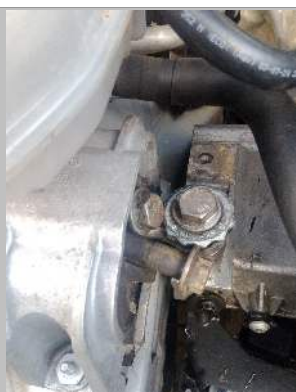
| Damage | Repair Way |
|---|---|
| Engine mountings Damaged | Replace |

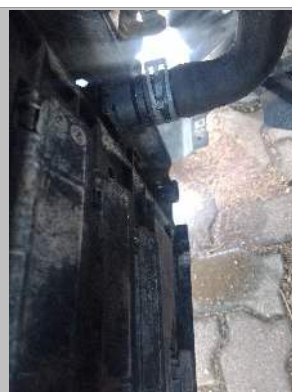
| Damage | Repair Way |
|---|---|
| Radiator Damaged | Repair |

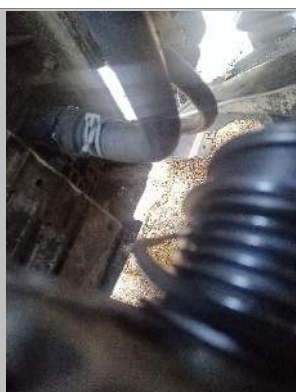
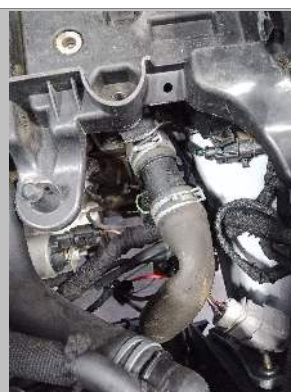
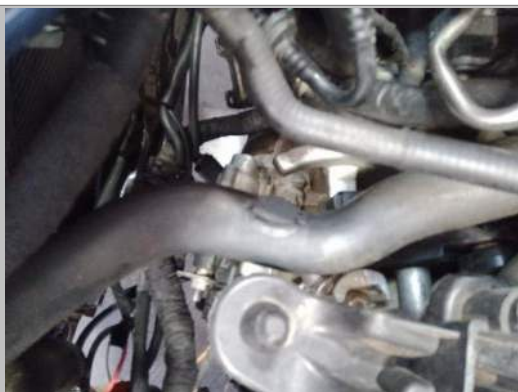
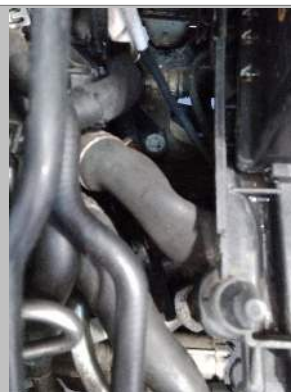
| Damage | Repair Way |
|---|---|
| Hoses Damaged | Replace |

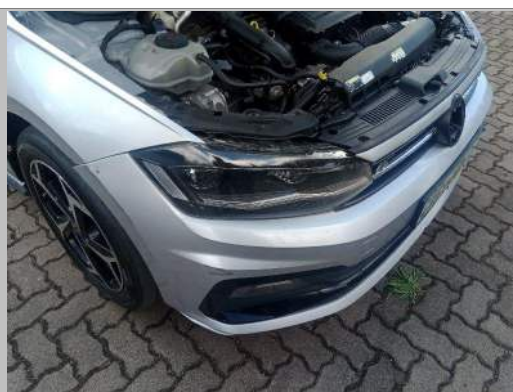
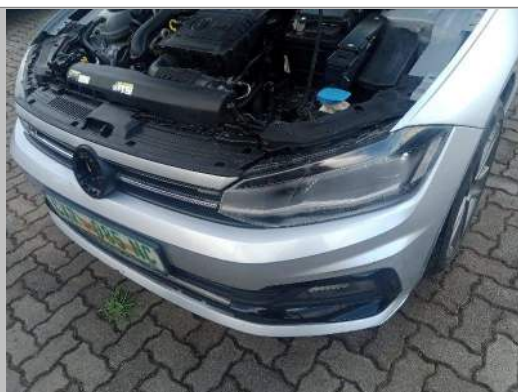
| Damage | Repair Way |
|---|---|
| Front Bumper Damaged | Repair |

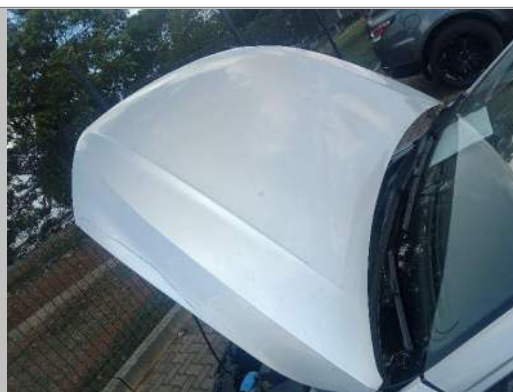
| Damage | Repair Way |
|---|---|
| Bonnet Damaged | Repair |

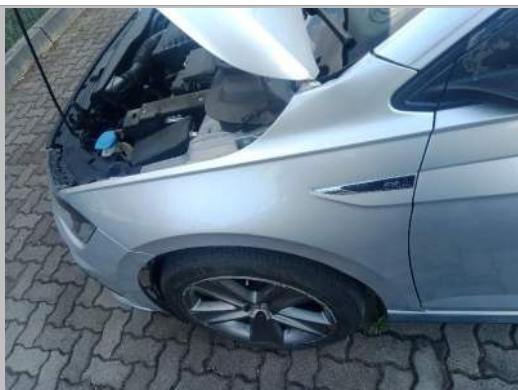
| Damage | Repair Way |
|---|---|
| Front Fender Left Damaged | Repair |

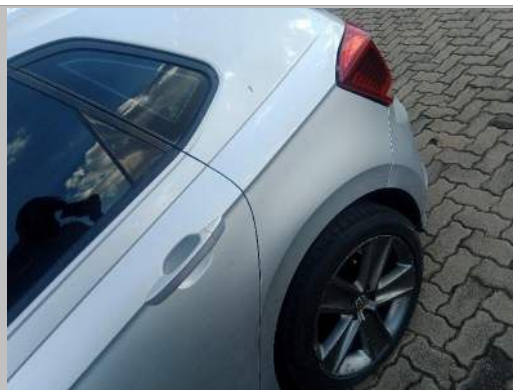
| Damage | Repair Way |
|---|---|
| Rear Fender Left Damaged | Repair |

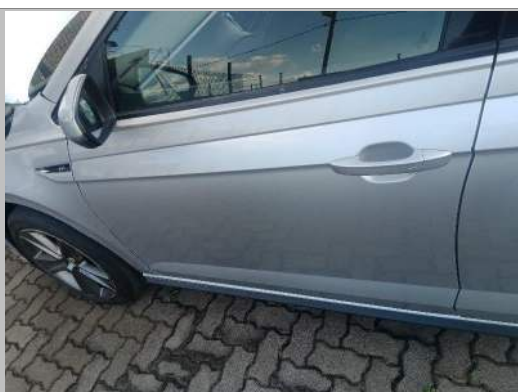
| Damage | Repair Way |
|---|---|
| Door Front Left Damaged | Repair |

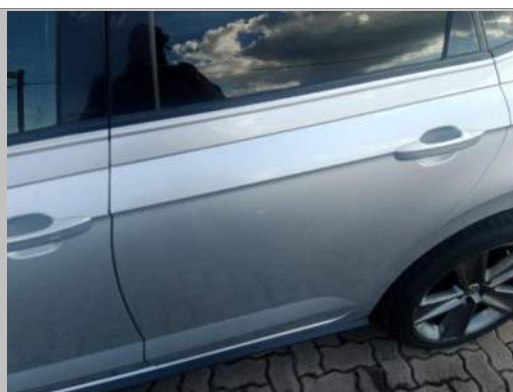
| Damage | Repair Way |
|---|---|
| Door Rear Left Damaged | Repair |

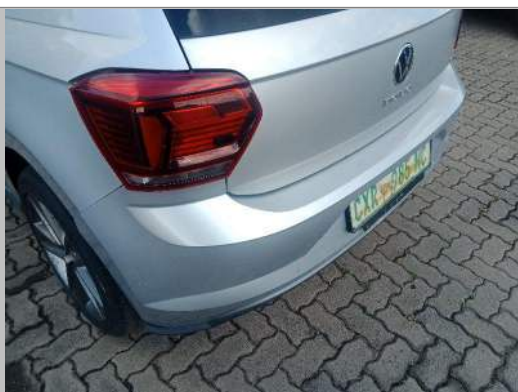
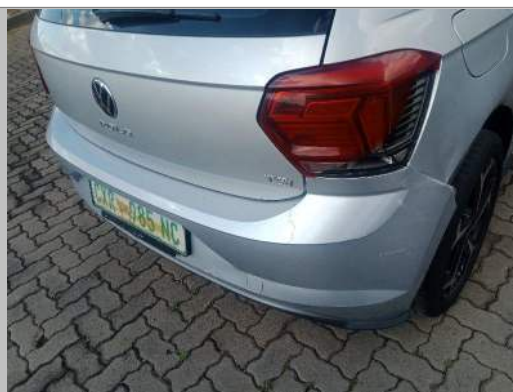
| Damage | Repair Way |
|---|---|
| Rear bumper Damaged | Repair |

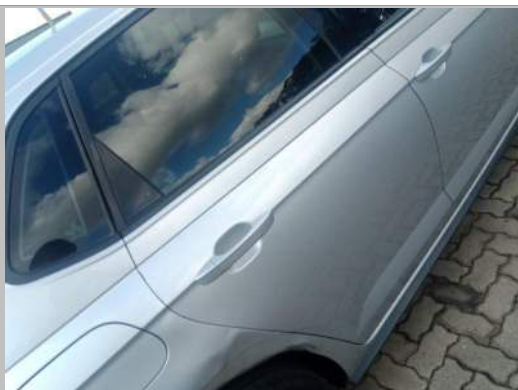
| Damage | Repair Way |
|---|---|
| Door Rear Right Damaged | Repair |

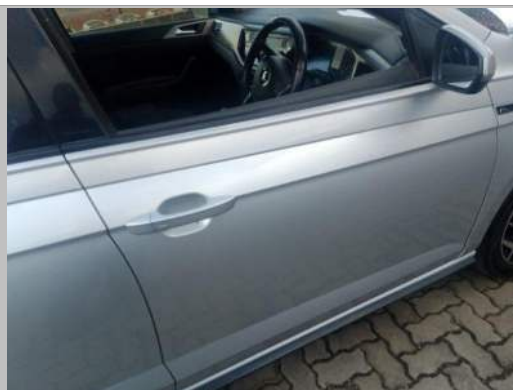
| Damage | Repair Way |
|---|---|
| Door Front Right Damaged | Repair |

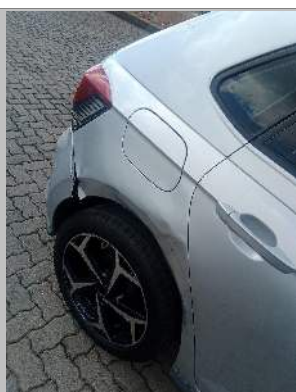
| Damage | Repair Way |
|---|---|
| Rear Fender Right Damaged | Repair |

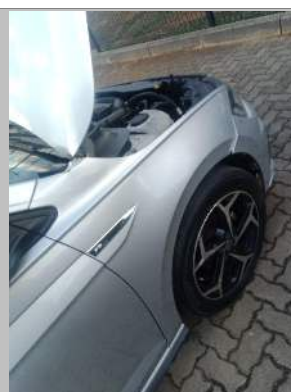
| Damage | Repair Way |
|---|---|
| Front Fender Right Damaged | Repair |

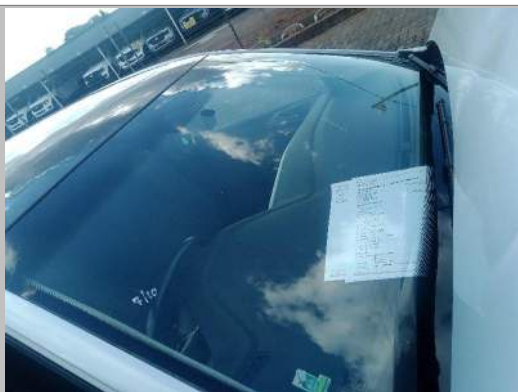
| Damage | Repair Way |
|---|---|
| Windscreen Damaged | Replace |

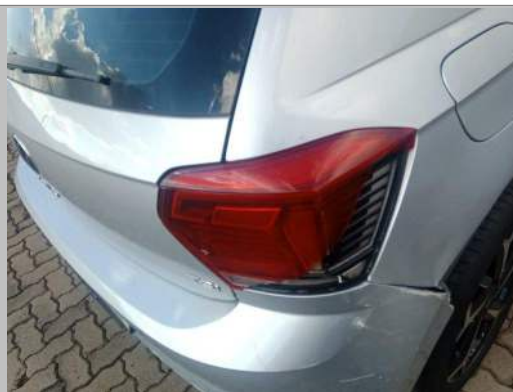
| Damage | Repair Way |
|---|---|
| Tail Light Right Damaged | Replace |

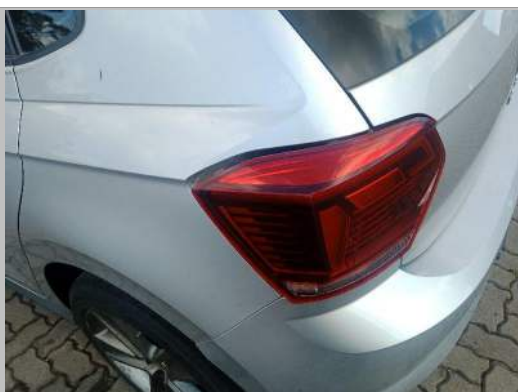
| Damage | Repair Way |
|---|---|
| Tail Light Left Damaged | Replace |

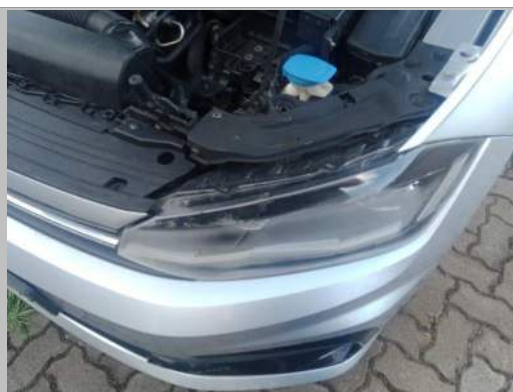
| Damage | Repair Way |
|---|---|
| Headlight Right Damaged | Repair |

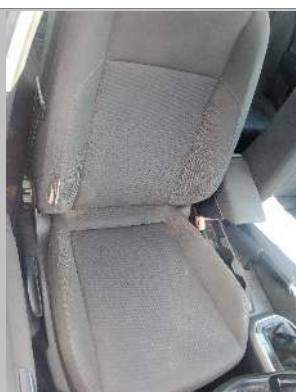
| Damage | Repair Way |
|---|---|
| Seat Front Right Damaged | Repair |

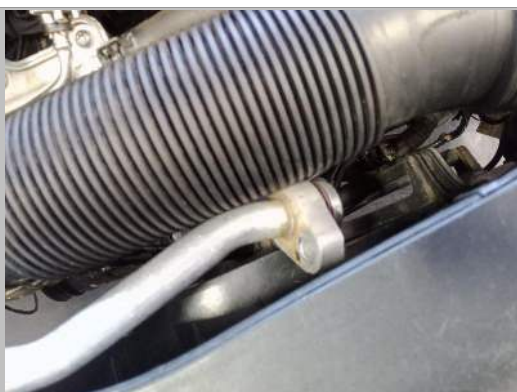
| Damage | Repair Way |
|---|---|
| Air conditioner pipes Damaged | Replace |

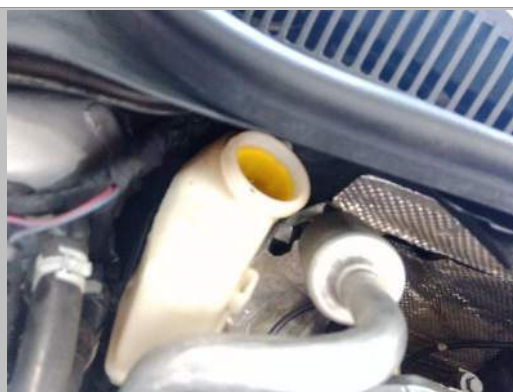
| Damage | Repair Way |
|---|---|
| Caps Missing | Replace |

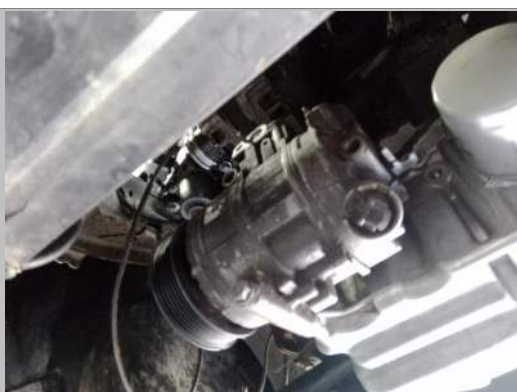
| Damage | Repair Way |
|---|---|
| Air conditioner pump Damaged | Repair |

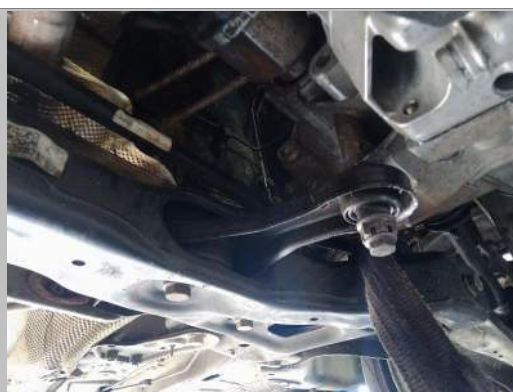
| Damage | Repair Way |
|---|---|
| Gearbox Mountings Damaged | Replace |

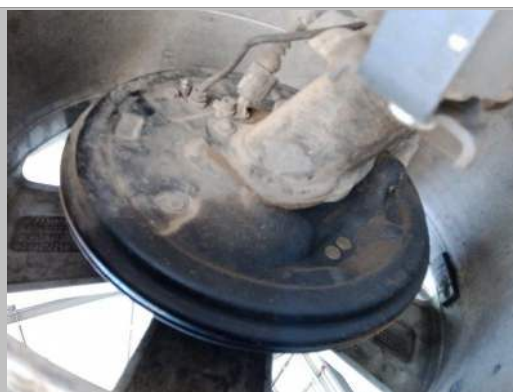
| Damage | Repair Way |
|---|---|
| Wheel Cylinder / Caliper 2. Axle left Leak | Replace |

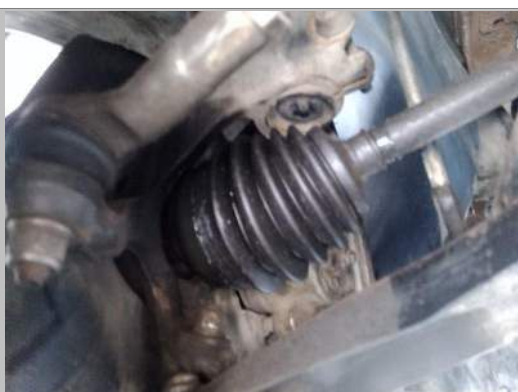
| Damage | Repair Way |
|---|---|
| CV Joint(s) Boot(s) Front Left (inner/outer) Damaged | Replace |

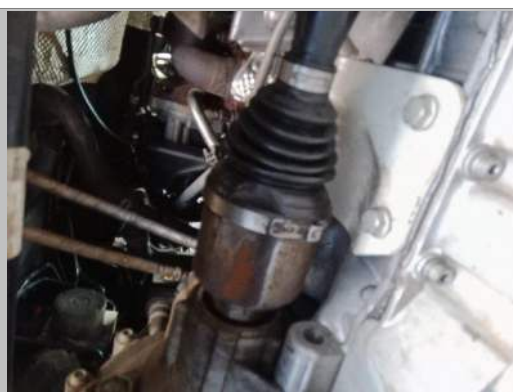
| Damage | Repair Way |
|---|---|
| CV Joint(s) Boot(s) Front Right (inner/outer) Damaged | Replace |

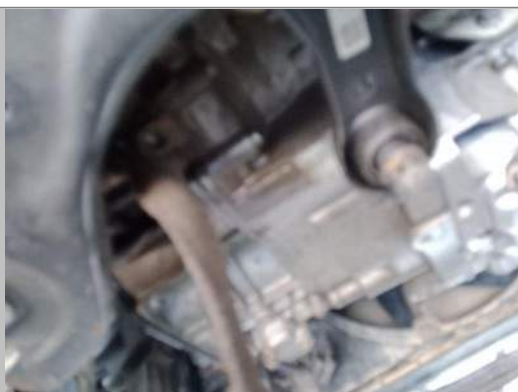
| Damage | Repair Way |
|---|---|
| Gearbox Oil Leak | Repair |

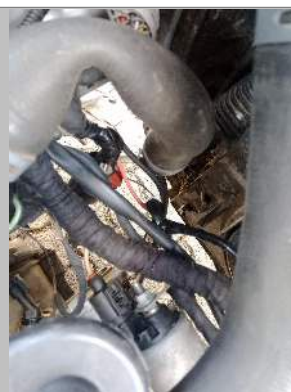
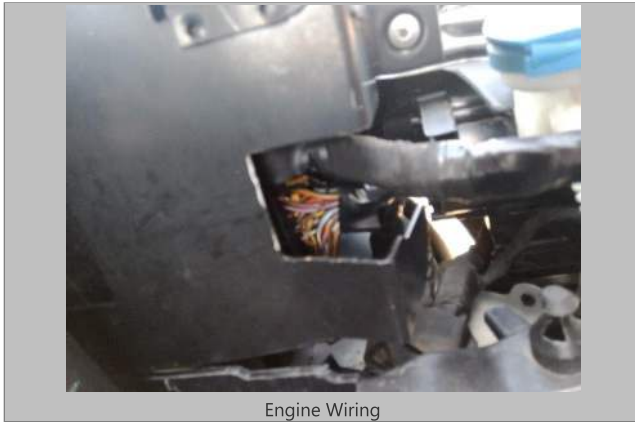
| Damage | Repair Way |
|---|---|
| Engine Wiring Damaged | Replace |
