## CONDITION REPORT

Report No:  
2017305926  
DATE  
01/10/2026

| Manufacturer | VOLKSWAGEN | Registration Number | NONE |
| Model | POLO 2.0 TSI 147KW GTI 5-DR DSG [2020-2022] | Register Number | |

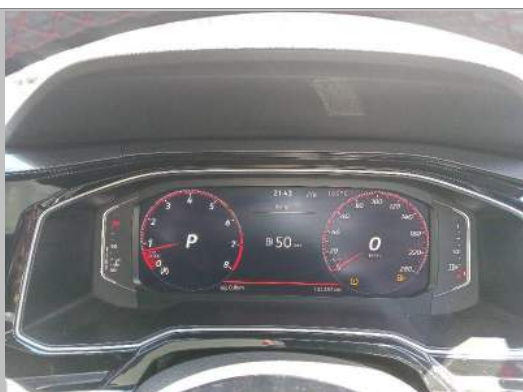
DASHBOARD (W/ ENGINE RUNNING)

| Warning light illuminated on dashboard | Repair |

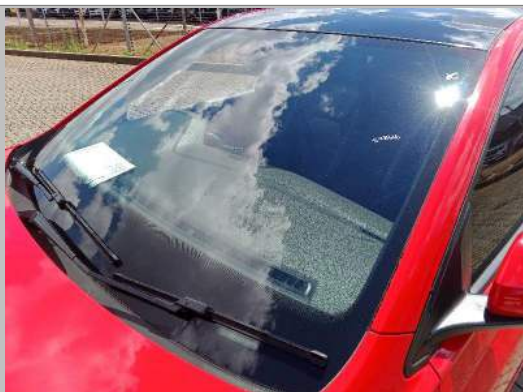
| Vehicle license disk missing | Replace |

NO LICENSE DISC

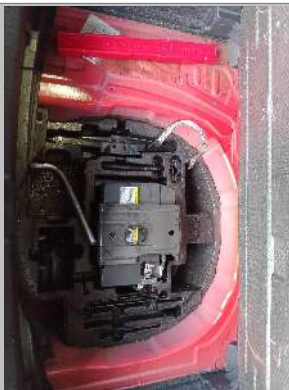
Spare wheel Accessories

| Spare wheel missing | Replace |

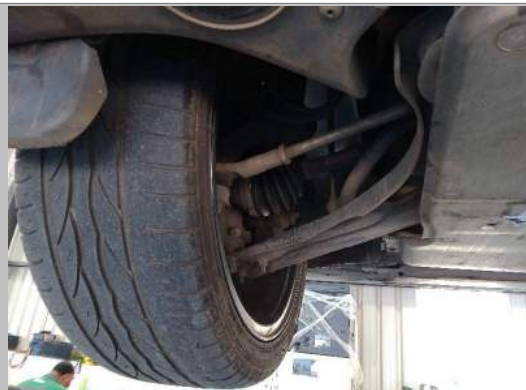
LF TYRE TREAD

| | Size | Load/Speed Index | Manufacture | Model | Type* | Production Date | Tread Depth (mm) |
|---|---|---|---|---|---|---|---|
| Front Left | 215/40 R18 | 92W | Symmetry | SY400 | V | 0723 | 1 mm |

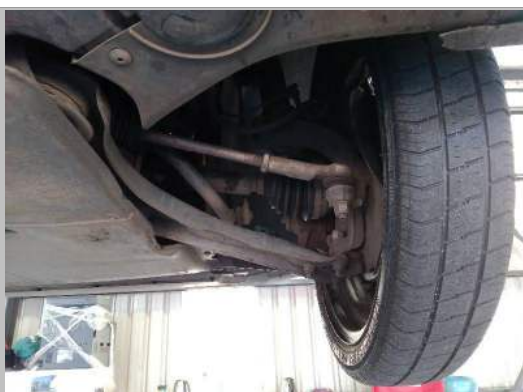
RF TYRE TREAD

| | Size | Load/Speed Index | Manufacture | Model | Type* | Production Date | Tread Depth (mm) |
|---|---|---|---|---|---|---|---|
| Front Right | T125/60 R18 | 94M | Linglong | Temporary | V | 0320 | 2 mm |

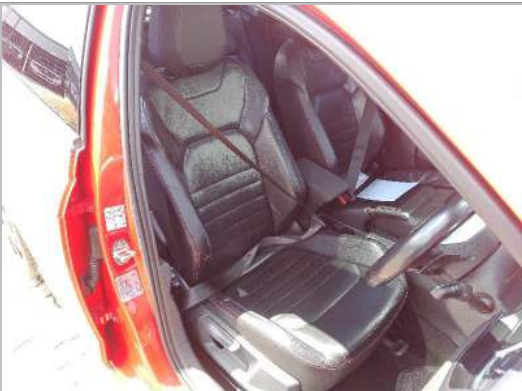
| Seat Front Right Damaged | Repair |

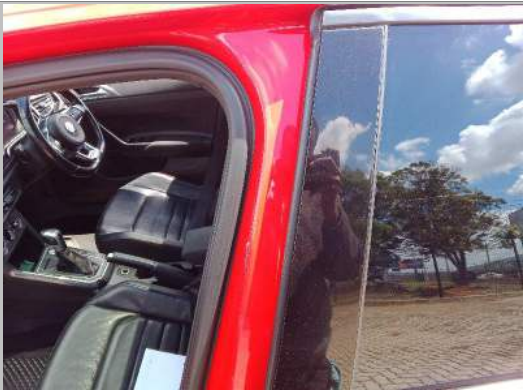
| B • Pillar Left Residual Traces of Repair | Repair |

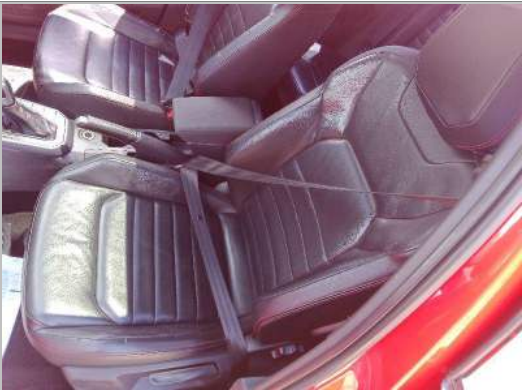
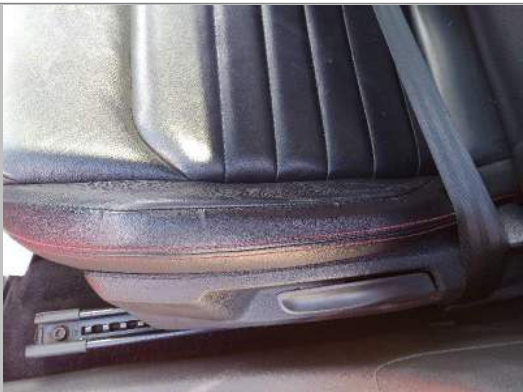
| Seat Front Left Torn / Cut | Repair |

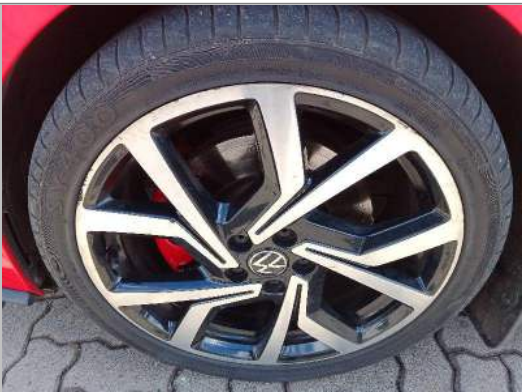
| Rim Front Left Scratched | Repair |

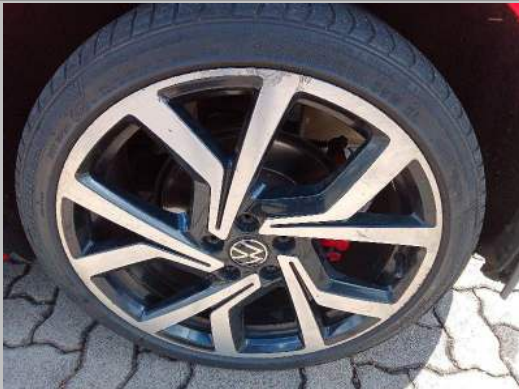
| Rim Rear Left Scratched | Repair |

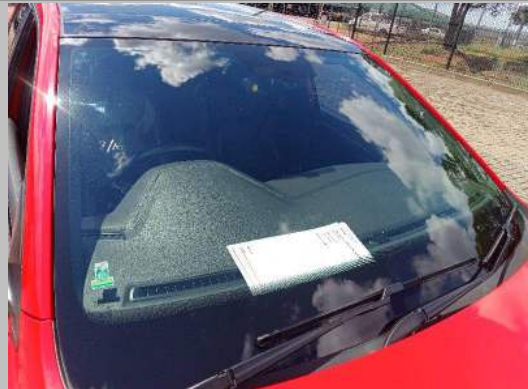
| Windscreen Chipped | Repair |

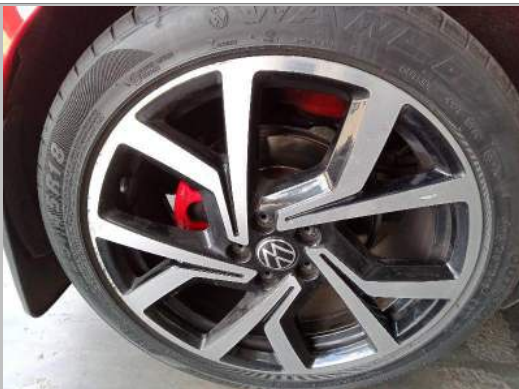
| Rim Rear Right Scratched | Repair |

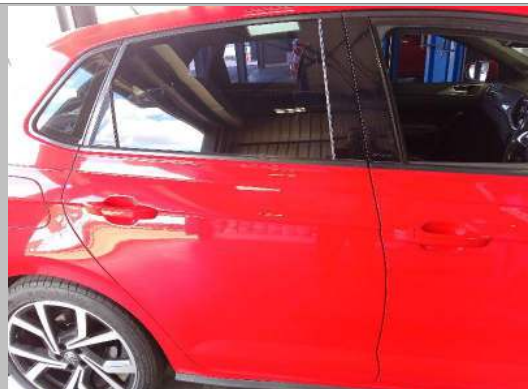
| Door Rear Right Dented | Repair |

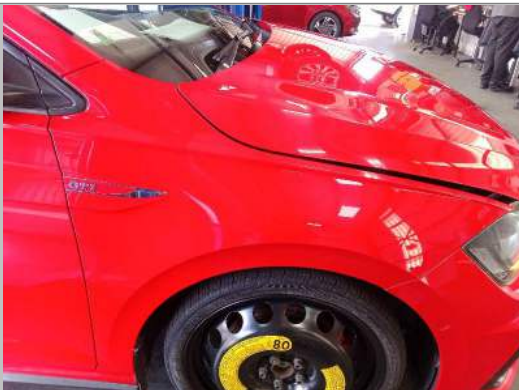
| Front Fender Right Dented | Repair |

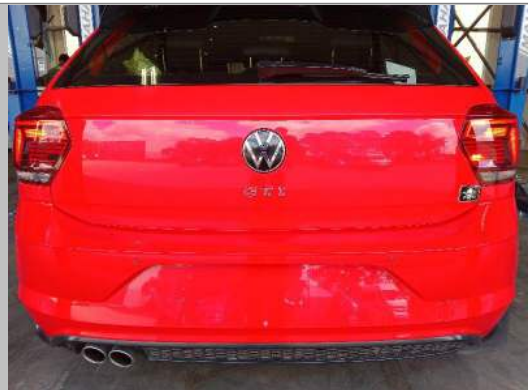
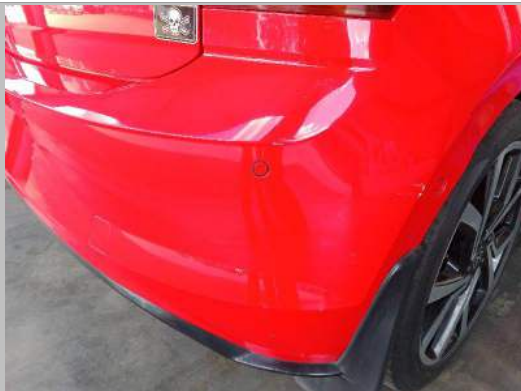
| Rear bumper Paintwork • Scratched | Repair |

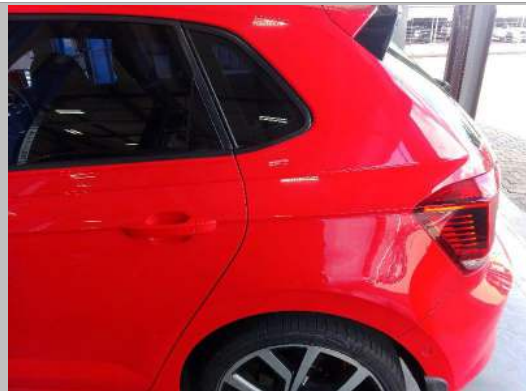
| Rear Fender Left Dented | Repair |

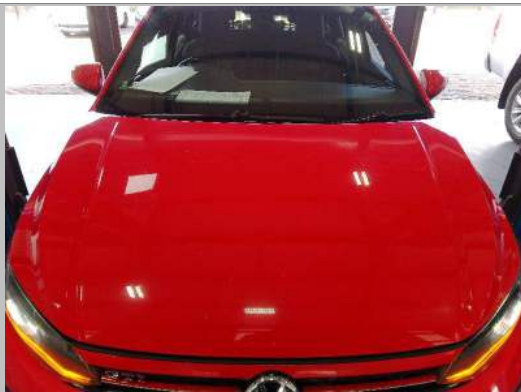
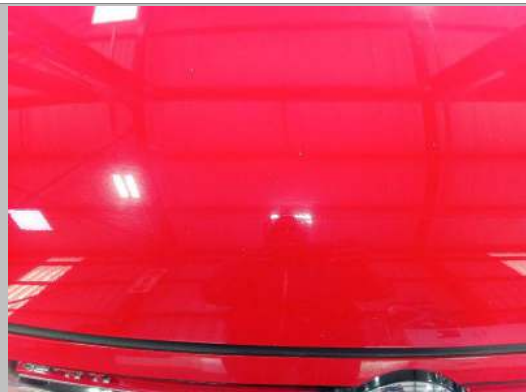
| Bonnet Paintwork • Chipmarks | Repair |

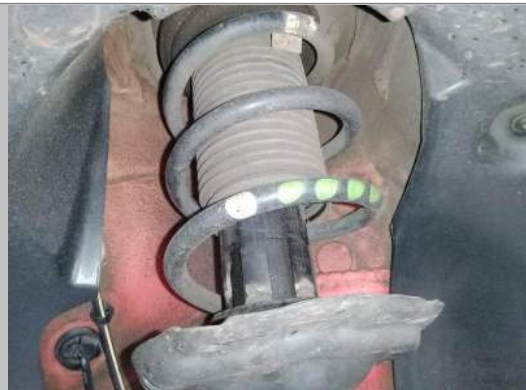
| Shock Absorber Front Right Sweat | Replace |

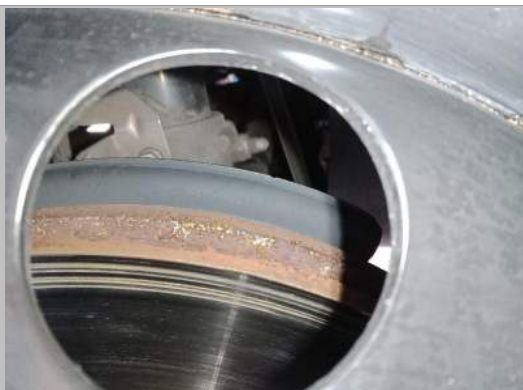
| Brake disc 1. Axle right Excessive Wear & Tear | Replace |

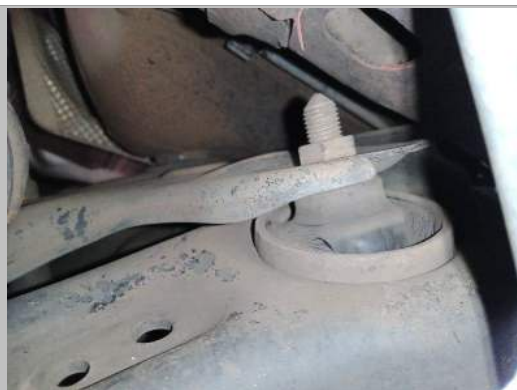
| Control Arm Bush(es) Front Axle Left Cracked | Replace |

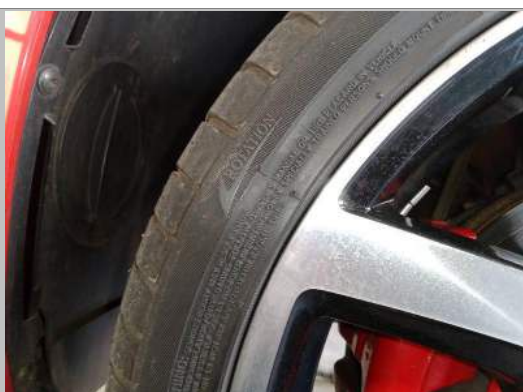
| Tyre Front Left Damaged | Replace |

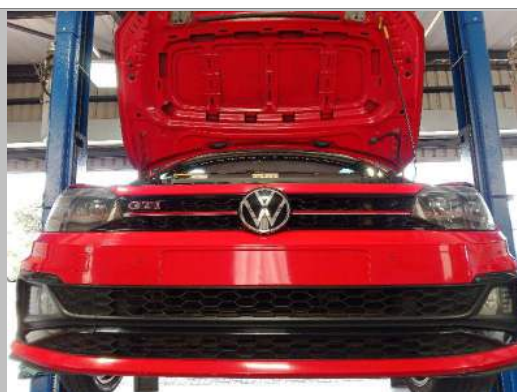
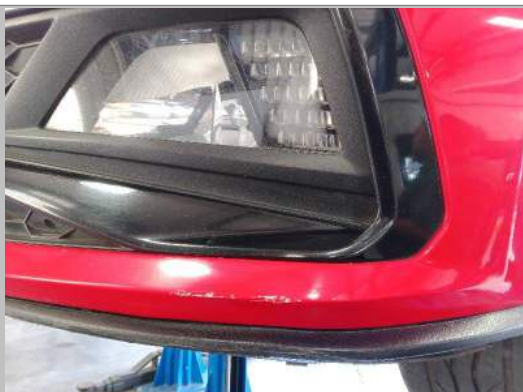
| Front Bumper Paintwork • Scratched | Repair |

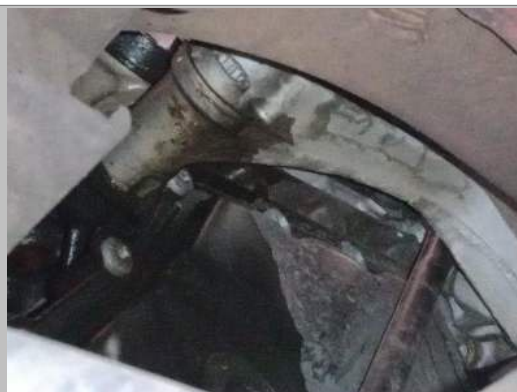
| Engine Oil Leak | Repair |

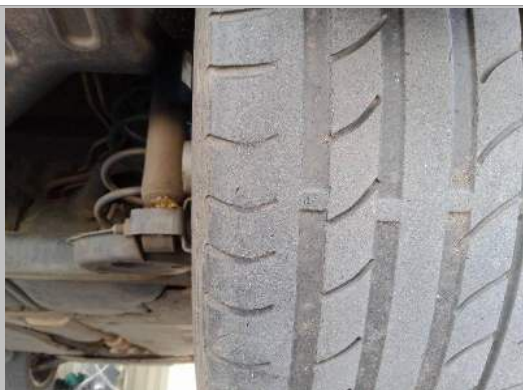
| Tyre Rear Right Worn | Replace |

| | Size | Load/Speed Index | Manufacture | Model | Type* | Production Date | Tread Depth (mm) |
|---|---|---|---|---|---|---|---|
| Rear Right | 225/45Z R19 | 95W | Wanli | Sport | V | 3219 | 0 mm |

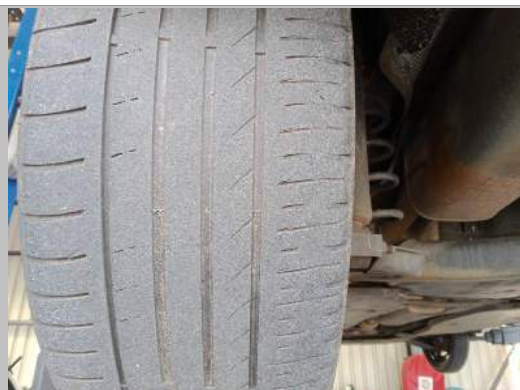
| Tyre Rear Left Worn | Replace |

| | Size | Load/Speed Index | Manufacture | Model | Type* | Production Date | Tread Depth (mm) |
|---|---|---|---|---|---|---|---|
| Rear Left | 215/40Z R18 | 89W | Winrun | Radial | V | 1521 | 0 mm |

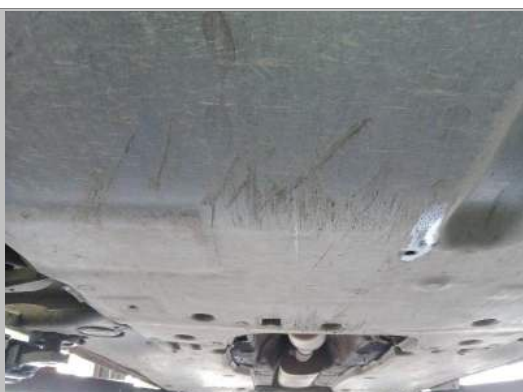
| Belly plates Damaged | Repair |
