## CONDITION REPORT

Report No:  
2017302310  
DATE  
22/09/2026

| Manufacturer | VOLKSWAGEN | Registration Number | JY31DZGP |
| Model | POLO 1.0 TSI 70KW COMFORTLINE 5-DR DSG [2020-2022] | Register Number | |

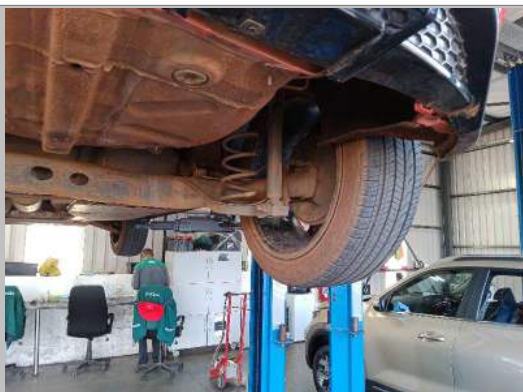
RR TYRE TREAD

| R/R tire deferred name brand | Repair |

| | Size | Load/Speed Index | Manufacture | Model | Type* | Production Date | Tread Depth (mm) |
|---|---|---|---|---|---|---|---|
| Rear Right | 215/45R17 | 91W | Annaite | An606 | V | 4323 | 4 mm |

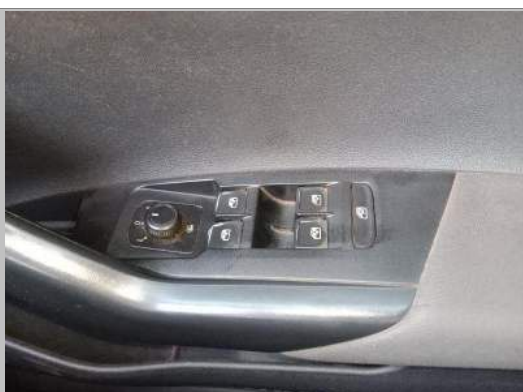
| Switch Electrical Window Winder front left Malfunction | Repair |

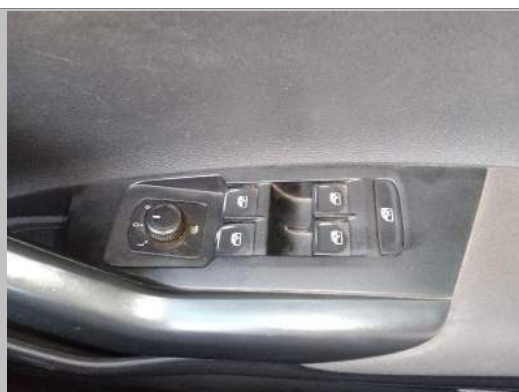
| Switch Electrical Window Winder front right Malfunction | Repair |

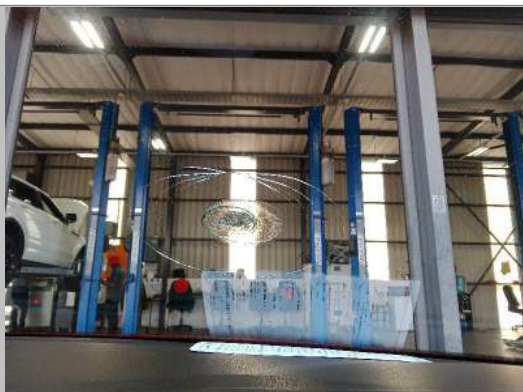
| Windscreen Damaged | Replace |

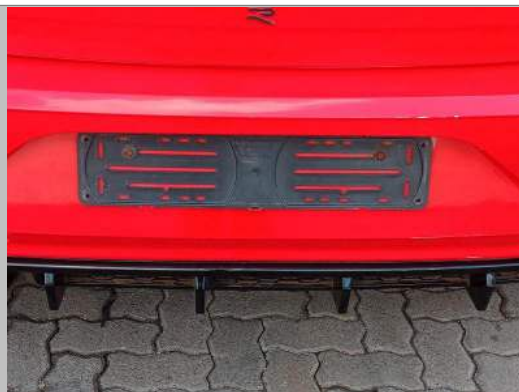
| Number Plate Rear Missing | Replace |

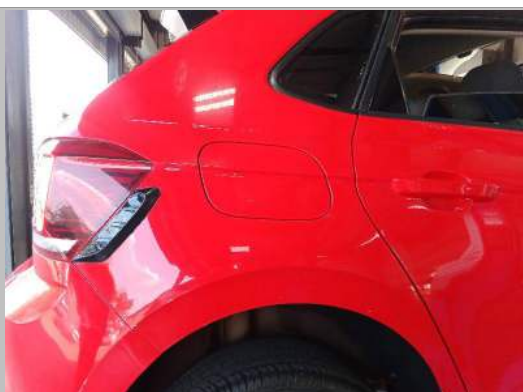
| Rear Fender Right Paintwork • Scratched | Repair |

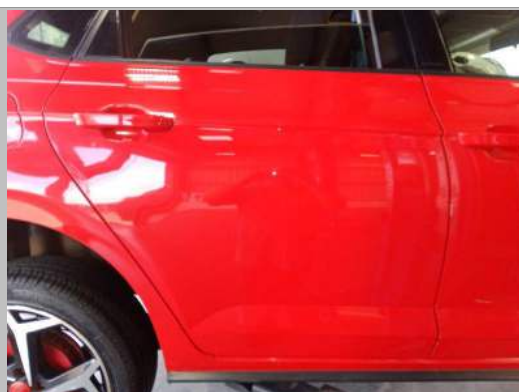
| Door Rear Right Paintwork • Chipmarks | Repair |

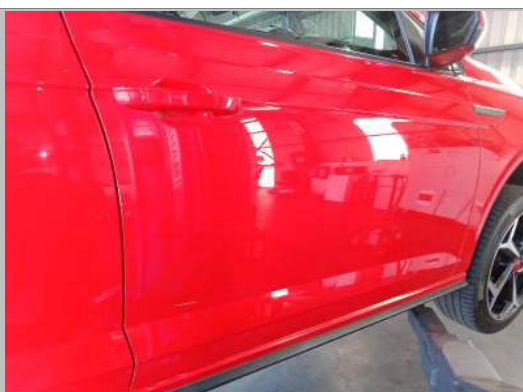
| Door Front Right Paintwork • Scratched | Repair |

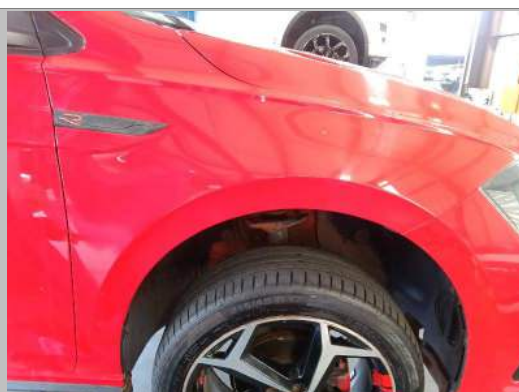
| Front Fender Right Paintwork • Chipmarks | Repair |

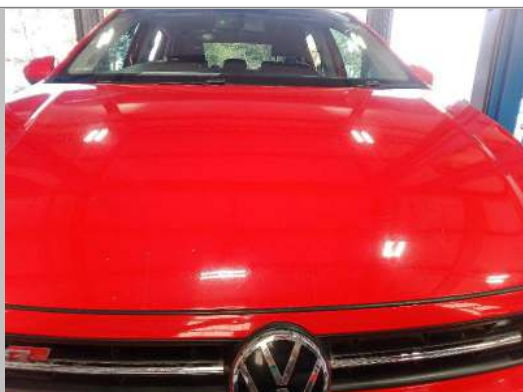
| Bonnet Paintwork • Chipmarks | Repair |

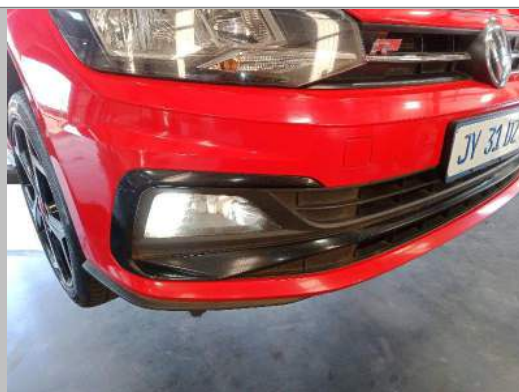
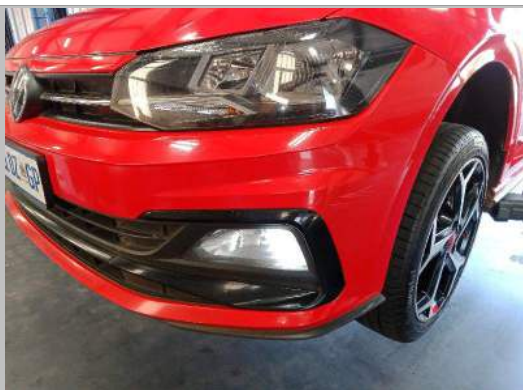
| Front Bumper Paintwork • Scratched | Repair |

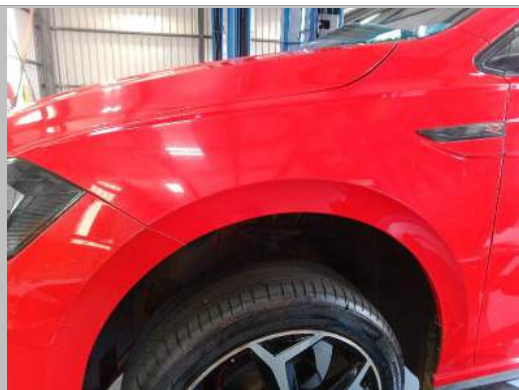
| Front Fender Left Paintwork • Scratched | Repair |

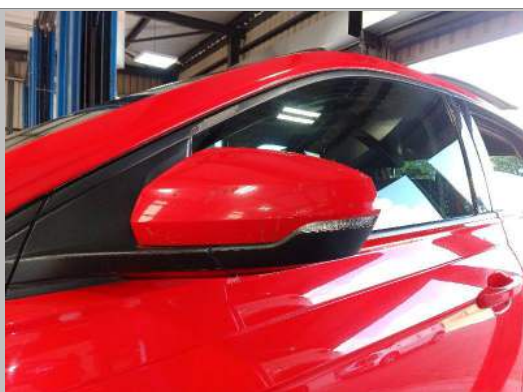
| Side Mirror Left Paintwork • Scratched | Repair |

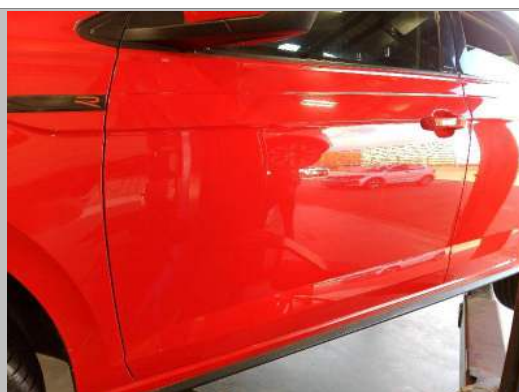
| Door Front Left Paintwork • Chipmarks | Repair |

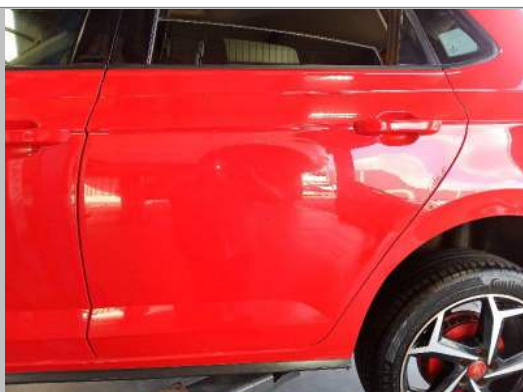
| Door Rear Left Paintwork • Scratched | Repair |

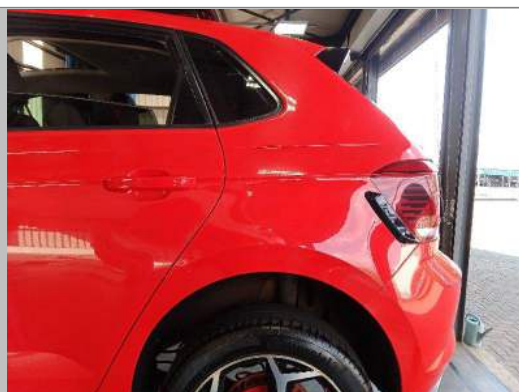
| Rear Fender Left Dented | Repair |

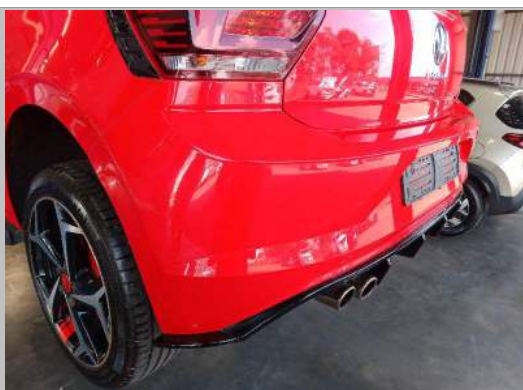
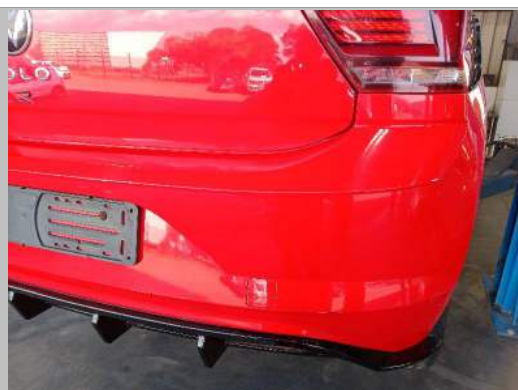
| Rear bumper Paintwork • Scratched | Repair |

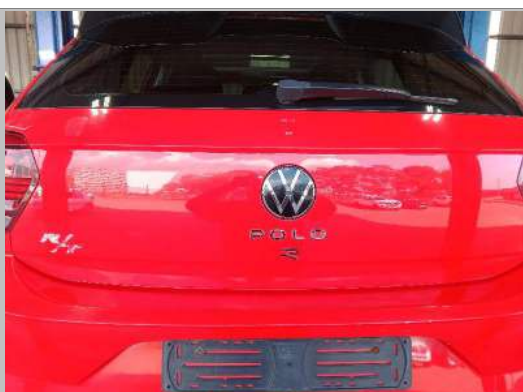
| Boot Lid / Hatch door Paintwork • Scratched | Repair |

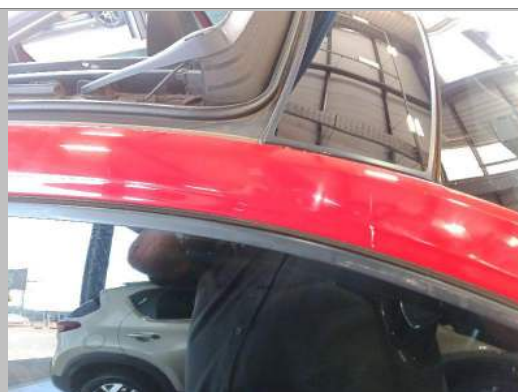
| A • Pillar Right Paintwork • Scratched | Repair |
