## CONDITION REPORT

Report No:  
2017302498  
DATE  
23/09/2026

MFC Auction House  
M57 Pretoria Rd, Glenmarais, KEMPTON PARK  
Gauteng

| Manufacturer | VOLKSWAGEN | Registration Number | HBZ487L |

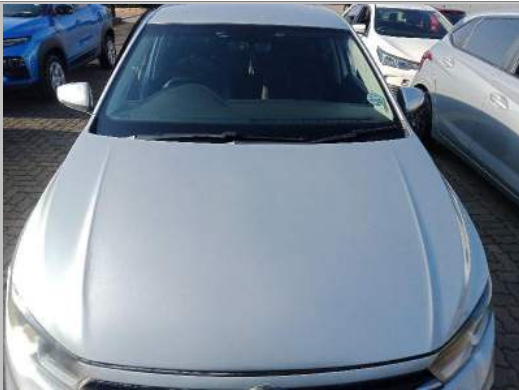
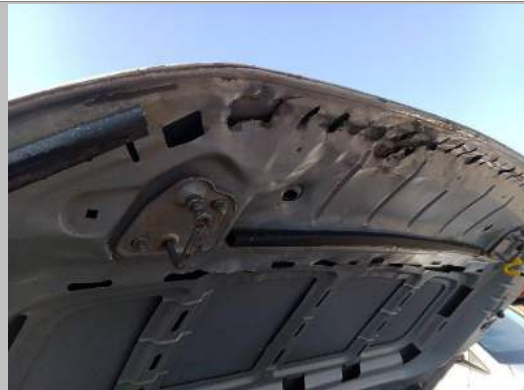
| Damage | Repair Way |
|---|---|
| Bonnet Residual Traces of Repair | Replace |

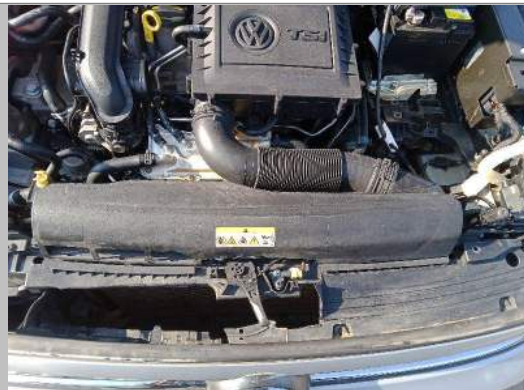
| Damage | Repair Way |
|---|---|
| Bonnet slam plate (Shock tower/ Inner tray) Damaged | Replace |

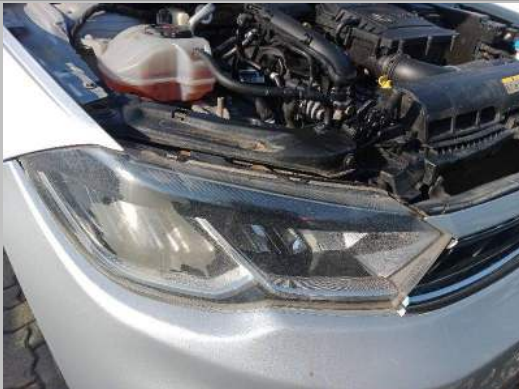
| Damage | Repair Way |
|---|---|
| Headlight Right Defective | Repair |

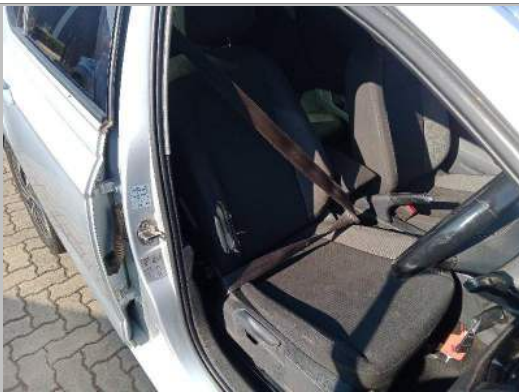
| Damage | Repair Way |
|---|---|
| Seat Front Right Damaged | Repair |

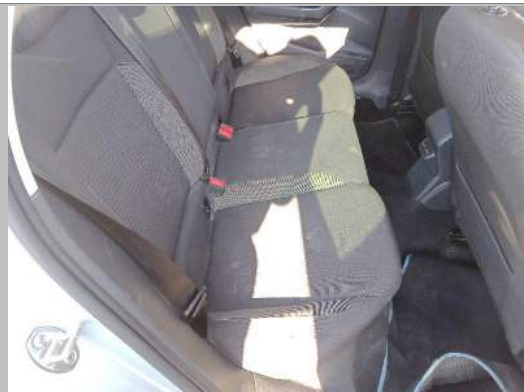
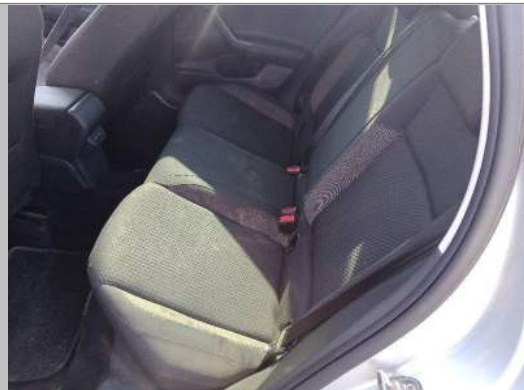
| Damage | Repair Way |
|---|---|
| Seat Rear Dirty | Repair |

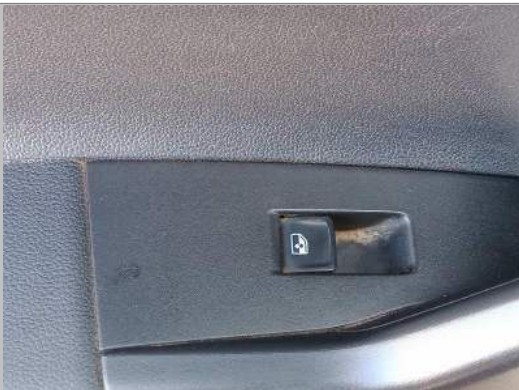
| Damage | Repair Way |
|---|---|
| Switch Electrical Window Winder rear left Damaged | Replace |

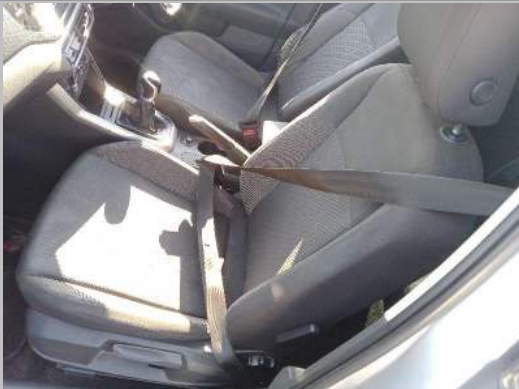
| Damage | Repair Way |
|---|---|
| Seat Front Left Dirty | Repair |

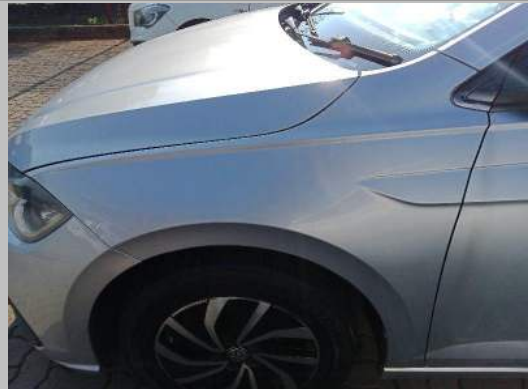
| Damage | Repair Way |
|---|---|
| Front Fender Left Residual Traces of Repair | Repair |

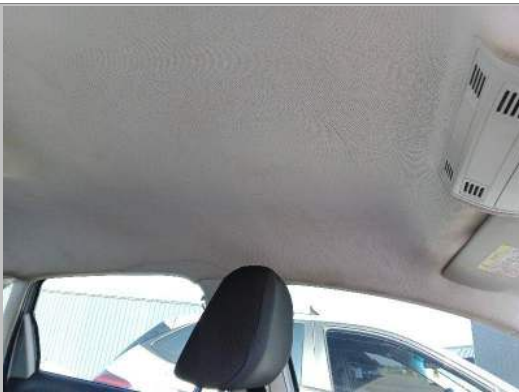
| Damage | Repair Way |
|---|---|
| Hood Lining Dirty | Repair |

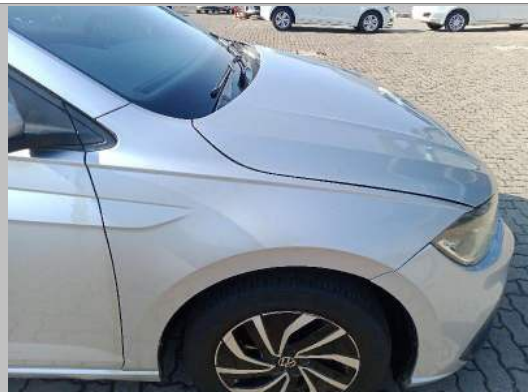
| Damage | Repair Way |
|---|---|
| Front Fender Right Residual Traces of Repair | Repair |

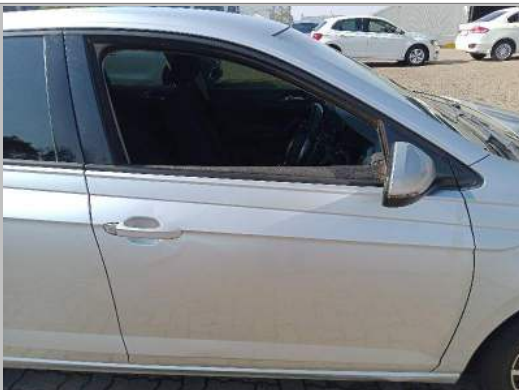
| Damage | Repair Way |
|---|---|
| Door Front Right Damaged | Repair |

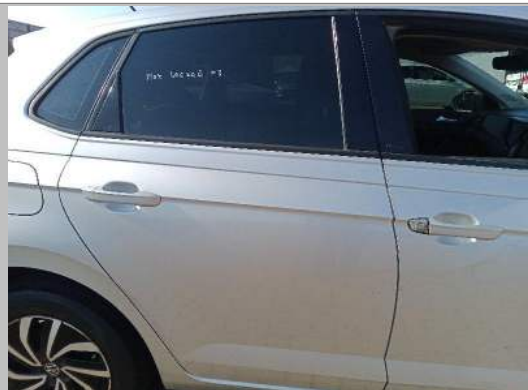
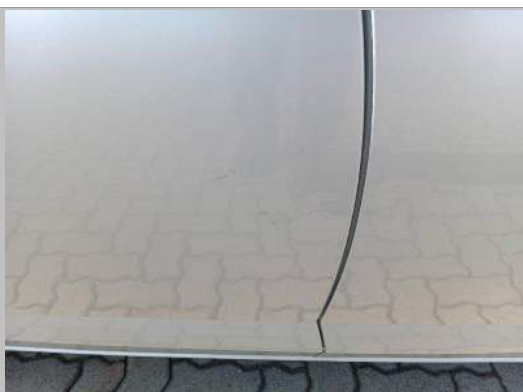
| Damage | Repair Way |
|---|---|
| Door Rear Right Damaged | Repair |

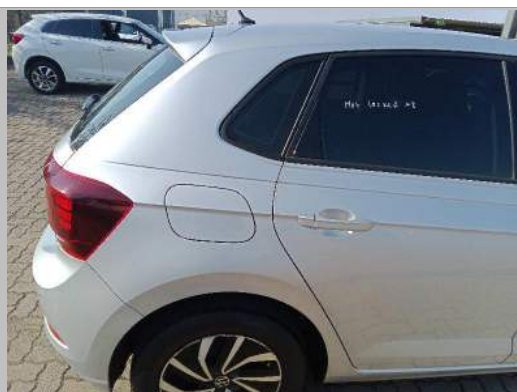
| Damage | Repair Way |
|---|---|
| Rear Fender Right Dented | Repair |

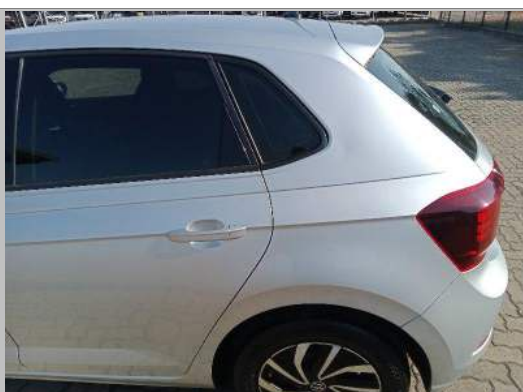
| Damage | Repair Way |
|---|---|
| Rear Fender Left Dented | Repair |

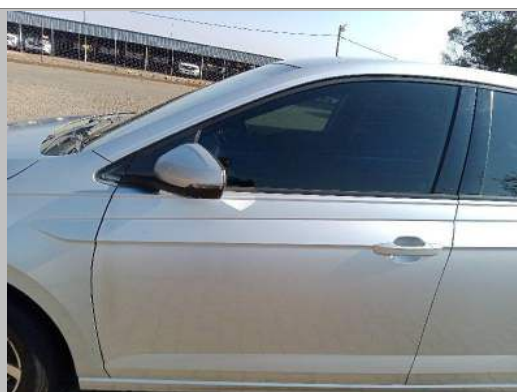
| Damage | Repair Way |
|---|---|
| Door Front Left Residual Traces of Repair | Repair |

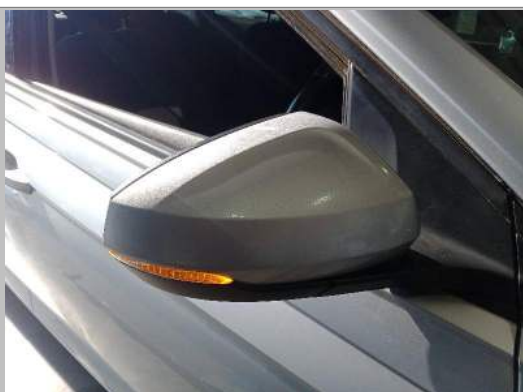
| Damage | Repair Way |
|---|---|
| Side Mirror Right Paintwork • Scratched | Repair |

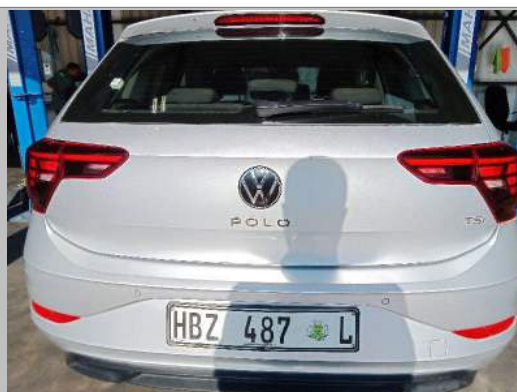
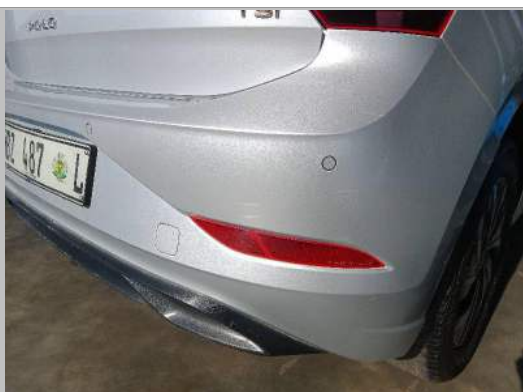
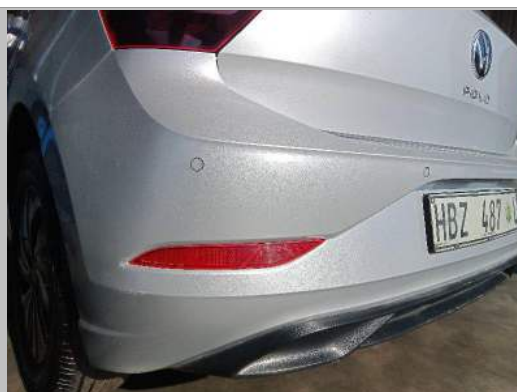
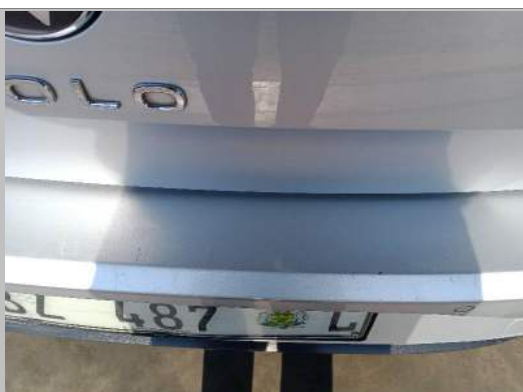
| Damage | Repair Way |
|---|---|
| Rear bumper Paintwork • Scratched | Repair |

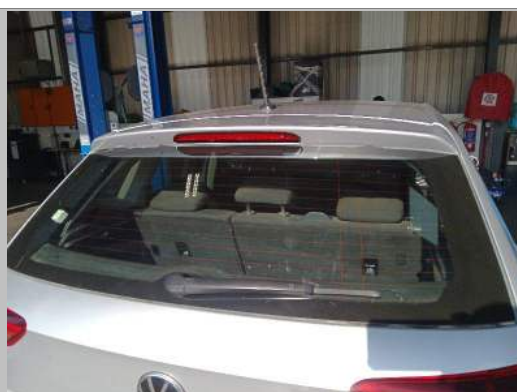
| Damage | Repair Way |
|---|---|
| Back Window Residual Traces of Repair | Repair |

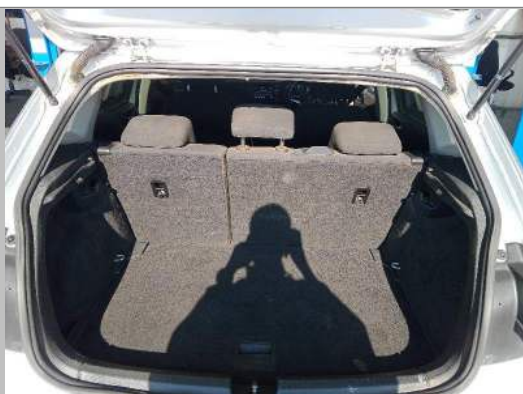
| Damage | Repair Way |
|---|---|
| Parcel Tray Missing | Replace |

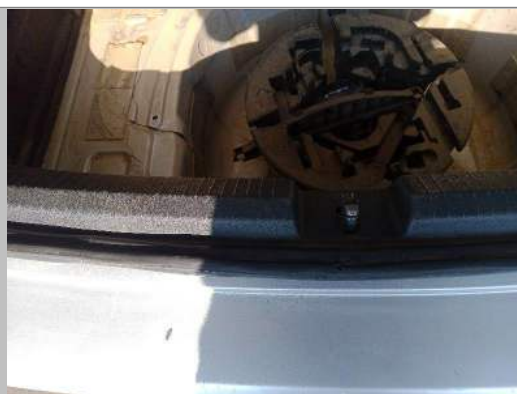
| Damage | Repair Way |
|---|---|
| Boot Lid / Hatch Door Rubbers Damaged | Replace |

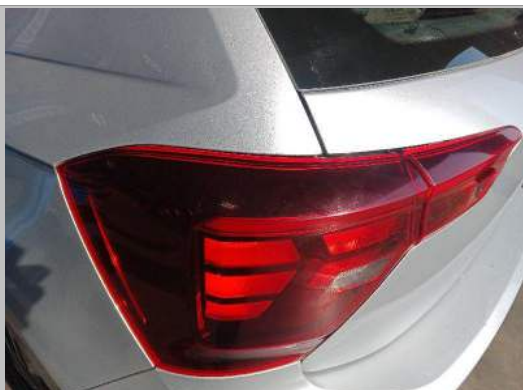
| Damage | Repair Way |
|---|---|
| Tail Light Left Cracked | Replace |

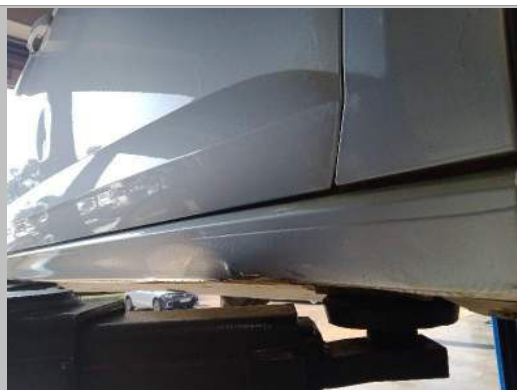
| Damage | Repair Way |
|---|---|
| Sill Panel Right Damaged | Repair |

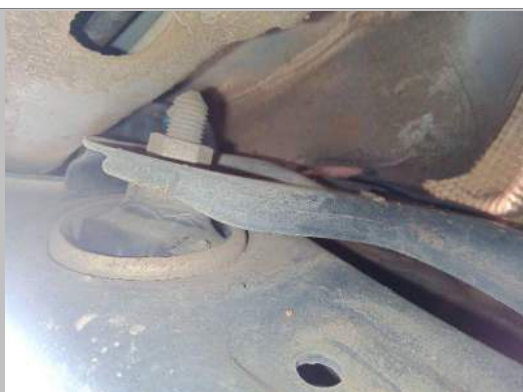
| Damage | Repair Way |
|---|---|
| Control Arm Bush(es) Front Axle Right Cracked | Replace |

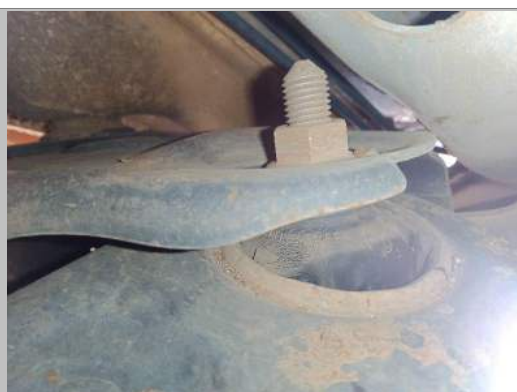
| Damage | Repair Way |
|---|---|
| Control Arm Bush(es) Front Axle Left Cracked | Replace |

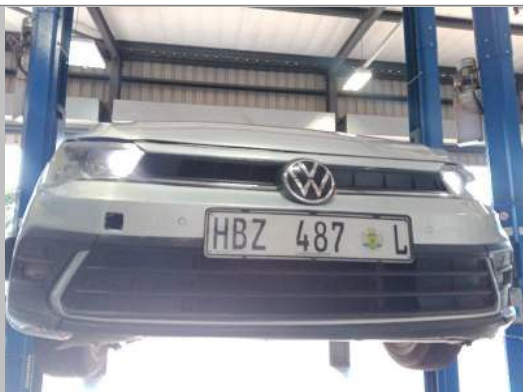
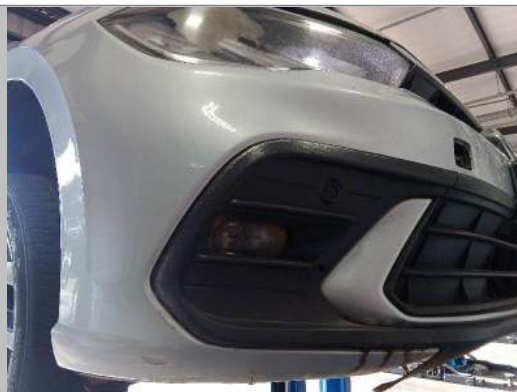
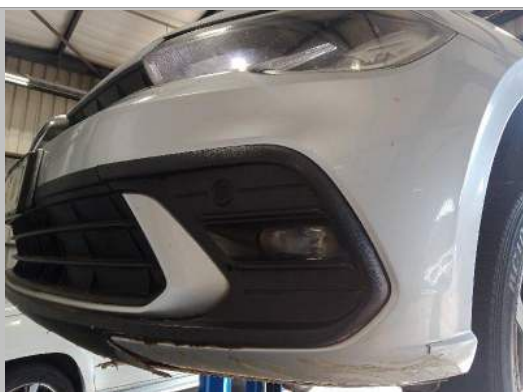
| Damage | Repair Way |
|---|---|
| Front Bumper Damaged | Replace |

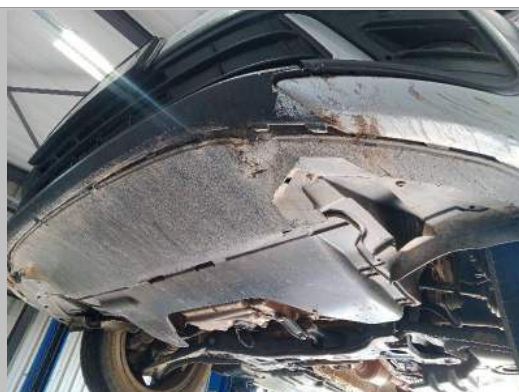
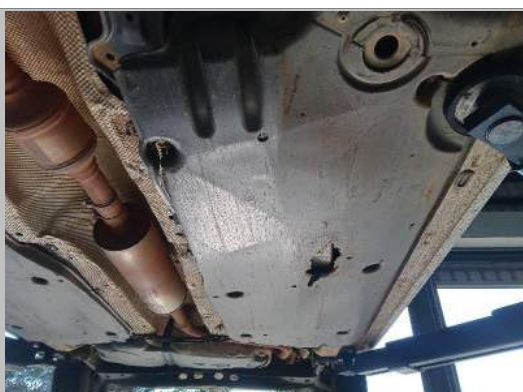
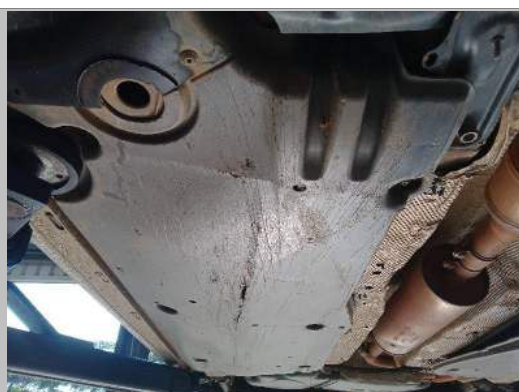
| Damage | Repair Way |
|---|---|
| Belly plates Damaged | Replace |

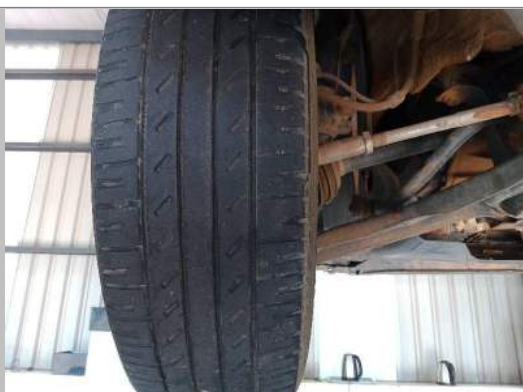
| Damage | Repair Way |
|---|---|
| Tyre Front Left Damaged | Replace |

| | Size | Load/Speed Index | Manufacture | Model | Type* | Production Date | Tread Depth (mm) |
|---|---|---|---|---|---|---|---|
| Front Left | 185/65 R15 | 92T | Sumitomo | Radial | V | 3825 | 0 mm |

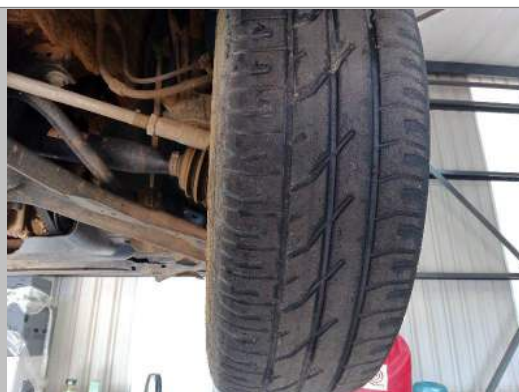
| Damage | Repair Way |
|---|---|
| Tyre Front Right Damaged | Replace |

| | Size | Load/Speed Index | Manufacture | Model | Type* | Production Date | Tread Depth (mm) |
|---|---|---|---|---|---|---|---|
| Front Right | 185/60 R15 | 84H | Continental | Contipremuim | V | 4422 | 0 mm |

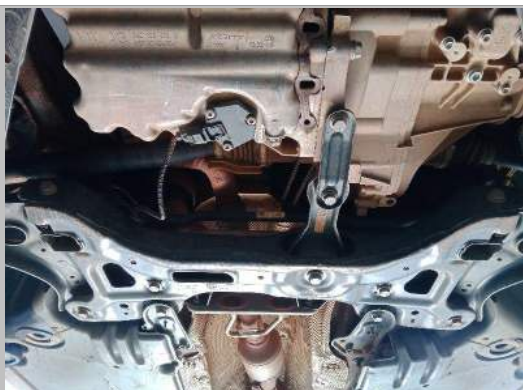
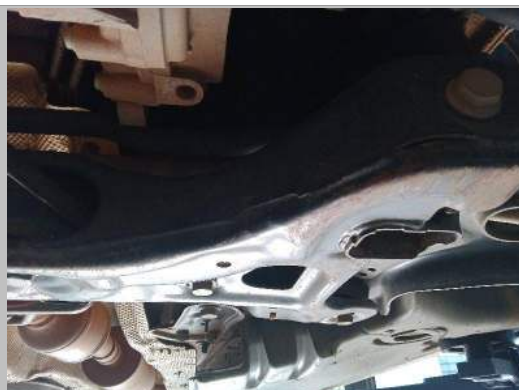
| Damage | Repair Way |
|---|---|
| Sub Frame Damaged | Repair |

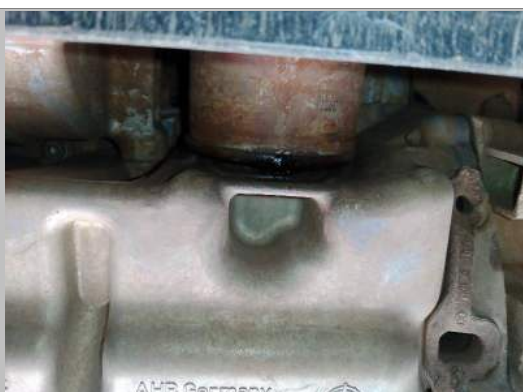
| Damage | Repair Way |
|---|---|
| Engine Oil Sweat | Repair |

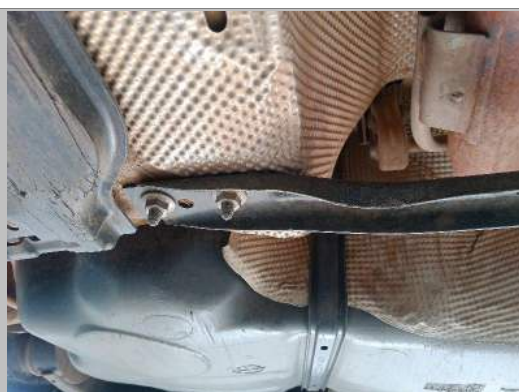
| Damage | Repair Way |
|---|---|
| Cross Member Rear Right Damaged | Repair |

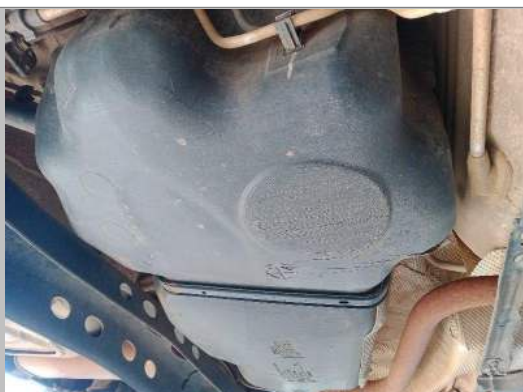
| Damage | Repair Way |
|---|---|
| Fuel Tank Damaged | Repair |

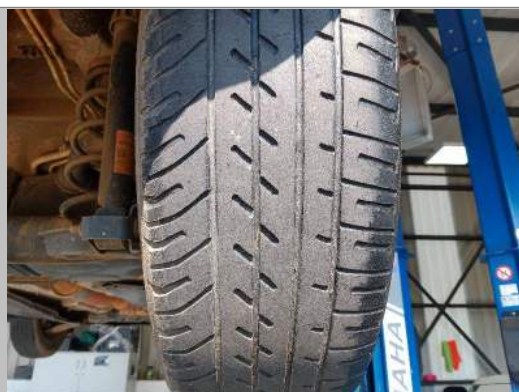
| Damage | Repair Way |
|---|---|
| Tyre Rear Right Damaged | Replace |

| | Size | Load/Speed Index | Manufacture | Model | Type* | Production Date | Tread Depth (mm) |
|---|---|---|---|---|---|---|---|
| Rear Right | 185/65 R15 | 88H | Autogrip | P308 | V | 0125 | 0 mm |

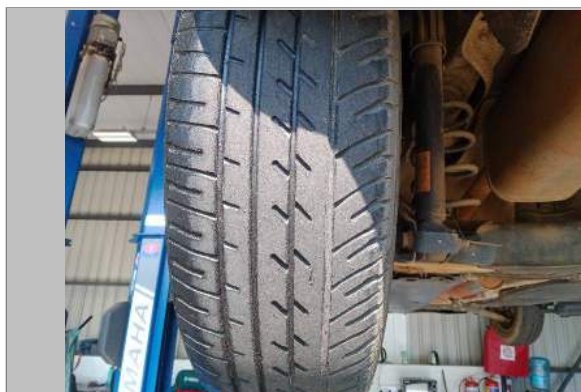
| Damage | Repair Way |
|---|---|
| Tyre Rear Left Damaged | Replace |

| | Size | Load/Speed Index | Manufacture | Model | Type* | Production Date | Tread Depth (mm) |
|---|---|---|---|---|---|---|---|
| Rear Left | 185/65 R15 | 88H | Autogrip | P308 | V | 0125 | 0 mm |

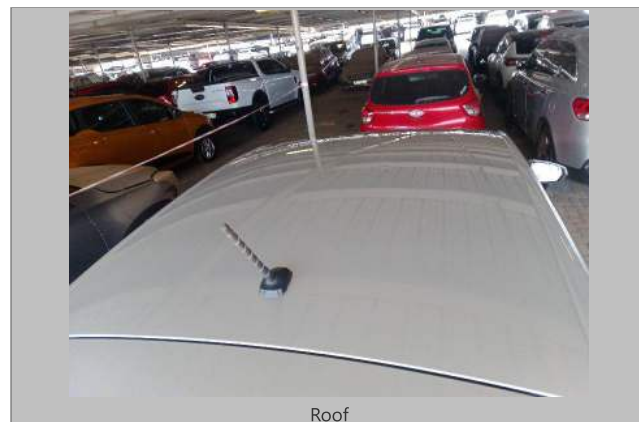
| Damage | Repair Way |
|---|---|
| Roof Dented | Repair |
