## CONDITION REPORT

Report No:  
2017295710  
DATE  
08/09/2026

| Manufacturer | VOLKSWAGEN | Registration Number | HCL866L |
| Model | POLO TSI | Register Number | |

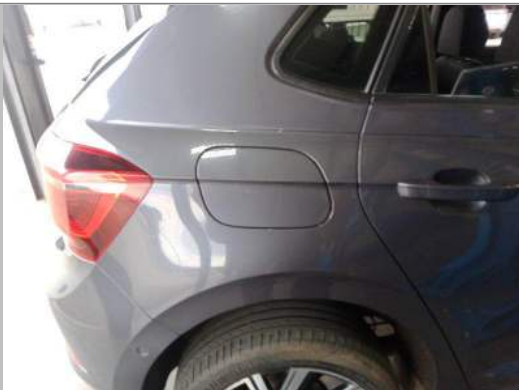
| Rear Fender Right Dented | Repair |

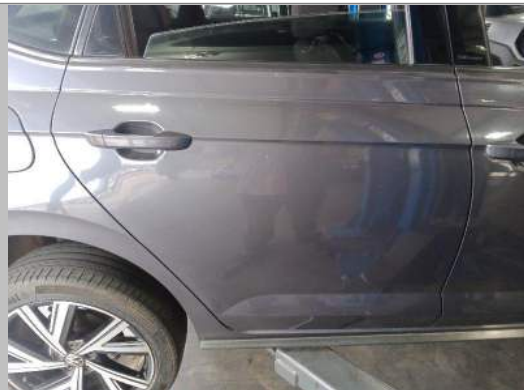
| Door Rear Right Paintwork • Scratched | Repair |

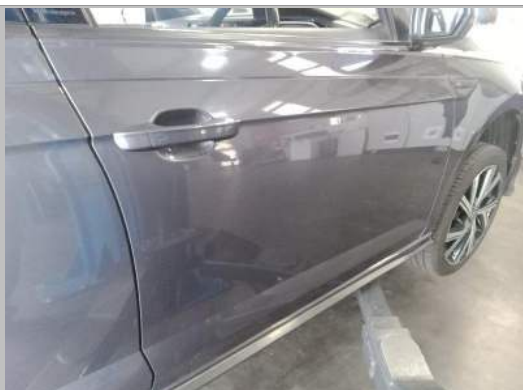
| Door Front Right Paintwork • Scratched | Repair |

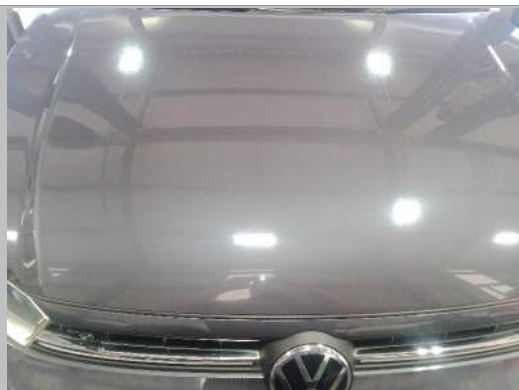
| Bonnet Paintwork • Chipmarks | Repair |

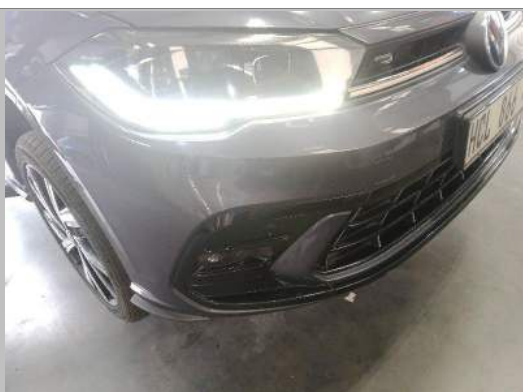
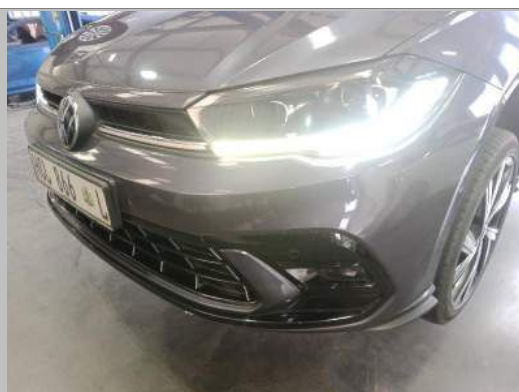
| Front Bumper Paintwork • Scratched | Repair |

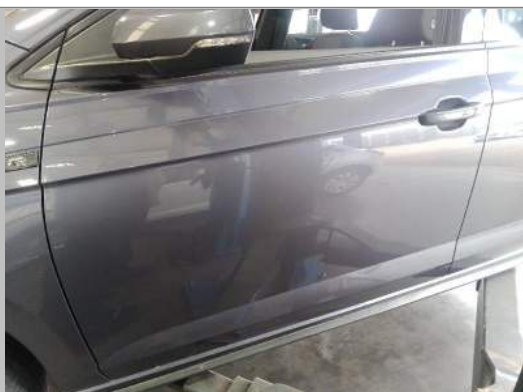
| Door Front Left Paintwork • Scratched | Repair |

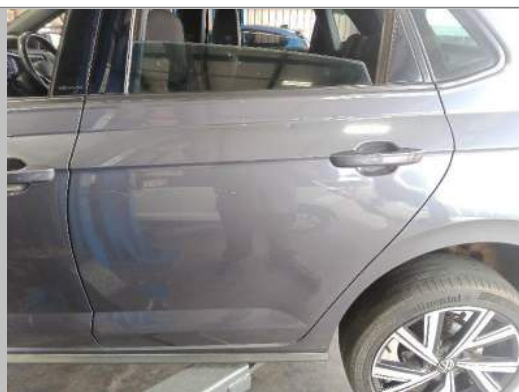
| Door Rear Left Dented | Repair |

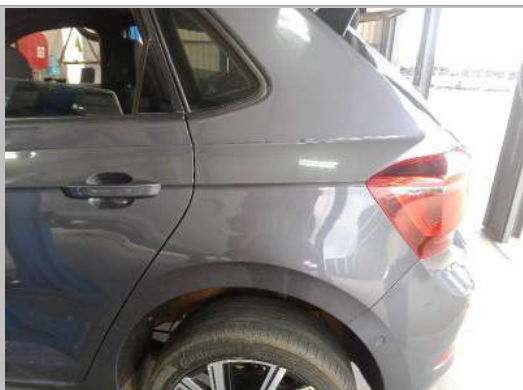
| Rear Fender Left Paintwork • Scratched | Repair |

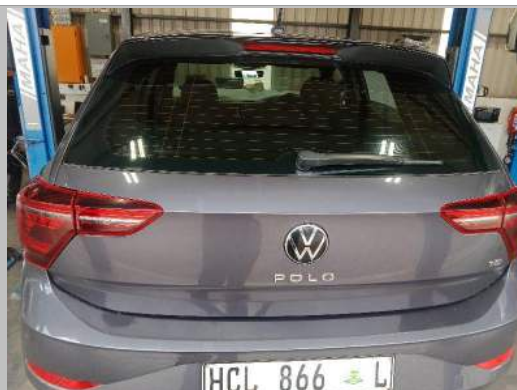
| Boot Lid / Hatch door Paintwork • Scratched | Repair |

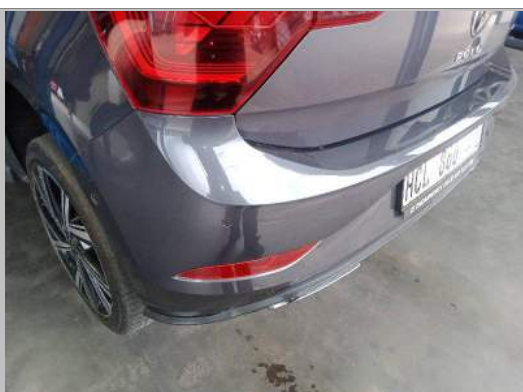
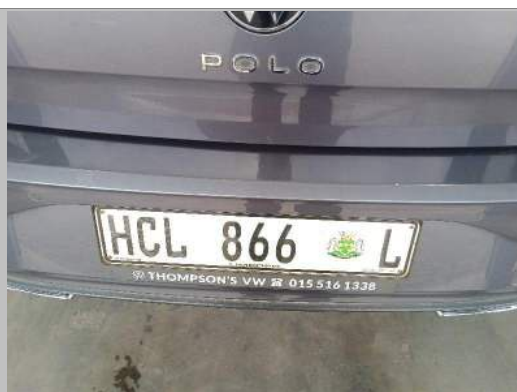
| Rear bumper Paintwork • Scratched | Repair |
