MFC Auction House
M57 Pretoria Rd, Glenmarais, KEMPTON PARK
Gauteng

Vehicle Type	LIGHT LOAD VEHICLE	Registered Owner	
Manufacturer	ISUZU	Registration Number	KBD980MP
Model	D-MAX 250C FLEETSIDE DSL PU [2020-2020]	Register Number	
VIN	ACVMRRAR1J4045222	Date Of First Licensing	
Engine Number		Last COR	
Doors	2	License Expiry Date	
Color	WHITE	Power / Displacement	
Year Model	2020	Paint Finish	TWO COAT UNI
Km Reading	187,322 KM	Fuel	DIESEL
Cab / Body Type	SINGLE CAB	Transmission	MANUAL

CONDITION REPORT

Report No:
2016918298
DATE
19/06/2025

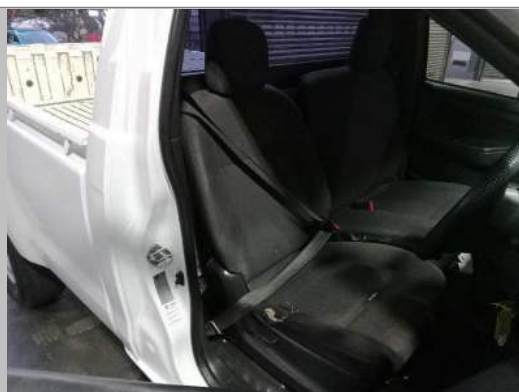
Damage	Repair Way
Engine Oil Leak	Repair
Engine Wiring Defective	Repair
Seat Front Right Damaged	Repair
Hood Lining Damaged	Repair
Front Bumper Damaged	Repair
Grill Broken	Repair
Bonnet Damaged	Repair
Bonnet slam plate (Shock tower/ Inner tray) Damaged	
Front Fender Left Residual Traces of Repair	Repair
Front Fender Right Residual Traces of Repair	Repair
Rear Fender Left Damaged	Repair
Rear Fender Right Dented	Repair
Rear Fender Left / Inner Tray Damaged	Repair
Door Front Left Dented	Repair
Door Front Right Dented	Repair
Weather Strip Door Front Right Damaged	Replace
Tailgate Damaged	Repair
Sill Panel Left Paintwork • Scratched	Repair
Roof Dented	Repair
Load Body Damaged	Repair
Windscreen Chipped	Repair
Service Brake Performance Rear Axle Left / Right	
Difference out of legal range	Repair
Parking Brake Performance Left / Right Difference out of legal range	Repair
Spring Rear Left Defective	Repair
Spring Rear Right Defective	Repair

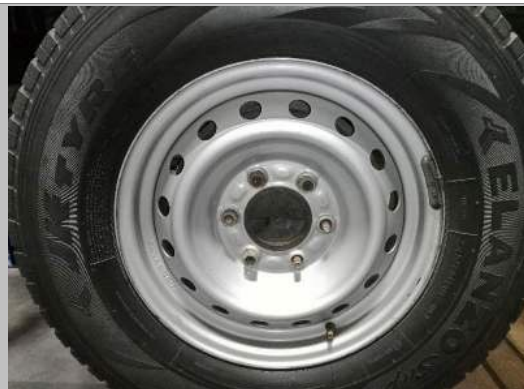
Stabilizer Mounting Front Right Damaged	Replace
Spare Tyre Worn	Replace
Bolt(s) / Nut(s) Rear Wheel Left Missing	Replace
Chassis Welded	Repair
Belly plates Damaged	Repair
Gearbox Oil Sweat	Repair
Center Prop Shaft Rubber(s) Cracked	Replace
Radiator Cradle Damaged	Repair
Brakes Noisy	Repair
Engine Performance Idling / Hunting	Repair
Jack Missing	Replace
Wheel Spanner Missing	Replace
Triangle Missing	Replace
Electrical instruments and components	Cluster misaligned
Undercarriage	Vehicle undercarriage dirty
Brakes	Rear left handbrake cable damaged
Undercarriage	Vehicle undercarriage dirty
Interior	Vehicle interior dirty and some panels scratched
Body and Exterior	Poor residual traces of repair on some body panels
Body and Exterior	Stone chips and spray work on some body panels
Body and Exterior	Dents and scratches on some body panels
Body and Exterior	Signs of impact damage to front of vehicle
Electrical instruments and components	Starter motor faulty
