## CONDITION REPORT

Report No:  
2016959196  
DATE  
26/07/2025

| Manufacturer | ISUZU | Registration Number | DXX836L |
| Model | KB250 HO HR D-CAB DSL PU [2016-2018] | Register Number | |

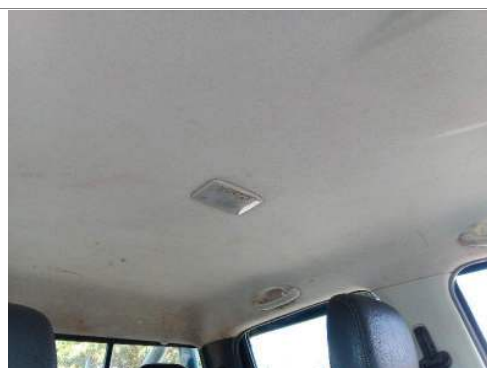
| Damage | Repair Way |
|---|---|
| Hood Lining Dirty | Repair |

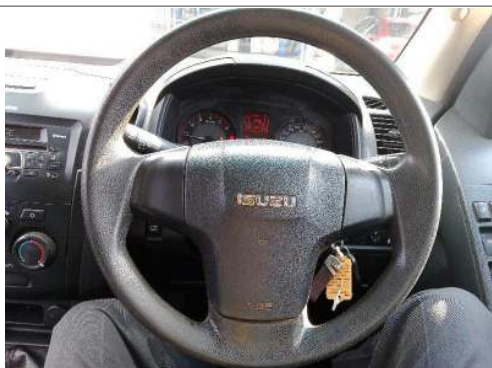
| Damage | Repair Way |
|---|---|
| Steering Wheel Trim Defective | Repair |

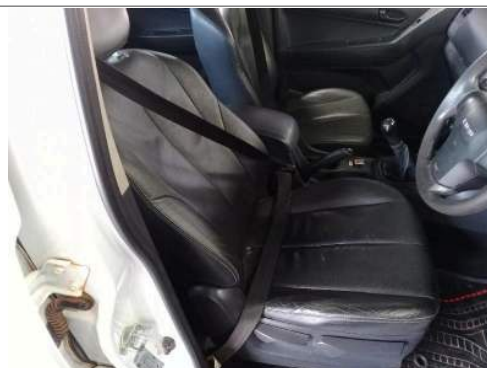
| Damage | Repair Way |
|---|---|
| Seat Front Right Defective | Repair |

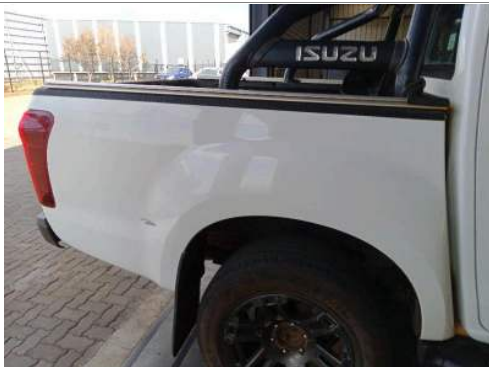
| Damage | Repair Way |
|---|---|
| Rear Fender Right Damaged | Repair |

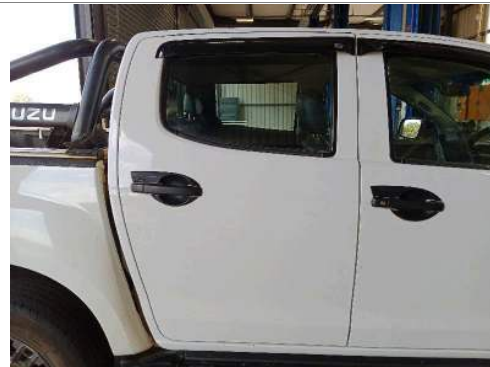
| Damage | Repair Way |
|---|---|
| Door Rear Right Paintwork • Scratched | Repair |

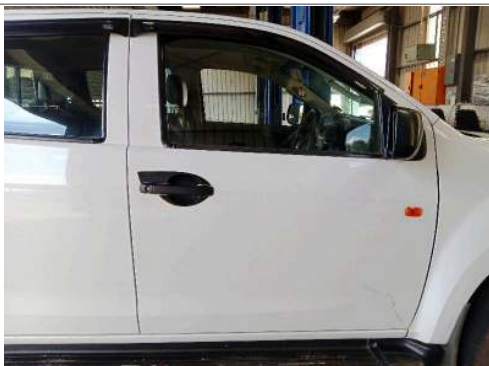
| Damage | Repair Way |
|---|---|
| Door Front Right Paintwork • Scratched | Repair |

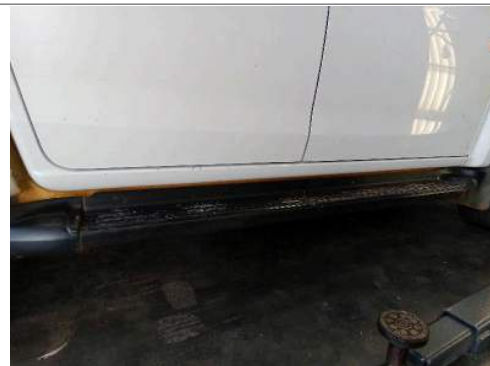
| Damage | Repair Way |
|---|---|
| Rocker Panel Right Paintwork • Scratched | Repair |

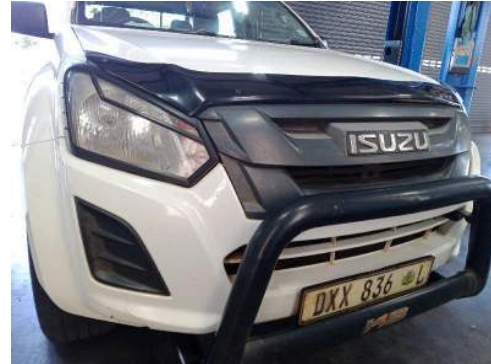
| Damage | Repair Way |
|---|---|
| Front Bumper Damaged | Repair |

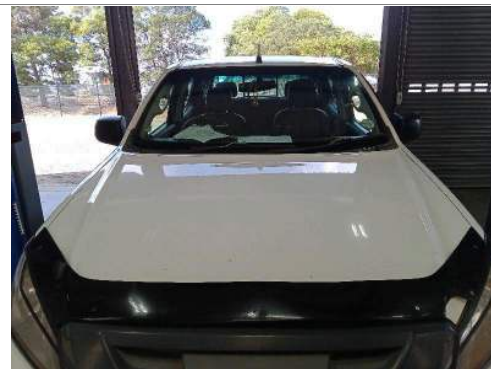
| Damage | Repair Way |
|---|---|
| Bonnet Damaged | Repair |

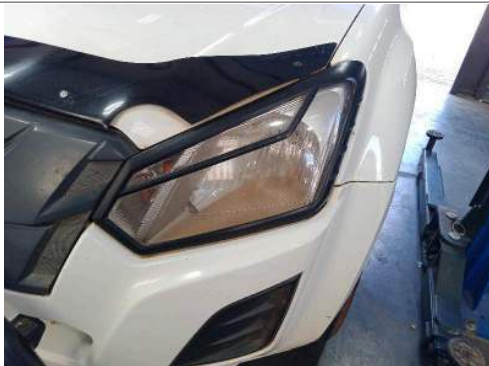
| Damage | Repair Way |
|---|---|
| Headlight Left Defective | Replace |

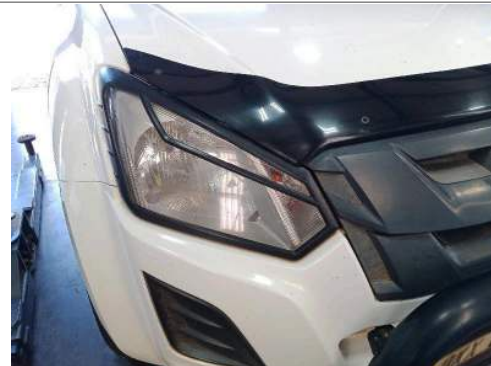
| Damage | Repair Way |
|---|---|
| Headlight Right Defective | Repair |

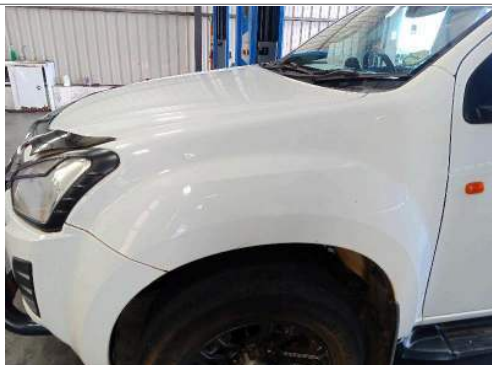
| Damage | Repair Way |
|---|---|
| Front Fender Left Damaged | Repair |

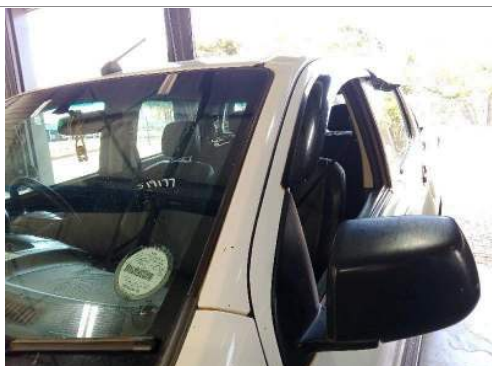
| Damage | Repair Way |
|---|---|
| A • Pillar Left Paintwork • Scratched | Repair |

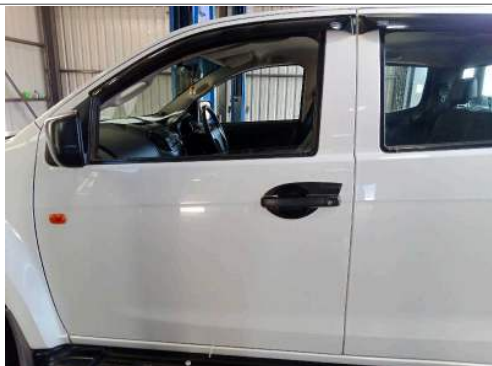
| Damage | Repair Way |
|---|---|
| Door Front Left Damaged | Repair |

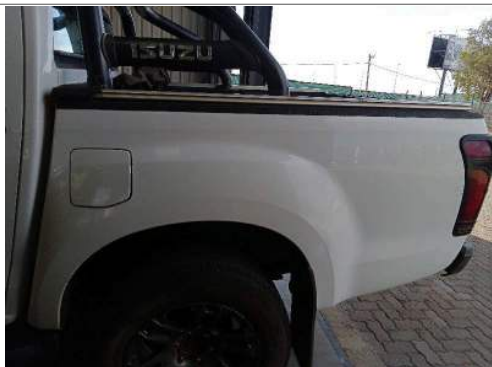
| Damage | Repair Way |
|---|---|
| Rear Fender Left Damaged | Repair |

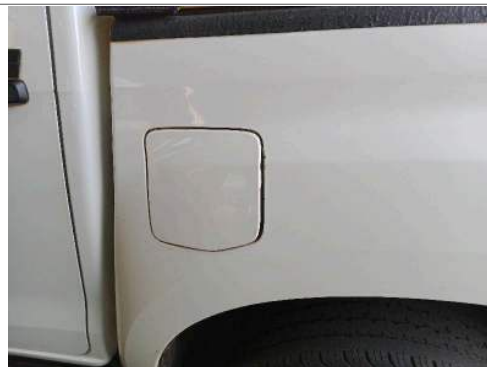
| Damage | Repair Way |
|---|---|
| Fuel Flap Defective | Repair |

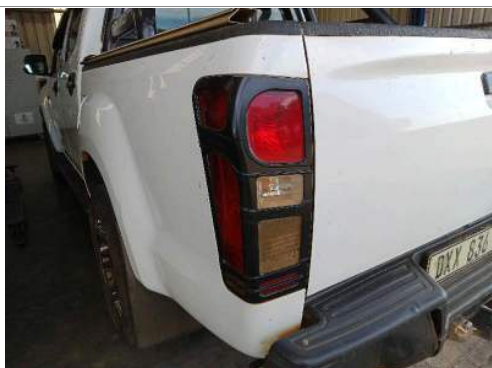
| Damage | Repair Way |
|---|---|
| Tail Light Left Damaged | Replace |

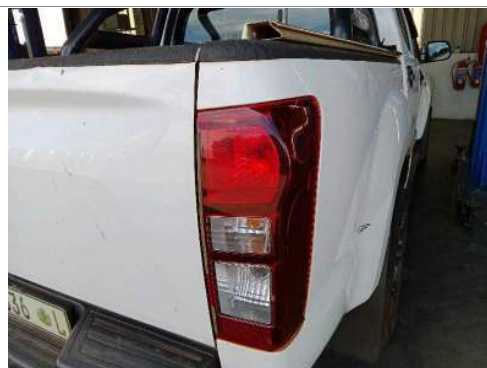
| Damage | Repair Way |
|---|---|
| Tail Light Right Damaged | Replace |

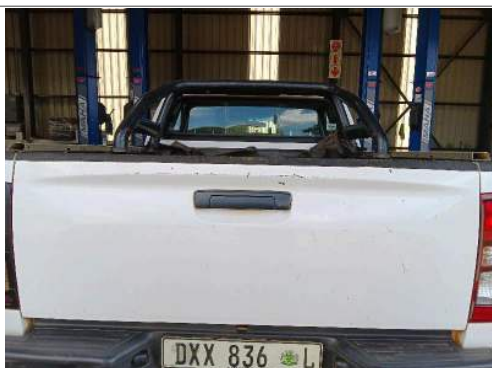
| Damage | Repair Way |
|---|---|
| Tailgate Damaged | Repair |

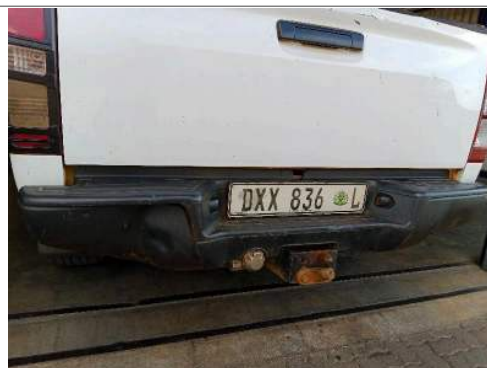
| Damage | Repair Way |
|---|---|
| Rear bumper Damaged | Repair |

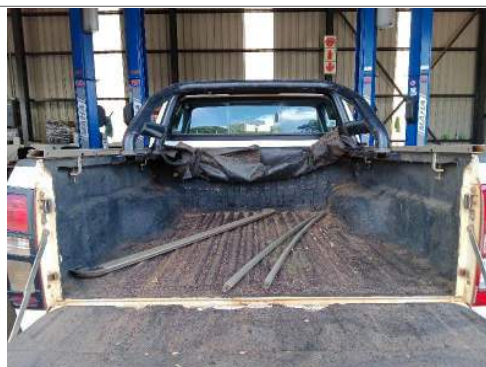
| Damage | Repair Way |
|---|---|
| Load Body Dented | Repair |

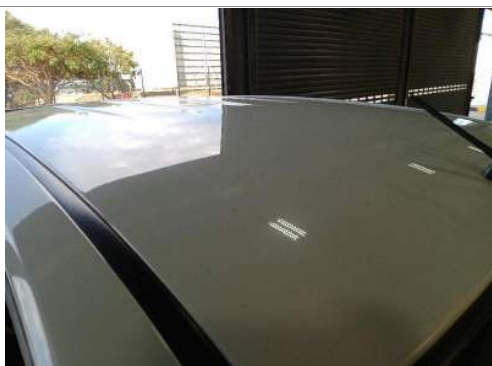
| Damage | Repair Way |
|---|---|
| Roof Paintwork • Scratched | Repair |

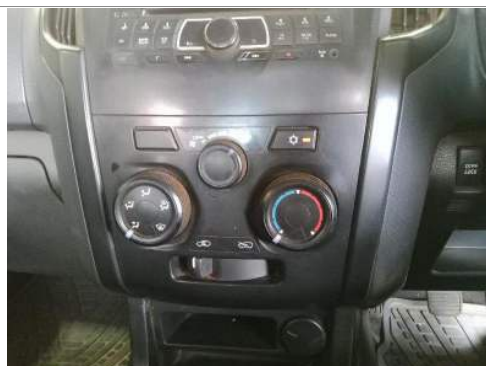
| Damage | Repair Way |
|---|---|
| Air Conditioner Insufficient | Replace |

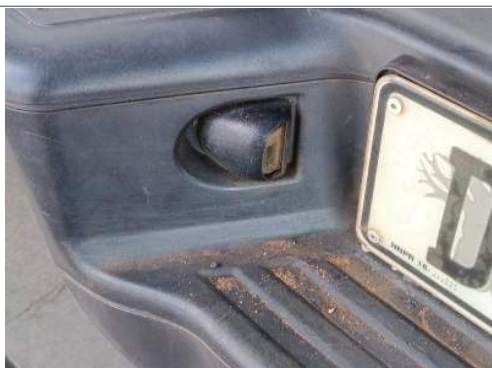
| Damage | Repair Way |
|---|---|
| Number Plate Light Left Defective | Repair |

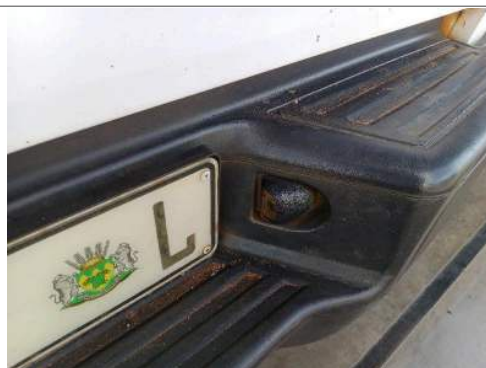
| Damage | Repair Way |
|---|---|
| Number Plate Light Right Defective | Repair |

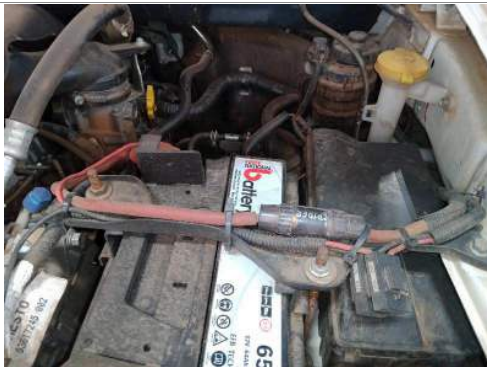
| Damage | Repair Way |
|---|---|
| Engine Wiring Defective | Repair |

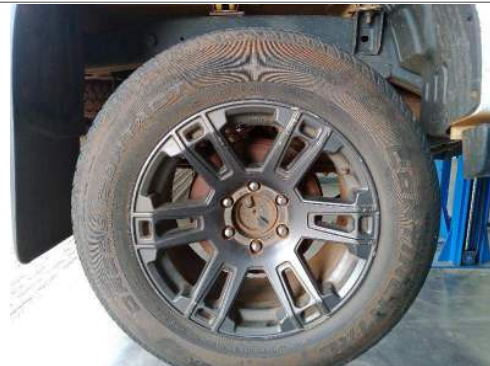
| Damage | Repair Way |
|---|---|
| Rim Rear Right Scratched | Repair |

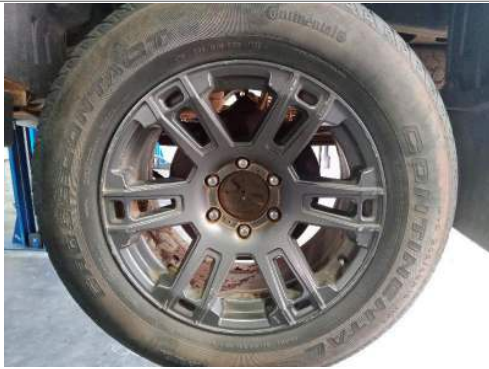
| Damage | Repair Way |
|---|---|
| Rim Rear Left Scratched | Repair |

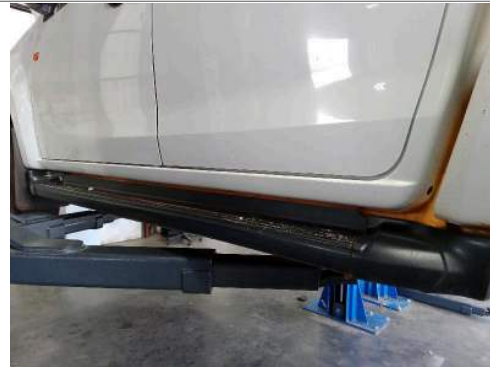
| Damage | Repair Way |
|---|---|
| Rocker Panel Left Paintwork • Scratched | Repair |

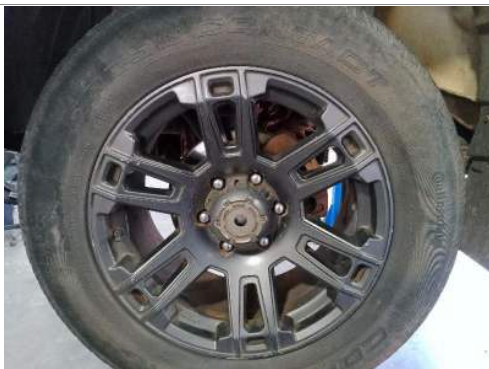
| Damage | Repair Way |
|---|---|
| Rim Front Left Scratched | Repair |

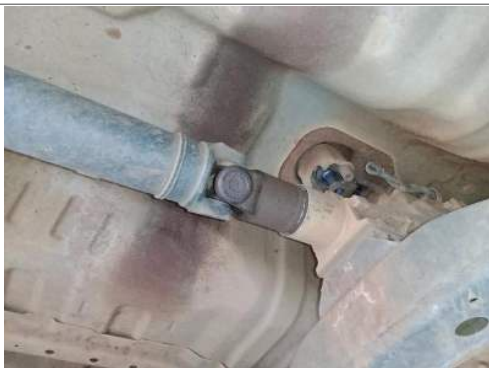
| Damage | Repair Way |
|---|---|
| Gearbox Oil Sweat | Repair |

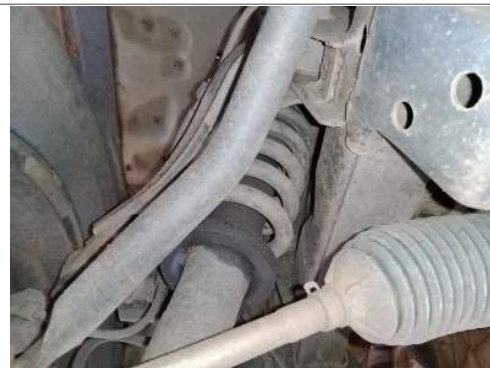
| Damage | Repair Way |
|---|---|
| Shock Absorber Front Right Leak | Replace |

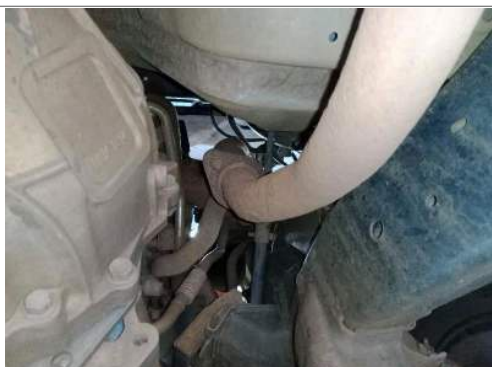
| Damage | Repair Way |
|---|---|
| Catalytic converter Missing | Replace |

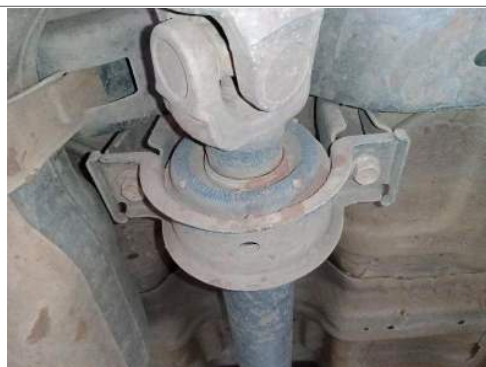
| Damage | Repair Way |
|---|---|
| Center Prop Shaft Rubber(s) Cracked | Replace |

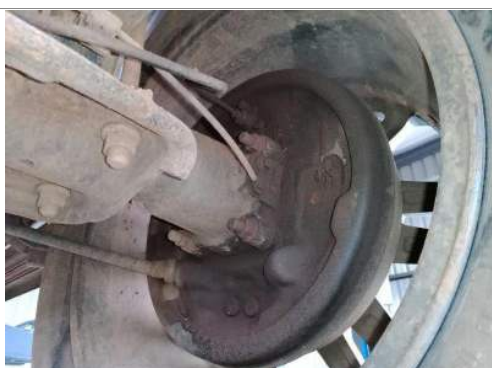
| Damage | Repair Way |
|---|---|
| Differential Oil Sweat | Repair |

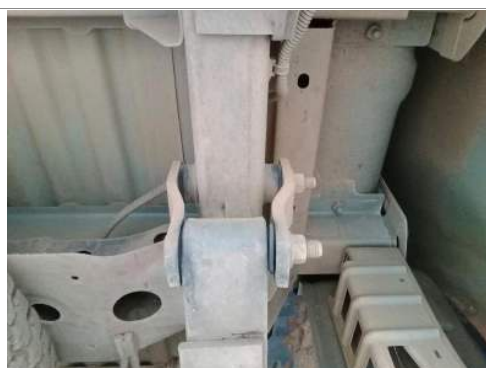
| Damage | Repair Way |
|---|---|
| Mounting Rubber(s) Rear Axle Right Damaged | Replace |

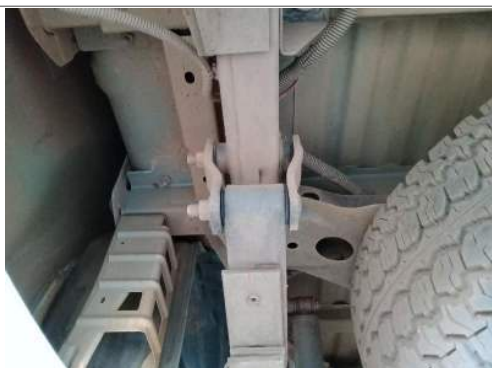
| Damage | Repair Way |
|---|---|
| Mounting Rubber(s) Rear Axle Left Damaged | Replace |

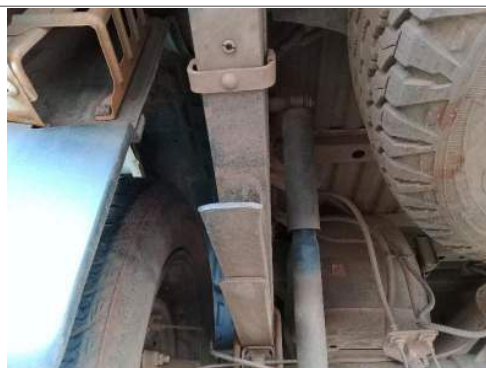
| Damage | Repair Way |
|---|---|
| Spring Rear Left Defective | Repair |

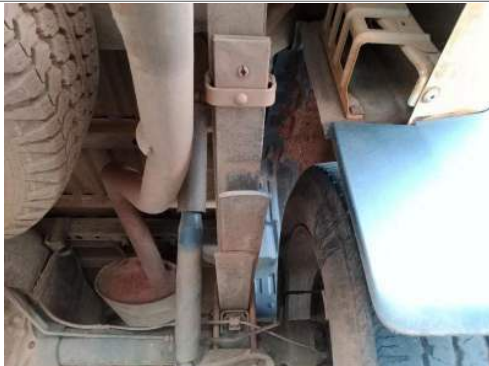
| Damage | Repair Way |
|---|---|
| Spring Rear Right Defective | Repair |

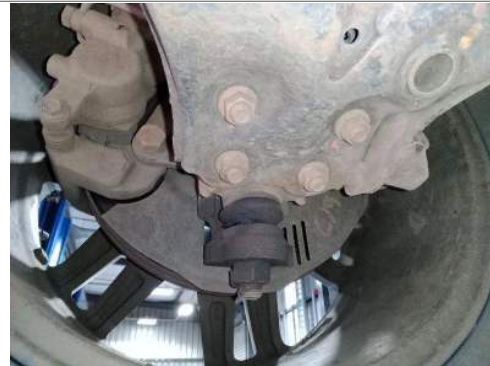
| Damage | Repair Way |
|---|---|
| Ball Joint(s) Front Axle Left Defective | Replace |

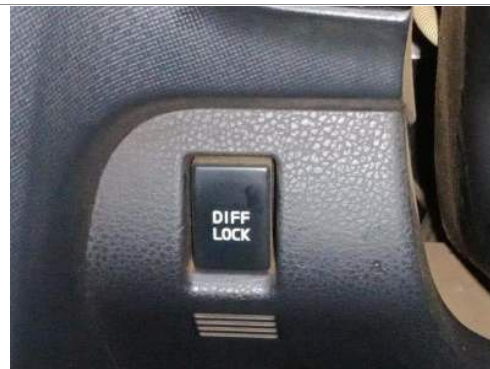
| Damage | Repair Way |
|---|---|
| 4x4 Differential Lock Insufficient | Repair |

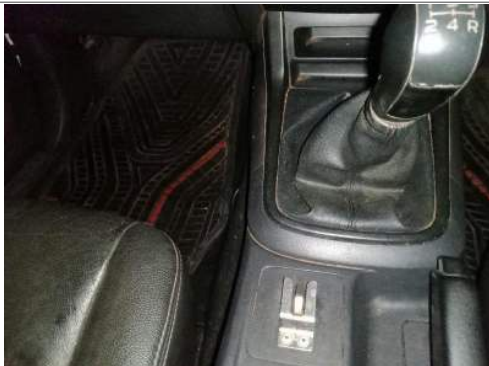
| Damage | Repair Way |
|---|---|
| Center Console / Cubbyhole + Lid Damaged | Repair |
