CONDITION REPORT

Report No:
2016919282
DATE
20/06/2025

Vehicle Type	LIGHT LOAD VEHICLE	Registered Owner	MFC AUCTION HOUSE
Manufacturer	ISUZU	Registration Number	FVM476L
Model	D-MAX 1.9 DDI HR L D-CAB DSL PU [2022-2023]	Register Number	
		Date Of First Licensing	
VIN	ACVTFR87JMD096494	Last COR	
Engine Number		License Expiry Date	31/07/2025
Doors	4	Power / Displacement	
Color	GREY	Paint Finish	TWO COAT METALLIC
Year Model	2022	Fuel	DIESEL
Km Reading	115,015 KM	Transmission	MANUAL
Cab / Body Type	DOUBLE CAB

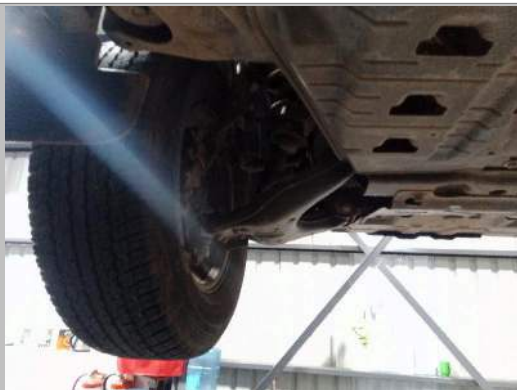
LF TYRE TREAD

Size	Load/Speed Index	Manufacture	Model	Type*	Production Date	Tread Depth (mm)
Front Left	255/65R17	110H	Dunlop	Grandtrek	V	0322	1 mm
Front Right	255/65R17	110H	Dunlop	Grandtrek	V	4721	0 mm
Rear Left	255/65R17	110H	Dunlop	Grandtrek	V	4821	1 mm
Rear Right	255/65R17	110H	Dunlop	Grandtrek	V	4022	1 mm

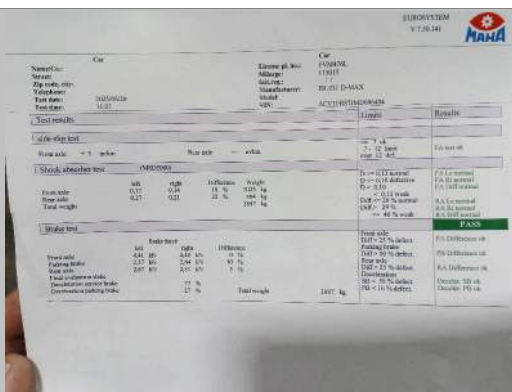
BRAKE REPORT

Left	Right		
	Braking Force [KN]	Braking Force [KN]	Axle Weight [KG]	Deceleration [m/s ²]
Front	4.41	4.4	-	
Rear	2.67	2.81	-	
Emergency / Parking	2.37	2.64	-

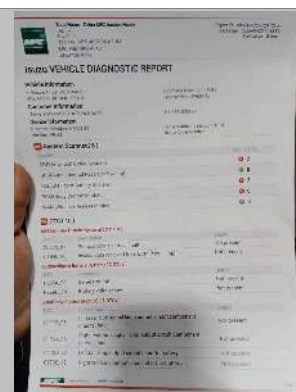
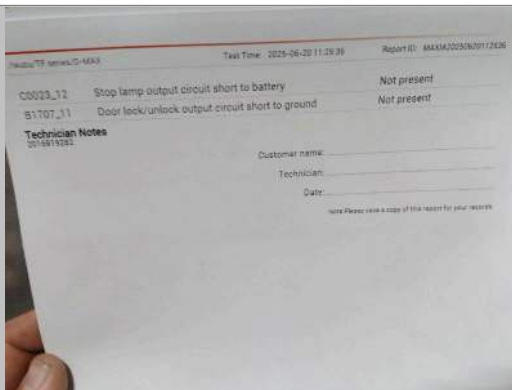
No	System	Code	Description	Status
1	ANTI LOCK BRAKE SYSTEM	C0020_01	PUMP MOTOR ELECTRICAL FAULT

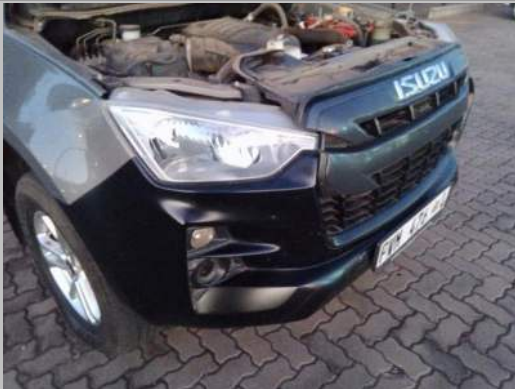
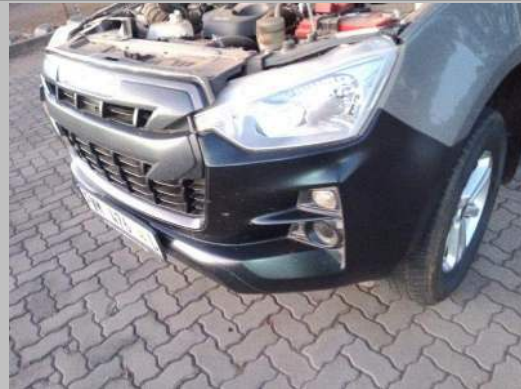
Damage	Repair Way
Seat Front Right Damaged	Repair
Front Bumper Damaged	Repair
Rear Fender Left Damaged	Repair
Rear Fender Right Damaged	Repair
Door Front Left Damaged	Repair
Door Rear Left Damaged	Repair
Door Rear Right Damaged	Repair
Tailgate Damaged	Repair
Rear bumper Damaged	Repair
Tyre Front Right Worn	Replace
