CONDITION REPORT

Report No:
2016993104
DATE
27/08/2025

Vehicle Type	LIGHT LOAD VEHICLE	Registered Owner	MFC
Manufacturer	CHEVROLET	Registration Number	FY78MDGP
Model	UTILITY 1.4 UTEFORCE EDITION PU [2014-2017]	Register Number	
VIN	ADMCF4MR0J4813797	Date Of First Licensing	
Engine Number		Last COR	
Doors	2	License Expiry Date	31/07/2025
Color	SILVER	Power / Displacement	
Year Model	2017	Paint Finish	TWO COAT METALLIC
Km Reading	43,400 KM	Fuel	PETROL
Cab / Body Type	SINGLE CAB	Transmission	MANUAL

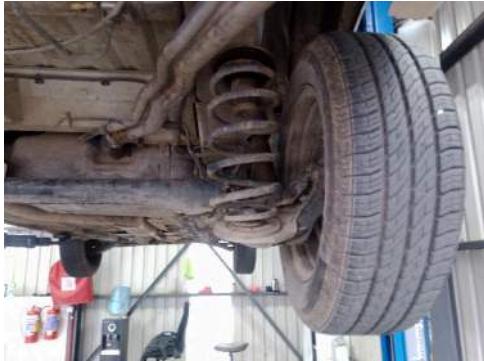
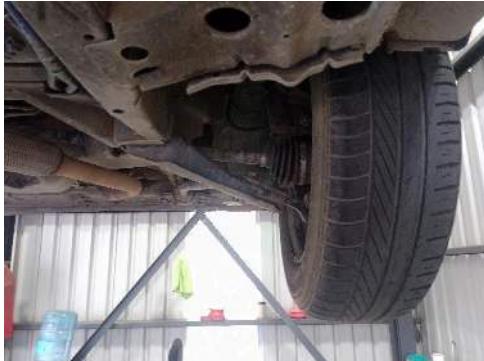
Size	Load/Speed Index	Manufacture	Model	Type*	Production Date	Tread Depth (mm)
Front Left	185/65R14	86H	Goodyear	Duragrip	V	0713	2 mm
Front Right	185/65R14	86H	Goodyear	Duragrip	V	0713	1 mm
Rear Left	185/60R14	82H	Continental	Contieco	V	4206	3 mm
Rear Right	185/60R14	82H	Continental	Contieco	V	0921	3 mm

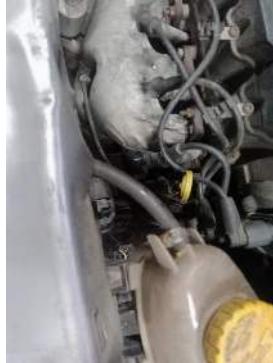
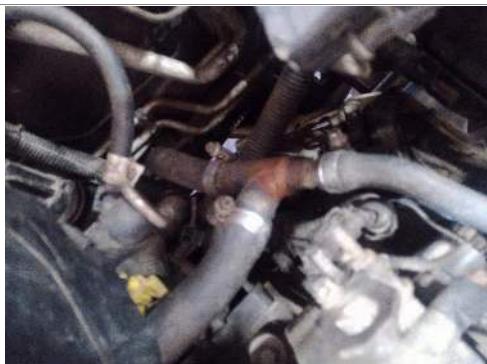
Damage	Repair Way
Engine Wiring Damaged	Repair
Hoses Damaged	Replace
Radio/CD/USB Damaged	Replace
Center Console / Cubbyhole + Lid Damaged	Replace
Engine Management Lights Set	Repair
Tail Light Left Damaged	Replace
Tail Light Right Damaged	Replace
Headlight Left Damaged	Repair
Headlight Right Damaged	Replace
Front Bumper Damaged	Repair
Bonnet Damaged	Repair
Bonnet slam plate (Shock tower/ Inner tray) Damaged	Repair
A • Pillar Left Damaged	Repair
A • Pillar Right Damaged	Repair
B • Pillar Left Damaged	Replace
B • Pillar Right Damaged	Replace
Front Fender Left Damaged	Repair
Front Fender Right Damaged	Repair
Rear Fender Left Damaged	Repair
Rear Fender Right Damaged	Repair
Front Fender Left / Inner Tray Damaged	Repair
Front Fender Right / Inner Tray Damaged	Repair
Door Front Left Damaged	Repair
Door Front Right Damaged	Repair
Sealing / Rubber Front Door Right Damaged	Repair
Tailgate Damaged	Repair
Rear bumper Damaged	Repair

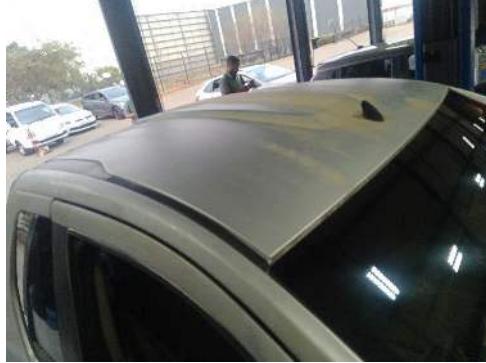
Sill Panel Right Damaged	Repair
Roof Damaged	Repair
Chassis Welded	Repair

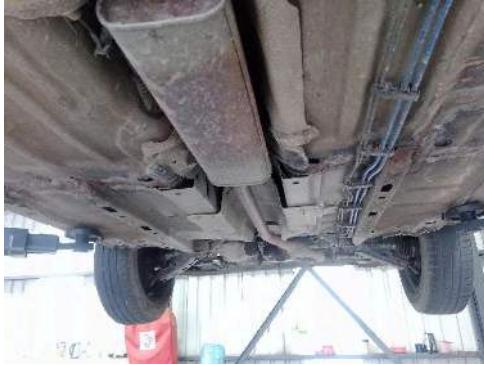
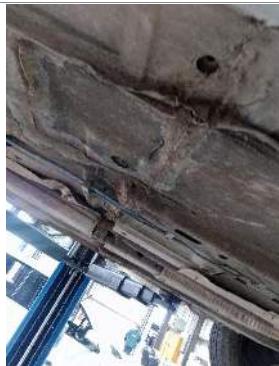
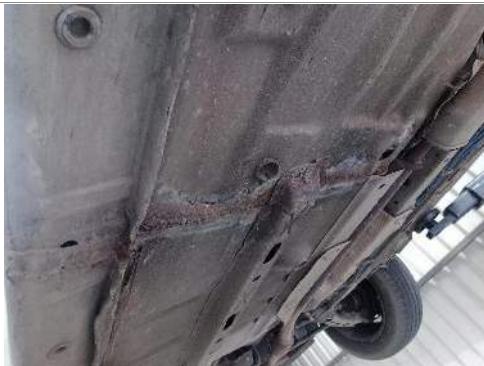
Chassis

Body • Exterior: Minor dents and scratches and stone chips to some body panels. Signs of repair work done to somebody panels. Poor alignment to somebody panels. Repair work done to vehicle below standard. Vehicle body in poor condition. Vehicle is a cut and join.

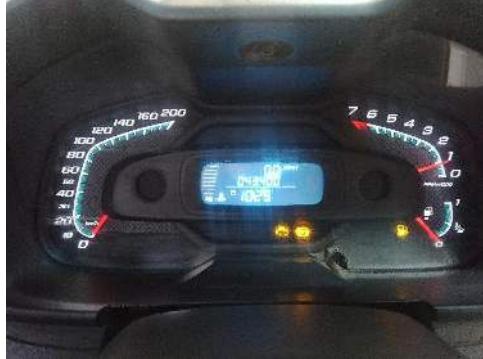
Engine Management Lights

No	System	Code	Description	Status
1	ENGINE CONTROL MODULE	P0335:00	CAMSHAFT POSITION SENSOR CIRCUIT
