## CONDITION REPORT

Report No:  
2016927175  
DATE  
27/06/2025

| Manufacturer | CHEVROLET | Registration Number | NO REG |
| Model | UTILITY 1.8 SPORT PU [2011-2017] | Register Number | |

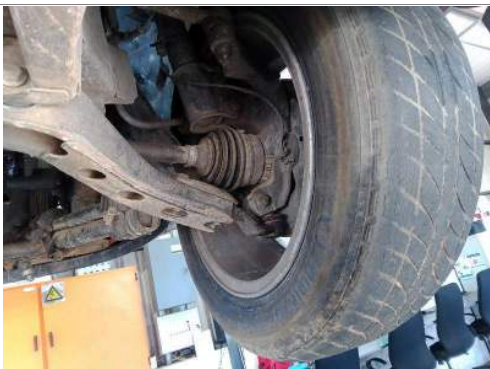
RF TYRE TREAD

| | Size | Load/Speed Index | Manufacture | Model | Type* | Production Date | Tread Depth (mm) |
|---|---|---|---|---|---|---|---|
| Front Right | 185/65R15 | 88H | Symmetry | SY101 | V | 0000 | 0 mm |

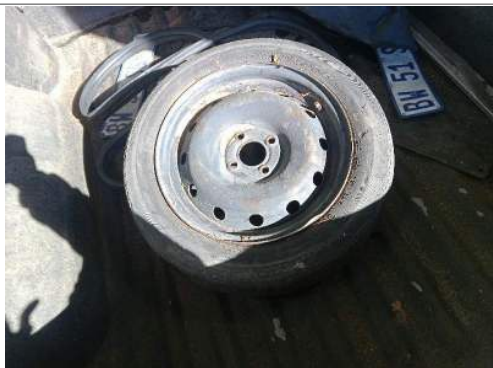
Sparewheel

| | Size | Load/Speed Index | Manufacture | Model | Type* | Production Date | Tread Depth (mm) |
|---|---|---|---|---|---|---|---|
| Spare | 185/60R15 | 84H | Bridgestone | Ecopia | V | 0000 | 0 mm |

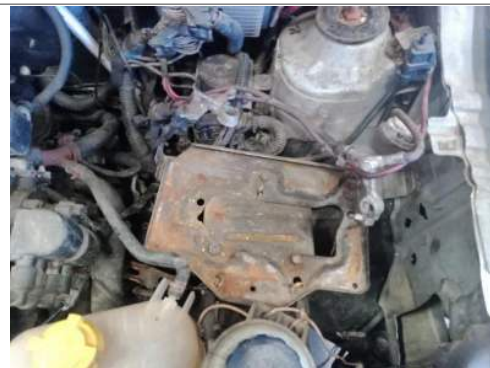
| Damage | Repair Way |
|---|---|
| No battery | Replace |

No battery

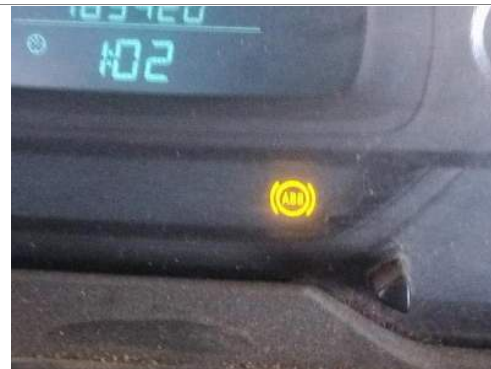
| Damage | Repair Way |
|---|---|
| ABS warning lights illuminated | Repair |

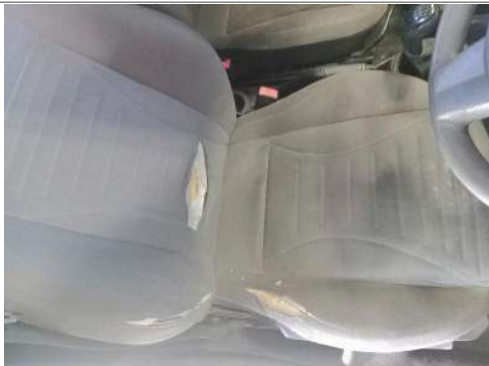
| Damage | Repair Way |
|---|---|
| Seat Front Right Torn / Cut | Repair |

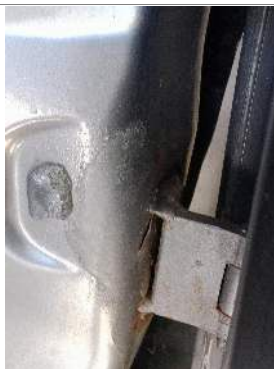
| Damage | Repair Way |
|---|---|
| A • Pillar Right Welded | Repair |

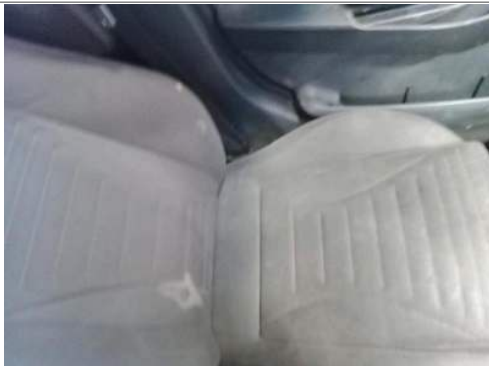
| Damage | Repair Way |
|---|---|
| Seat Front Left Torn / Cut | Repair |

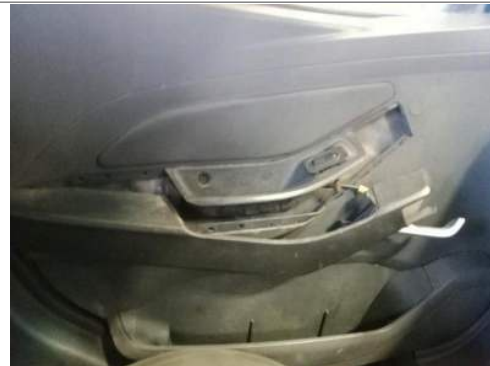
| Damage | Repair Way |
|---|---|
| Door Panel Front Left Damaged | Repair |

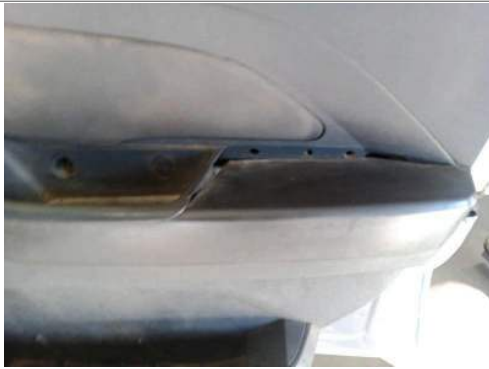
| Damage | Repair Way |
|---|---|
| Door Panel Front Right Damaged | Repair |

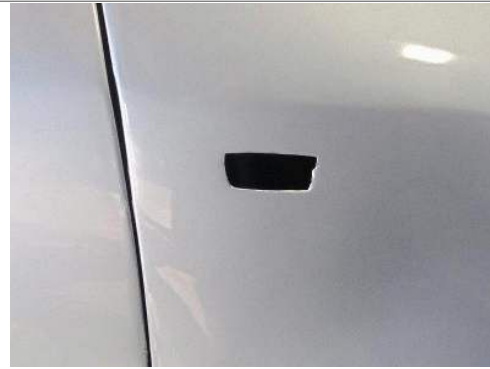
| Damage | Repair Way |
|---|---|
| Indicator Light Front Right Missing | Replace |

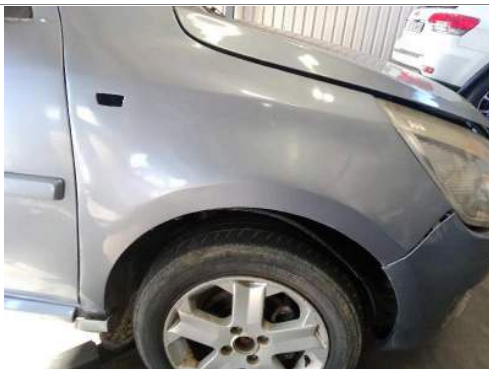
| Damage | Repair Way |
|---|---|
| Front Fender Right Residual Traces of Repair | Repair |

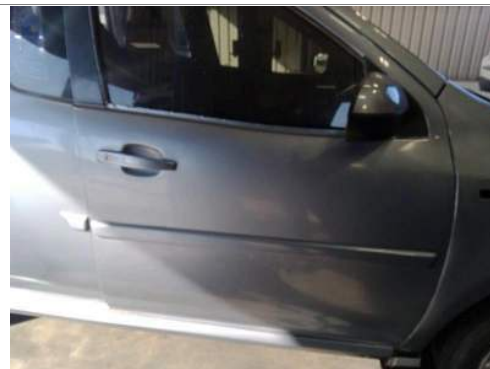
| Damage | Repair Way |
|---|---|
| Door Front Right Residual Traces of Repair | Repair |

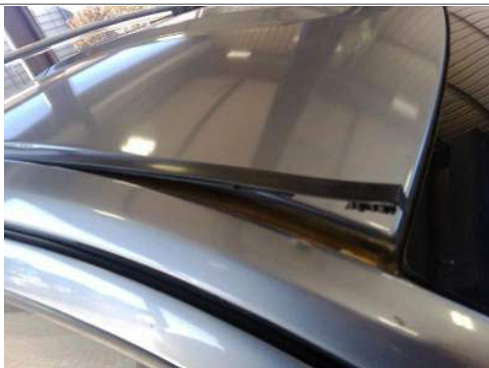
| Damage | Repair Way |
|---|---|
| Channel / Roof Gutter Right Damaged | Repair |

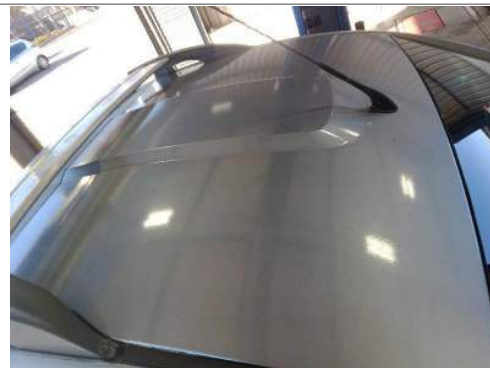
| Damage | Repair Way |
|---|---|
| Roof Residual Traces of Repair | Repair |

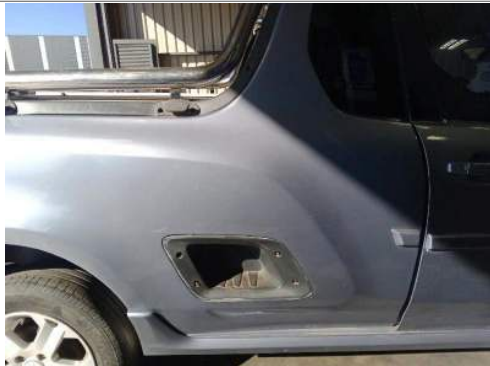
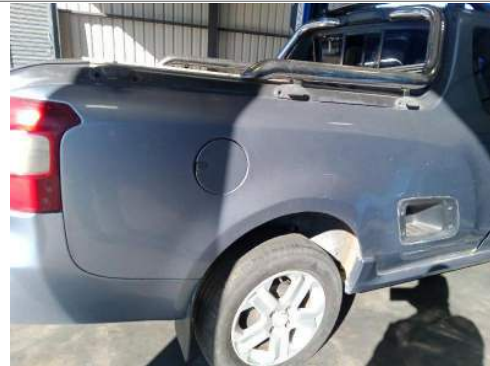
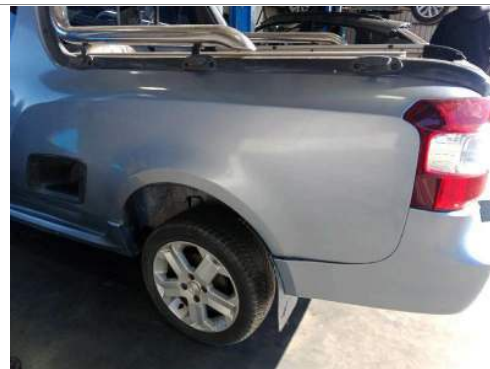
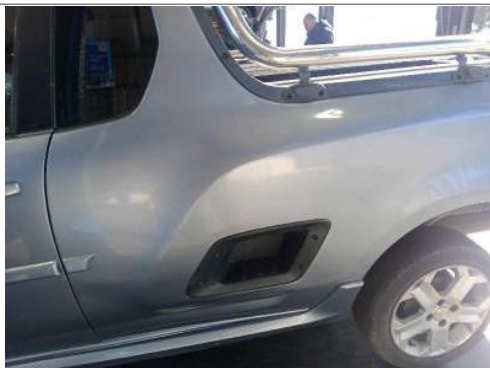
| Damage | Repair Way |
|---|---|
| Load Body Residual Traces of Repair | Repair |

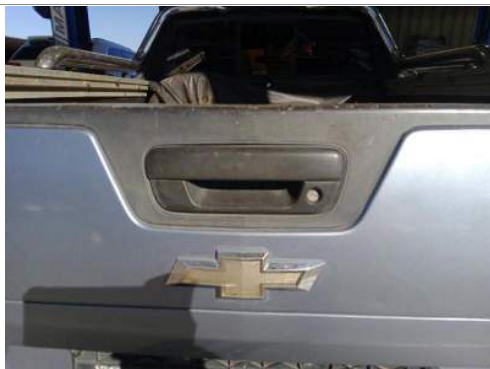
| Damage | Repair Way |
|---|---|
| Tailgate Damaged | Replace |

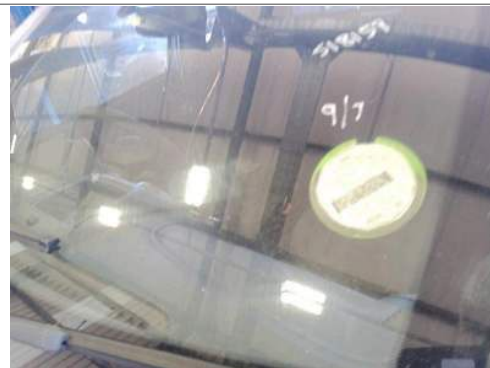
| Damage | Repair Way |
|---|---|
| Windscreen Cracked | Replace |

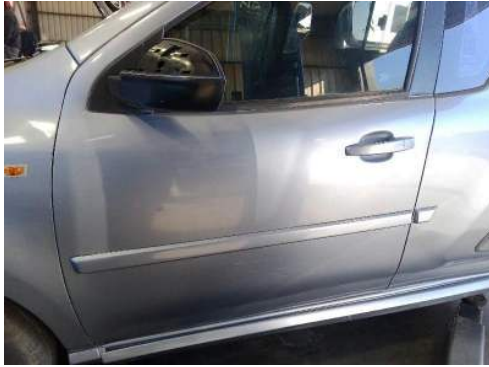
| Damage | Repair Way |
|---|---|
| Door Front Left Residual Traces of Repair | Repair |

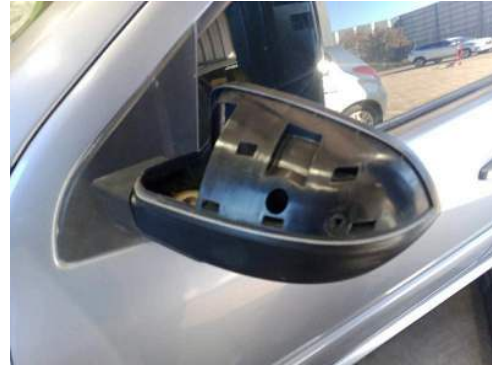
| Damage | Repair Way |
|---|---|
| Side Mirror Left Damaged | Repair |

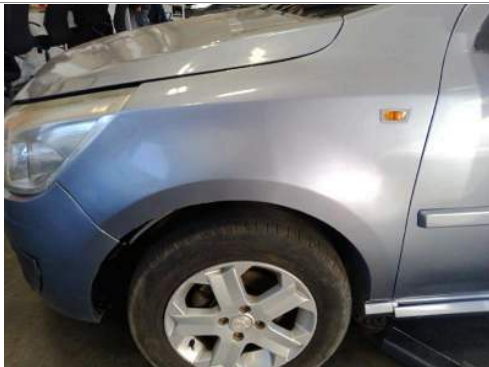
| Damage | Repair Way |
|---|---|
| Front Fender Left Residual Traces of Repair | Repair |

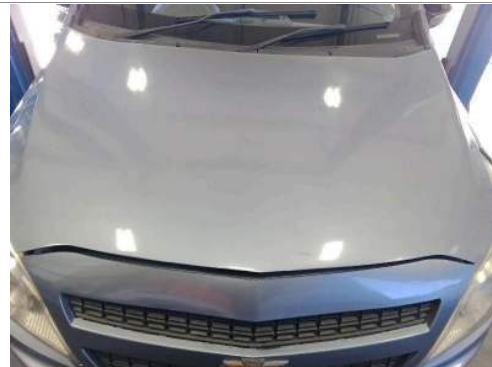
| Damage | Repair Way |
|---|---|
| Bonnet Residual Traces of Repair | Repair |

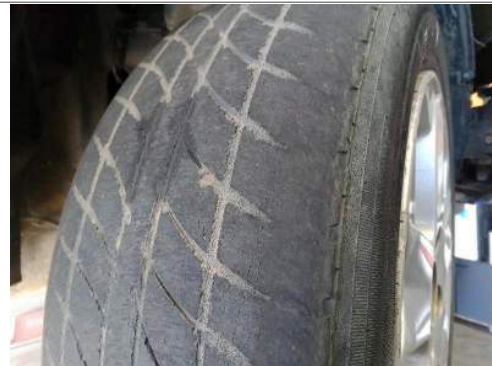
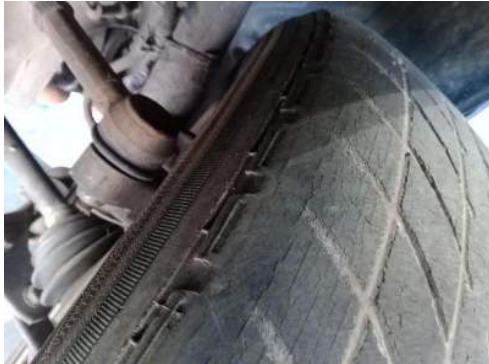
| Damage | Repair Way |
|---|---|
| Tyre Front Right Smooth | Replace |

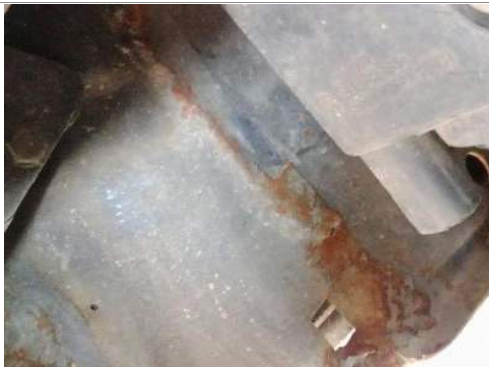
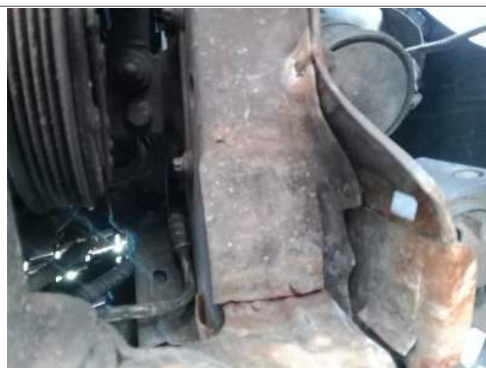
| Damage | Repair Way |
|---|---|
| Main Beam Right Welded | Repair |

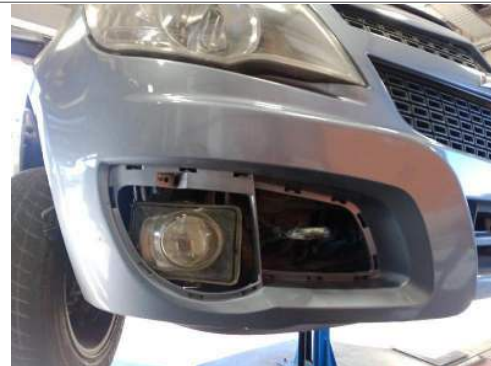
| Damage | Repair Way |
|---|---|
| Front Bumper Damaged | Repair |

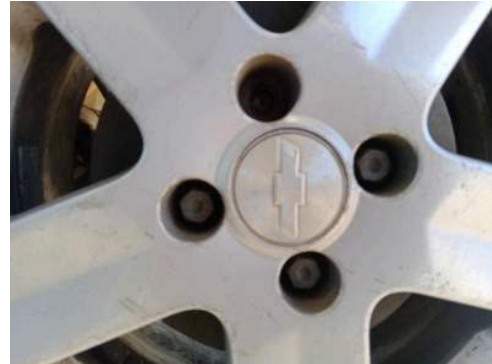
| Damage | Repair Way |
|---|---|
| Bolt(s) / Nut(s) Rear Wheel Left Missing | Replace |

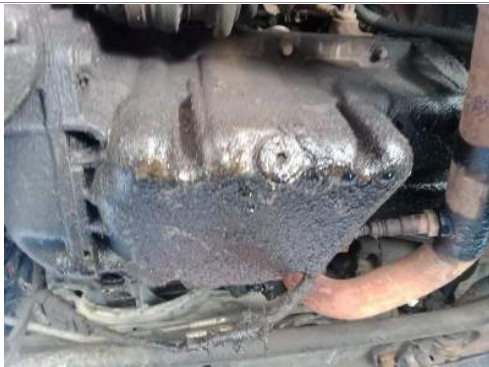
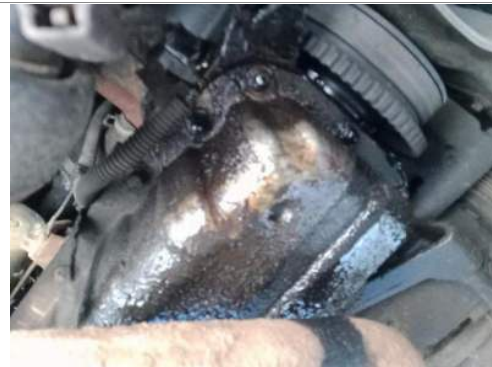
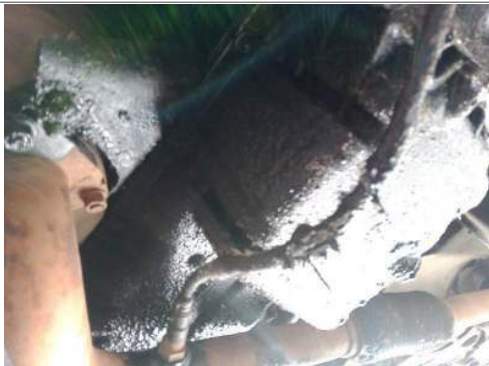
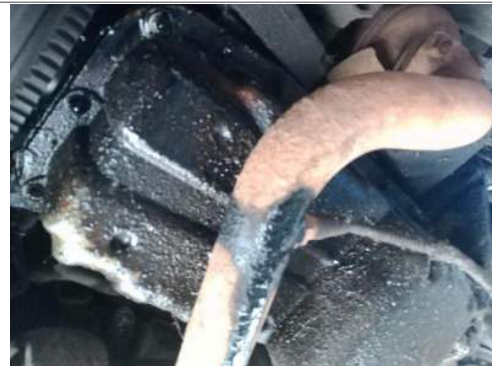
| Damage | Repair Way |
|---|---|
| Engine Oil Leak | Repair |
| engine water leak. | Repair |

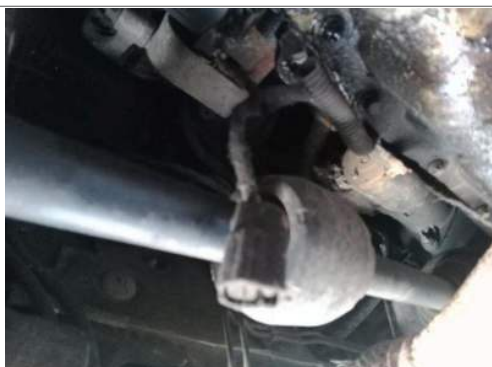
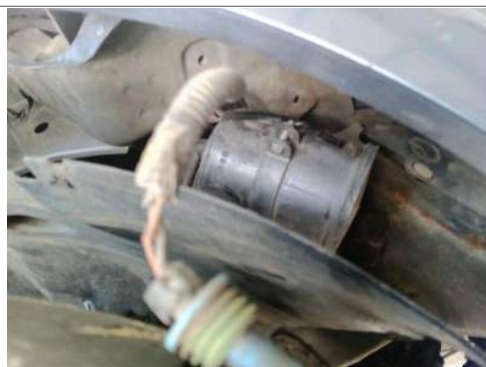
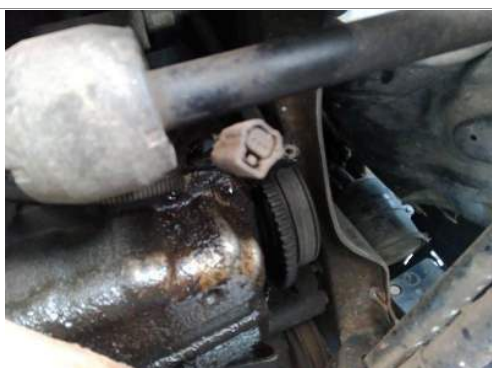
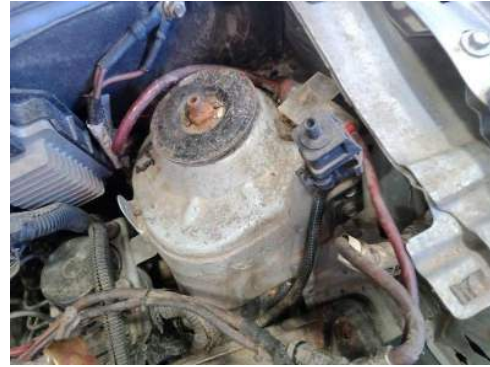
| Damage | Repair Way |
|---|---|
| Engine Wiring Damaged | Repair |

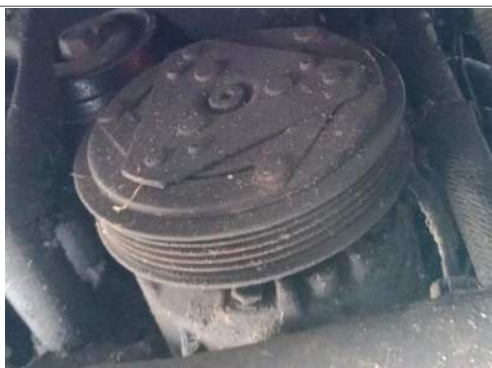
| Damage | Repair Way |
|---|---|
| Air conditioner pump Damaged | Replace |

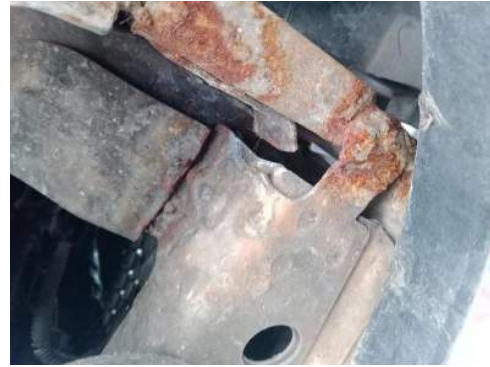
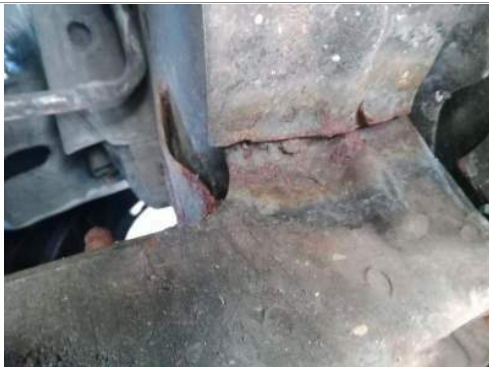
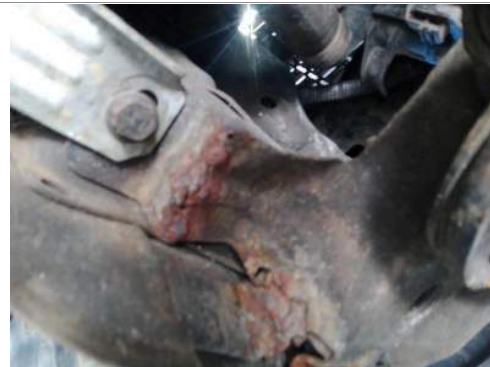
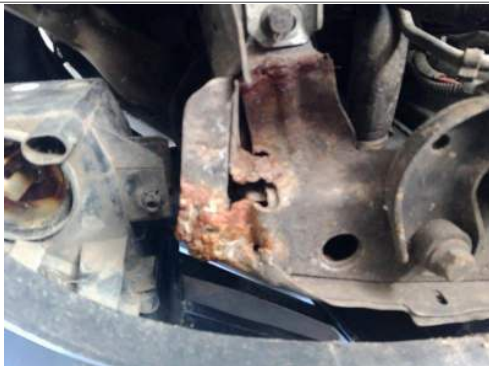
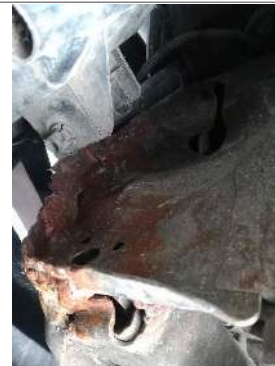
| Damage | Repair Way |
|---|---|
| Radiator Cradle Welded | Repair |

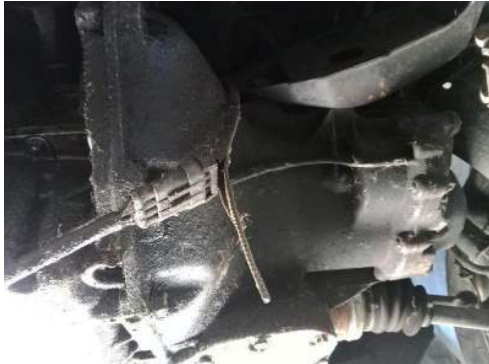
| Damage | Repair Way |
|---|---|
| Gearbox Grease Leak | Repair |

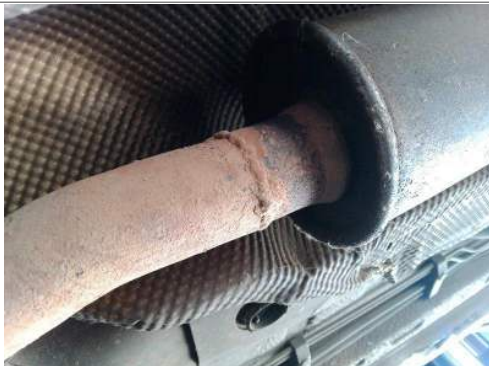
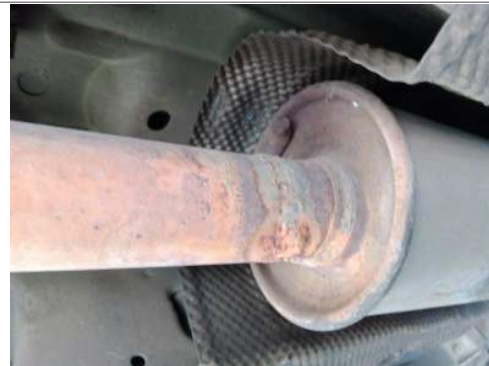
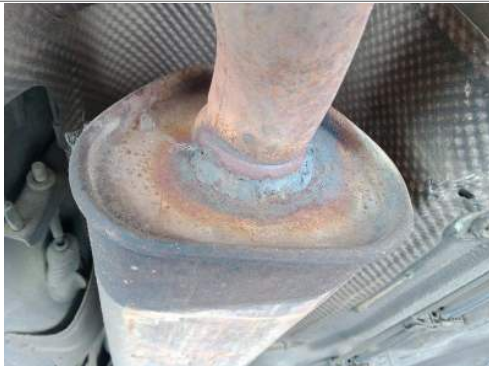
| Damage | Repair Way |
|---|---|
| Engine to silencer pipe Welded | Replace |

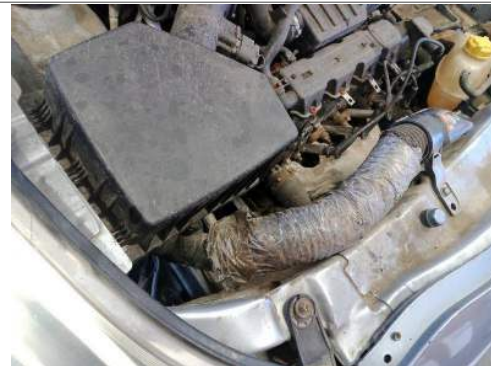
| Damage | Repair Way |
|---|---|
| Air cleaner Damaged | Repair |
