MFC Auction House  
M57 Pretoria Rd, Glenmarais, KEMPTON PARK  
Gauteng

## CONDITION REPORT

Report No: 2016309147

DATE  
18/03/2024

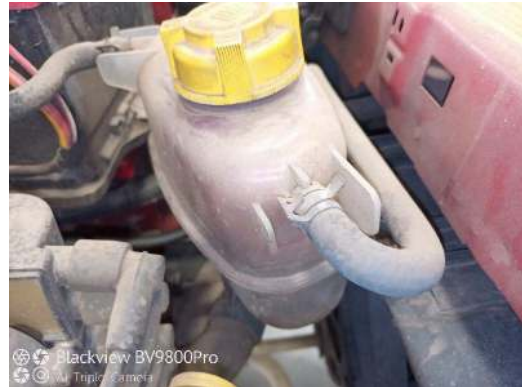
**Expansion Bottle**

| Damage | Repair Way |
|---|---|
| Expansion Bottle Defective | Replace |

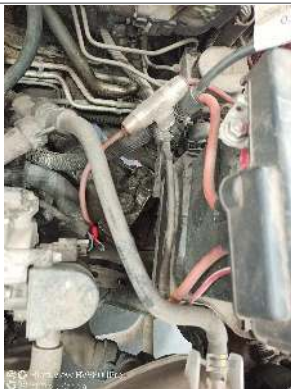
**Engine Wiring**

| Damage | Repair Way |
|---|---|
| Engine Wiring Defective | Repair |

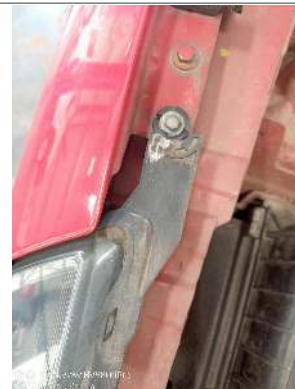
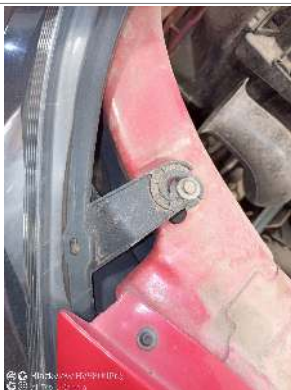
**Headlight Right**

| Damage | Repair Way |
|---|---|
| Headlight Right Damaged | Repair |

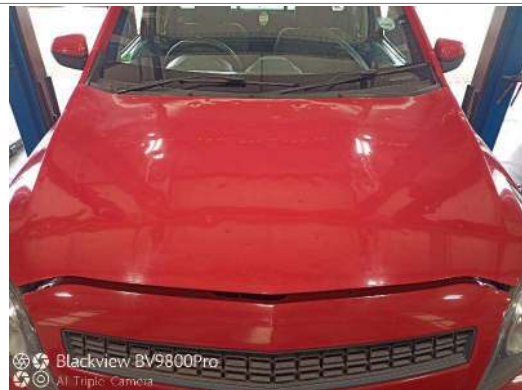
**Bonnet**

| Damage | Repair Way |
|---|---|
| Bonnet Dented | Repair |

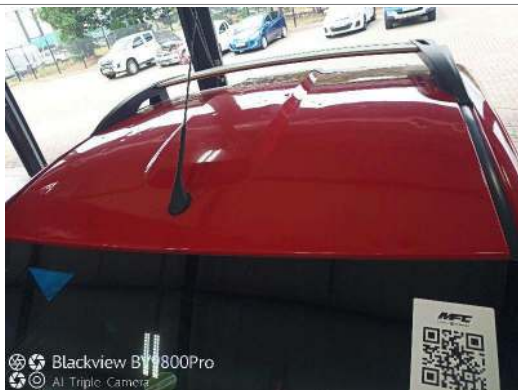
| Damage | Repair Way |
|---|---|
| Roof Dented | Repair |

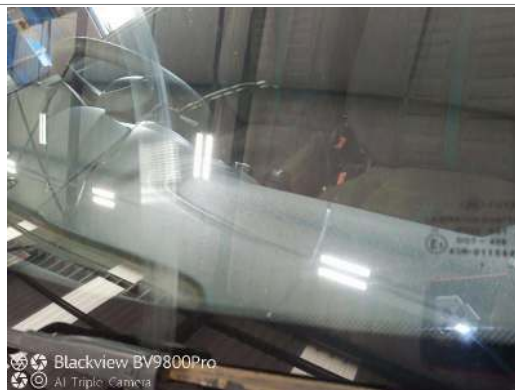
| Damage | Repair Way |
|---|---|
| Windscreen Cracked | Replace |

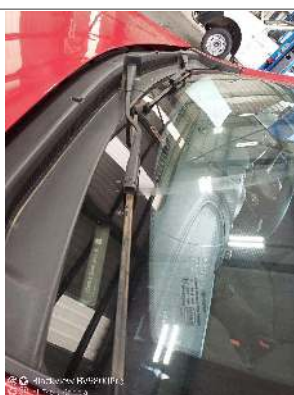
| Damage | Repair Way |
|---|---|
| Windscreen Wiper Damaged | Replace |

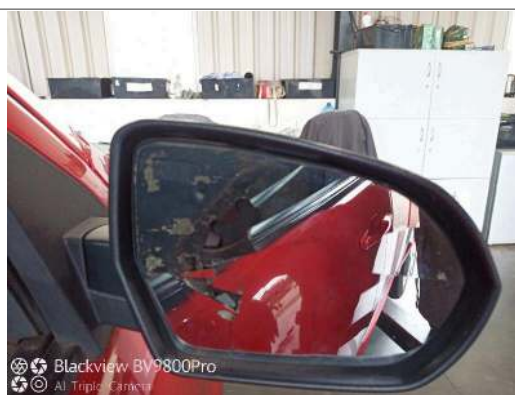
| Damage | Repair Way |
|---|---|
| Side Mirror Right Damaged | Repair |

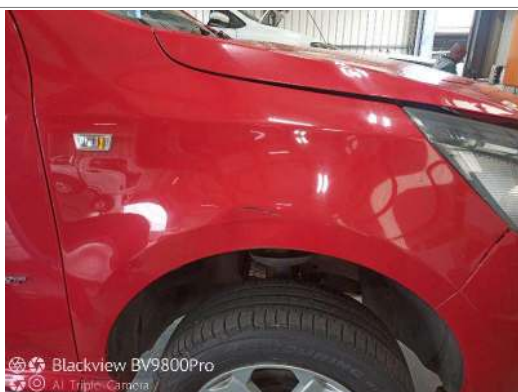
| Damage | Repair Way |
|---|---|
| Front Fender Right Paintwork • Scratched | Repair |

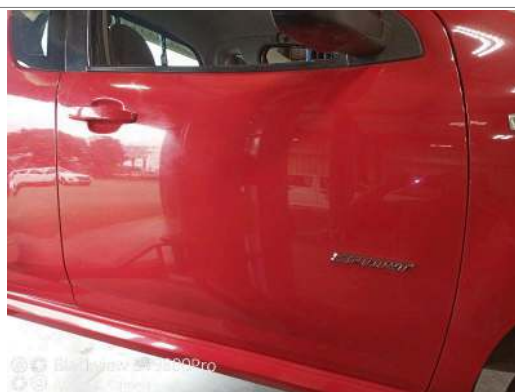
| Damage | Repair Way |
|---|---|
| Door Front Right Dented | Repair |

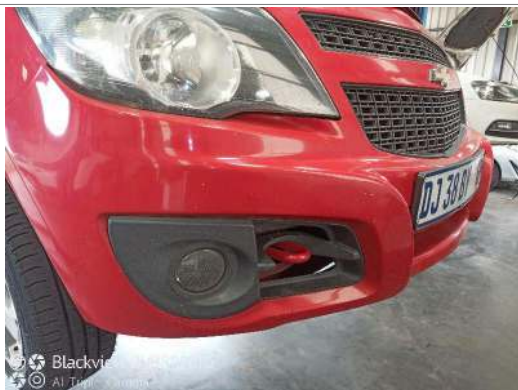
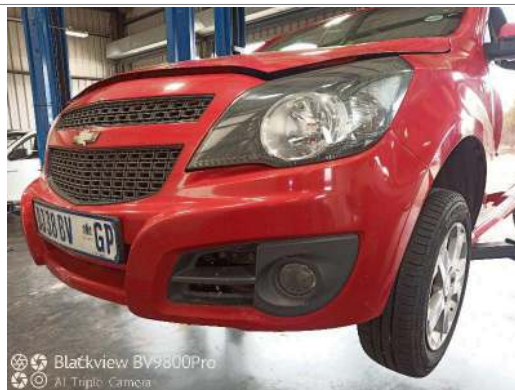
| Damage | Repair Way |
|---|---|
| Front Bumper Paintwork • Chipmarks | Repair |

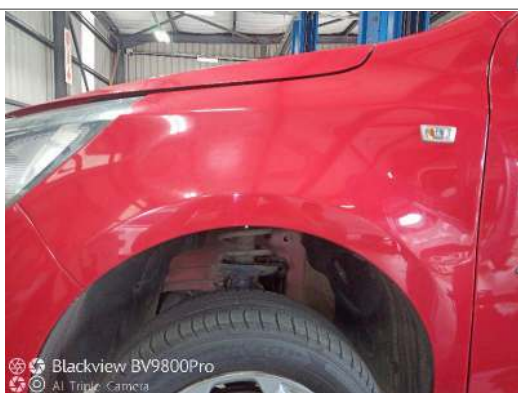
| Damage | Repair Way |
|---|---|
| Front Fender Left Paintwork • Scratched | Repair |

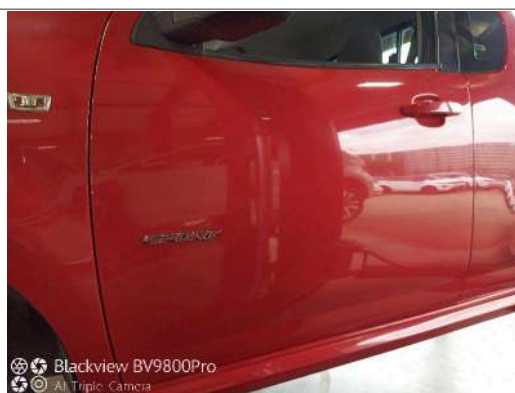
| Damage | Repair Way |
|---|---|
| Door Front Left Paintwork • Scratched | Repair |

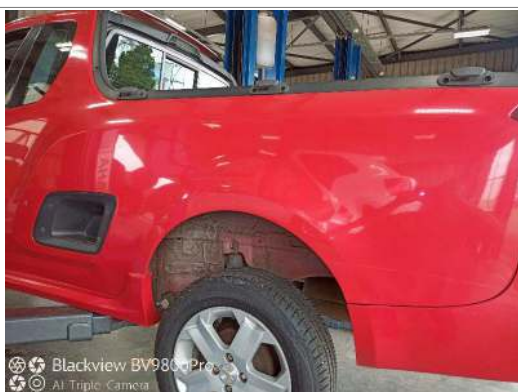
| Damage | Repair Way |
|---|---|
| Rear Fender Left Paintwork • Scratched | Repair |

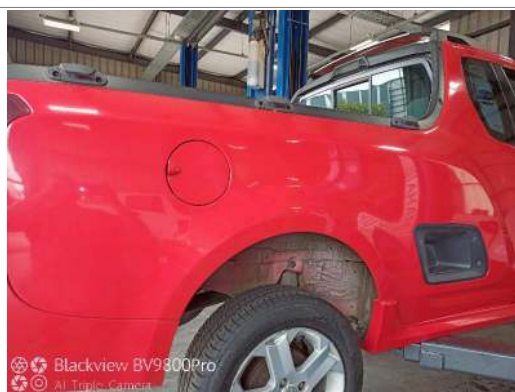
| Damage | Repair Way |
|---|---|
| Rear Fender Right Paintwork • Scratched | Repair |

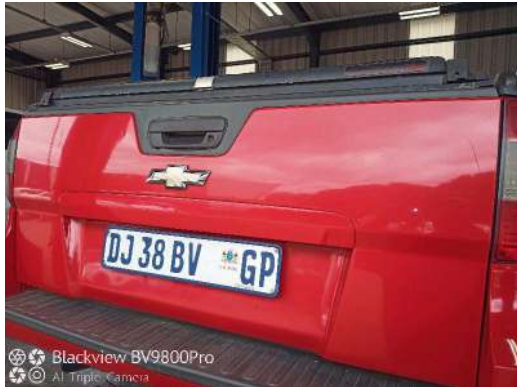
| Damage | Repair Way |
|---|---|
| Tailgate Paintwork • Scratched | Repair |

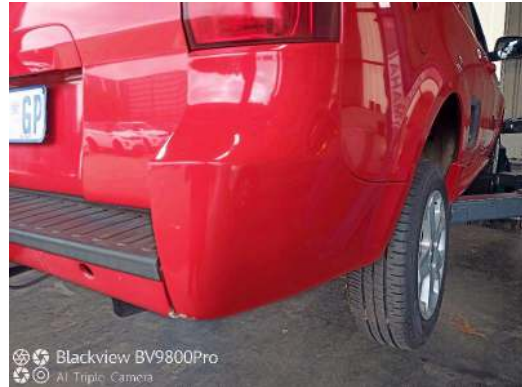
| Damage | Repair Way |
|---|---|
| Rear bumper Paintwork • Scratched | Repair |

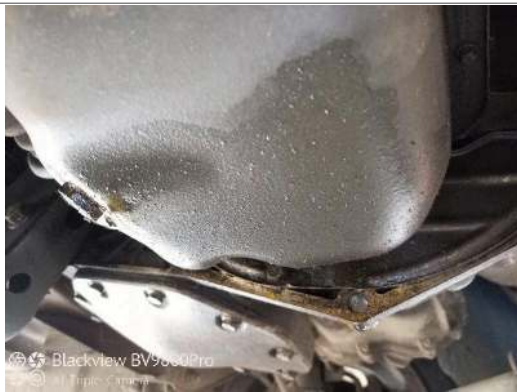
| Damage | Repair Way |
|---|---|
| Engine Oil Leak | Repair |
