## CONDITION REPORT

Report No:  
2016963494  
DATE  
31/07/2025

| Manufacturer | ISUZU | Registration Number | JDY681NW |
| Model | KB300 LX 4X4 DSL PU [2013-2014] | Register Number | |

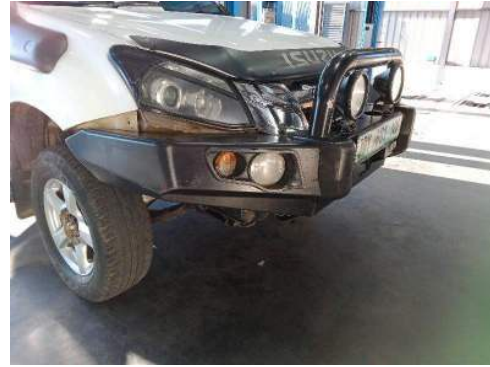
| Damage | Repair Way |
|---|---|
| Front Bumper Corrosion | Repair |

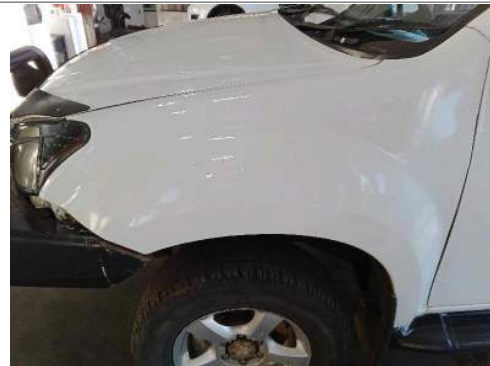
| Damage | Repair Way |
|---|---|
| Front Fender Left Residual Traces of Repair | Repair |

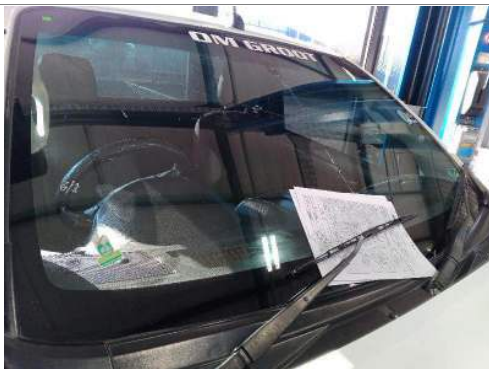
| Damage | Repair Way |
|---|---|
| Windscreen Cracked | Replace |

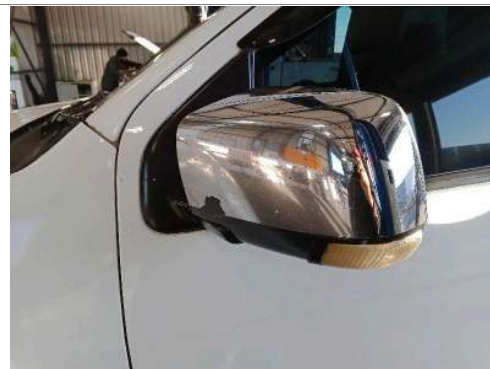
| Damage | Repair Way |
|---|---|
| Side Mirror Left Damaged | Replace |

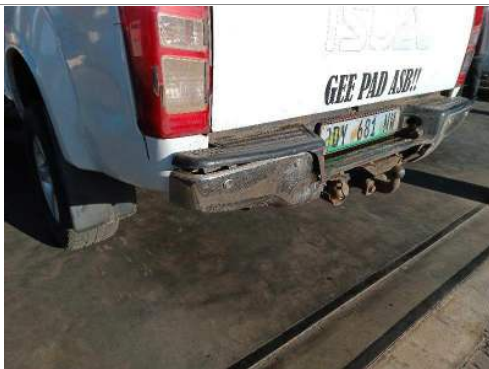
| Damage | Repair Way |
|---|---|
| Rear bumper Damaged | Repair |

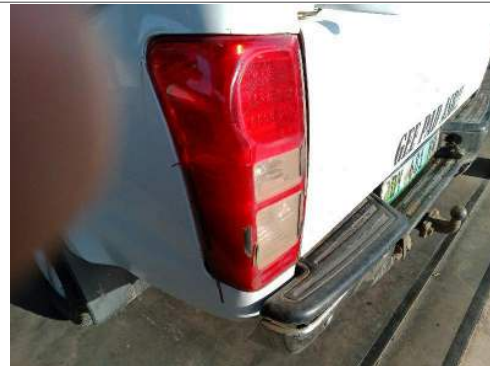
| Damage | Repair Way |
|---|---|
| Tail Light Left Damaged | Replace |

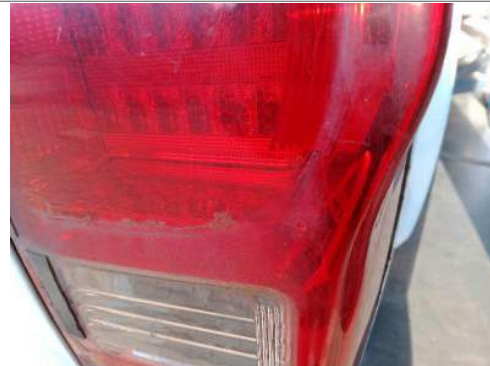
| Damage | Repair Way |
|---|---|
| Tail Light Right Damaged | Replace |

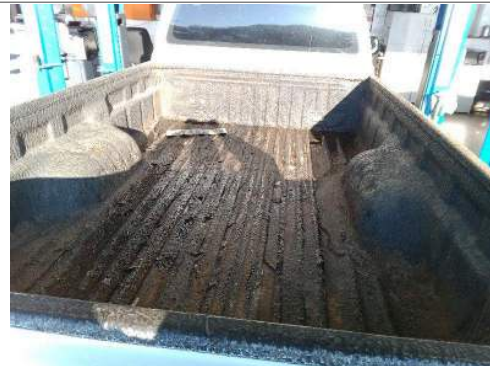
| Damage | Repair Way |
|---|---|
| Load Body Welded | Replace |

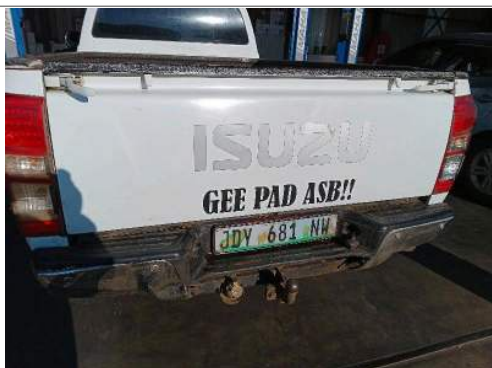
| Damage | Repair Way |
|---|---|
| Tailgate Defective | Replace |

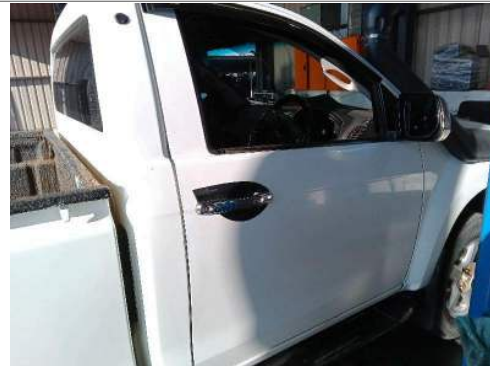
| Damage | Repair Way |
|---|---|
| Door Front Right Residual Traces of Repair | Repair |

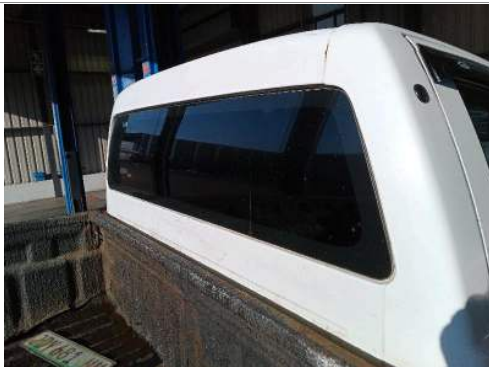
| Damage | Repair Way |
|---|---|
| C • Pillar Right Residual Traces of Repair | Repair |

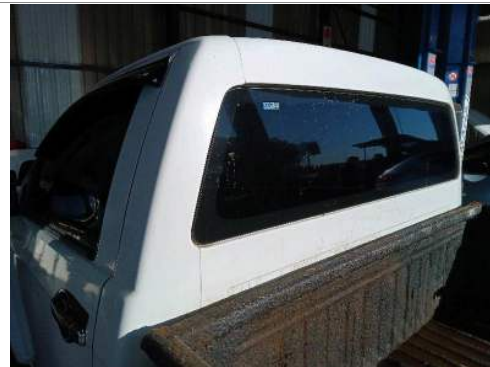
| Damage | Repair Way |
|---|---|
| C • Pillar Left Residual Traces of Repair | Repair |

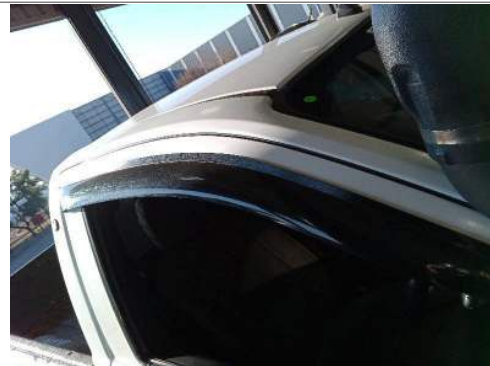
| Damage | Repair Way |
|---|---|
| A • Pillar Right Residual Traces of Repair | Repair |

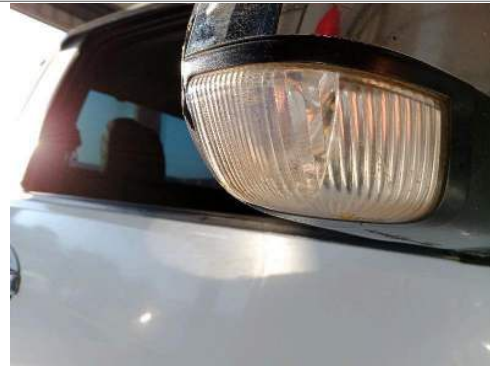
| Damage | Repair Way |
|---|---|
| Side Mirror Right Damaged | Replace |

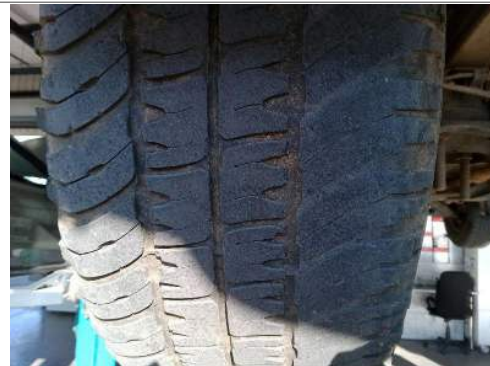
| Damage | Repair Way |
|---|---|
| Tyre Rear Left Worn | Replace |

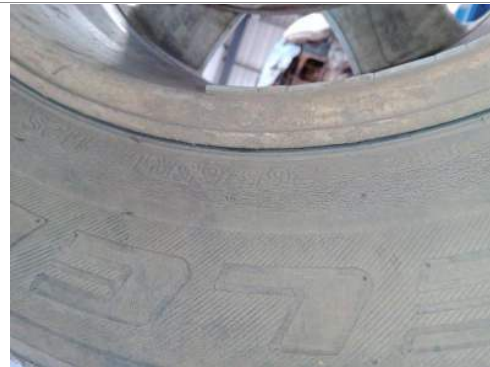
| Damage | Repair Way |
|---|---|
| Tyre Front Right Excessive Wear & Tear | Replace |

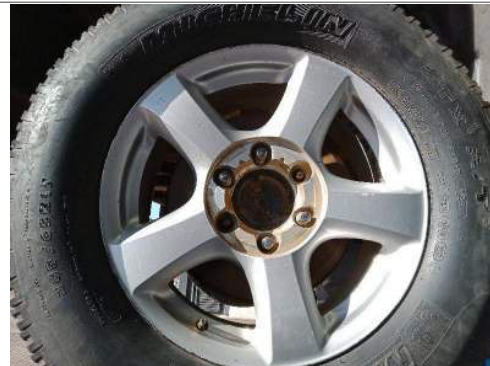
| Damage | Repair Way |
|---|---|
| Rim Rear Right Scratched | Repair |

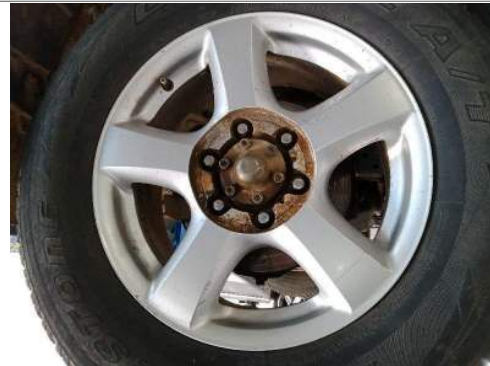
| Damage | Repair Way |
|---|---|
| Rim Front Right Scratched | Repair |

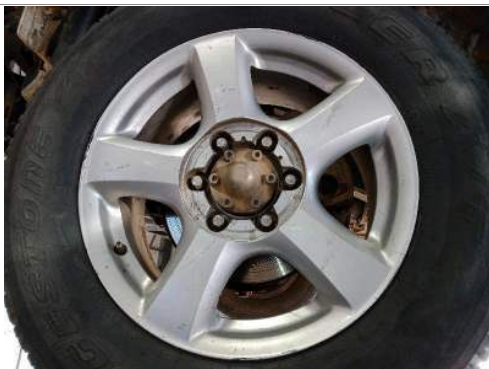
| Damage | Repair Way |
|---|---|
| Rim Front Left Scratched | Repair |

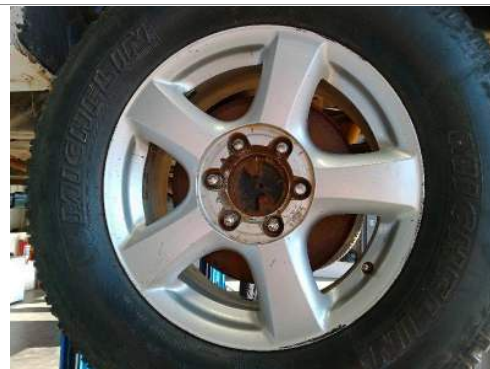
| Damage | Repair Way |
|---|---|
| Rim Rear Left Scratched | Repair |

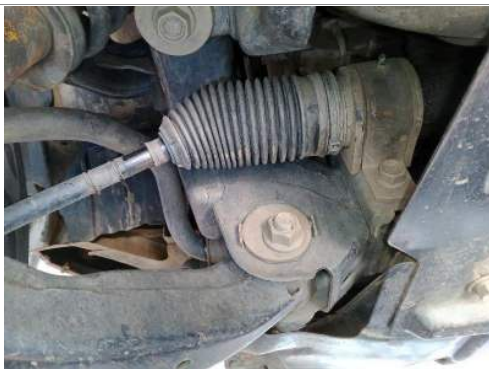
| Damage | Repair Way |
|---|---|
| Steering Rack Boot Left Defective | Replace |

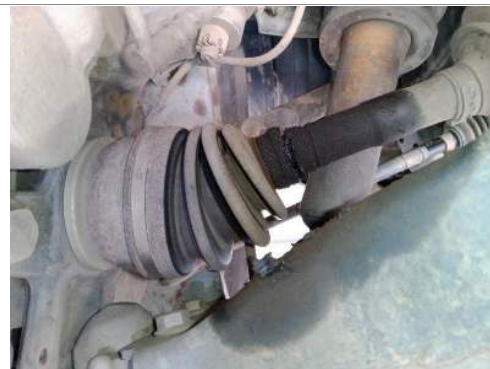
| Damage | Repair Way |
|---|---|
| CV Joint(s) Boot(s) Front Left (inner/outer) Defective | Replace |

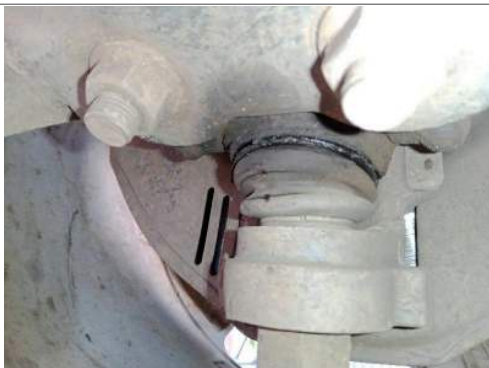
| Damage | Repair Way |
|---|---|
| Ball Joint(s) Front Axle Right Damaged | Replace |

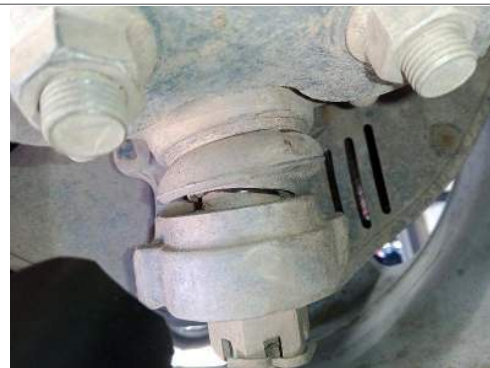
| Damage | Repair Way |
|---|---|
| Ball Joint(s) Front Axle Left Damaged | Replace |

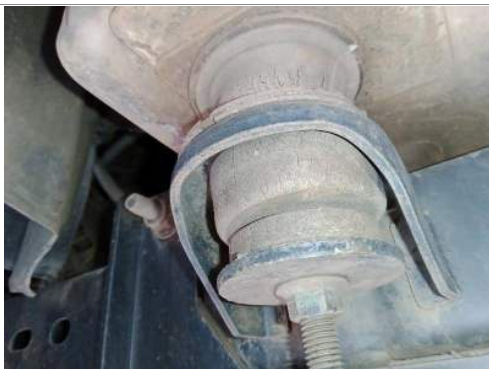
| Damage | Repair Way |
|---|---|
| Mounting rubber(s) Front Right Cracked | Replace |

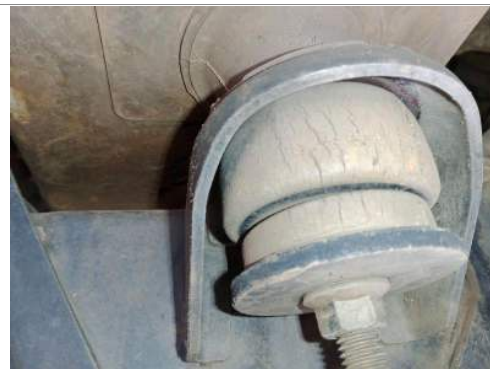
| Damage | Repair Way |
|---|---|
| Mounting rubber(s) Front Left Cracked | Replace |

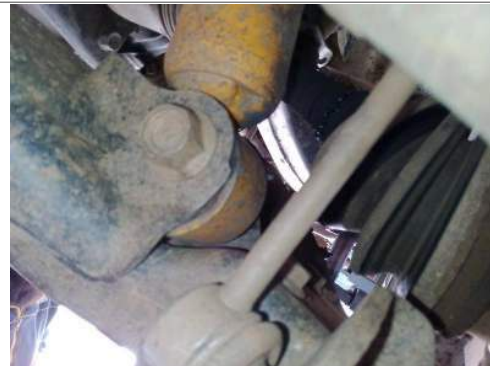
| Damage | Repair Way |
|---|---|
| Shock Absorber Mounting Front Left Excessive Wear & Tear | Repair |

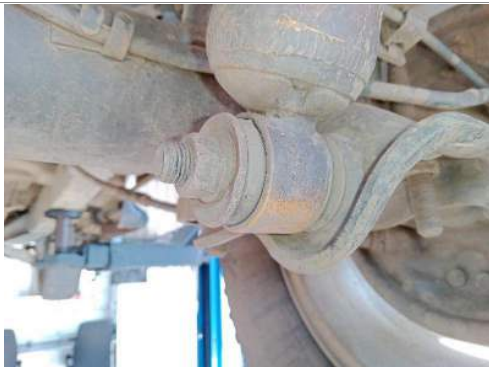
| Damage | Repair Way |
|---|---|
| Shock Absorber Mounting Rear Right Cracked | Replace |

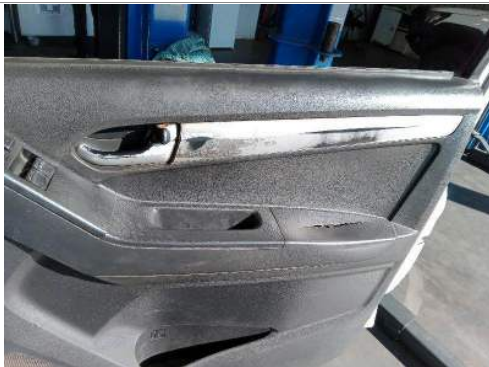
| Damage | Repair Way |
|---|---|
| Door Panel Front Right Damaged | Replace |

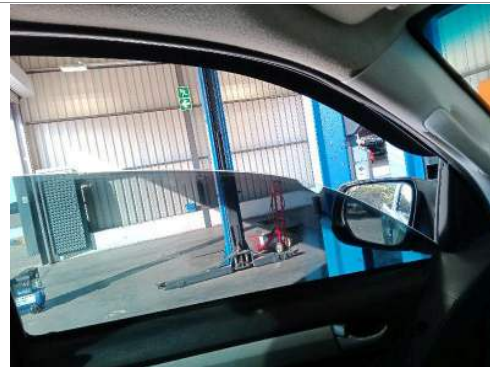
| Damage | Repair Way |
|---|---|
| Window Front Door Left Defective | Repair |

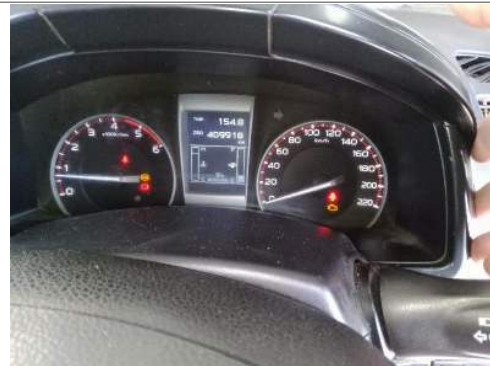
| Damage | Repair Way |
|---|---|
| Engine Management Lights Set | Repair |

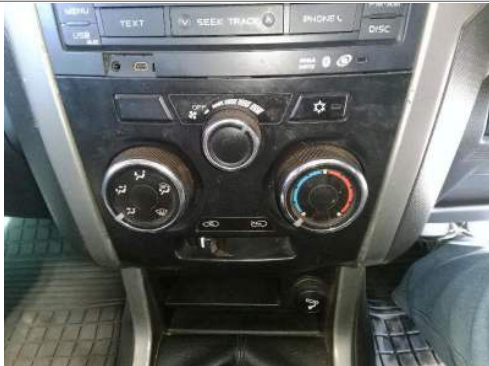
| Damage | Repair Way |
|---|---|
| Air Conditioner Defective | Repair |

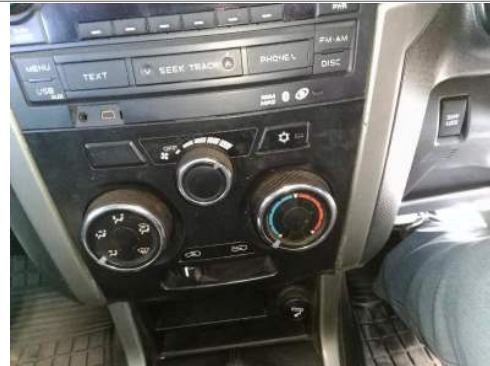
| Damage | Repair Way |
|---|---|
| Heater operation Malfunction | Repair |

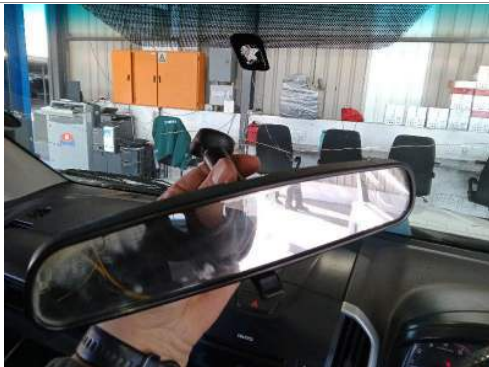
| Damage | Repair Way |
|---|---|
| Interior Mirror Defective | Repair |

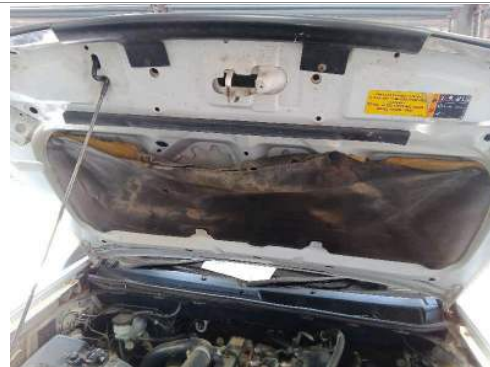
| Damage | Repair Way |
|---|---|
| Under bonnet insulation cover Worn | Replace |
