## CONDITION REPORT

Report No:  
2016958074  
DATE  
25/07/2025

| Manufacturer | CHEVROLET | Registration Number | JCL625MP |
| Model | CORSA 1.4 CLUB UTILITY PU [2010-2012] | Register Number | |

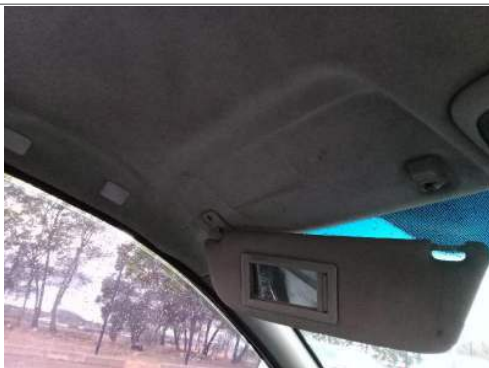
| Damage | Repair Way |
|---|---|
| Sun Visor Right Missing | Replace |

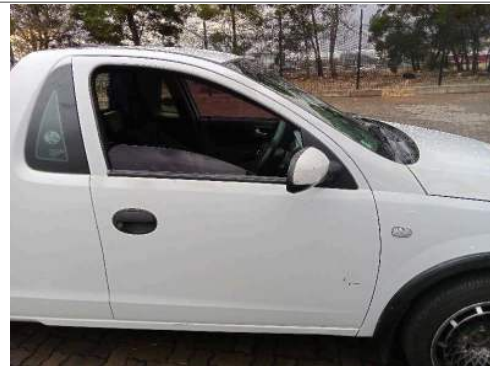
| Damage | Repair Way |
|---|---|
| Side Mirror Right Paintwork • Scratched | Repair |

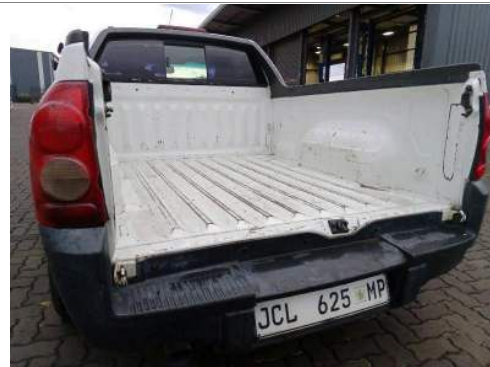
| Damage | Repair Way |
|---|---|
| Rear bumper Damaged | Repair |

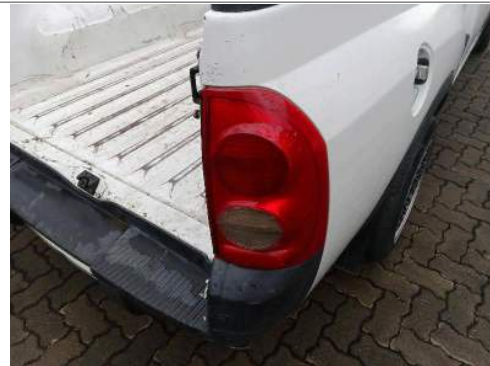
| Damage | Repair Way |
|---|---|
| Load Body Damaged | Repair |

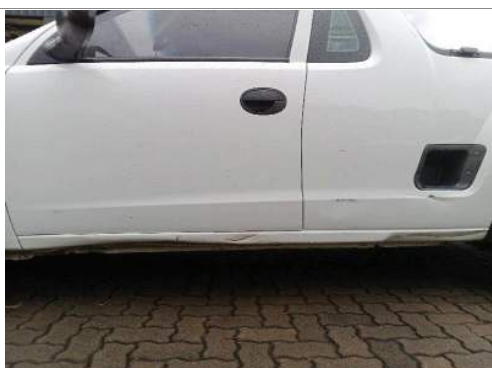
| Damage | Repair Way |
|---|---|
| Rear Fender Left Damaged | Repair |

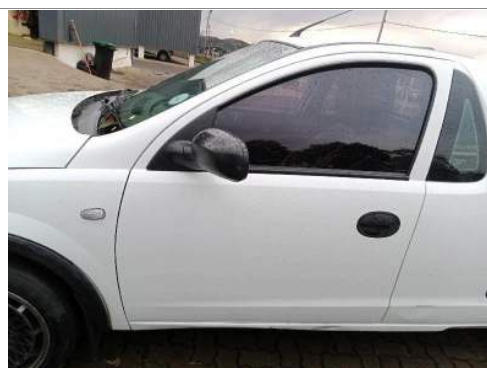
| Damage | Repair Way |
|---|---|
| Sill Panel Left Damaged | Repair |

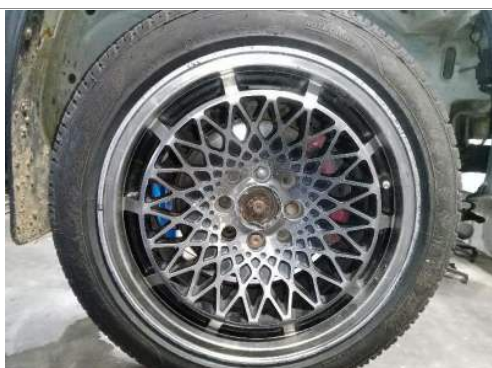
| Damage | Repair Way |
|---|---|
| Bolt(s) / Nut(s) Rear Wheel Right Missing | Replace |

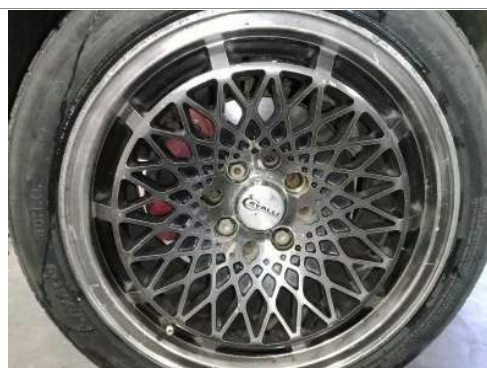
| Damage | Repair Way |
|---|---|
| Rim Front Right Scratched | Repair |

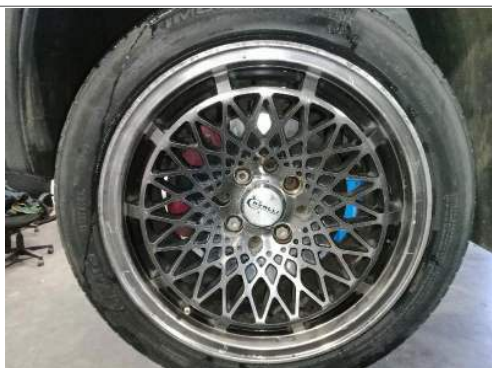
| Damage | Repair Way |
|---|---|
| Bolt(s) / Nut(s) Front Wheel Left Missing | Replace |

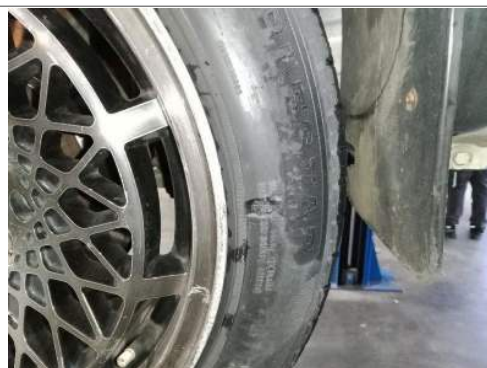
| Damage | Repair Way |
|---|---|
| Rim Front Left Scratched | Repair |

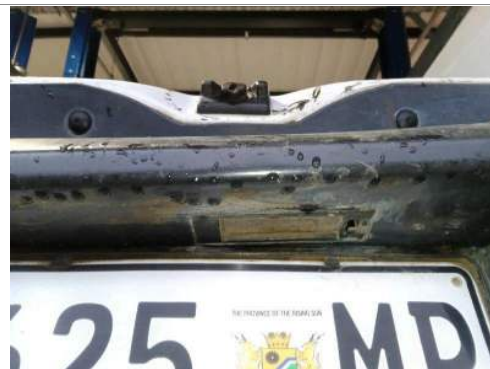
| Damage | Repair Way |
|---|---|
| Number Plate Light Left Damaged | Replace |

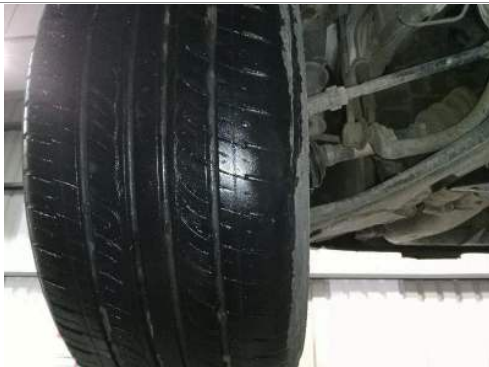
| Damage | Repair Way |
|---|---|
| Tyre Front Right Damaged | Replace |

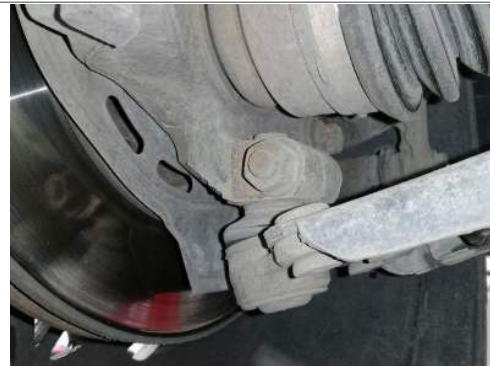
| Damage | Repair Way |
|---|---|
| Stabilizer Mounting Front Right Damaged | Replace |

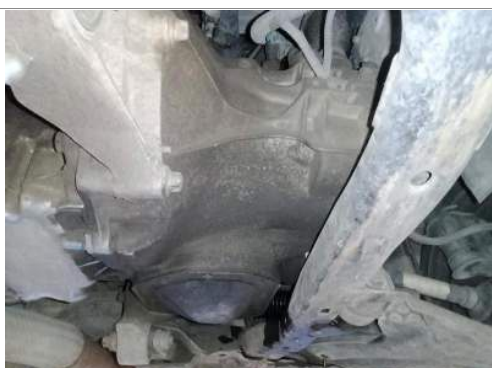
| Damage | Repair Way |
|---|---|
| Gearbox Mountings Cracked | Replace |

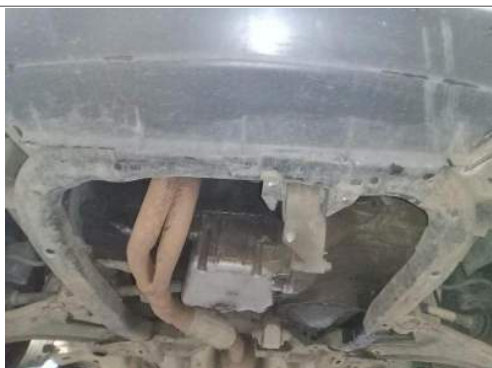
| Damage | Repair Way |
|---|---|
| Engine Noise Excessive | Repair |
| Engine Smoke Excessive | Repair |

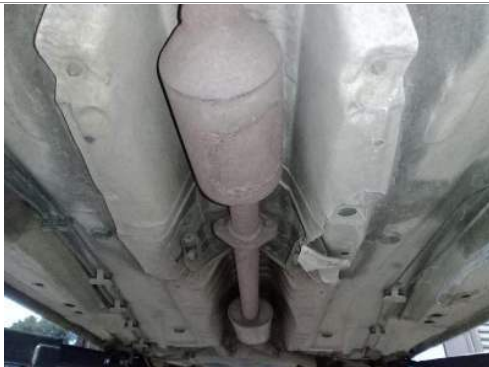
| Damage | Repair Way |
|---|---|
| Catalytic converter Welded | Replace |

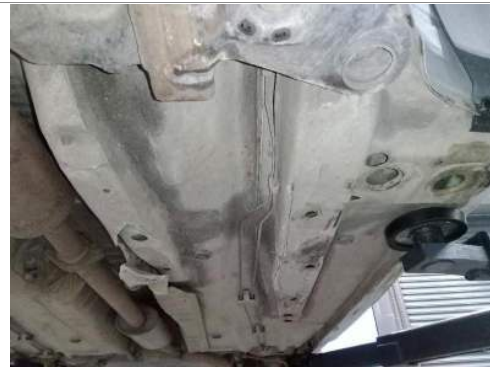
| Damage | Repair Way |
|---|---|
| Belly plates Damaged | Replace |

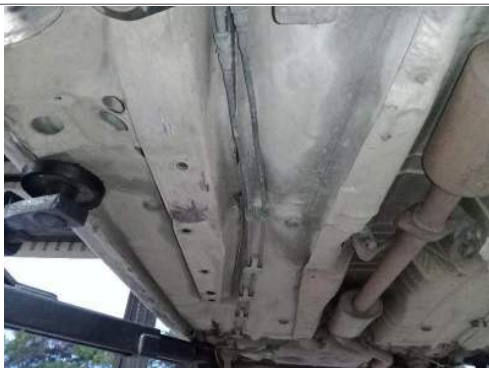
| Damage | Repair Way |
|---|---|
| Chassis Damaged | Repair |

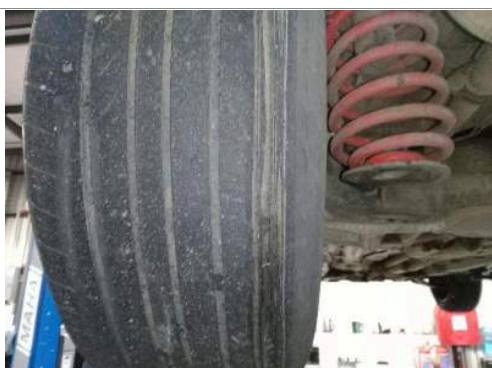
| Damage | Repair Way |
|---|---|
| Spring Rear Right Defective | Replace |

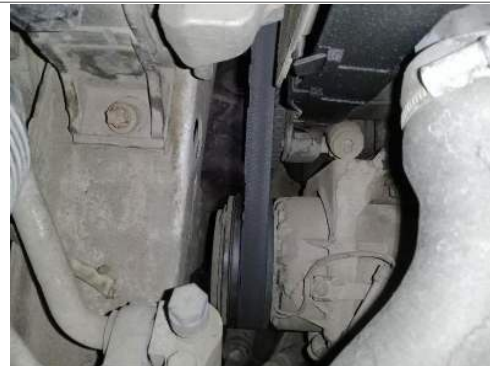
| Damage | Repair Way |
|---|---|
| Engine mountings Loose / Excessive Play | Replace |

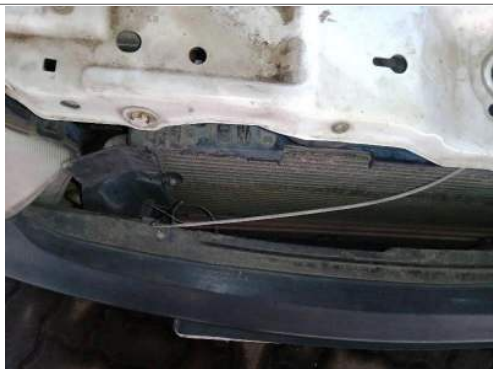
| Damage | Repair Way |
|---|---|
| Bonnet cable Damaged | Replace |

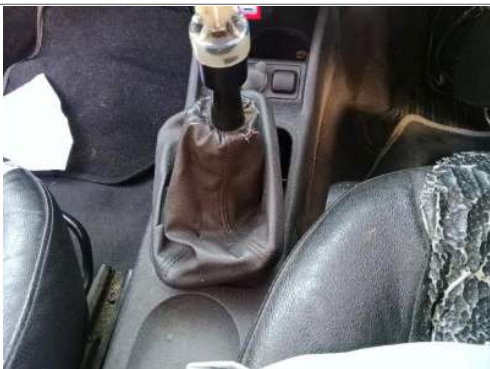
| Damage | Repair Way |
|---|---|
| Gear Lever Dust Boot Damaged | Repair |

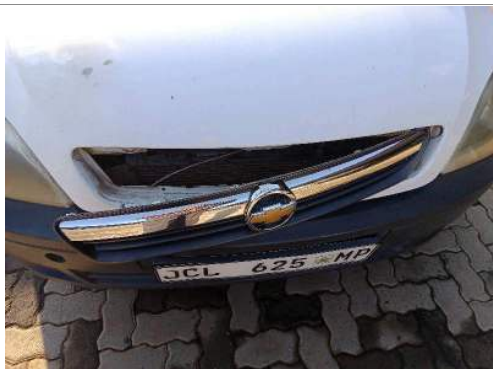
| Damage | Repair Way |
|---|---|
| Grill Damaged | Replace |

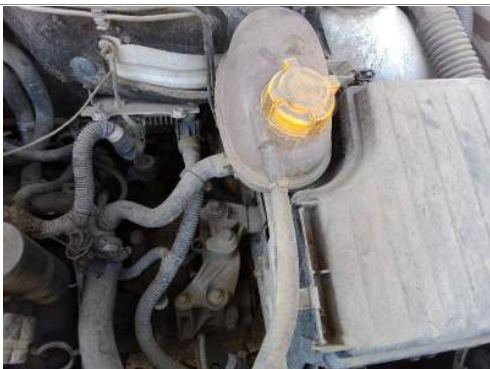
| Damage | Repair Way |
|---|---|
| Hoses Defective | Repair |
