## CONDITION REPORT

2017305034

| Manufacturer | NISSAN | Registration Number | LLV585MP |
| Model | NP200 1.6 8V BASE +AC PU [2011-2019] | Register Number | |

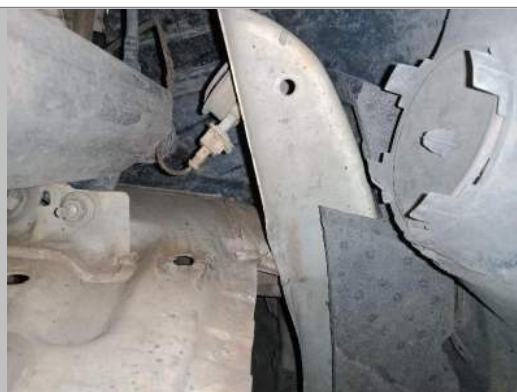
Radiator Cradle Dented  
Engine Performance Insufficient  
Engine Noise Idling / Hunting  
Gearbox Noise Excessive  
Jack Missing  
Wheel Spanner Missing  
Triangle Missing  
Foreign substance on oil cap  
Aircon condenser dented  
Front bumper stiffener damaged

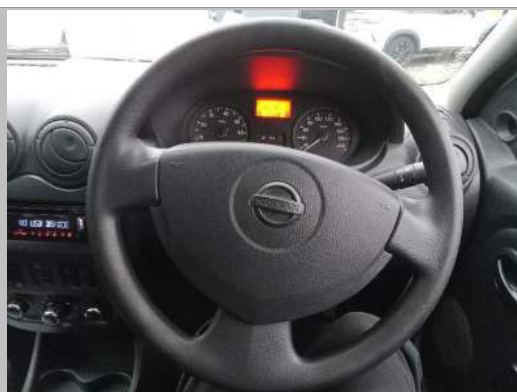
| Damage | Repair Way |
|---|---|
| Steering Wheel Trim Excessive Wear & Tear | Repair |

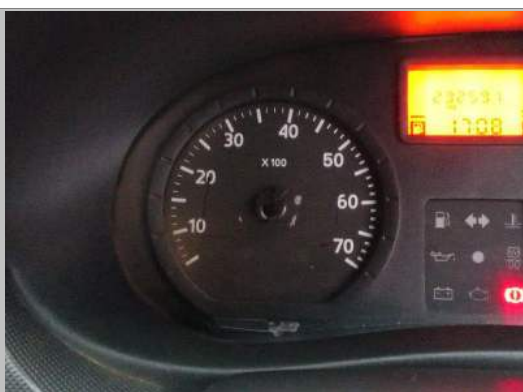
| Damage | Repair Way |
|---|---|
| Ref Counter Damaged | Replace |

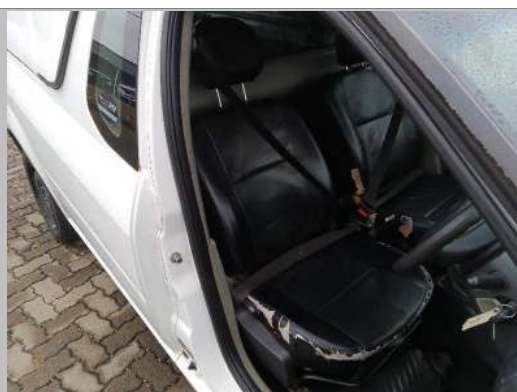
| Damage | Repair Way |
|---|---|
| Seat Front Right Damaged | Repair |

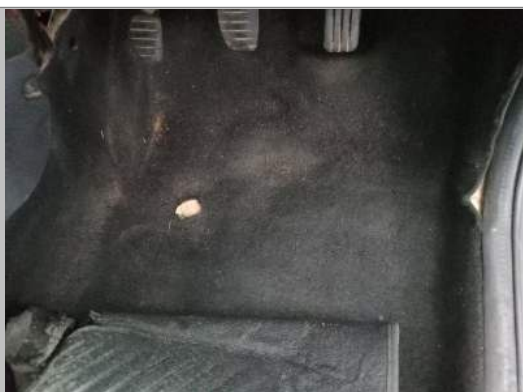
| Damage | Repair Way |
|---|---|
| Carpet Front Damaged | Repair |

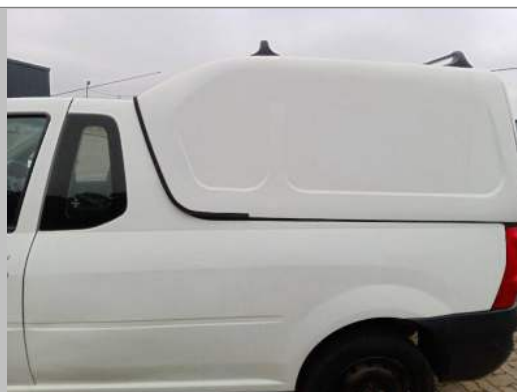
| Damage | Repair Way |
|---|---|
| Rear Fender Left Residual Traces of Repair | Repair |

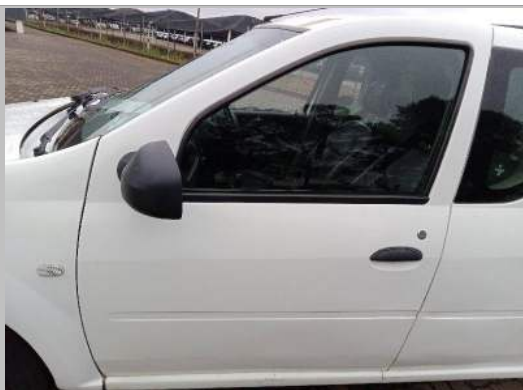
| Damage | Repair Way |
|---|---|
| Door Front Left Residual Traces of Repair | Repair |

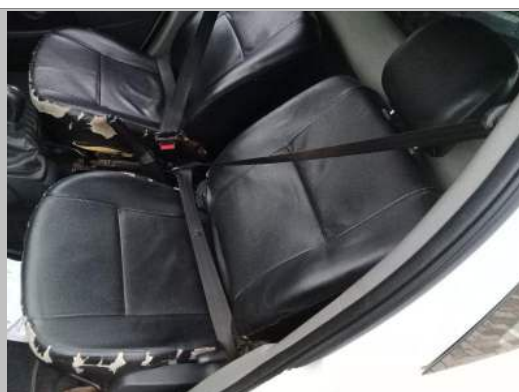
| Damage | Repair Way |
|---|---|
| Seat Front Left Damaged | Repair |

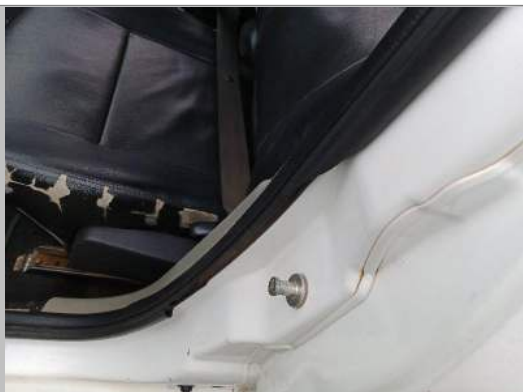
| Damage | Repair Way |
|---|---|
| Door Sealing Rubber Front Left Damaged | Replace |

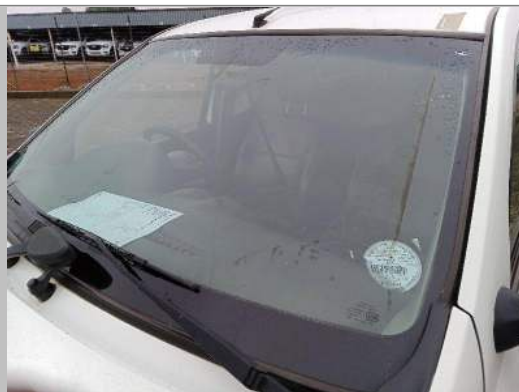
| Damage | Repair Way |
|---|---|
| Windscreen Cracked | Replace |

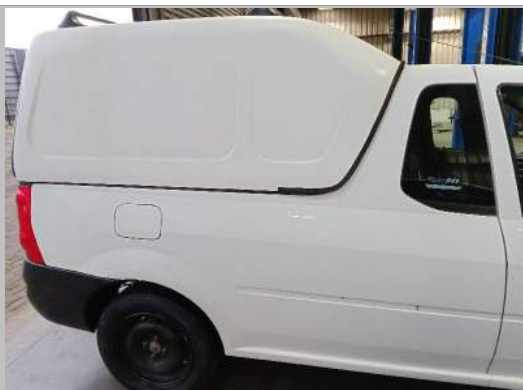
| Damage | Repair Way |
|---|---|
| Rear Fender Right Paintwork • Scratched | Repair |

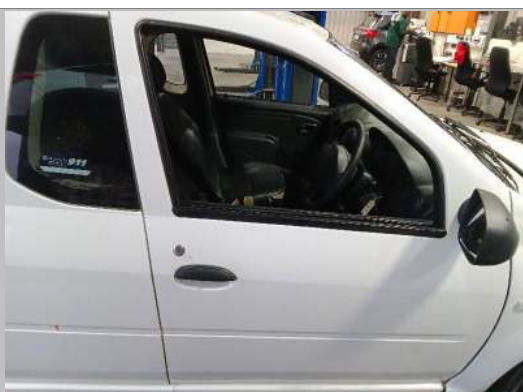
| Damage | Repair Way |
|---|---|
| Door Front Right Damaged | Repair |

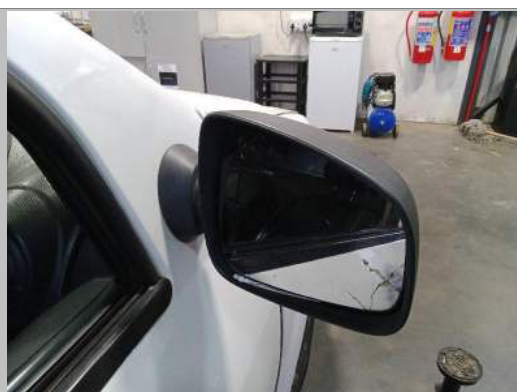
| Damage | Repair Way |
|---|---|
| Side Mirror Right Damaged | Replace |

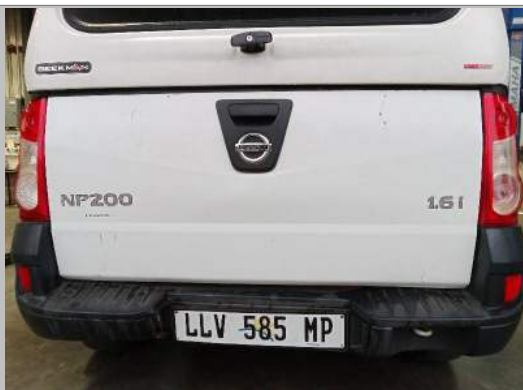
| Damage | Repair Way |
|---|---|
| Rear bumper Damaged | Repair |

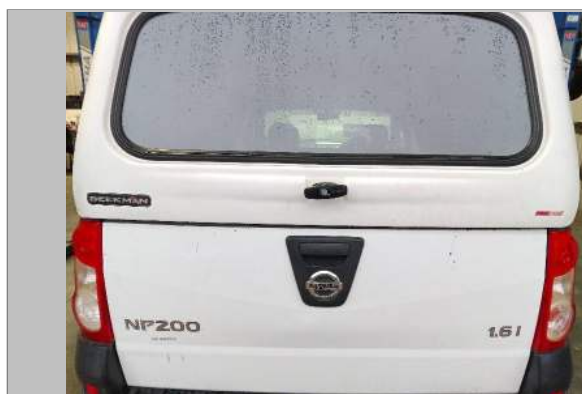
| Damage | Repair Way |
|---|---|
| Tailgate Damaged | Repair |

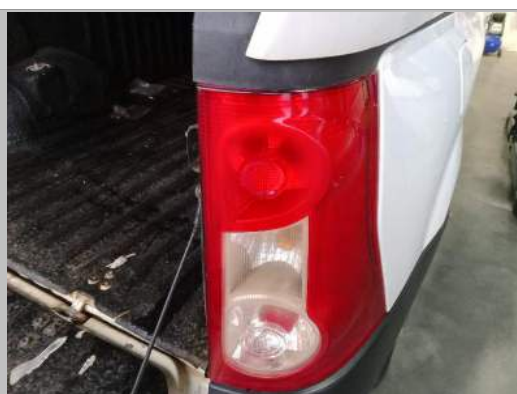
| Damage | Repair Way |
|---|---|
| Tail Light Right Defective | Repair |

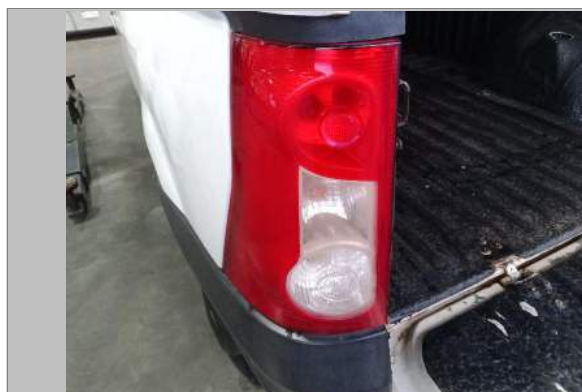
| Damage | Repair Way |
|---|---|
| Tail Light Left Defective | Repair |

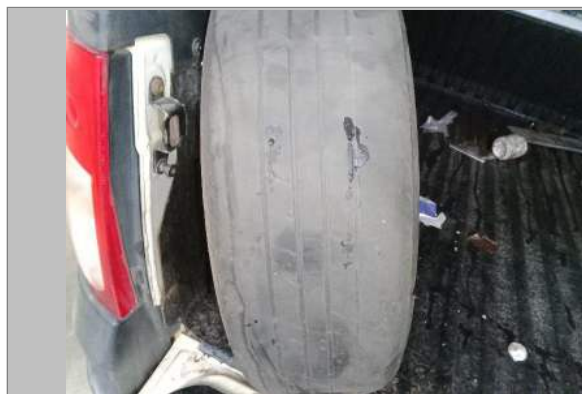
| Damage | Repair Way |
|---|---|
| Spare Tyre Damaged | Replace |

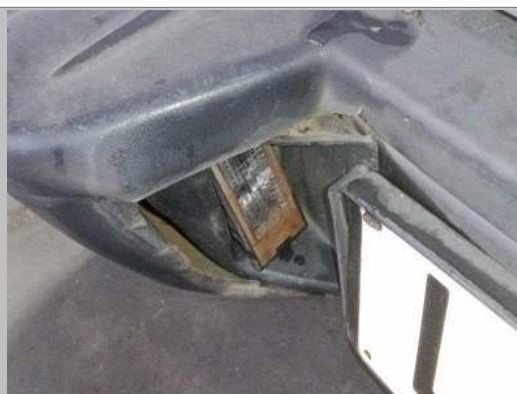
| Damage | Repair Way |
|---|---|
| Number Plate Light Left Damaged | Replace |

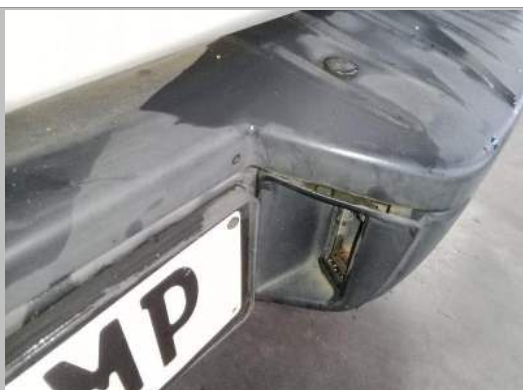
| Damage | Repair Way |
|---|---|
| Number Plate Light Right Damaged | Replace |

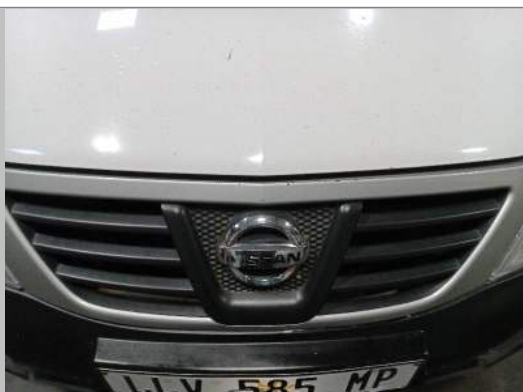
| Damage | Repair Way |
|---|---|
| Grill Paintwork • Scratched | Repair |

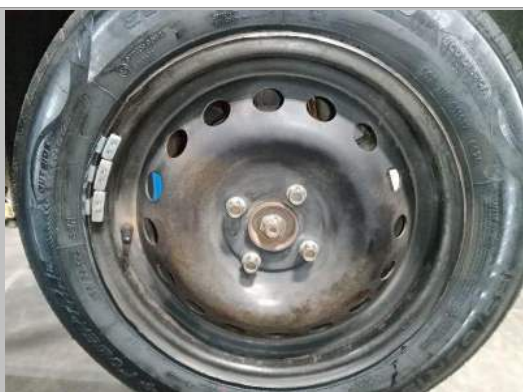
| Damage | Repair Way |
|---|---|
| Rim Front Right Dented | Repair |

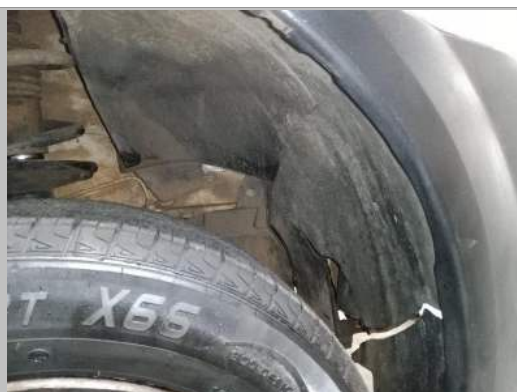
| Damage | Repair Way |
|---|---|
| Front Fender Right / Inner Tray Damaged | Replace |

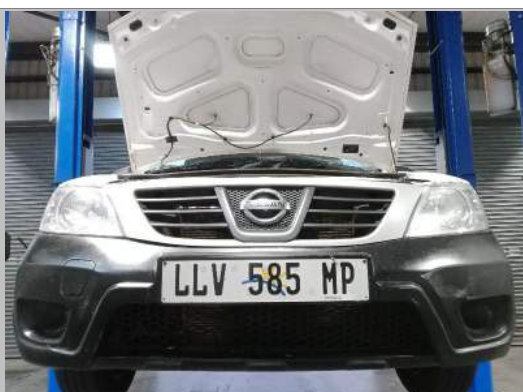
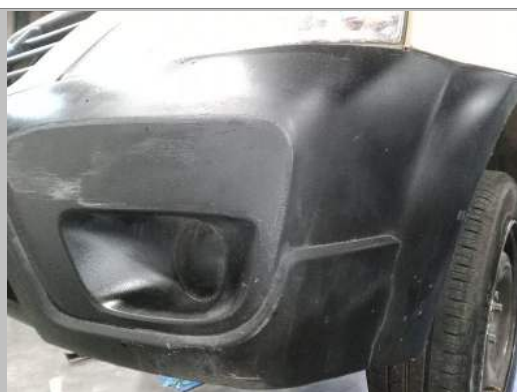
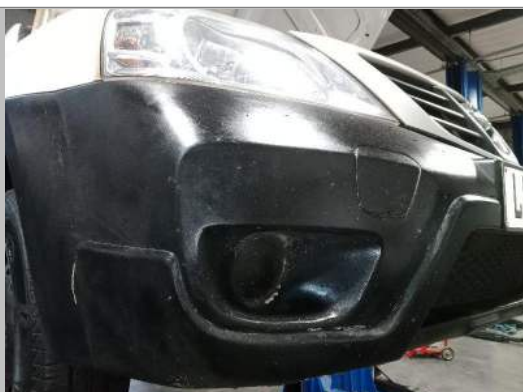
| Damage | Repair Way |
|---|---|
| Front Bumper Damaged | Replace |

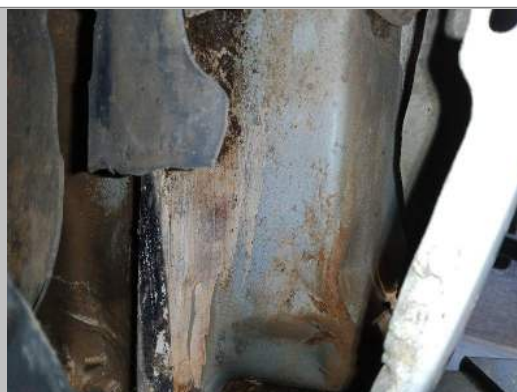
| Damage | Repair Way |
|---|---|
| A • Pillar Left Damaged | Repair |

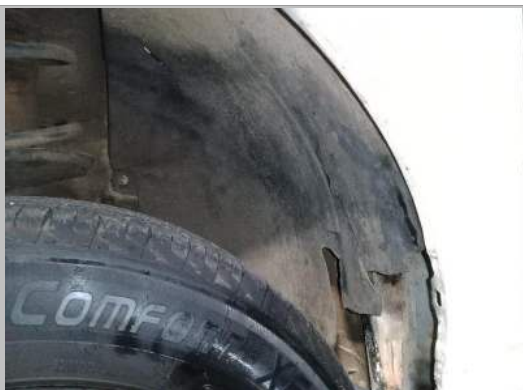
| Damage | Repair Way |
|---|---|
| Front Fender Left / Inner Tray Damaged | Replace |

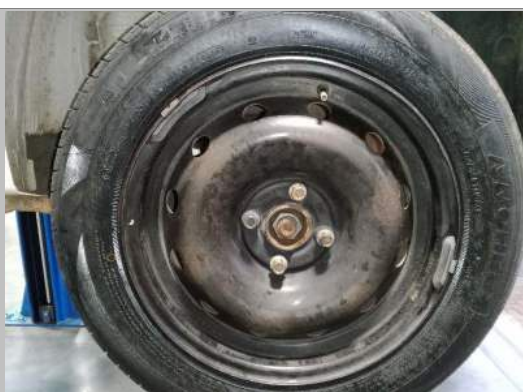
| Damage | Repair Way |
|---|---|
| Rim Rear Left Dented | Repair |

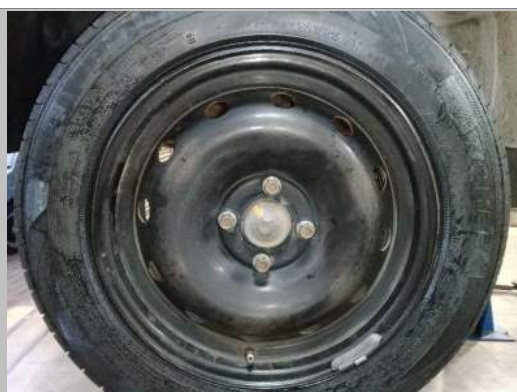
| Damage | Repair Way |
|---|---|
| Rim Rear Right Dented | Repair |

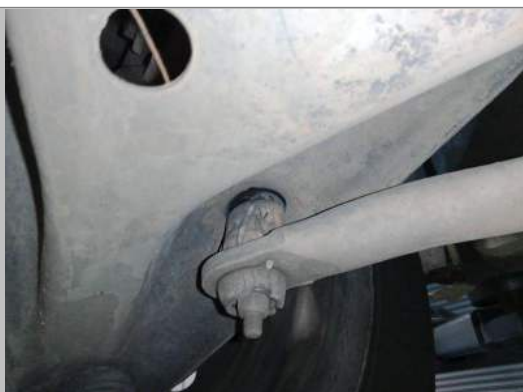
| Damage | Repair Way |
|---|---|
| Stabilizer Mounting Front Right Damaged | Replace |

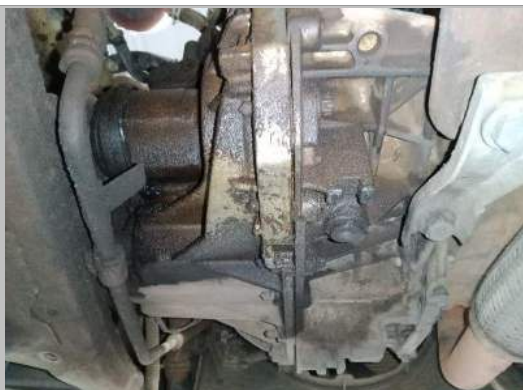
| Damage | Repair Way |
|---|---|
| Gearbox Oil Leak | Repair |

Road Test: Vehicle struggles to start. Gearbox faulty.

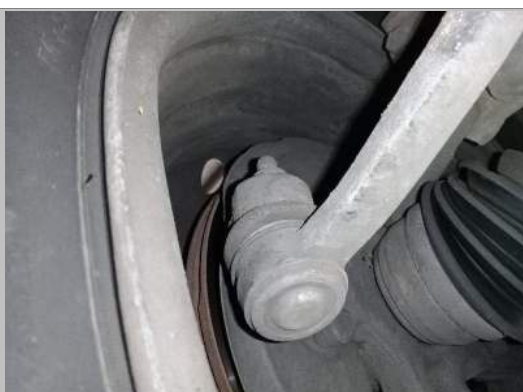
| Damage | Repair Way |
|---|---|
| Tie Rod End left Damaged | Replace |

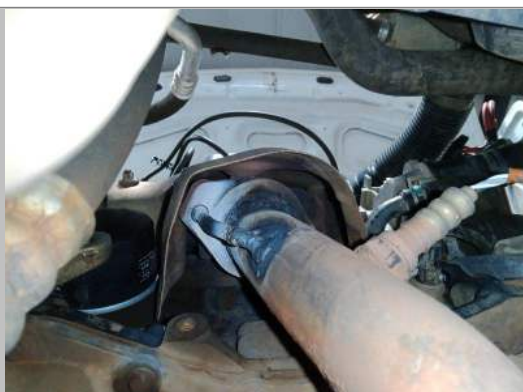
| Damage | Repair Way |
|---|---|
| Engine to silencer pipe Welded | Repair |

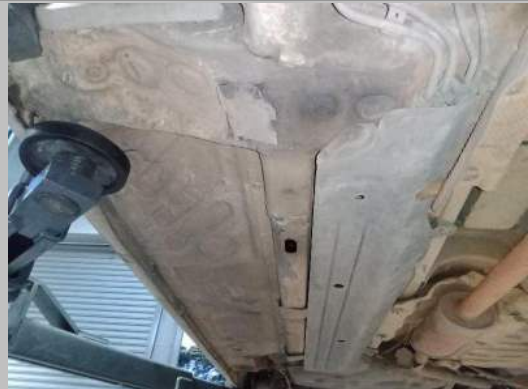
| Damage | Repair Way |
|---|---|
| Chassis Damaged | Repair |

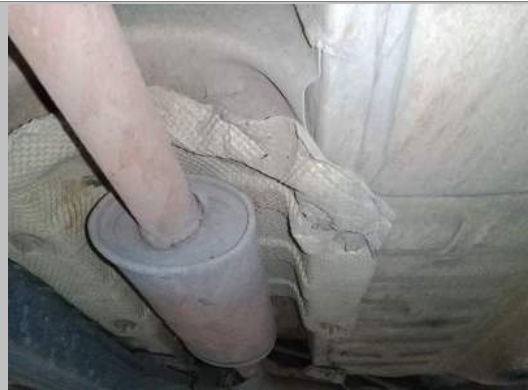
| Damage | Repair Way |
|---|---|
| Belly plates Damaged | Repair |

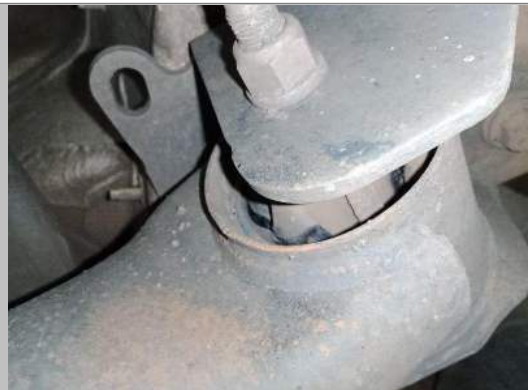
| Damage | Repair Way |
|---|---|
| Mounting Rubber(s) Rear Axle Right Cracked | Replace |

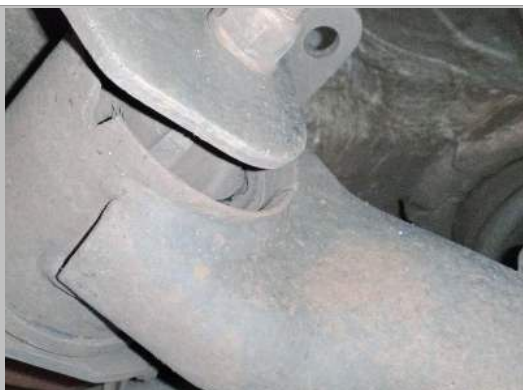
| Damage | Repair Way |
|---|---|
| Mounting Rubber(s) Rear Axle Left Cracked | Replace |

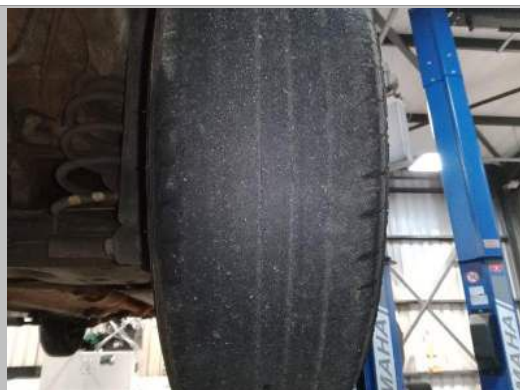
| Damage | Repair Way |
|---|---|
| Tyre Rear Right Worn | Replace |

| | Size | Load/Speed Index | Manufacture | Model | Type* | Production Date | Tread Depth (mm) |
|---|---|---|---|---|---|---|---|
| Rear Right | 185/65 R15 | 88T | Annaite | Anchee | V | 3125 | 0 mm |

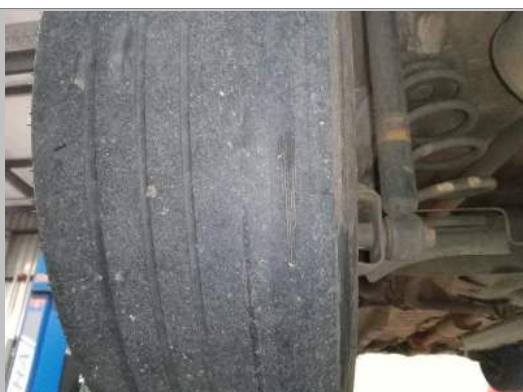
| Damage | Repair Way |
|---|---|
| Tyre Rear Left Damaged | Replace |

| | Size | Load/Speed Index | Manufacture | Model | Type* | Production Date | Tread Depth (mm) |
|---|---|---|---|---|---|---|---|
| Rear Left | 185/65 R15 | 88H | Annaite | Anchee | V | 3125 | 0 mm |

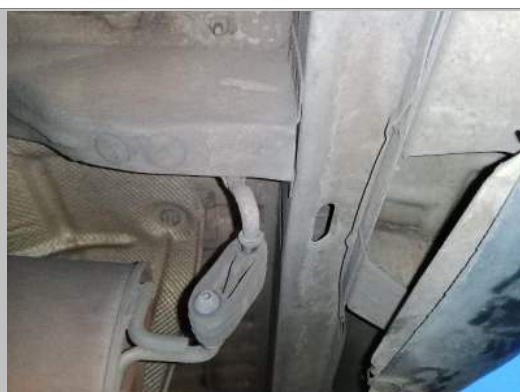
| Damage | Repair Way |
|---|---|
| Load Body Damaged | Repair |

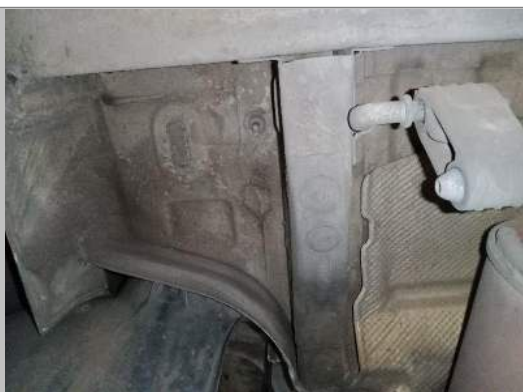
| Damage | Repair Way |
|---|---|
| Main Beam Left Damaged | Repair |

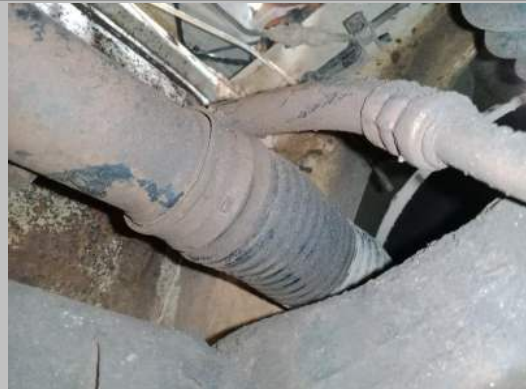
| Damage | Repair Way |
|---|---|
| Steering Rack Boot Left Sweat | Replace |

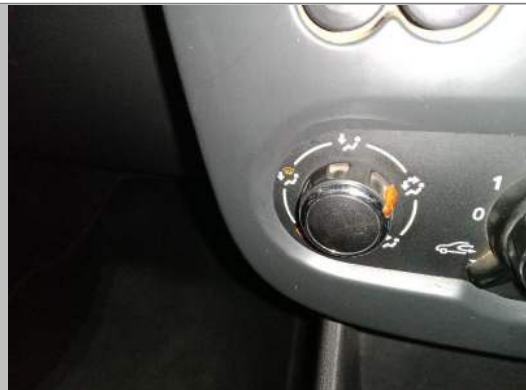
| Damage | Repair Way |
|---|---|
| Heater control Damaged | Replace |
