## CONDITION REPORT

Report No:  
2016960583  
DATE  
28/07/2025

| Manufacturer | NISSAN | Registration Number | BK47VKZN |
| Model | NP200 1.6 8V BASE +AC SAFETY PU [2011-ON] | Register Number | |

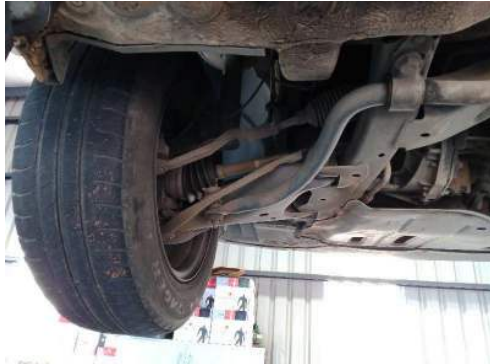
LF TYRE TREAD

| | Size | Load/Speed Index | Manufacture | Model | Type* | Production Date | Tread Depth (mm) |
|---|---|---|---|---|---|---|---|
| Front Left | 185/65 R15 | 88H | Voyager | Radial | V | 0219 | 2 mm |

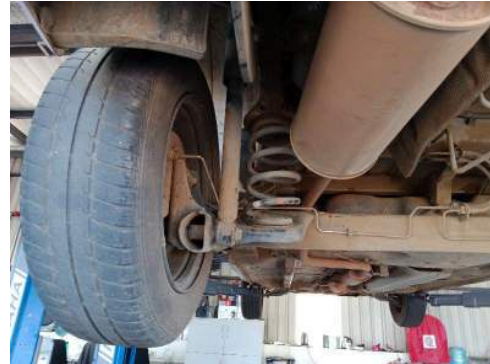
LR TYRE TREAD

| | Size | Load/Speed Index | Manufacture | Model | Type* | Production Date | Tread Depth (mm) |
|---|---|---|---|---|---|---|---|
| Rear Left | 185/65 R15 | 92T | Barum | Brillantis | V | 4719 | 1 mm |

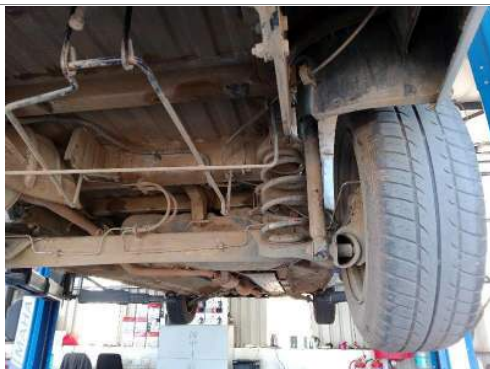
RR TYRE TREAD

| | Size | Load/Speed Index | Manufacture | Model | Type* | Production Date | Tread Depth (mm) |
|---|---|---|---|---|---|---|---|
| Rear Right | 185/65 R15 | 92T | Barum | Brillantis | V | 4719 | 1 mm |

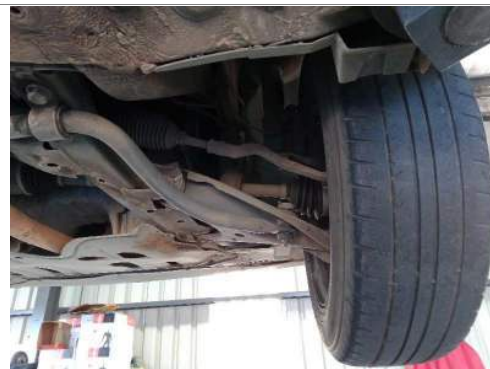
RF TYRE TREAD

| | Size | Load/Speed Index | Manufacture | Model | Type* | Production Date | Tread Depth (mm) |
|---|---|---|---|---|---|---|---|
| Front Right | 185/65 R15 | 88H | Encore | Reflex | V | 2020 | 1 mm |

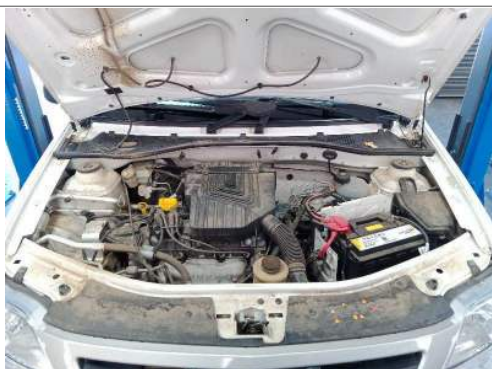
ENGINE 1

| Engine | Engine bay dirty. |

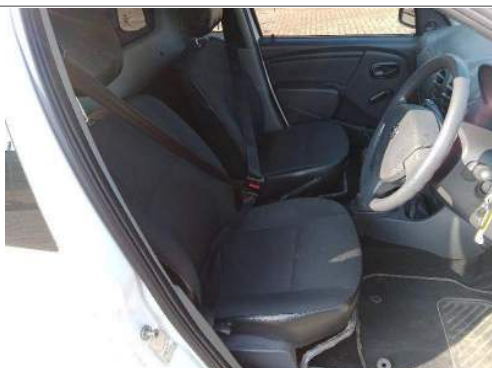
| Seat Front Right Damaged | Repair |

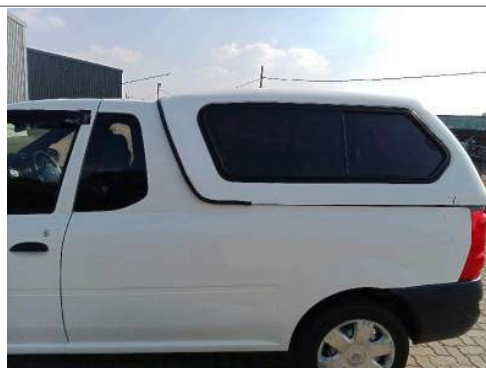
| Rear Fender Left Damaged | Repair |

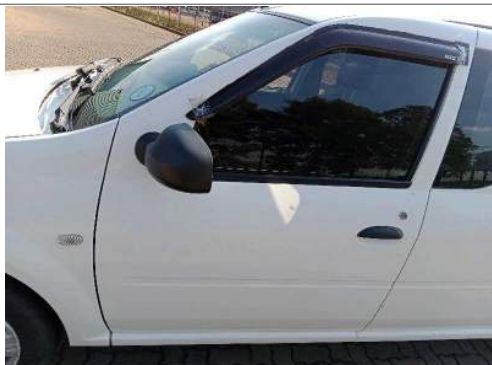
| Door Front Left Paintwork • Scratched | Repair |

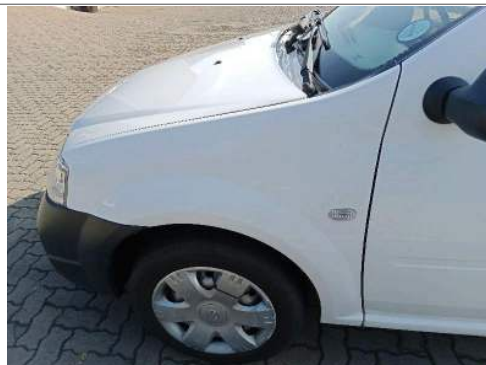
| Front Fender Left Dented | Repair |

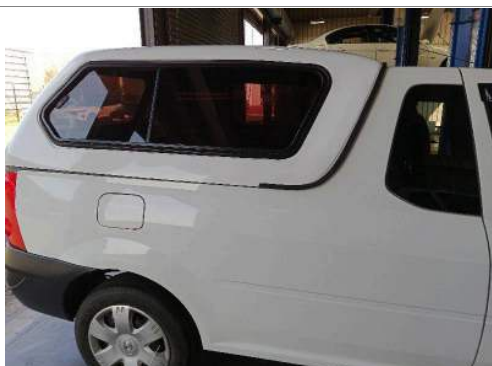
| Rear Fender Right Paintwork • Scratched | Repair |

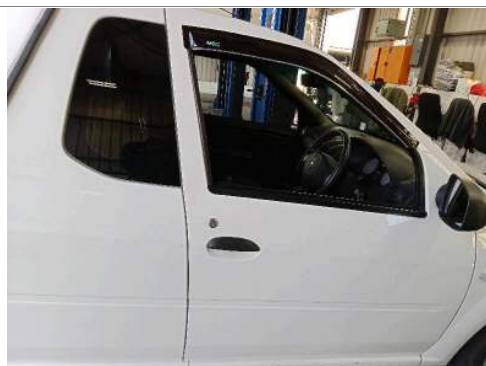
| Door Front Right Dented | Repair |

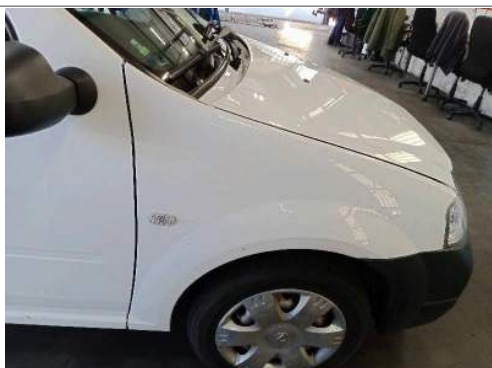
| Front Fender Right Paintwork • Scratched | Repair |

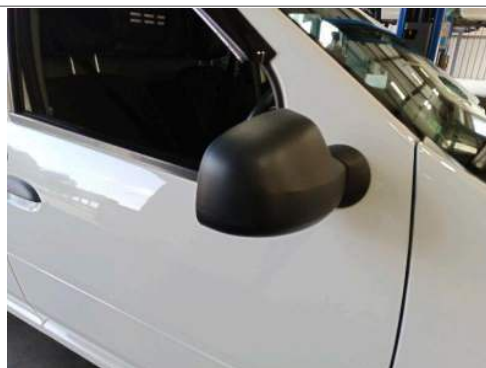
| Side Mirror Right Paintwork • Scratched | Repair |

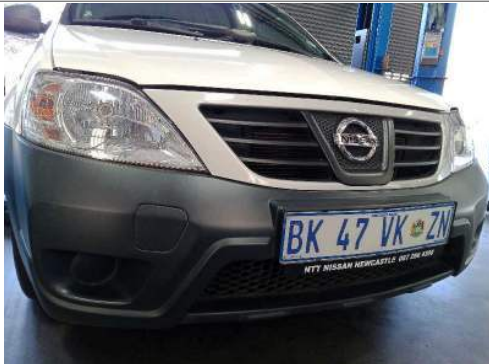
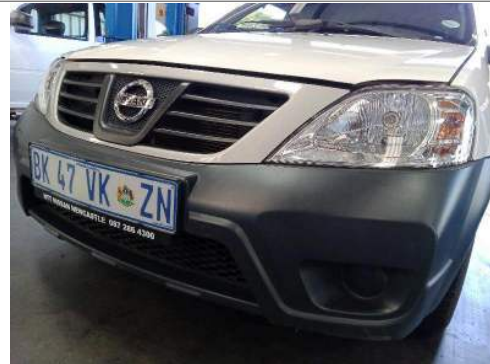
| Front Bumper Paintwork • Scratched | Repair |

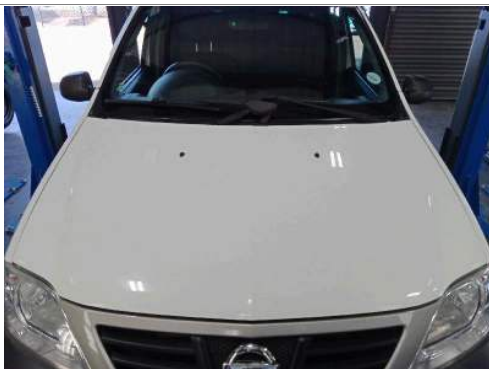
| Bonnet Dented | Repair |

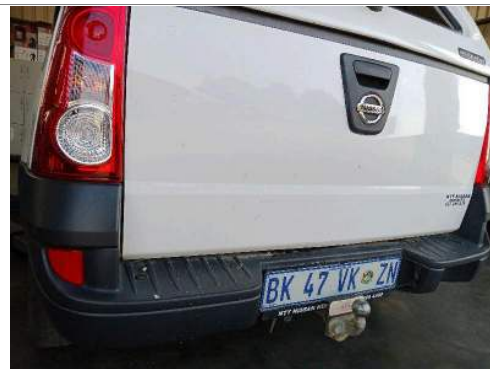
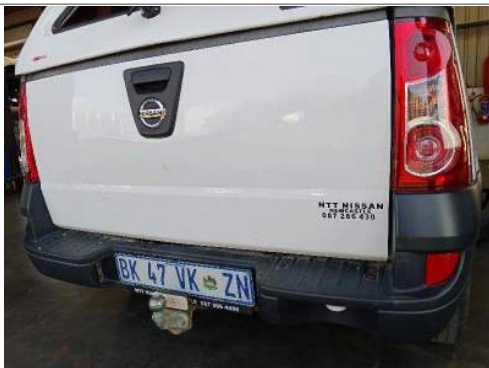
| Rear bumper Damaged | Repair |

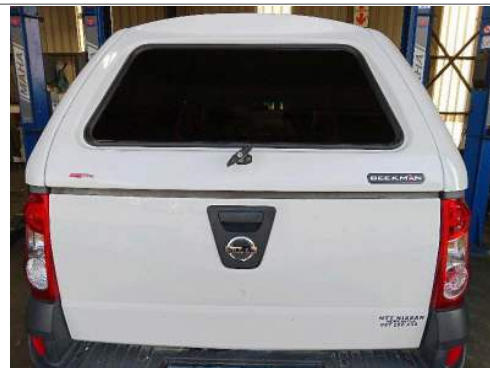
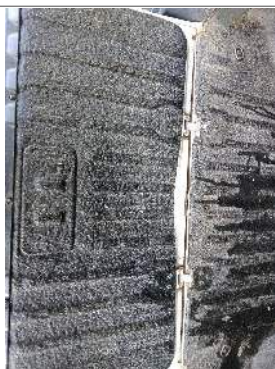
| Tailgate Damaged | Repair |

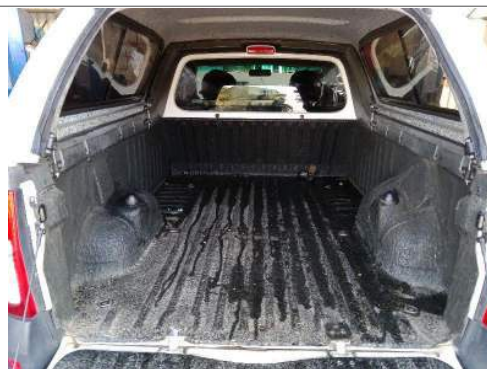
| Load Body Dented | Repair |

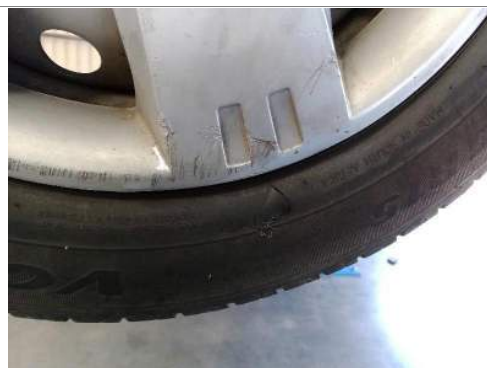
| Tyre Front Left Torn / Cut | Replace |

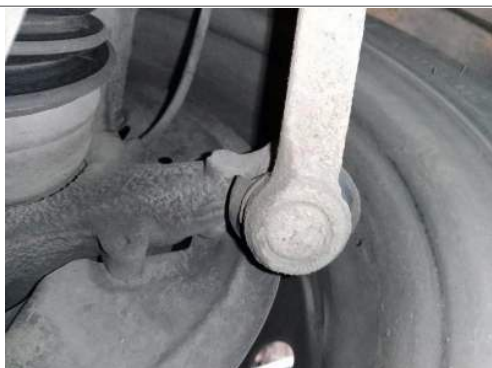
| Tie Rod End right Damaged | Replace |

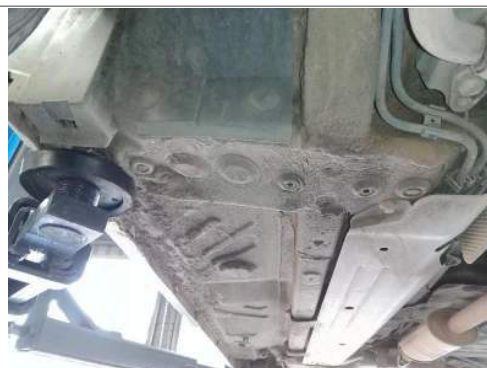
| Chassis Dented | Repair |

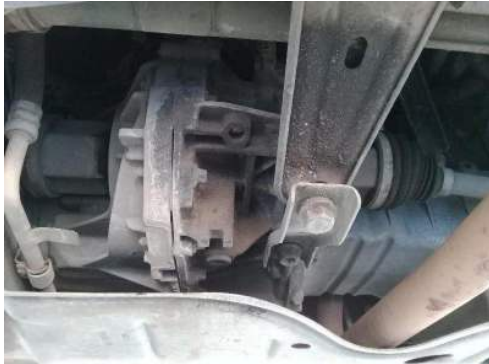
| Gearbox Oil Sweat | Repair |
