| Manufacturer | NISSAN | Registration Number | FXG759L |
| Model | NP200 1.6 8V BASE +AC SAFETY PU [2011-ON] | Register Number | |

## CONDITION REPORT

Report No: 2016649680

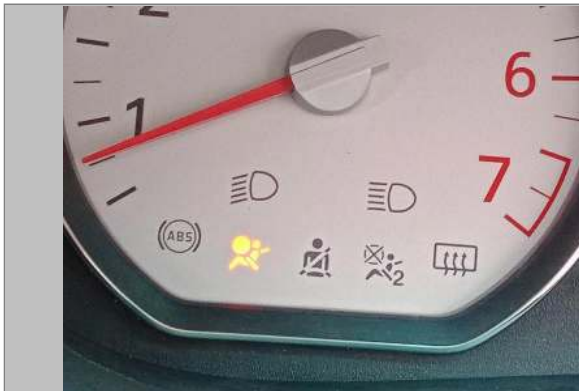
| Damage | Repair Way |
|---|---|
| Airbag warning lights illuminated | Repair |

Airbag warning lights illuminated

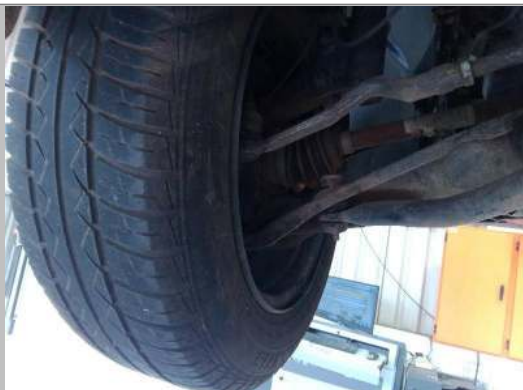
LF TYRE TREAD

| | Size | Load/Speed Index | Manufacture | Model | Type* | Production Date | Tread Depth (mm) |
|---|---|---|---|---|---|---|---|
| Front Left | 185/65R15 | 92T | Barum | Brillantis | V | 3620 | 3 mm |

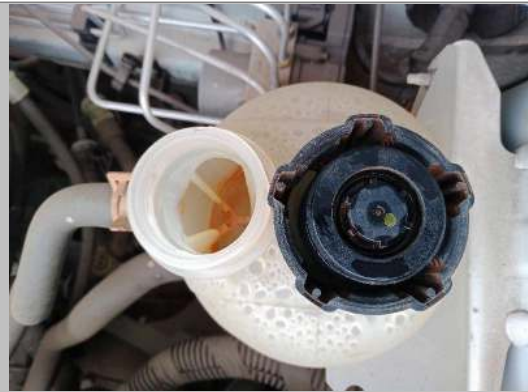
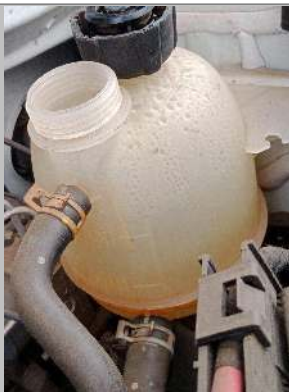
| Damage | Repair Way |
|---|---|
| Water level Insufficient | Repair |

Water level

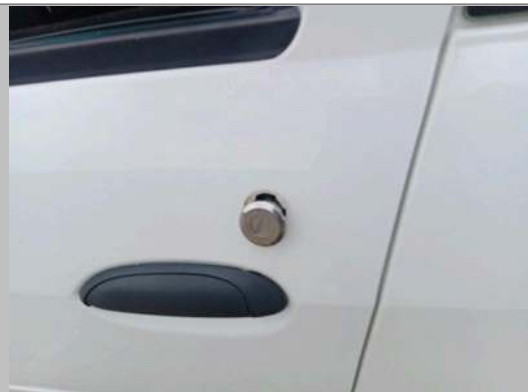
| Damage | Repair Way |
|---|---|
| Door Lock Front Left Damaged | Repair |

Door Lock Front Left

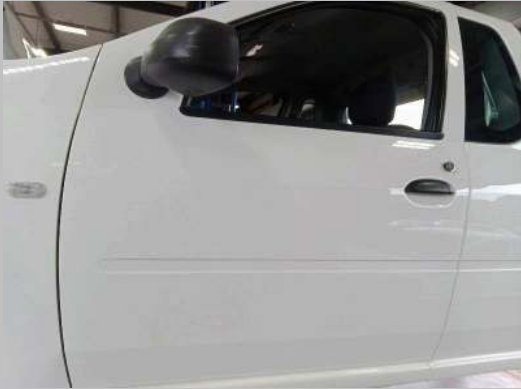
| Damage | Repair Way |
|---|---|
| Door Front Left Residual Traces of Repair | Repair |

Door Front Left

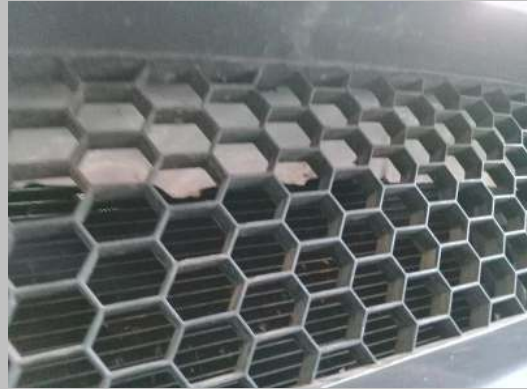
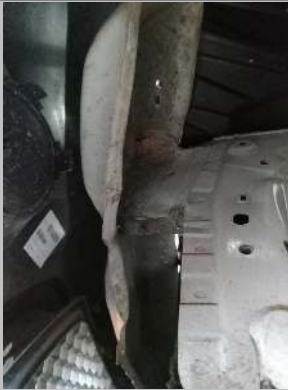
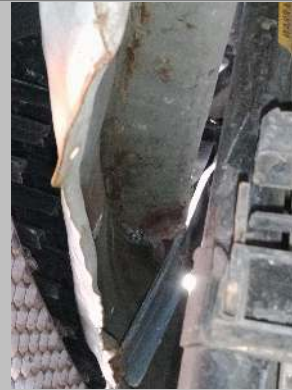
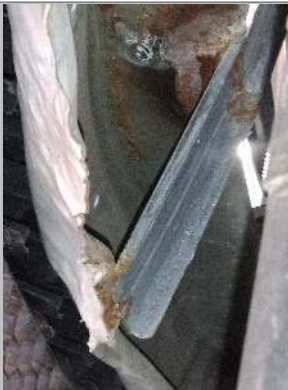
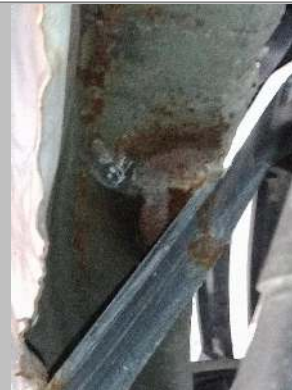
| Damage | Repair Way |
|---|---|
| Front Bumper Damaged | Repair |

Front Bumper

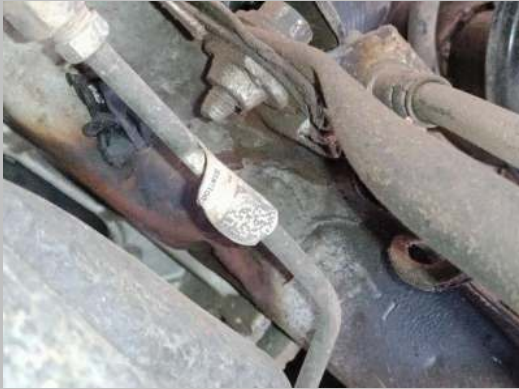
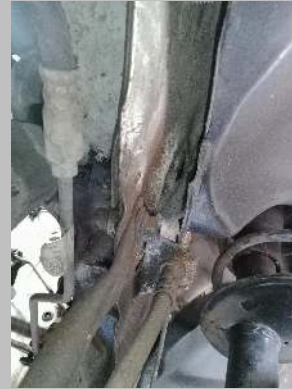
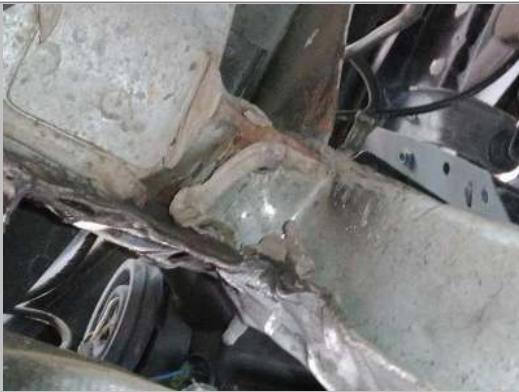
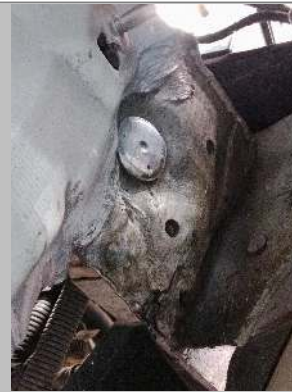
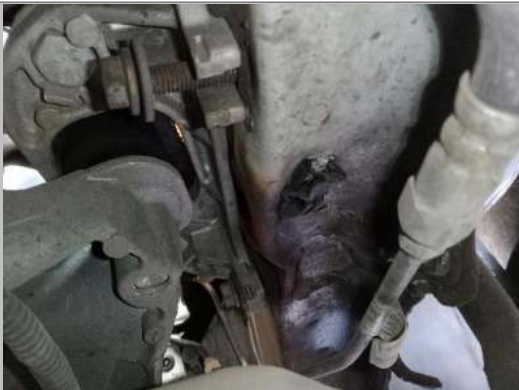
| Damage | Repair Way |
|---|---|
| Main Beam Left Damaged | Repair |
| Cut and join L/F main beam | Replace |

Main Beam Left
