## CONDITION REPORT

Report No:  
2016978055  
DATE  
13/08/2025

| Manufacturer | NISSAN | Registration Number | HP64FXGP |
| Model | NP200 1.5DCI BASE +AC SAFETY DSL PU<br>[2014-2022] | Register Number | |

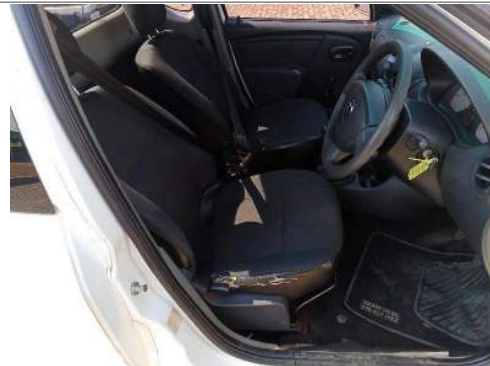
| Damage | Repair Way |
|---|---|
| Seat Front Right Damaged | Repair |

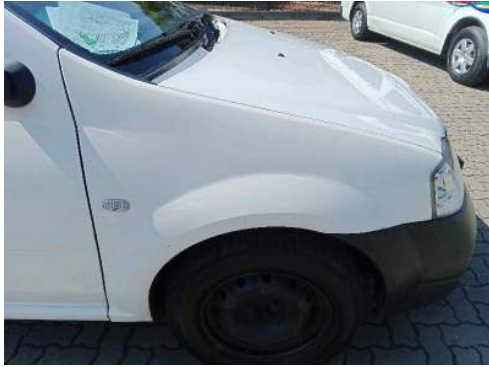
| Damage | Repair Way |
|---|---|
| Front Fender Right Damaged | Repair |

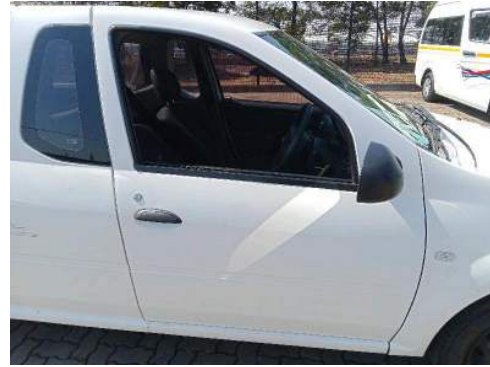
| Damage | Repair Way |
|---|---|
| Door Front Right Residual Traces of Repair | Repair |

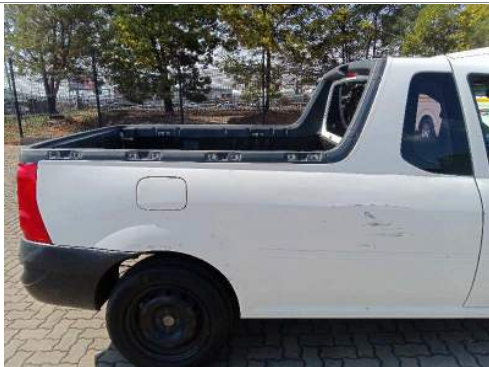
| Damage | Repair Way |
|---|---|
| Rear Fender Right Damaged | Repair |

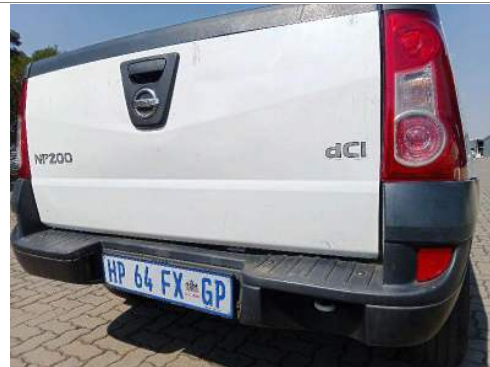
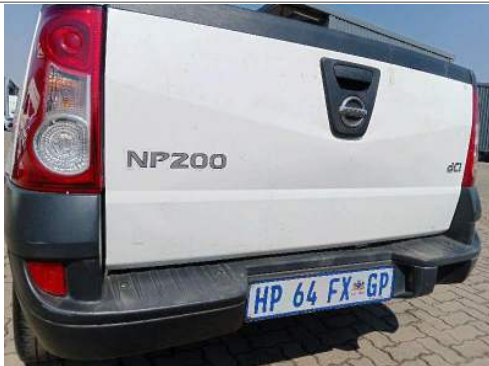
| Damage | Repair Way |
|---|---|
| Rear bumper Damaged | Repair |

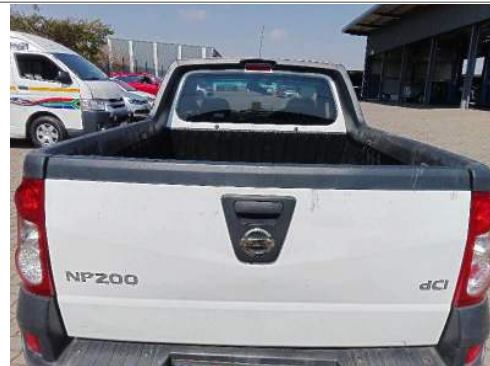
| Damage | Repair Way |
|---|---|
| Tailgate Paintwork • Scratched | Repair |

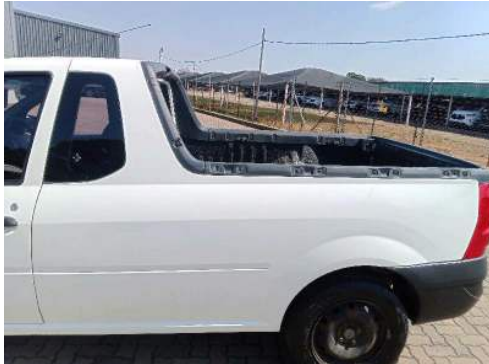
| Damage | Repair Way |
|---|---|
| Rear Fender Left Dented | Repair |

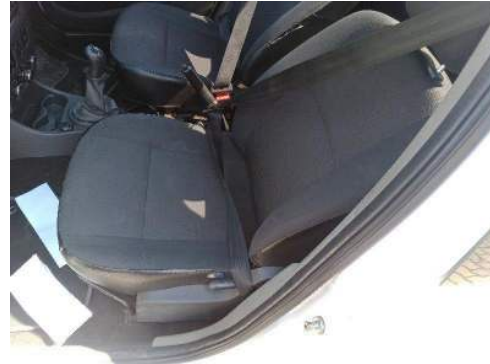
| Damage | Repair Way |
|---|---|
| Seat Front Left Damaged | Repair |

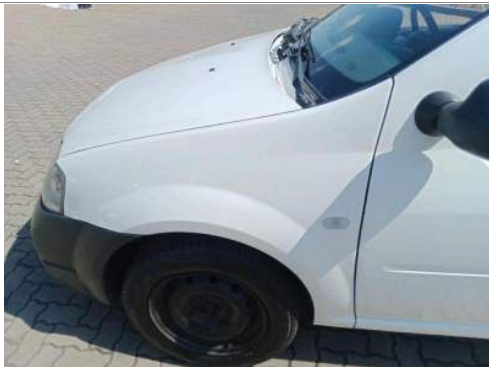
| Damage | Repair Way |
|---|---|
| Front Fender Left Damaged | Repair |

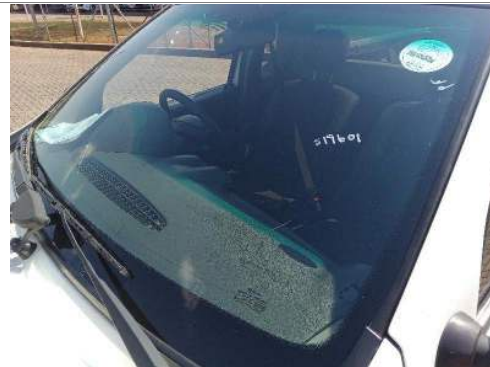
| Damage | Repair Way |
|---|---|
| Windscreen Cracked | Replace |

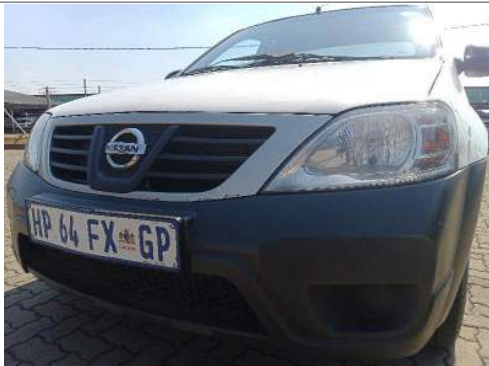
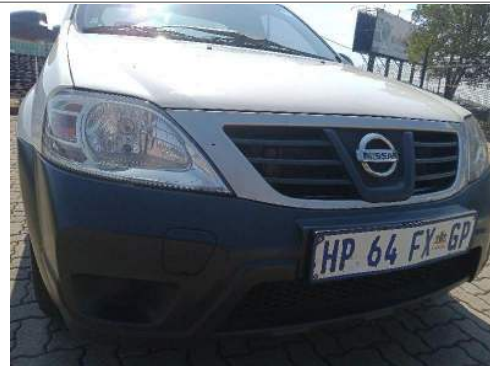
| Damage | Repair Way |
|---|---|
| Front Bumper Damaged | Repair |
| Body and Exterior | Signs of impact damage to front of vehicle |

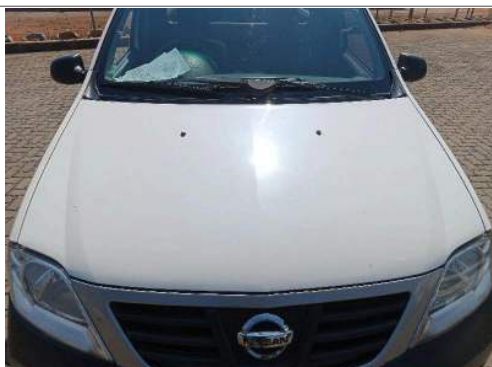
| Damage | Repair Way |
|---|---|
| Bonnet Damaged | Repair |

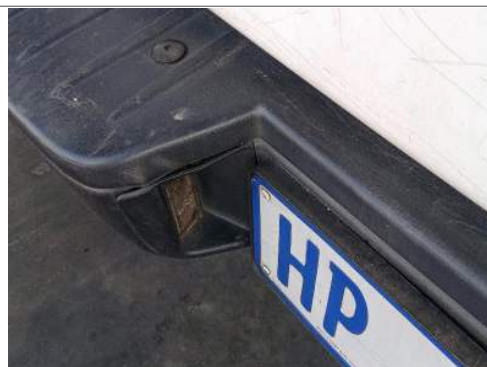
| Damage | Repair Way |
|---|---|
| Number Plate Light Left Damaged | Replace |

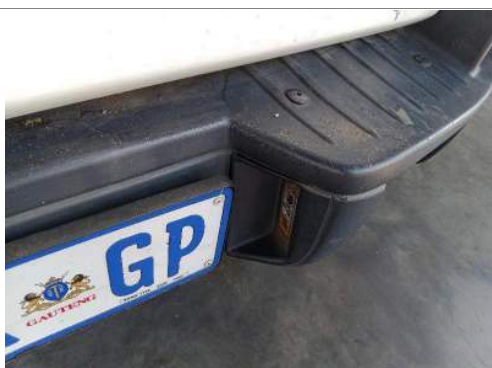
| Damage | Repair Way |
|---|---|
| Number Plate Light Right Damaged | Replace |

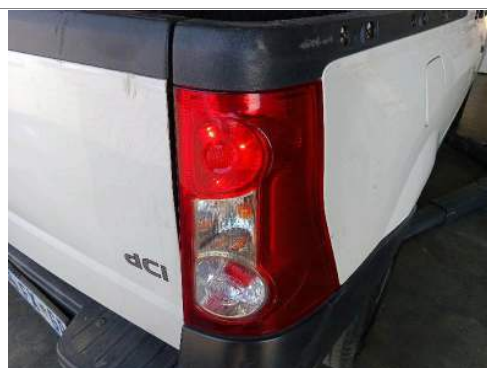
| Damage | Repair Way |
|---|---|
| Tail Light Right Scratched | Repair |

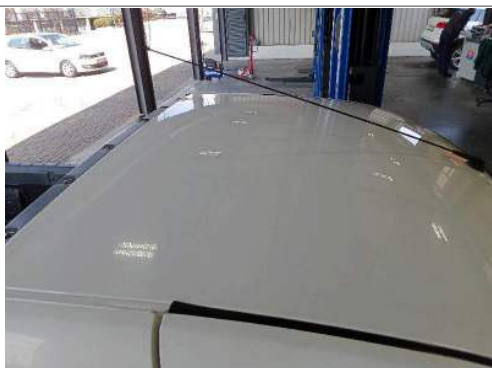
| Damage | Repair Way |
|---|---|
| Roof Dented | Repair |

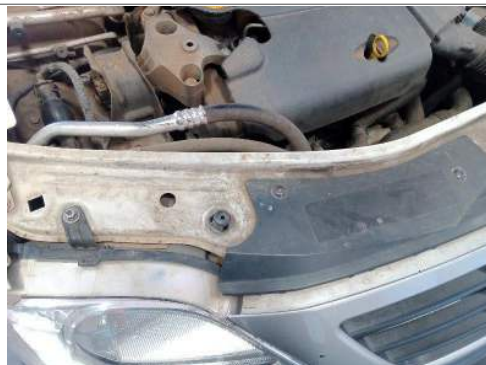
| Damage | Repair Way |
|---|---|
| Bonnet slam plate (Shock tower/ Inner tray) Dented | Repair |

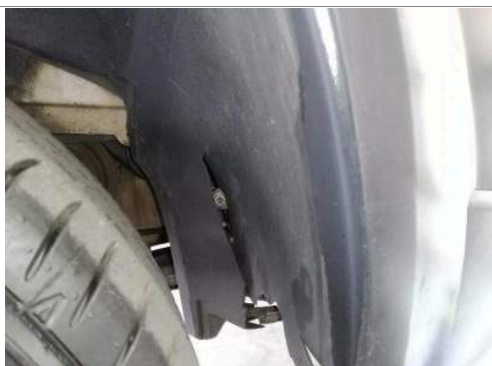
| Damage | Repair Way |
|---|---|
| Front Fender Right / Inner Tray Damaged | Repair |

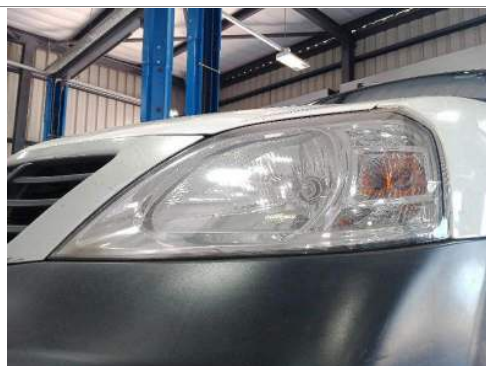
| Damage | Repair Way |
|---|---|
| Headlight Left Cracked | Replace |

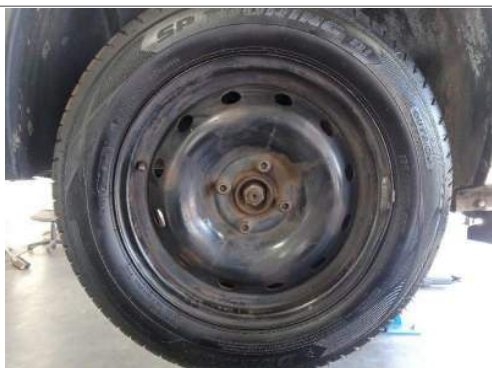
| Damage | Repair Way |
|---|---|
| Rim Front Left Dented | Repair |

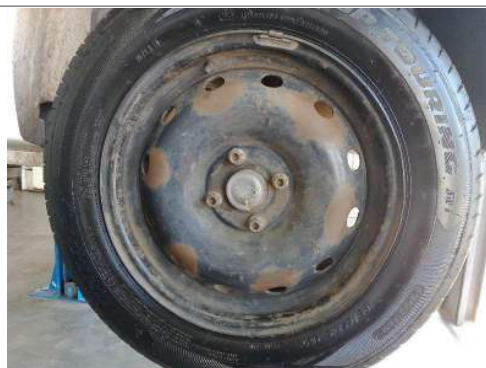
| Damage | Repair Way |
|---|---|
| Rim Rear Left Dented | Repair |

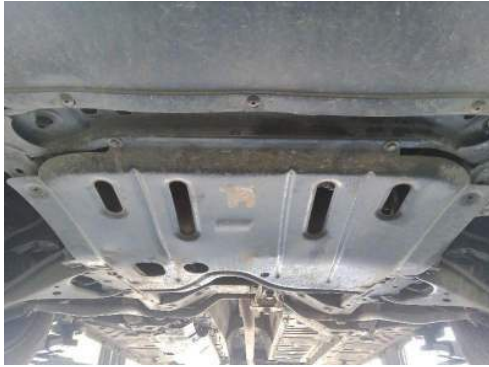
| Damage | Repair Way |
|---|---|
| Belly plates Damaged | Repair |

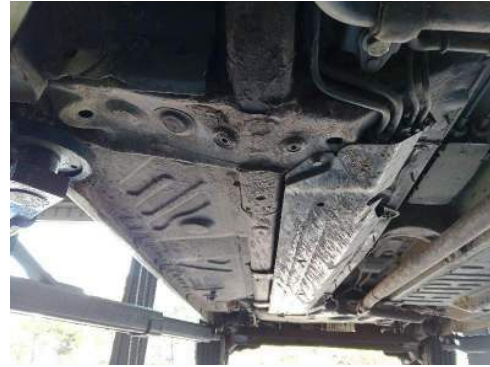
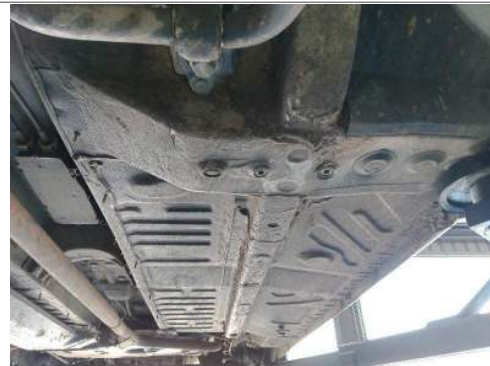
| Damage | Repair Way |
|---|---|
| Chassis Damaged | Repair |

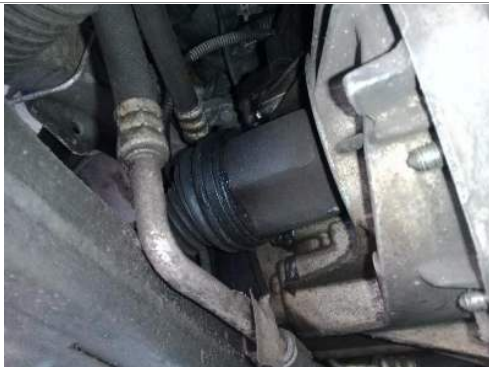
| Damage | Repair Way |
|---|---|
| CV Joint(s) Boot(s) Front Left (inner/outer) Defective | Replace |

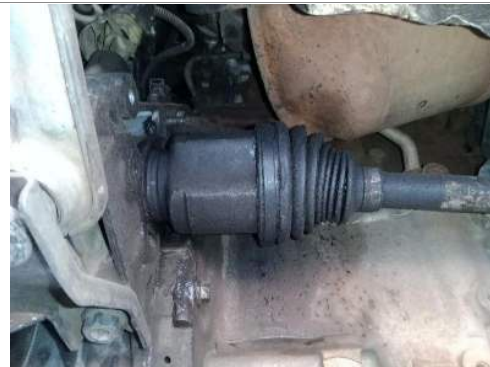
| Damage | Repair Way |
|---|---|
| CV Joint(s) Boot(s) Front Right (inner/outer) Defective | Replace |

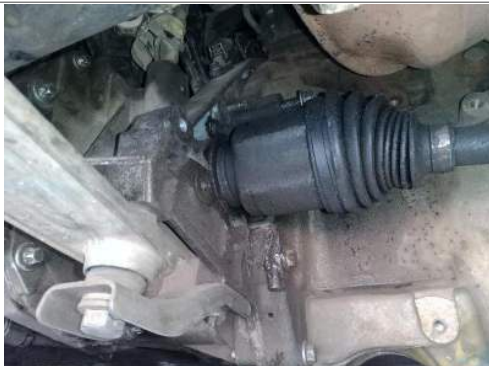
| Damage | Repair Way |
|---|---|
| Gearbox Oil Sweat | Repair |
| Undercarriage | Some loose bolts on gearbox |

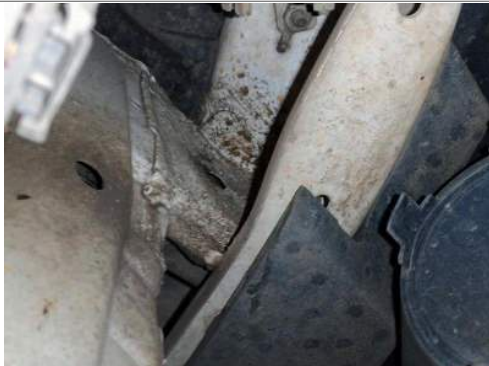
| Damage | Repair Way |
|---|---|
| Main Beam Right Residual Traces of Repair | Repair |

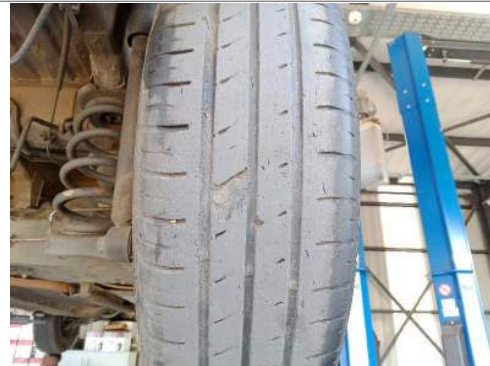
| Damage | Repair Way |
|---|---|
| Tyre Rear Right Damaged | Replace |

| | Size | Load/Speed Index | Manufacture | Model | Type* | Production Date | Tread Depth (mm) |
|---|---|---|---|---|---|---|---|
| Rear Right | 185/65 R15 | 88H | Kumho | Ecowing | V | 3722 | 0 mm |

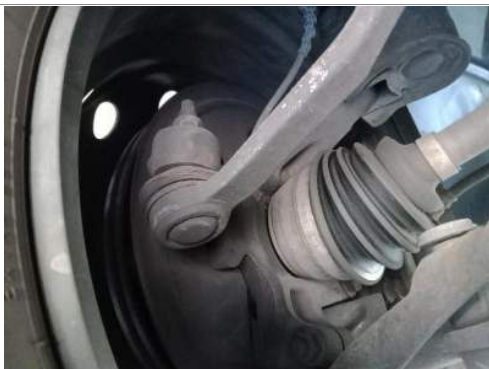
| Damage | Repair Way |
|---|---|
| Tie Rod End left Cracked | Replace |

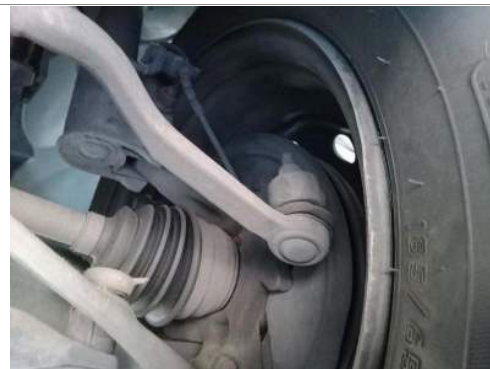
| Damage | Repair Way |
|---|---|
| Tie Rod End right Cracked | Replace |

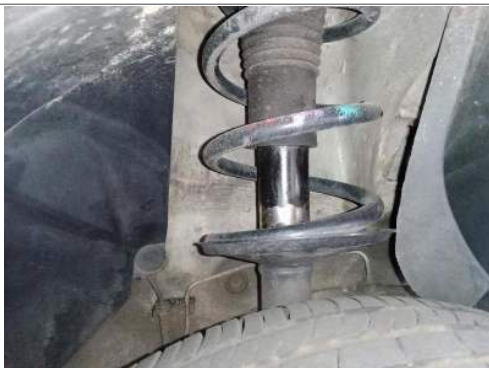
| Damage | Repair Way |
|---|---|
| Shock Absorber Front Right Leak | Replace |

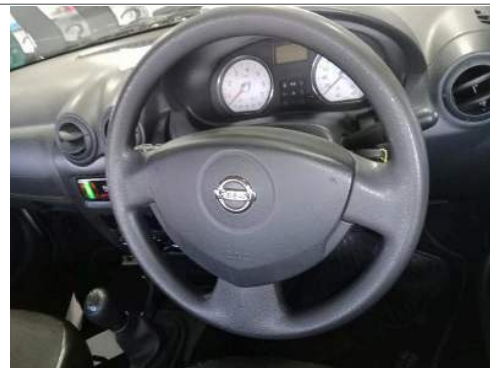
| Damage | Repair Way |
|---|---|
| Steering Wheel Trim Defective | Repair |
