MFC Auction House  
M57 Pretoria Rd, Glenmarais, KEMPTON PARK  
Gauteng

DEKRA MFC  
M57 Pretoria Rd - 1619  
KEMPTON PARK - GT  
08610 33572

| Manufacturer | RENAULT | Registration Number | CX11VNGP |
| Model | SANDERO 1.6I STEPWAY 5-DR [2013-2015] | Register Number | |

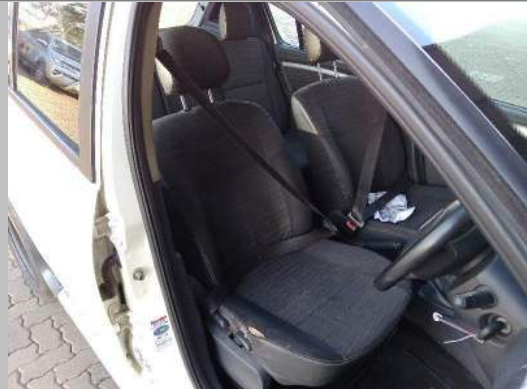
| Damage | Repair Way |
|---|---|
| Seat Front Right Damaged | Repair |

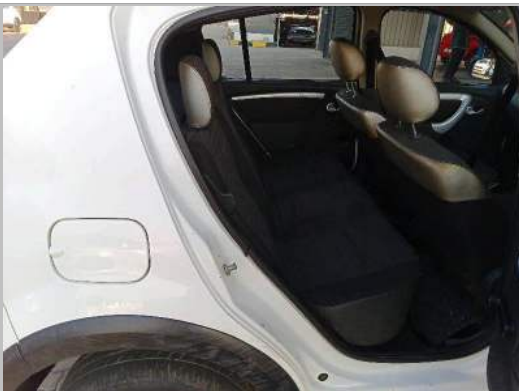
| Damage | Repair Way |
|---|---|
| C • Pillar Right Damaged | Repair |

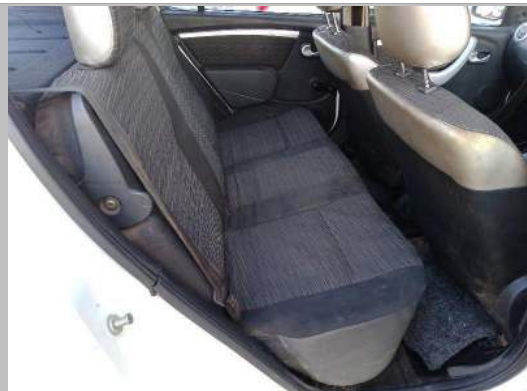
| Damage | Repair Way |
|---|---|
| Seat Rear Damaged | Repair |

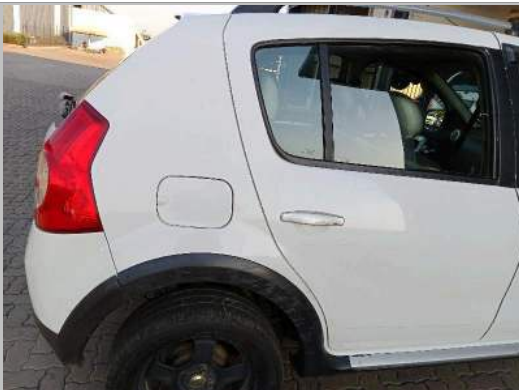
| Damage | Repair Way |
|---|---|
| Rear Fender Right Damaged | Repair |

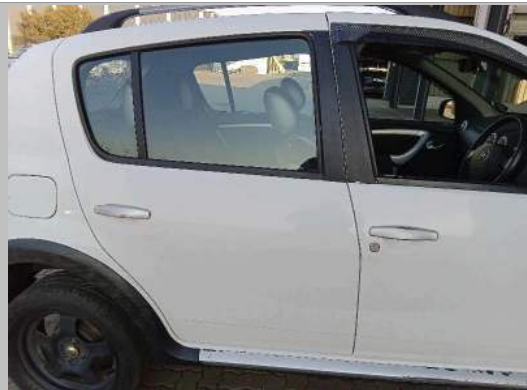
| Damage | Repair Way |
|---|---|
| Door Rear Right Damaged | Repair |

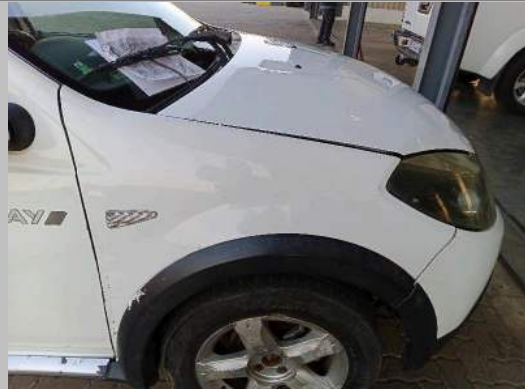
| Damage | Repair Way |
|---|---|
| Front Fender Right Damaged | Repair |

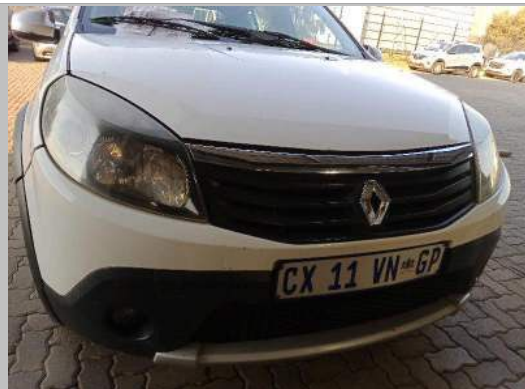
| Damage | Repair Way |
|---|---|
| Front Bumper Damaged | Repair |

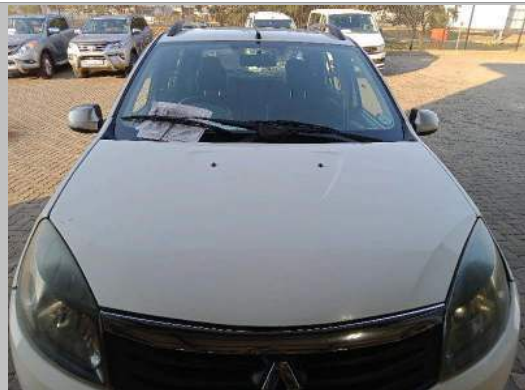
| Damage | Repair Way |
|---|---|
| Bonnet Paintwork • Scratched | Repair |

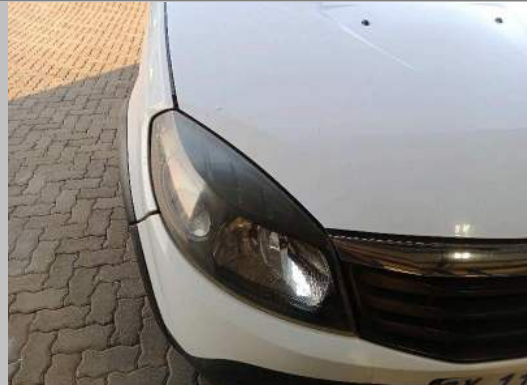
| Damage | Repair Way |
|---|---|
| Headlight Right Defective | Replace |

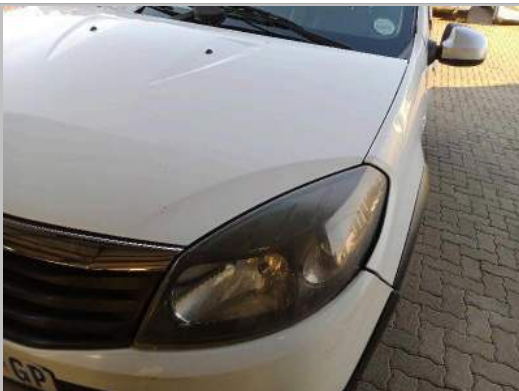
| Damage | Repair Way |
|---|---|
| Headlight Left Defective | Replace |

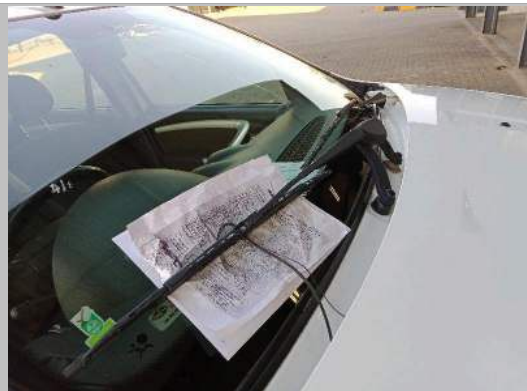
| Damage | Repair Way |
|---|---|
| Windscreen Wiper Damaged | Replace |

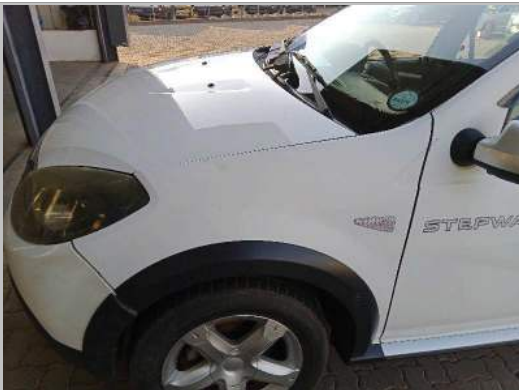
| Damage | Repair Way |
|---|---|
| Front Fender Left Damaged | Repair |

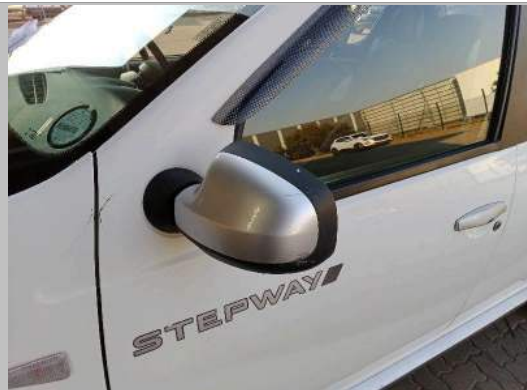
| Damage | Repair Way |
|---|---|
| Side Mirror Left Paintwork • Scratched | Repair |

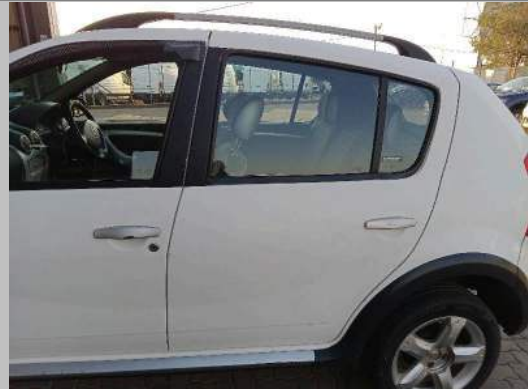
| Damage | Repair Way |
|---|---|
| Door Rear Left Damaged | Repair |

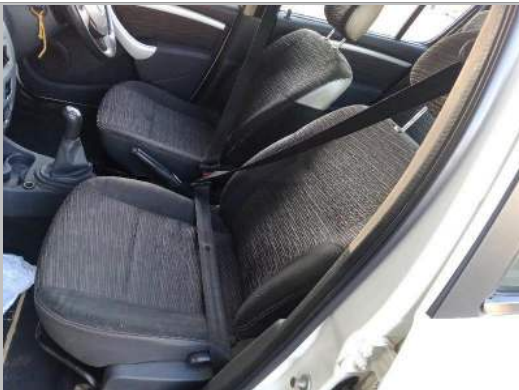
| Damage | Repair Way |
|---|---|
| Seat Front Left Damaged | Repair |

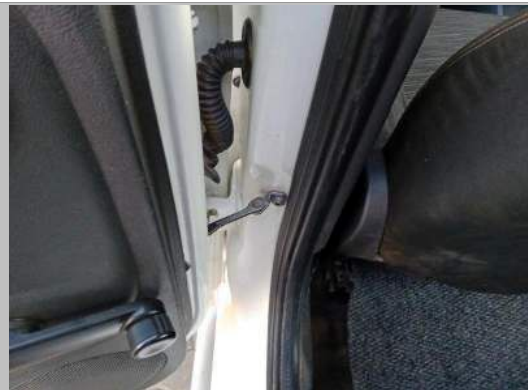
| Damage | Repair Way |
|---|---|
| Doorstopper Rear Left Defective | Repair |

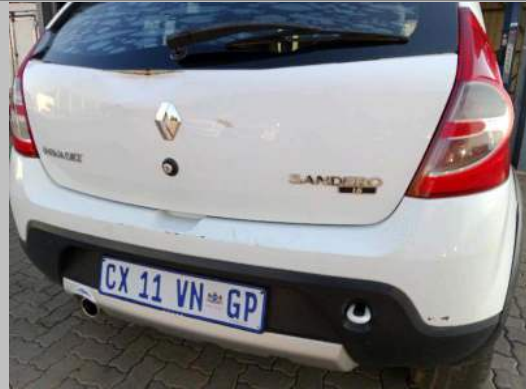
| Damage | Repair Way |
|---|---|
| Rear bumper Damaged | Repair |

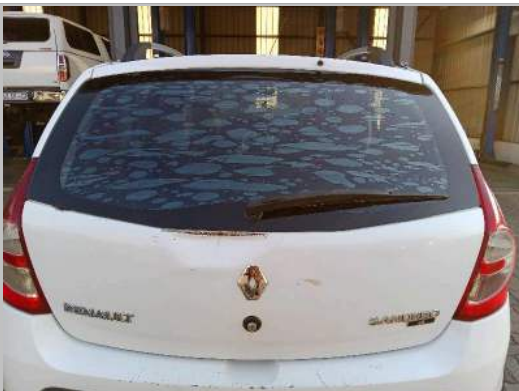
| Damage | Repair Way |
|---|---|
| Boot Lid / Hatch door Damaged | Repair |

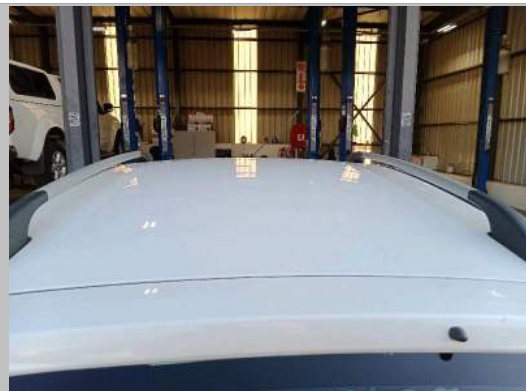
| Damage | Repair Way |
|---|---|
| Roof Dented | Repair |

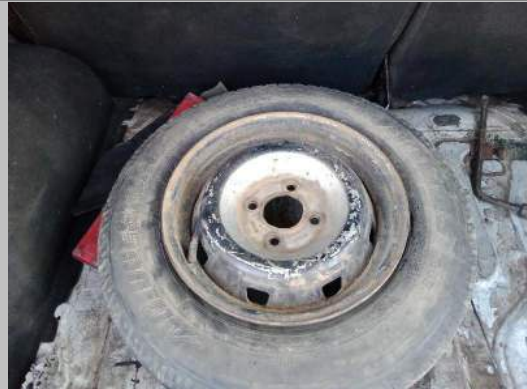
| Damage | Repair Way |
|---|---|
| Rim Spare Wheel Dented | Repair |

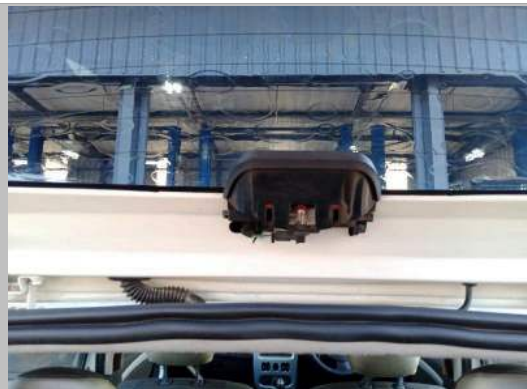
| Damage | Repair Way |
|---|---|
| Brake Light Centre Defective | Repair |

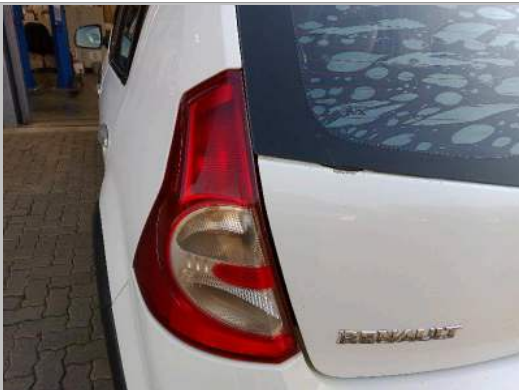
| Damage | Repair Way |
|---|---|
| Tail Light Left Cracked | Replace |

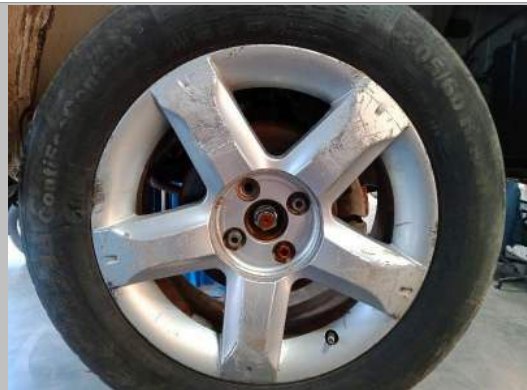
| Damage | Repair Way |
|---|---|
| Rim Front Right Scratched | Repair |

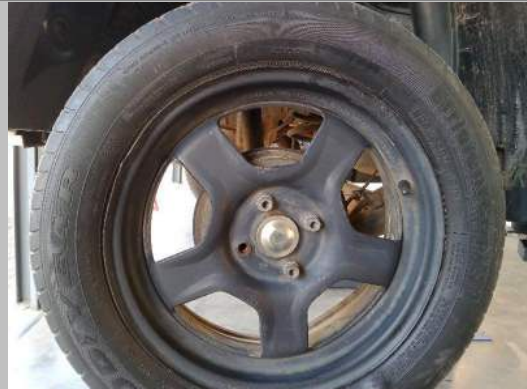
| Damage | Repair Way |
|---|---|
| Bolt(s) / Nut(s) Rear Wheel Right Missing | Replace |

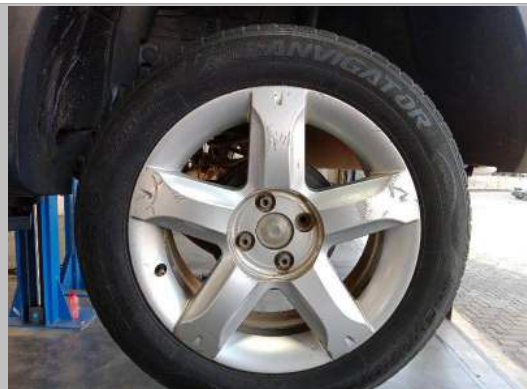
| Damage | Repair Way |
|---|---|
| Rim Rear Left Scratched | Repair |

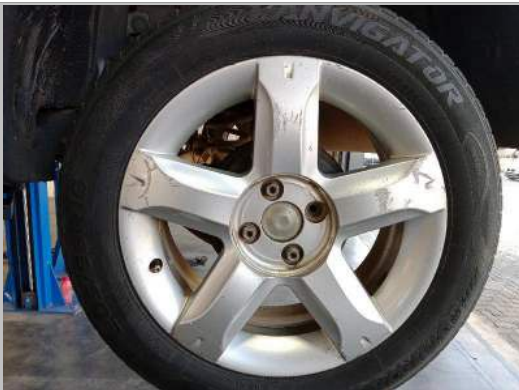
| Damage | Repair Way |
|---|---|
| Bolt(s) / Nut(s) Rear Wheel Left Missing | Replace |

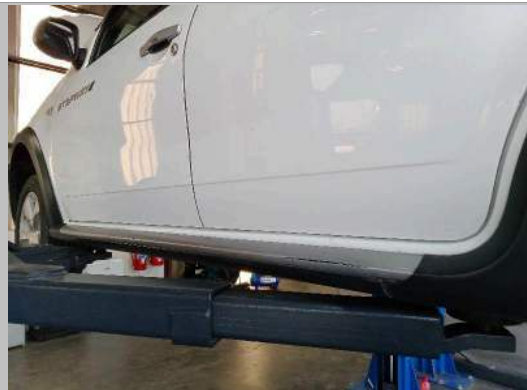
| Damage | Repair Way |
|---|---|
| Sill Panel Left Damaged | Repair |

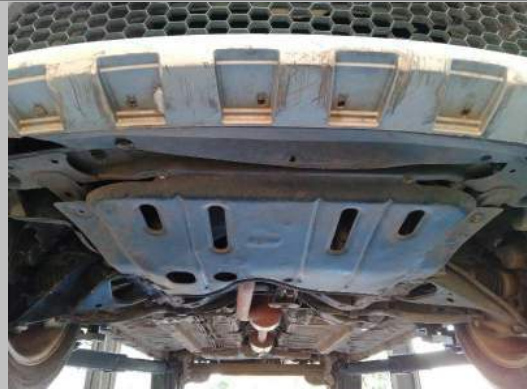
| Damage | Repair Way |
|---|---|
| Belly plates Damaged | Repair |

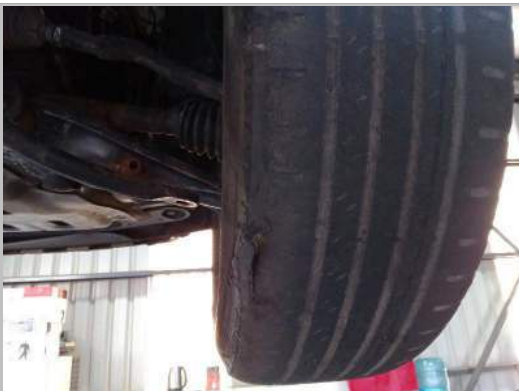
| Damage | Repair Way |
|---|---|
| Tyre Front Right Worn | Replace |

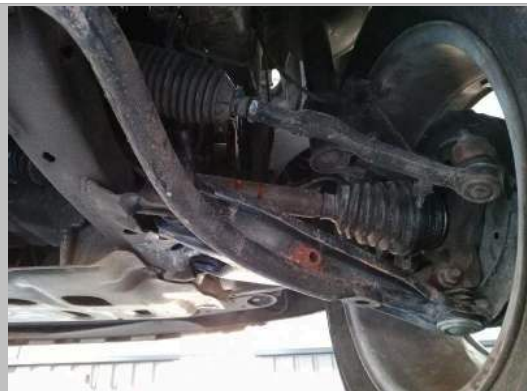
| Damage | Repair Way |
|---|---|
| Stabilizer Mounting Front Right Missing | Replace |

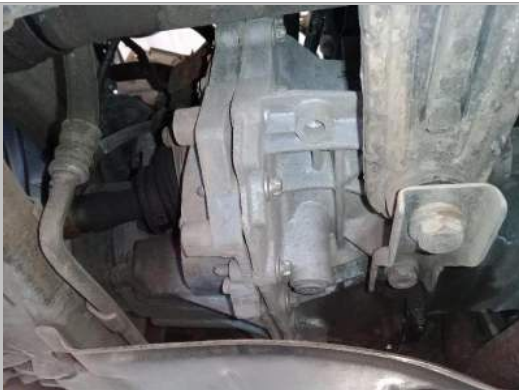
| Damage | Repair Way |
|---|---|
| Gearbox Oil Leak | Repair |

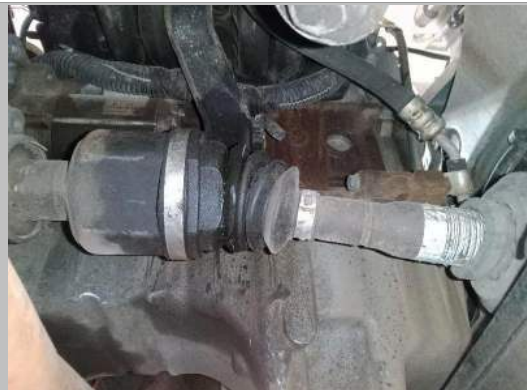
| Damage | Repair Way |
|---|---|
| CV Joint(s) Boot(s) Front Right (inner/outer) Damaged | Replace |

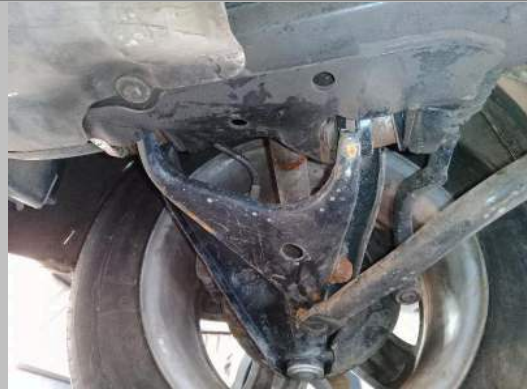
| Damage | Repair Way |
|---|---|
| Control Arm(s) Front Axle Right Welded | Replace |

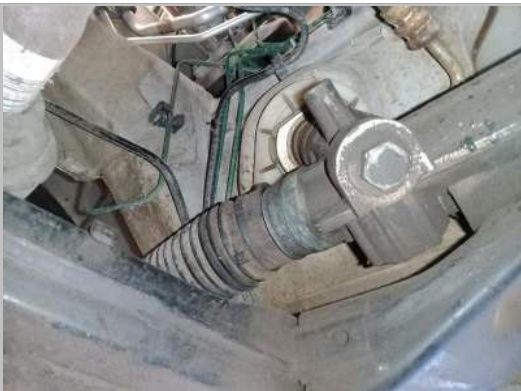
| Damage | Repair Way |
|---|---|
| Steering Rack Boot Right Damaged | Replace |

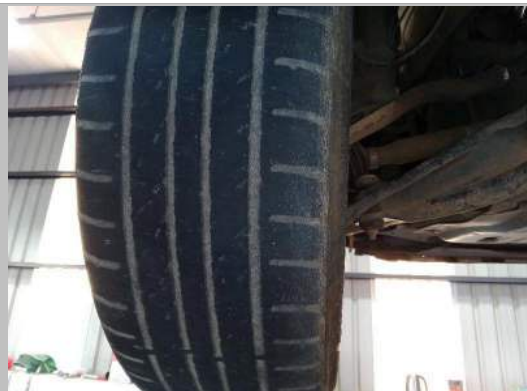
| Damage | Repair Way |
|---|---|
| Tyre Front Left Worn | Replace |

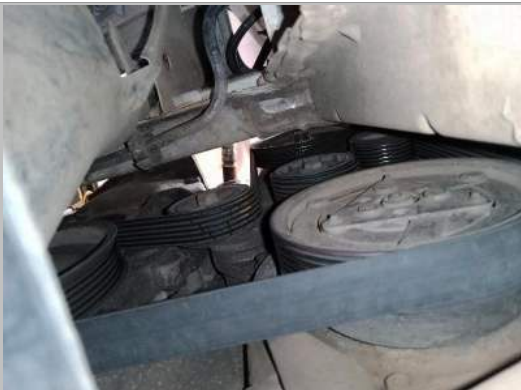
| Damage | Repair Way |
|---|---|
| Fan Belt Defective | Replace |

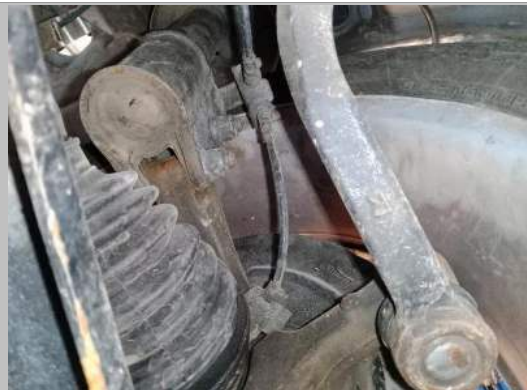
| Damage | Repair Way |
|---|---|
| Speed Sensor Damaged | Replace |

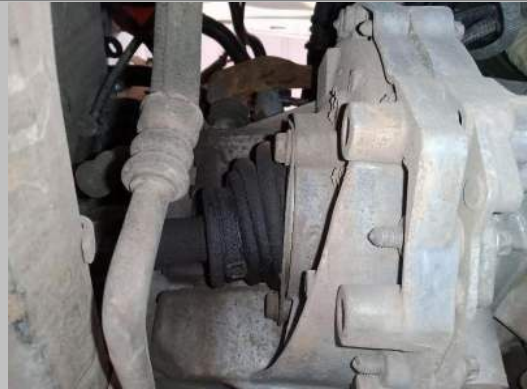
| Damage | Repair Way |
|---|---|
| CV Joint(s) Front Left (inner/outer) Defective | Replace |

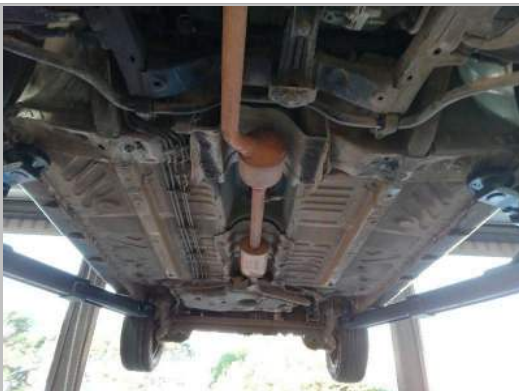
| Damage | Repair Way |
|---|---|
| Chassis Damaged | Repair |

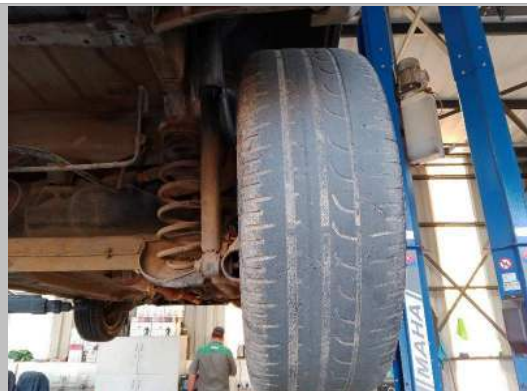
| Damage | Repair Way |
|---|---|
| Tyre Rear Right Damaged | Replace |

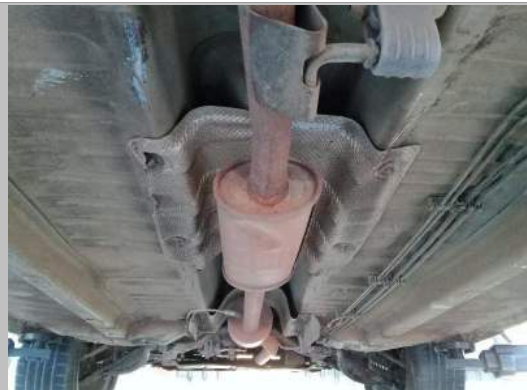
| Damage | Repair Way |
|---|---|
| Silencer Damaged | Replace |

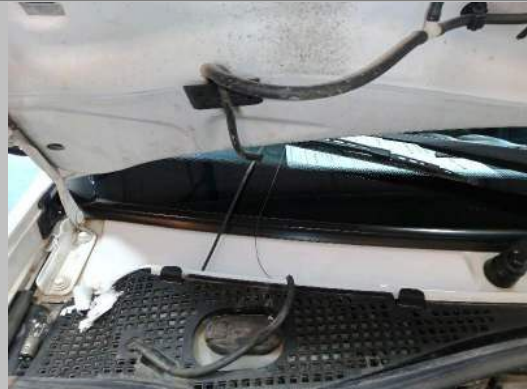
| Damage | Repair Way |
|---|---|
| Windscreen Washer Damaged | Replace |

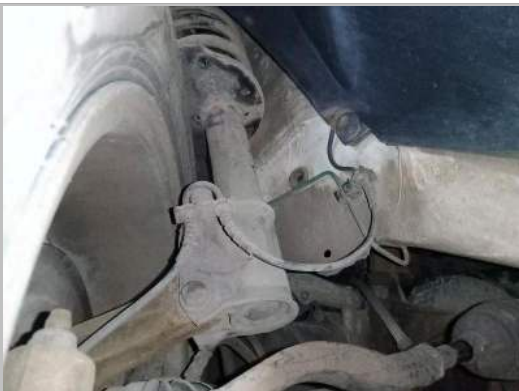
| Damage | Repair Way |
|---|---|
| Shock Absorber Front Left Damaged | Replace |
| Front left and right shock absorbers weak | Replace |

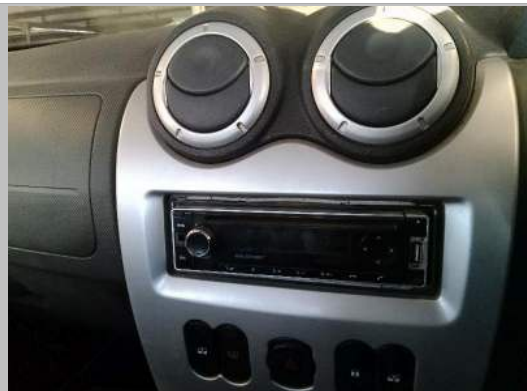
| Damage | Repair Way |
|---|---|
| Radio/CD/USB Damaged | Replace |
