MFC Auction House
M57 Pretoria Rd, Glenmarais, KEMPTON PARK
Gauteng

VEHICLE INSPECTION

CONDITION REPORT

Report No: 2016309471

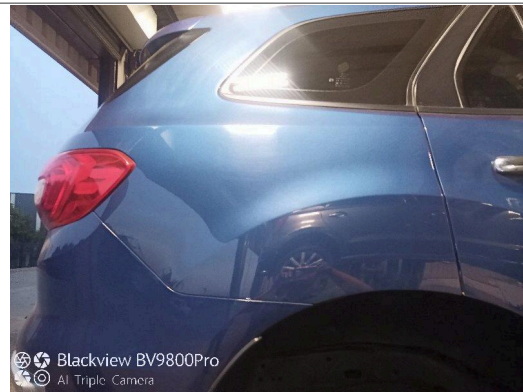
Damage	Repair Way
Front Bumper Paintwork • Scratched	Repair
Front Fender Left Paintwork • Scratched	Repair
Front Fender Right Paintwork • Scratched	Repair
Rear Fender Left Paintwork • Scratched	Repair
Rear Fender Right Paintwork • Scratched	Repair
Door Front Left Paintwork • Scratched	Repair
Door Front Right Dented	Repair
Door Rear Left Paintwork • Scratched	Repair
Door Rear Right Paintwork • Scratched	Repair
Rear bumper Paintwork • Scratched	Repair
Windscreen Chipped	Repair
Gearbox Oil Leak	Repair
