## CONDITION REPORT

Report No: 2016388044

DATE  
22/05/2024

| Manufacturer | FORD | Registration Number | FKN035L |

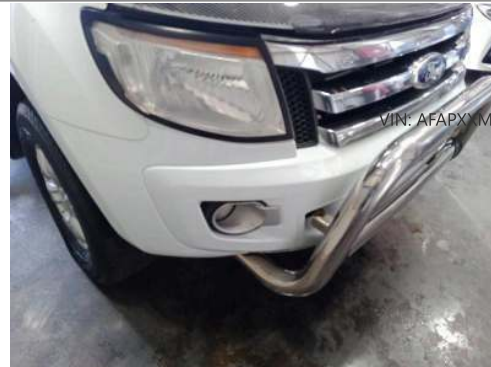
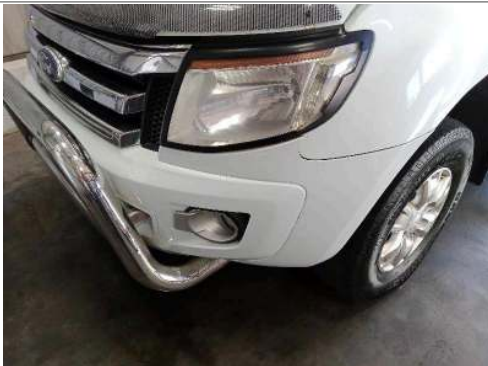
| Damage | Repair Way |
|---|---|
| Front Bumper Damaged | Repair |

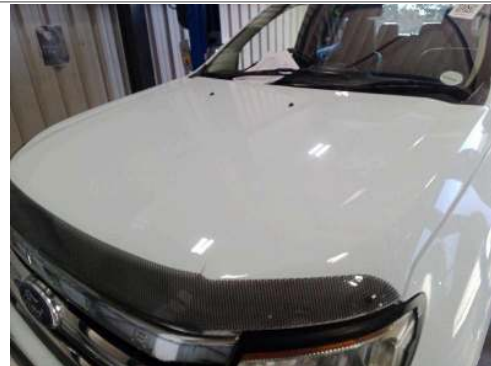
| Damage | Repair Way |
|---|---|
| Bonnet Damaged | Repair |

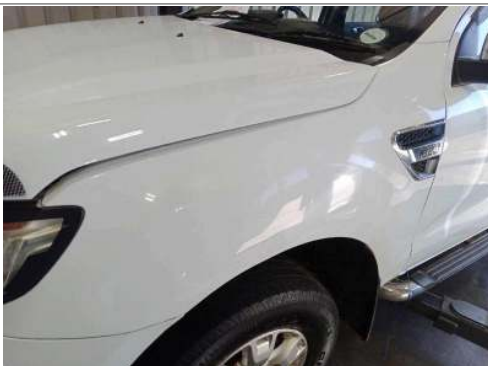
| Damage | Repair Way |
|---|---|
| Front Fender Left Damaged | Repair |

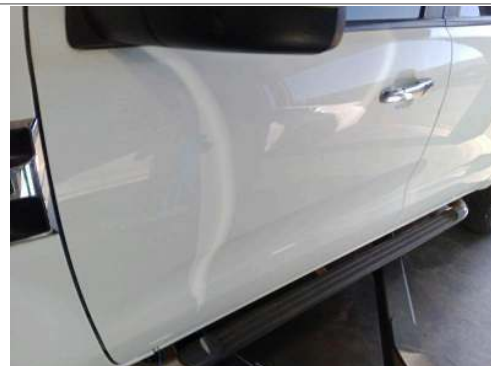
| Damage | Repair Way |
|---|---|
| Door Front Left Damaged | Repair |

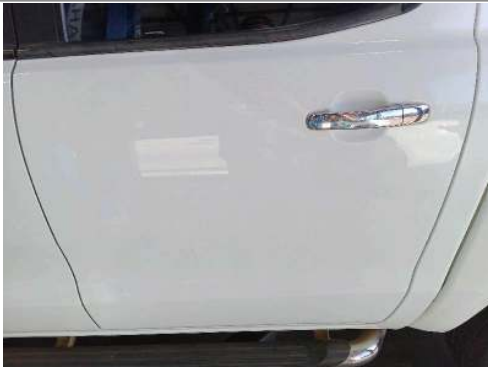
| Damage | Repair Way |
|---|---|
| Door Rear Left Damaged | Repair |

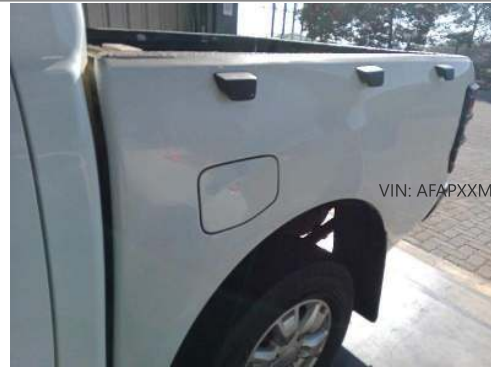
| Damage | Repair Way |
|---|---|
| Rear Fender Left Damaged | Repair |

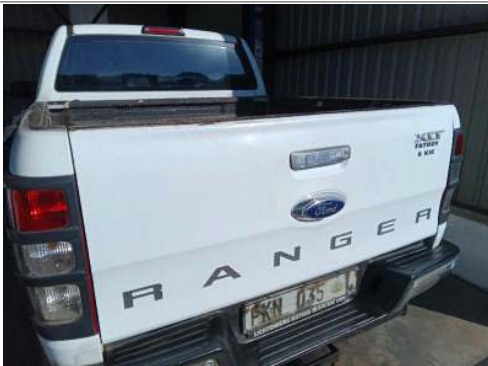
| Damage | Repair Way |
|---|---|
| Tailgate Damaged | Repair |

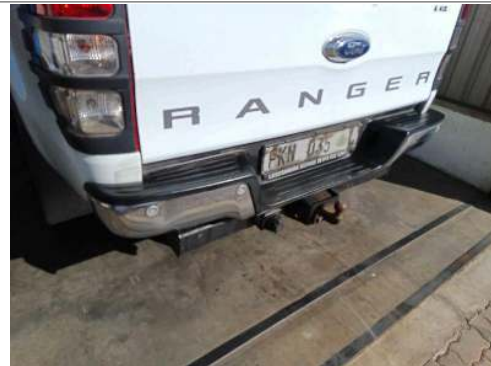
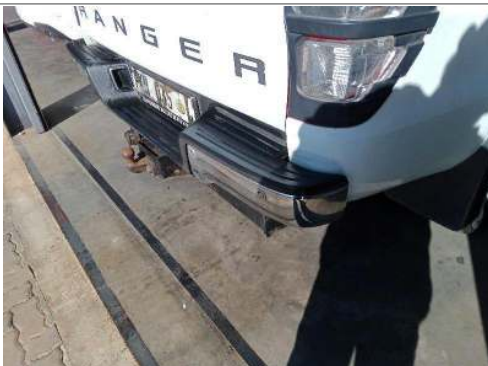
| Damage | Repair Way |
|---|---|
| Rear bumper Damaged | Repair |

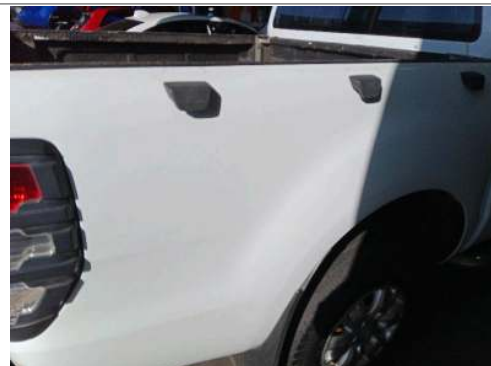
| Damage | Repair Way |
|---|---|
| Rear Fender Right Damaged | Repair |

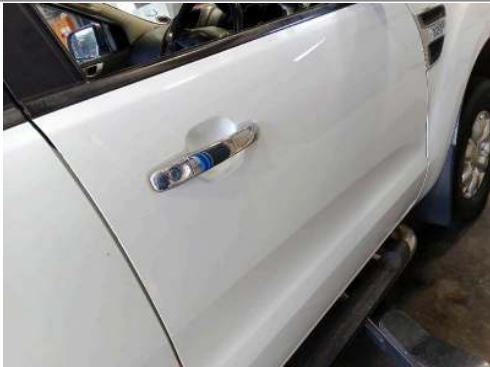
| Damage | Repair Way |
|---|---|
| Door Front Right Damaged | Repair |

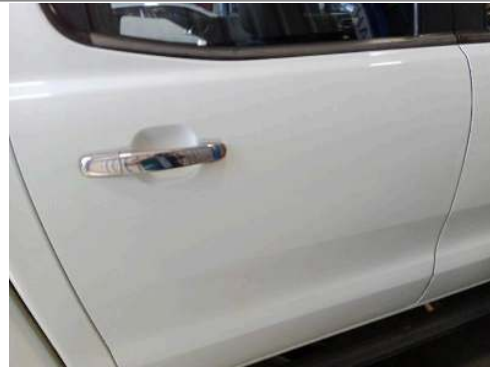
| Damage | Repair Way |
|---|---|
| Door Rear Right Damaged | Repair |

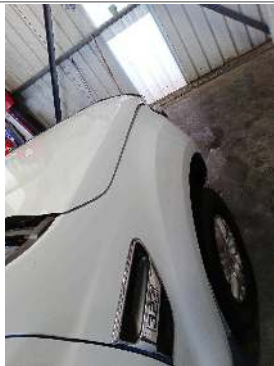
| Damage | Repair Way |
|---|---|
| Front Fender Right Damaged | Repair |

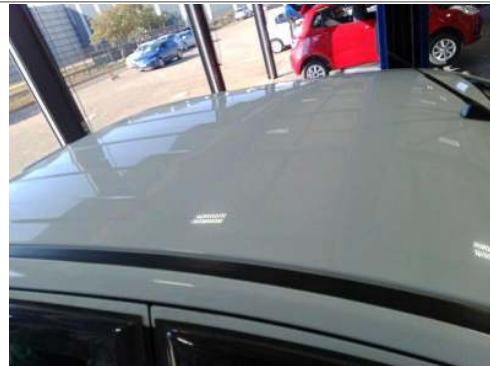
| Damage | Repair Way |
|---|---|
| Roof Damaged | Repair |

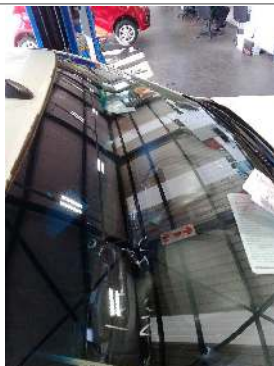
| Damage | Repair Way |
|---|---|
| Windscreen Damaged | Replace |

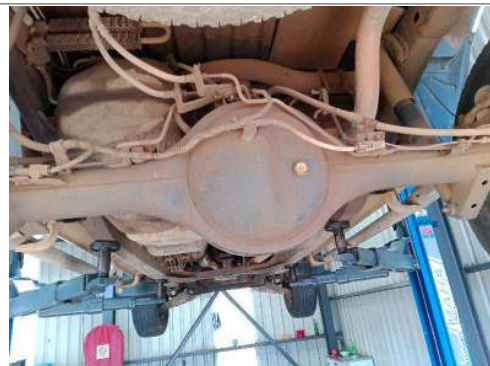
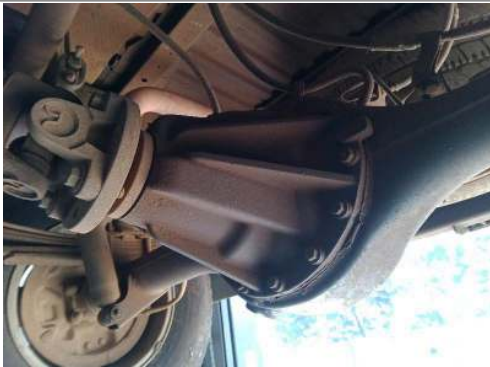
| Damage | Repair Way |
|---|---|
| Differential Oil Sweat | Repair |

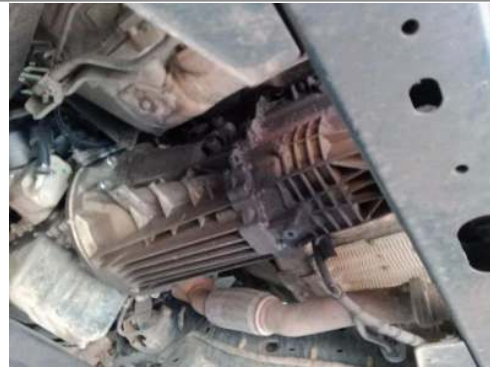
| Damage | Repair Way |
|---|---|
| Gearbox Oil Leak | Repair |

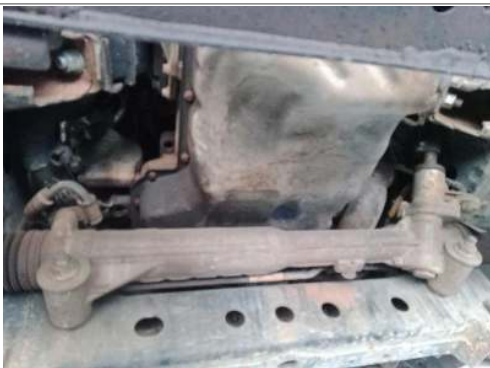
| Damage | Repair Way |
|---|---|
| Engine Oil Leak | Repair |

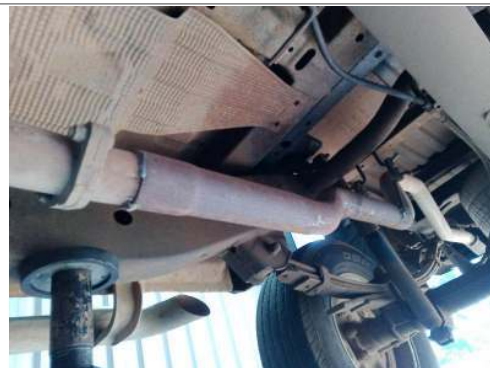
| Damage | Repair Way |
|---|---|
| Engine to silencer pipe Welded | Replace |

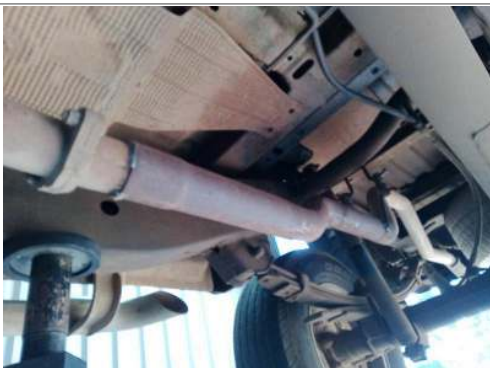
| Damage | Repair Way |
|---|---|
| Silencer Missing | Replace |

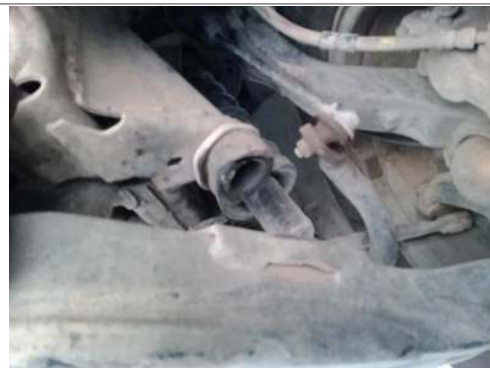
| Damage | Repair Way |
|---|---|
| Rebound Rubber Front Axle Right Damaged | Replace |

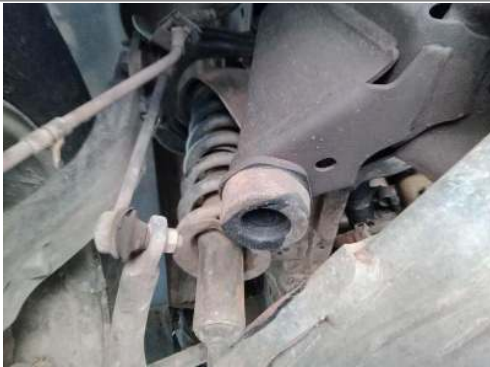
| Damage | Repair Way |
|---|---|
| Rebound Rubber Front Axle Left Damaged | Replace |

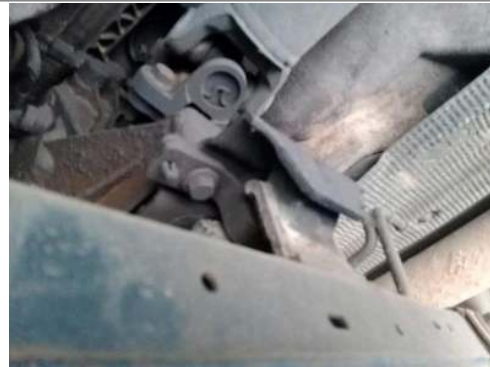
| Damage | Repair Way |
|---|---|
| Gearbox Mountings Damaged | Replace |

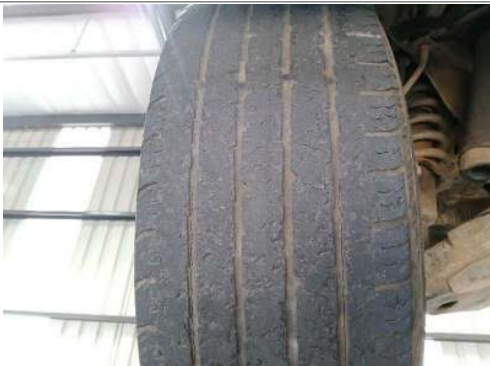
| Damage | Repair Way |
|---|---|
| Tyre Front Left Worn | Replace |

| | Size | Load/Speed Index | Manufacture | Model | Type* | Production Date | Tread Depth (mm) |
|---|---|---|---|---|---|---|---|
| Front Left | 225/70R16 | 111T | Continental | Crosscontact | V | 2516 | 0 mm |

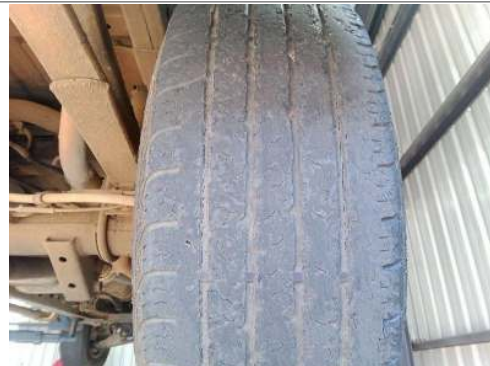
| Damage | Repair Way |
|---|---|
| Tyre Rear Right Worn | Replace |

| | Size | Load/Speed Index | Manufacture | Model | Type* | Production Date | Tread Depth (mm) |
|---|---|---|---|---|---|---|---|
| Rear Right | 255/70R16 | 111T | Continental | Crosscontact | V | 2516 | 0 mm |

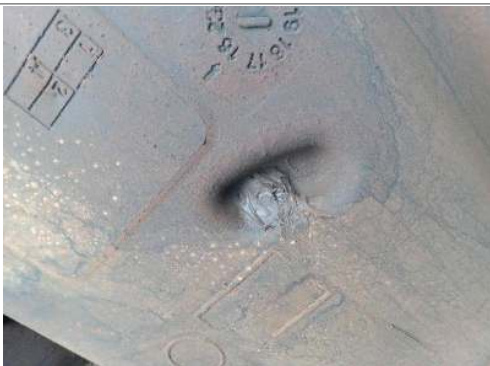
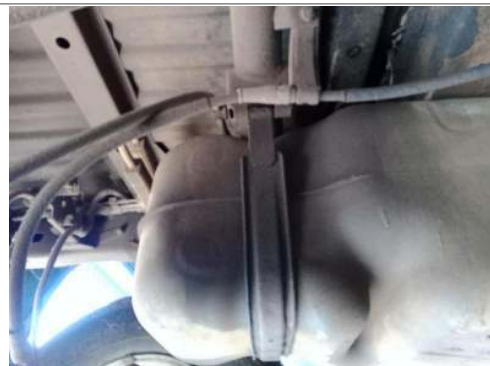
| Damage | Repair Way |
|---|---|
| Fuel Tank Damaged | Replace |

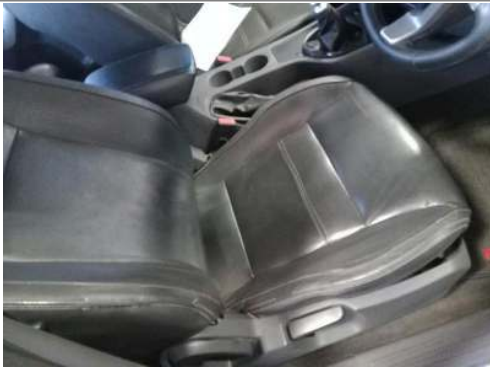
| Damage | Repair Way |
|---|---|
| Seat Front Right Worn | Repair |

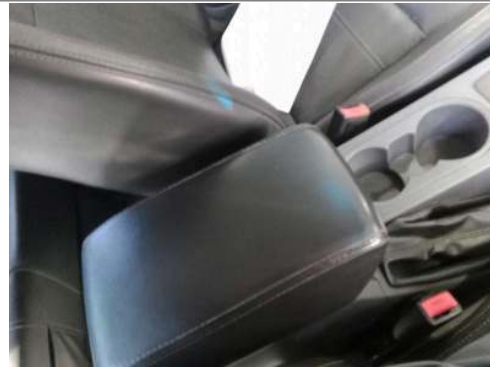
| Damage | Repair Way |
|---|---|
| Center Console / Cubbyhole + Lid Damaged | Repair |
