## CONDITION REPORT

Report No:  
2017303138  
DATE  
25/09/2026

| Manufacturer | FORD | Registration Number | DB32DMGP |
| Model | RANGER 3.2 XLT HR D-CAB DSL PU AT [2012-2016] | Register Number | |

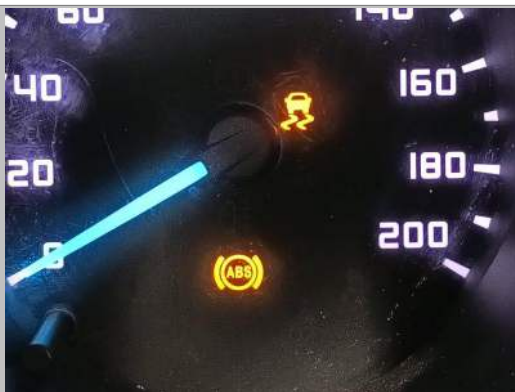
| No | System | Code | Description | Status |
|---|---|---|---|---|
| 1 | POWERTRAIN CONTROL MODULE | P064C:00-28 | GLOW PLUG CONTROL MODULE 1 | |

Warning lights illuminated

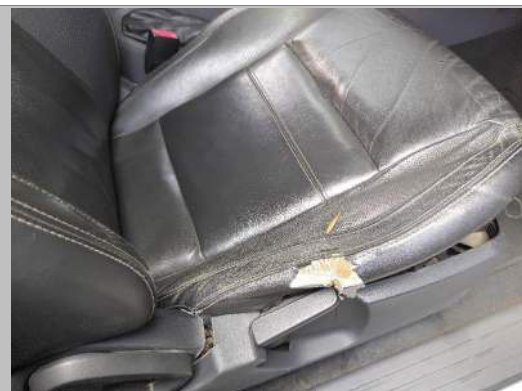
| Seat Front Right Torn / Cut | Repair |

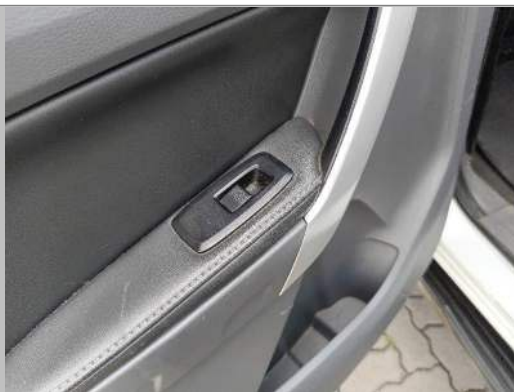
| Switch Electrical Window Winder rear left Defective | Repair |

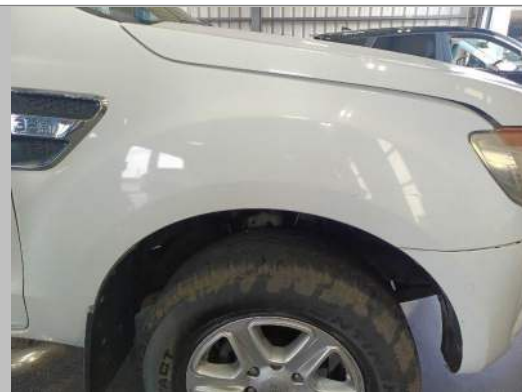
| Front Fender Right Paintwork • Scratched | Repair |

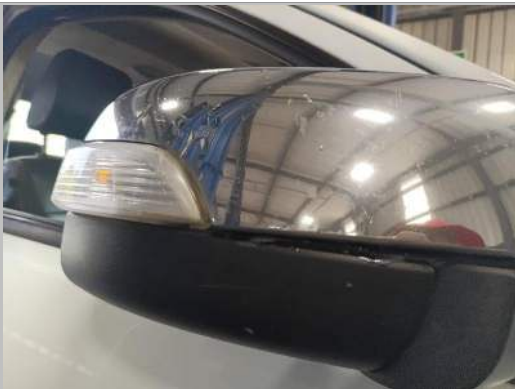
| Side Mirror Right Damaged | Replace |

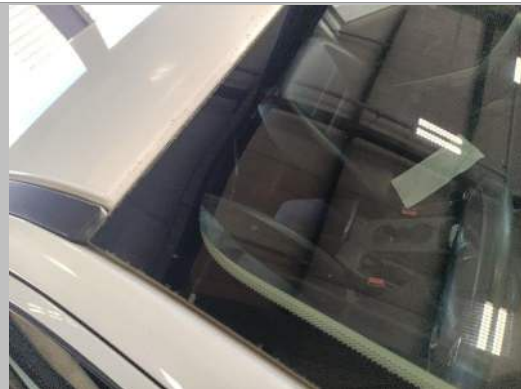
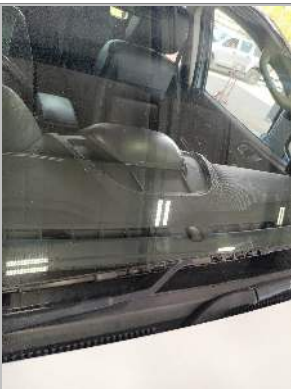
| Windscreen Cracked | Replace |

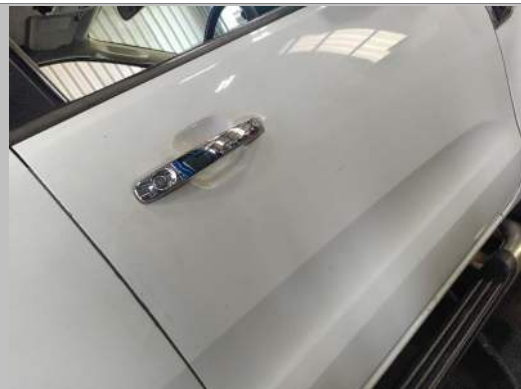
| Door Front Right Paintwork • Scratched | Repair |

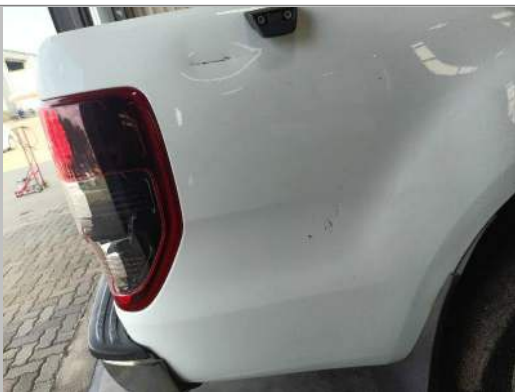
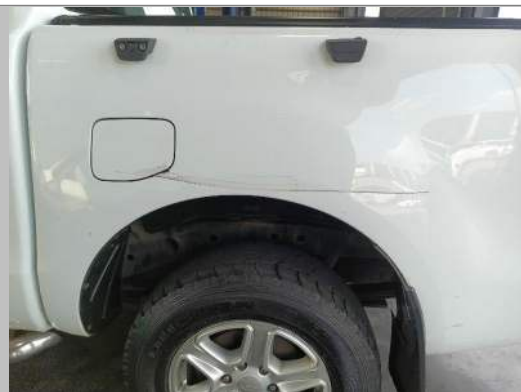
| Load Body Dented | Repair |

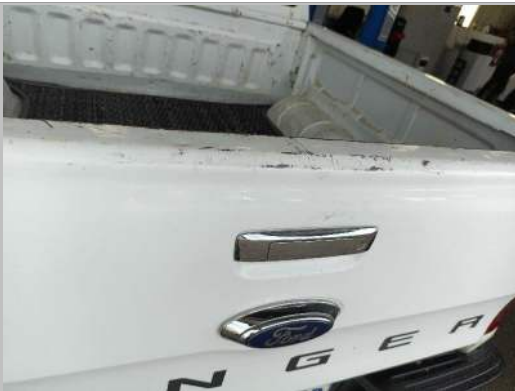
| Tailgate Paintwork • Scratched | Repair |

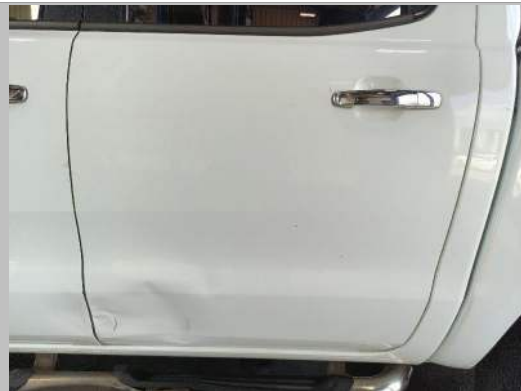
| Door Rear Left Dented | Repair |

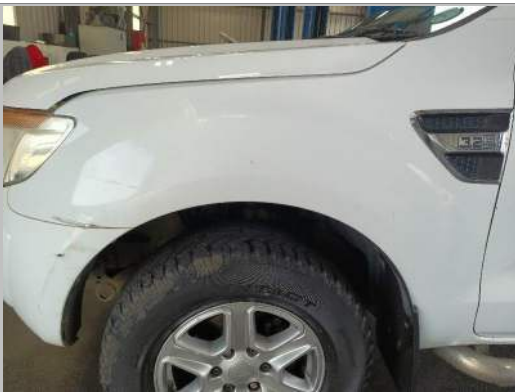
| Front Fender Left Paintwork • Scratched | Repair |

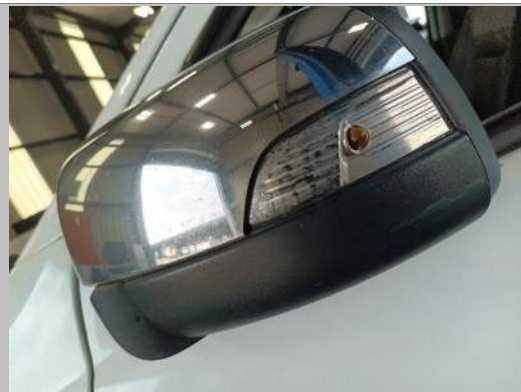
| Indicator Light Front Left Damaged | Replace |

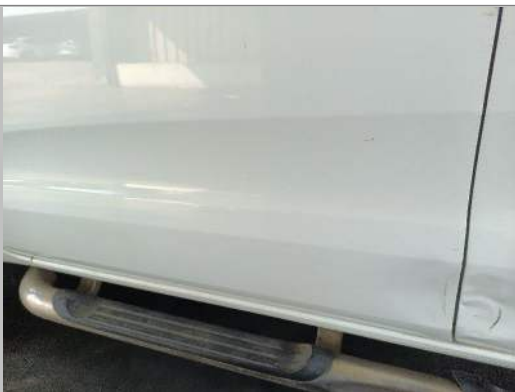
| Door Front Left Dented | Repair |

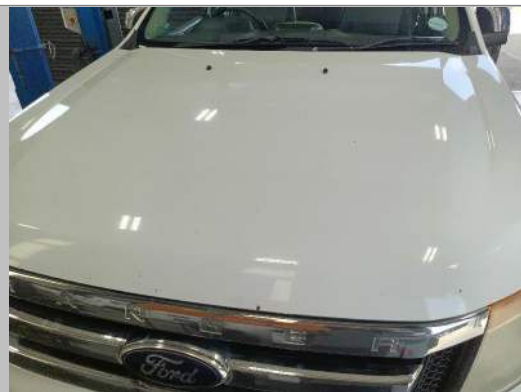
| Bonnet Paintwork • Chipmarks | Repair |

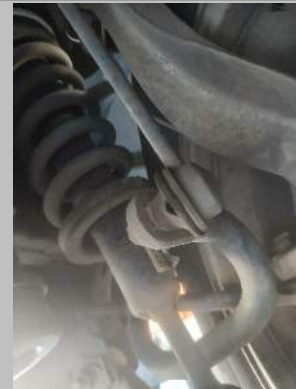
| Stabilizer Mounting Front Right Damaged | Replace |

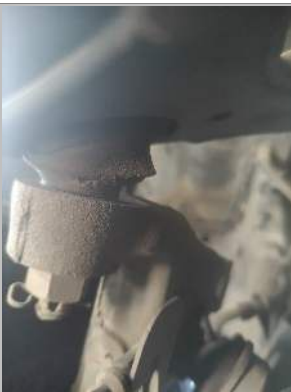
| Ball Joint(s) Rear Axle Left Damaged | Replace |

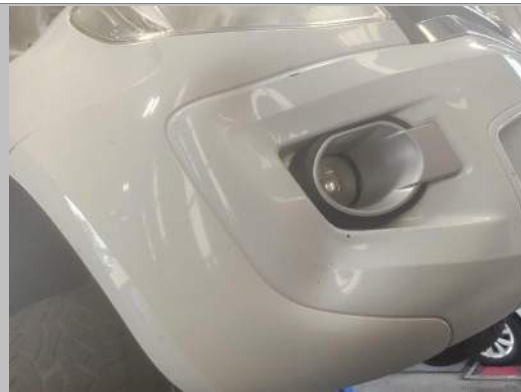
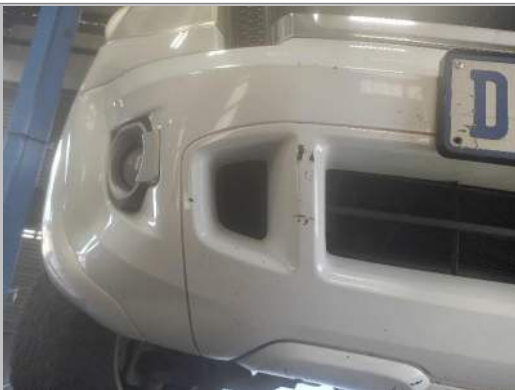
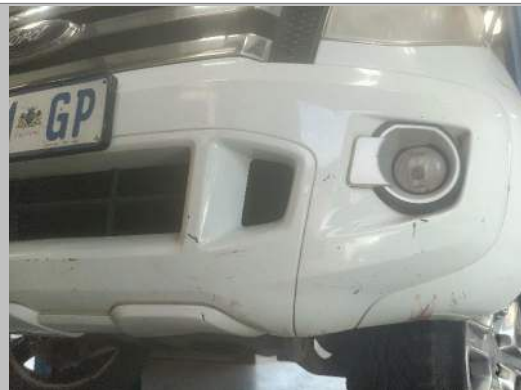
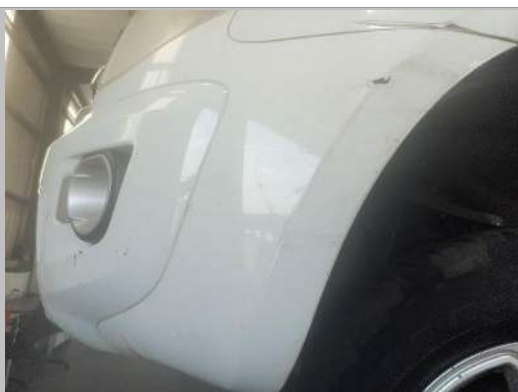
| Front Bumper Dented | Repair |

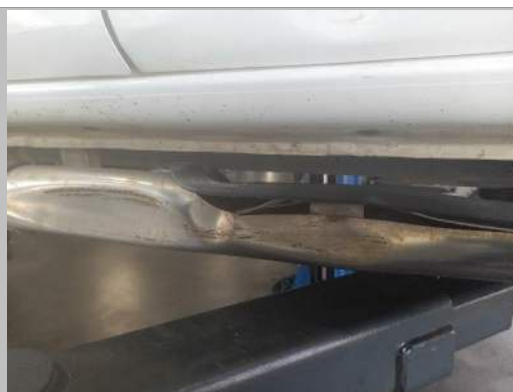
| Sill Panel Left Dented | Repair |

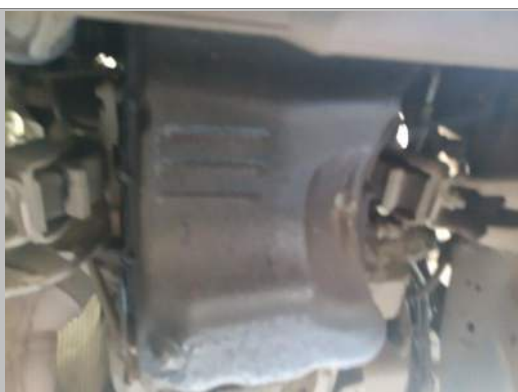
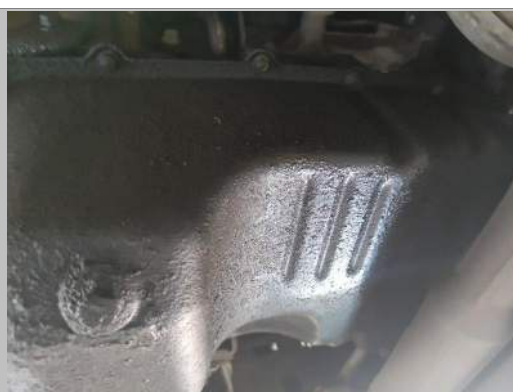
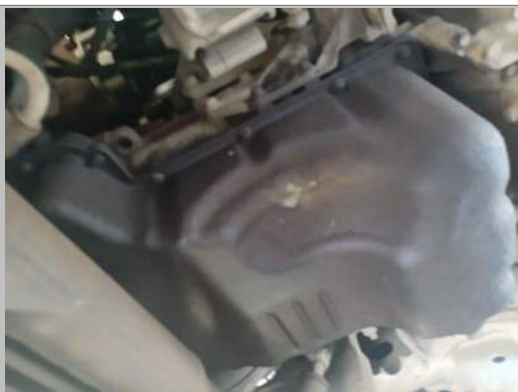
| Engine Oil Leak | Repair |

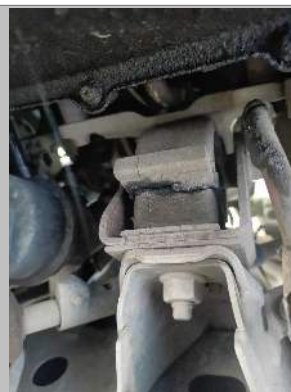
| Gearbox Mountings Cracked | Replace |
