CONDITION REPORT

Report No: 2016814686

DATE  
26/03/2025

Vehicle Type	LIGHT LOAD VEHICLE	Registered Owner	MFC
Manufacturer	FORD	Registration Number	DHW563L
Model	RANGER 2.2 HP XL D-CAB DSL PU [2012-2016]	Register Number	
VIN	AFAPXXMJ2PFY83452	Date Of First Licensing	
Engine Number		Last COR	
Doors	4	License Expiry Date	31/03/2025
Color	SILVER	Power / Displacement	
Year Model	2015	Paint Finish	M - METALLIC
Km Reading	263,946 KM	Fuel	DIESEL
Cab / Body Type	DOUBLE CAB	Transmission	MANUAL

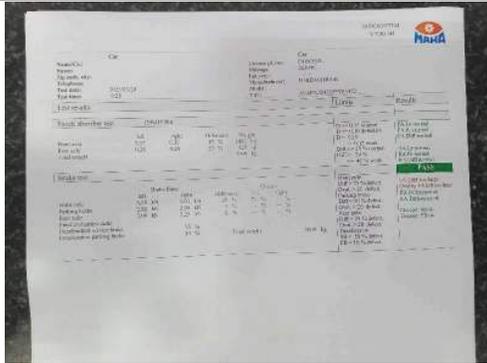
Shock and brake report

Left	Right	Axle Weight [KG]	Deceleration [m/s <sup>2</sup> ]
	Braking Force [KN]	Braking Force [KN]		
Front	3.5	5.0	-	
Rear	3.0	3.2	-	
Emergency / Parking	2.8	3	-

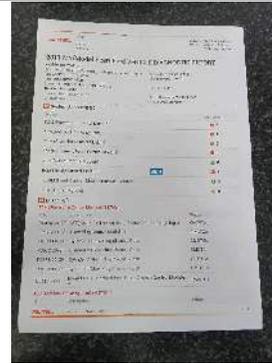
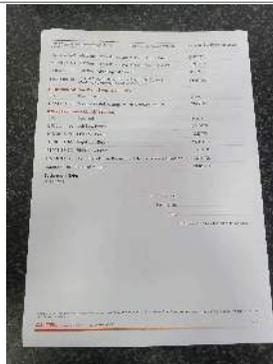
Diagnostic report

No	System	Code	Description	Status
1	CMDTCS	P0671:00-2F	CYLINDER 1 GLOW PLUG CIRCUIT/OPEN

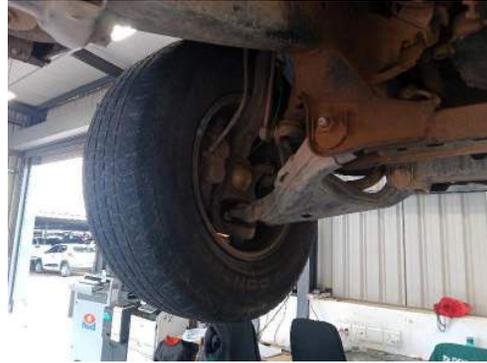
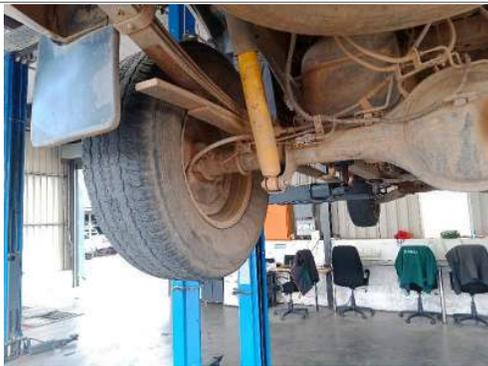
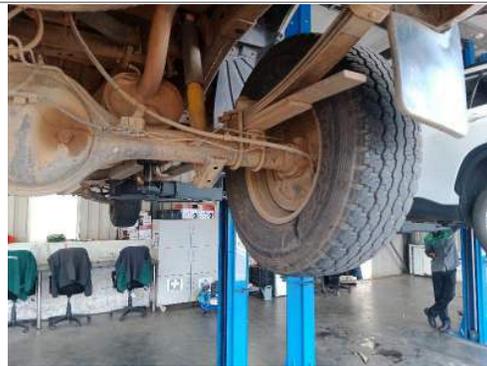
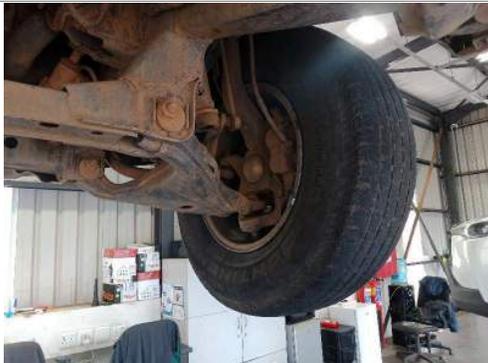
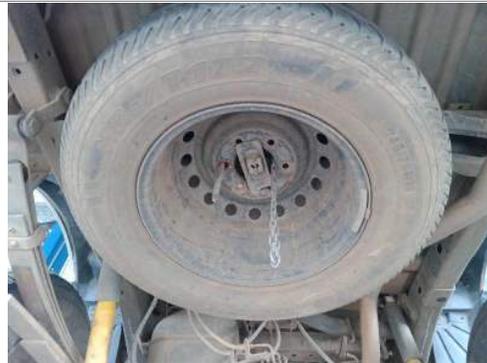
Size	Load/Speed Index	Manufacture	Model	Type*	Production Date	Tread Depth (mm)
Front Left	255/70R16	111T	Continental	Contact	V	3812	1 mm
Front Right	255/70R16	111T	Continental	Contact	V	4313	1 mm
Rear Left	265/70R16	112T	Dunlop	Grandtrek	V	4419	2 mm
Rear Right	275/70R16	114T	Dunlop	Grandtrek	V	5014	4 mm
Spare	245/70R16	107T	Mirage	Mr-at172	V	0000	3 mm

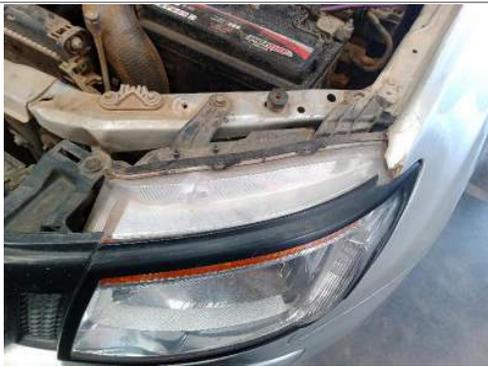
Damage	Repair Way
Bonnet stay and shocks Defective	Repair
Switch Electrical Window Winder front left Malfunction	Repair
Switch Electrical Window Winder front right Malfunction	Repair
Switch Electrical Window Winder rear left Malfunction	Repair
Tail Light Left Cracked	Repair
Headlight Left Damaged	Repair
Seat Front Right Damaged	Repair
Side Mirror Left Damaged	Repair
Side Mirror Right Paintwork • Scratched	Repair
Front Bumper Paintwork • Scratched	Repair
Bonnet Dented	Repair
Bonnet slam plate (Shock tower/ Inner tray) Residual	Repair
Traces of Repair	Repair
C • Pillar Right Dented	Repair
Front Fender Left Residual Traces of Repair	Repair
Front Fender Right Paintwork • Scratched	Repair
Rear Fender Left Paintwork • Scratched	Repair
Rear Fender Right Paintwork • Scratched	Repair
Door Front Left Paintwork • Scratched	Repair

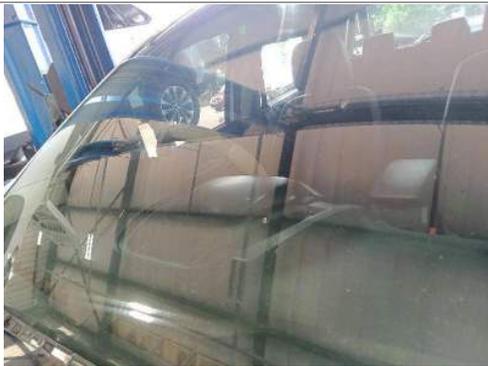
Damage	Repair Way
Door Front Right Residual Traces of Repair	Repair
Door Rear Left Paintwork • Scratched	Repair
Door Rear Right Residual Traces of Repair	Repair
Tailgate Paintwork • Scratched	Repair
Rear bumper Damaged	Repair
Rocker Panel Left Damaged	Repair
Windscreen Cracked	Repair
Stabilizer Mounting Front Left Damaged	Replace
Stabilizer Mounting Front Right Damaged	Replace
Ball Joint(s) Front Axle Left Damaged	Replace
Ball Joint(s) Front Axle Right Damaged	Replace
Body exterior	Vehicle got some scratches, stone chips and dents
Body exterior	Signs of spray work done on some body panels
ABS and traction control light on	Repair
Both front fog lights malfunction	Repair
