## CONDITION REPORT

Report No: 2016212412

MFC Auction House  
M57 Pretoria Rd, Glenmarais, KEMPTON PARK  
Gauteng

| Manufacturer | FORD | Registration Number | FVK501FS |

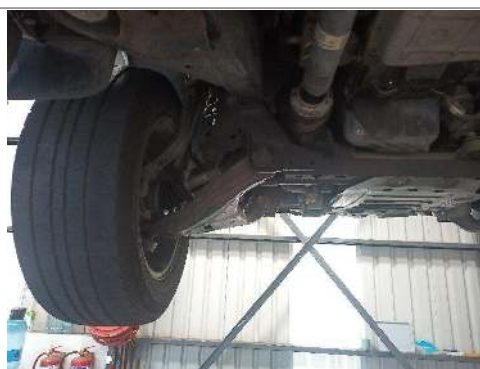
LF TYRE TREAD

| | Size | Load/Speed Index | Manufacture | Model | Type* | Production Date | Tread Depth (mm) |
|---|---|---|---|---|---|---|---|
| Front Left | 255/60R18 | 112T | Continental | Crosscontact | V | 1017 | 0 mm |

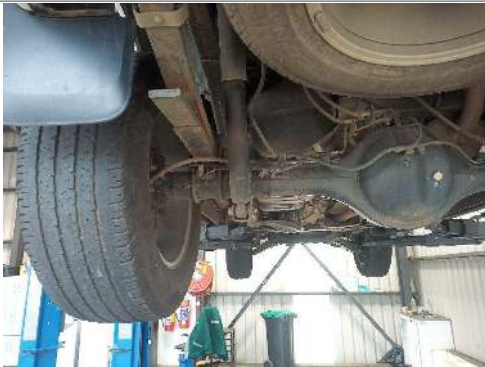
LR TYRE TREAD

| | Size | Load/Speed Index | Manufacture | Model | Type* | Production Date | Tread Depth (mm) |
|---|---|---|---|---|---|---|---|
| Rear Left | 265/60R18 | 110T | Continental | Crosscontact | V | 2716 | 2 mm |

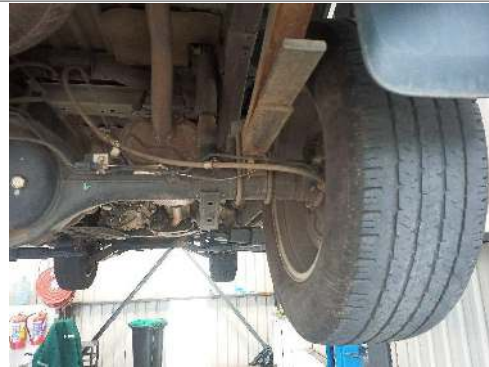
RR TYRE TREAD

| | Size | Load/Speed Index | Manufacture | Model | Type* | Production Date | Tread Depth (mm) |
|---|---|---|---|---|---|---|---|
| Rear Right | 265/60R18 | 110T | Continental | Crosscontact | V | 1116 | 2 mm |

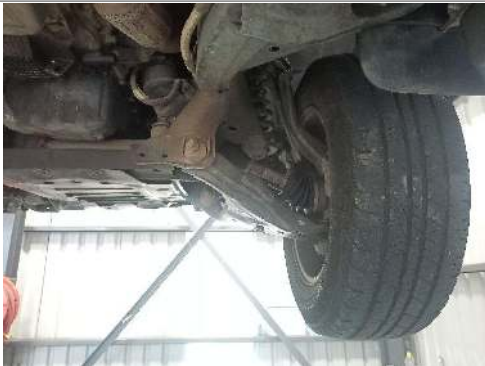
RF TYRE TREAD

| | Size | Load/Speed Index | Manufacture | Model | Type* | Production Date | Tread Depth (mm) |
|---|---|---|---|---|---|---|---|
| Front Right | 255/60R18 | 112T | Continental | Crosscontact | V | 1516 | 0 mm |

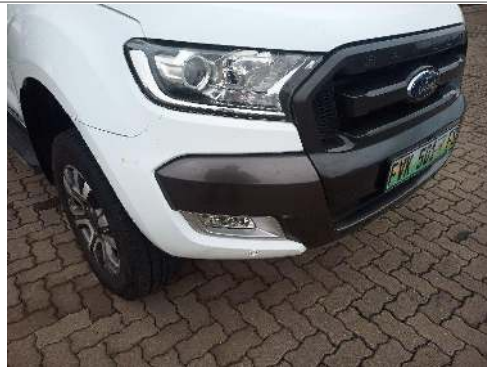
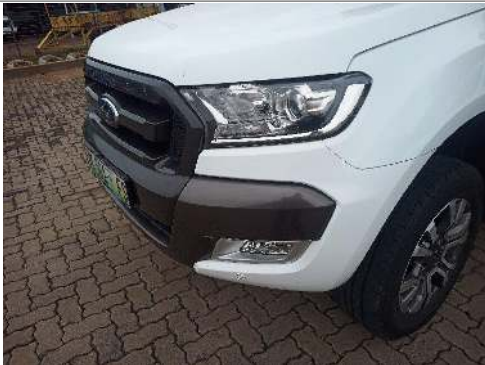
| Damage | Repair Way |
|---|---|
| Front Bumper Damaged | Repair |

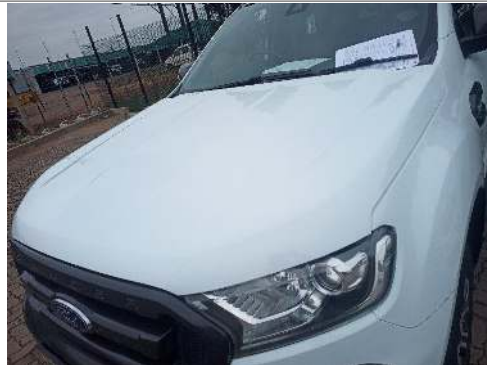
| Damage | Repair Way |
|---|---|
| Bonnet Damaged | Repair |

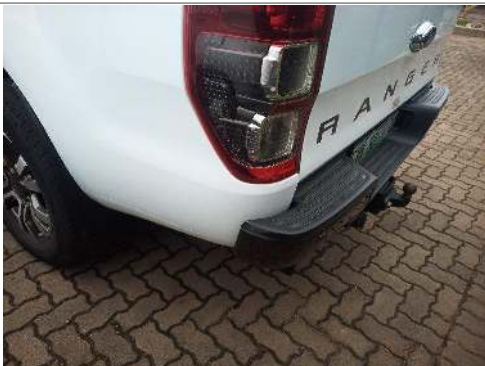
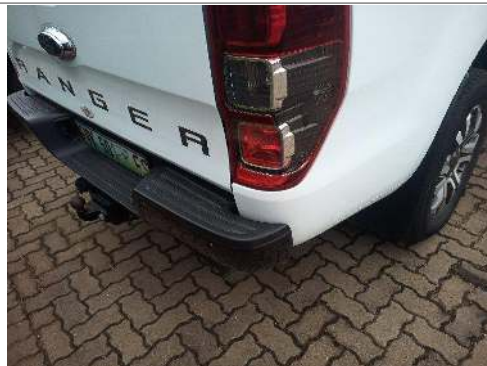
| Damage | Repair Way |
|---|---|
| Rear bumper Damaged | Repair |

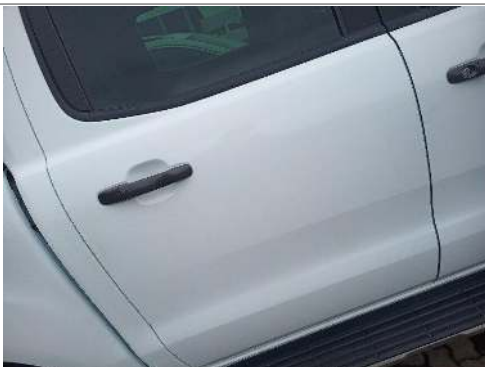
| Damage | Repair Way |
|---|---|
| Door Rear Right Damaged | Repair |

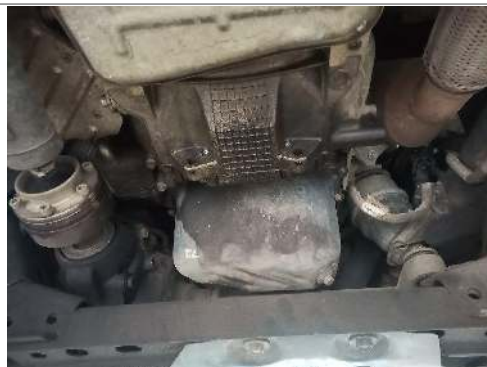
| Damage | Repair Way |
|---|---|
| Engine Oil Leak | Repair |

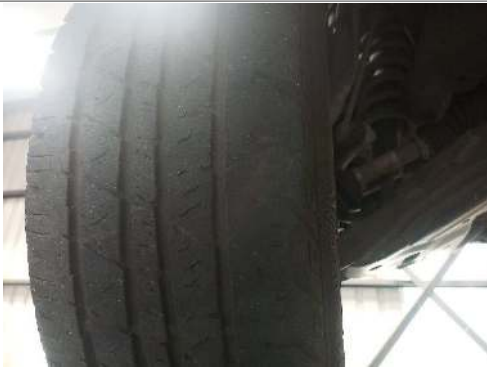
| Damage | Repair Way |
|---|---|
| Tyre Front Left Worn | Replace |

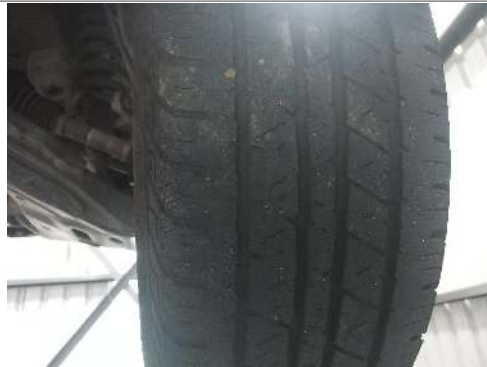
| Damage | Repair Way |
|---|---|
| Tyre Front Right Worn | Replace |

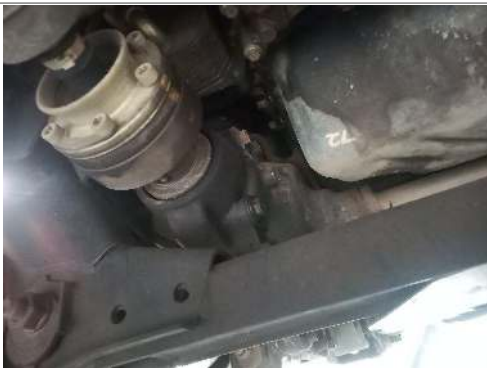
| Damage | Repair Way |
|---|---|
| Differential Oil Leak | Repair |
