## CONDITION REPORT

Report No:  
2017303136  
DATE  
25/09/2026

| Manufacturer | FORD | Registration Number | KPV873MP |
| Model | RANGER 2.2 TDCI XL D-CAB DSL PU [2017-2020] | Register Number | |

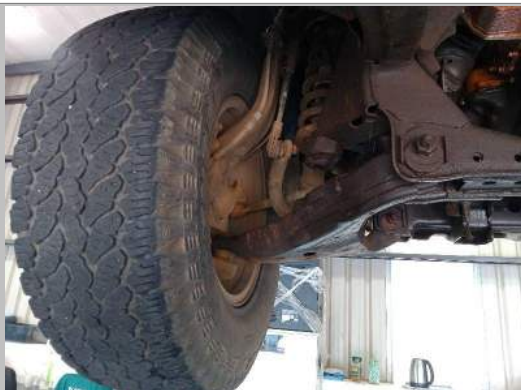
LF TYRE TREAD

| | Size | Load/Speed Index | Manufacture | Model | Type* | Production Date | Tread Depth (mm) |
|---|---|---|---|---|---|---|---|
| Front Left | 265/70 R16 | 112H | General | Grabber | V | 4219 | 2 mm |

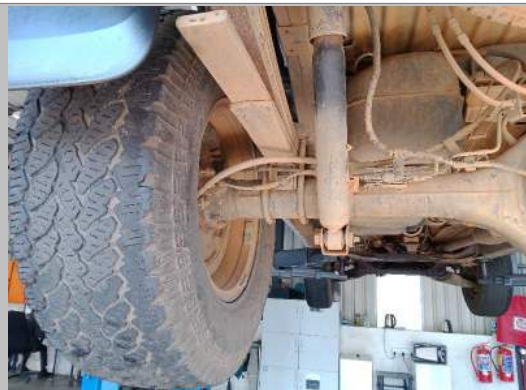
LR TYRE TREAD

| | Size | Load/Speed Index | Manufacture | Model | Type* | Production Date | Tread Depth (mm) |
|---|---|---|---|---|---|---|---|
| Rear Left | 265/70 R16 | 112H | General | Grabber | V | 4219 | 1 mm |

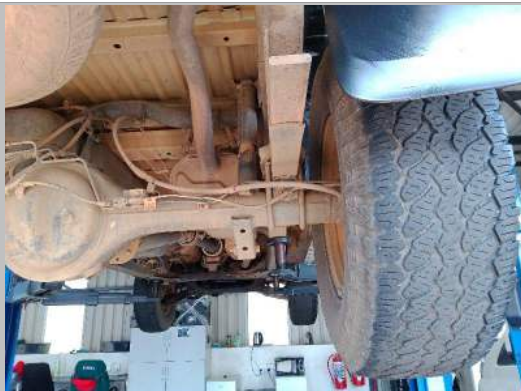
RR TYRE TREAD

| | Size | Load/Speed Index | Manufacture | Model | Type* | Production Date | Tread Depth (mm) |
|---|---|---|---|---|---|---|---|
| Rear Right | 265/70 R16 | 112H | General | Grabber | V | 4219 | 2 mm |

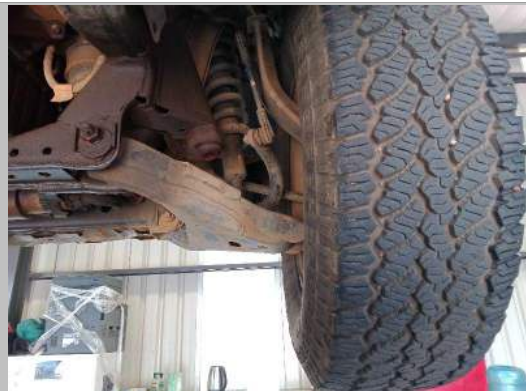
RF TYRE TREAD

| | Size | Load/Speed Index | Manufacture | Model | Type* | Production Date | Tread Depth (mm) |
|---|---|---|---|---|---|---|---|
| Front Right | 265/70 R16 | 112M | General | Grabber | V | 4021 | 4 mm |

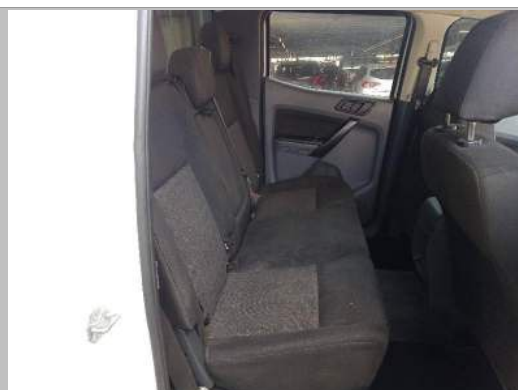
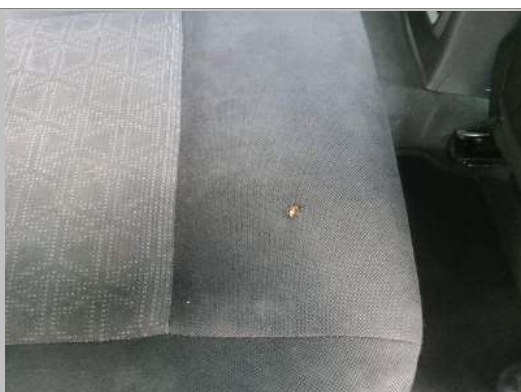
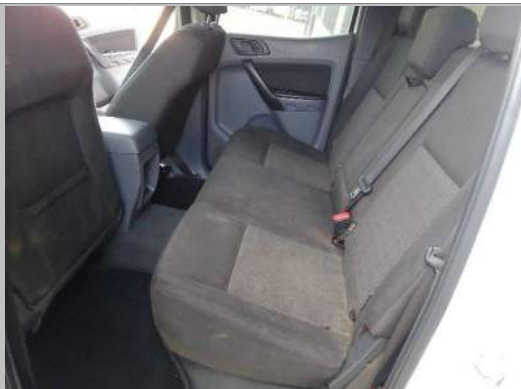
| Damage | Repair Way |
|---|---|
| Seat Rear Damaged | Repair |

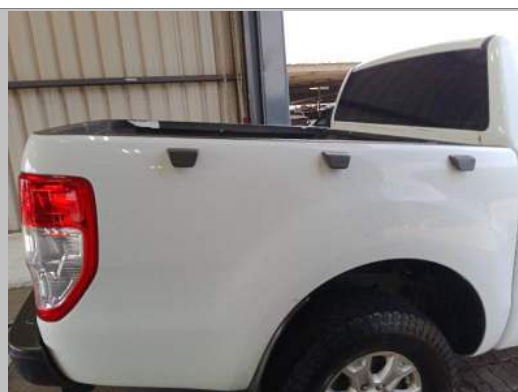
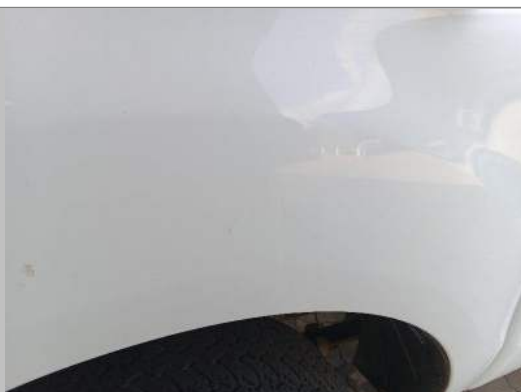
| Damage | Repair Way |
|---|---|
| Rear Fender Right Paintwork • Scratched | Repair |

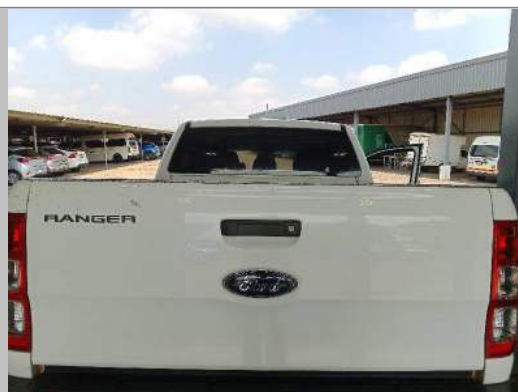
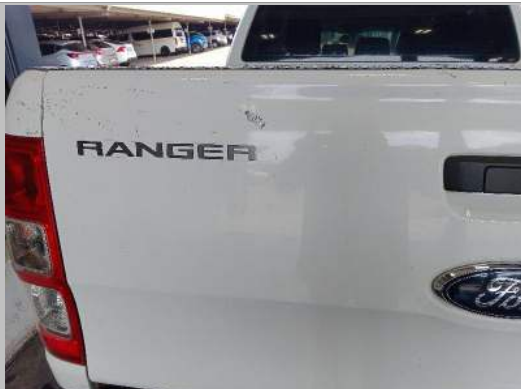
| Damage | Repair Way |
|---|---|
| Tailgate Paintwork • Scratched | Repair |

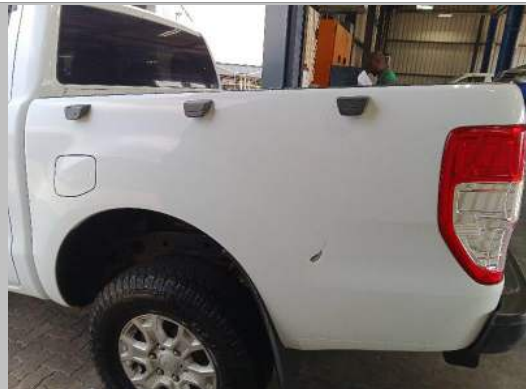
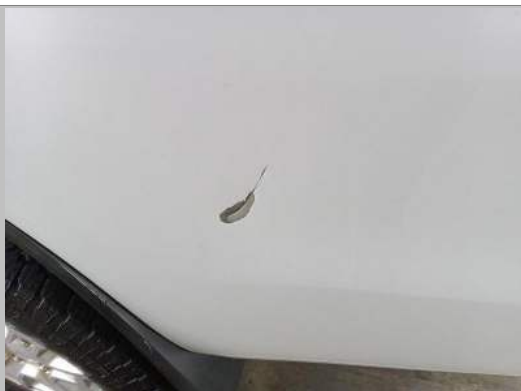
| Damage | Repair Way |
|---|---|
| Rear Fender Left Damaged | Repair |

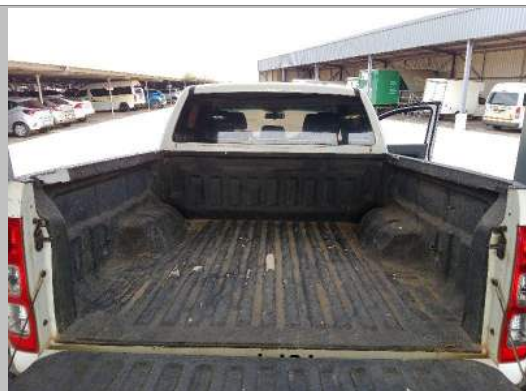
| Damage | Repair Way |
|---|---|
| Load Body Damaged | Repair |

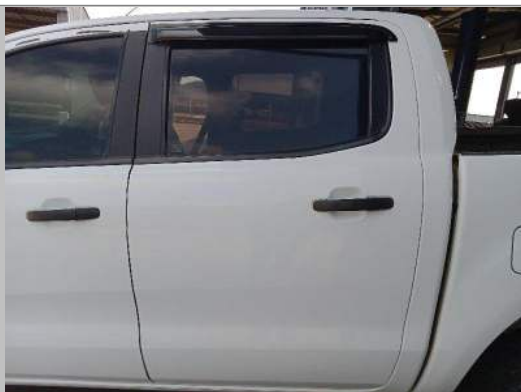
| Damage | Repair Way |
|---|---|
| Door Rear Left Paintwork • Scratched | Repair |

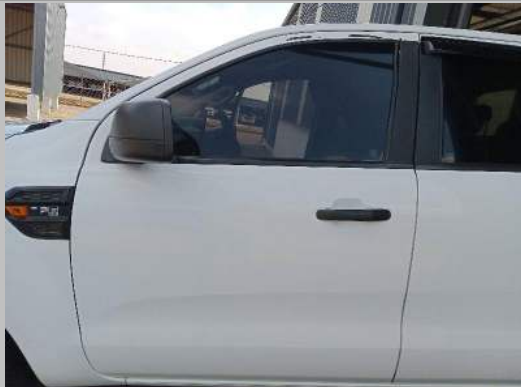
| Damage | Repair Way |
|---|---|
| Door Front Left Dented | Repair |

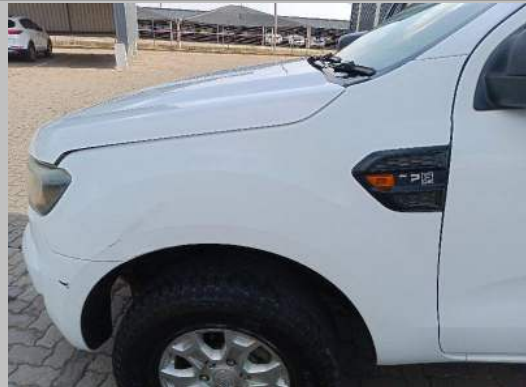
| Damage | Repair Way |
|---|---|
| Front Fender Left Damaged | Repair |

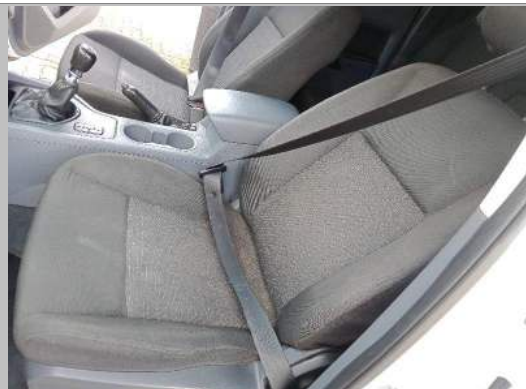
| Damage | Repair Way |
|---|---|
| Seat Front Left Dirty | Repair |

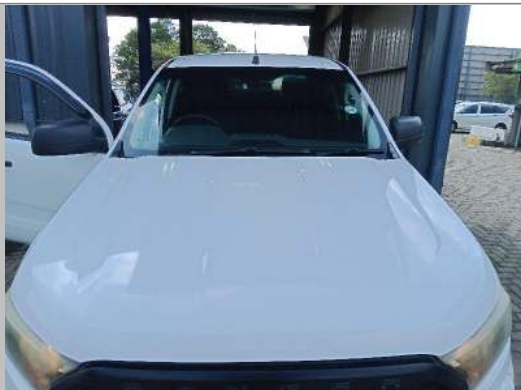
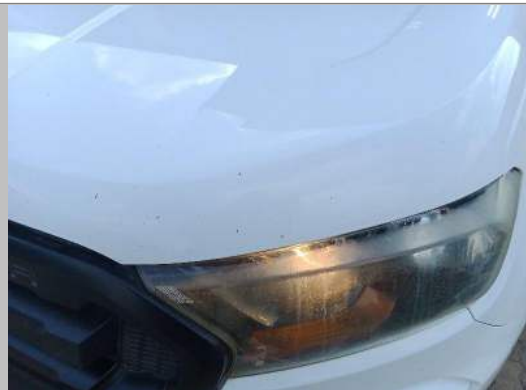
| Damage | Repair Way |
|---|---|
| Bonnet Paintwork • Chipmarks | Repair |

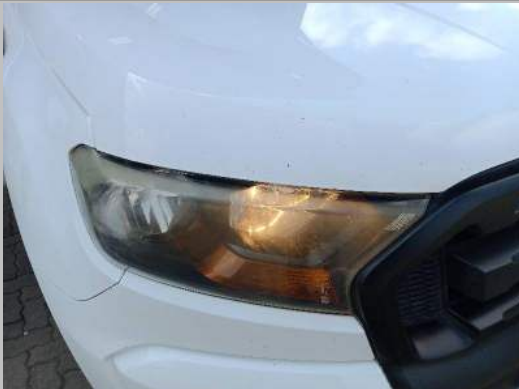
| Damage | Repair Way |
|---|---|
| Headlight Right Defective | Repair |

General Comments: ACCORDING TO THE AGE AND MILEAGE OF THE VEHICLE, NORMAL WEAR AND TEAR MARKS ARE VISIBLE ON THE INTERIOR, EXTERIOR, ELECTRICAL AND MECHANICAL PARTS. Lights: Front left and right headlight lenses faded.

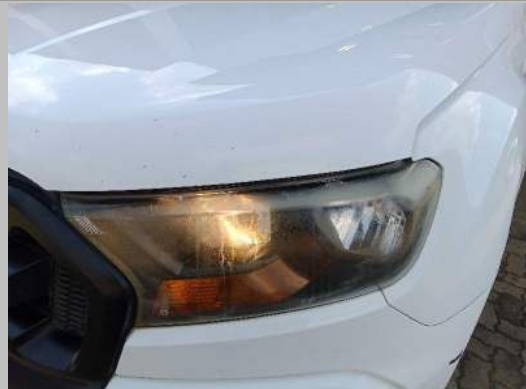
| Damage | Repair Way |
|---|---|
| Headlight Left Defective | Repair |

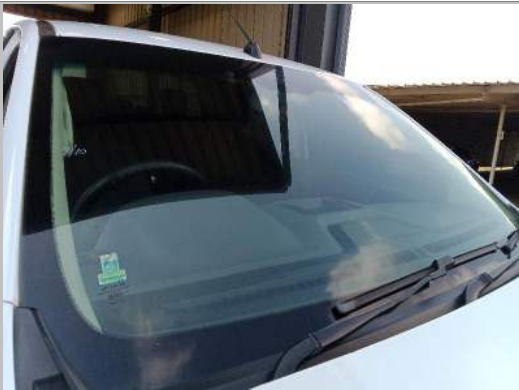
| Damage | Repair Way |
|---|---|
| Windscreen Chipped | Repair |

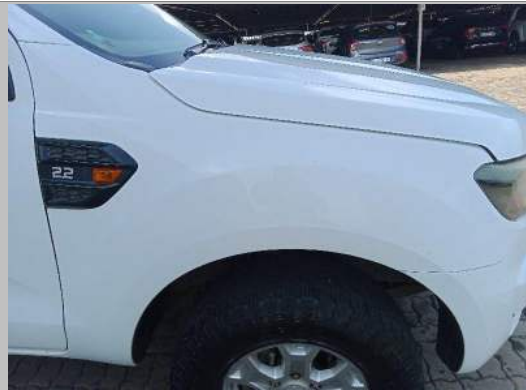
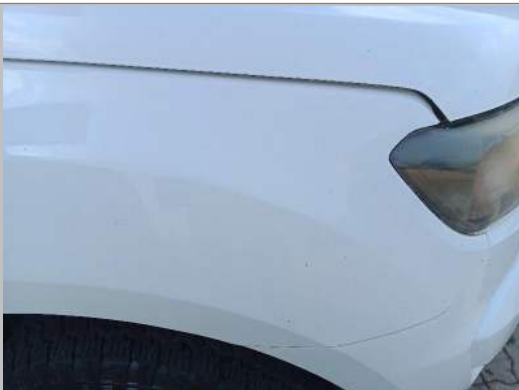
| Damage | Repair Way |
|---|---|
| Front Fender Right Paintwork • Chipmarks | Repair |

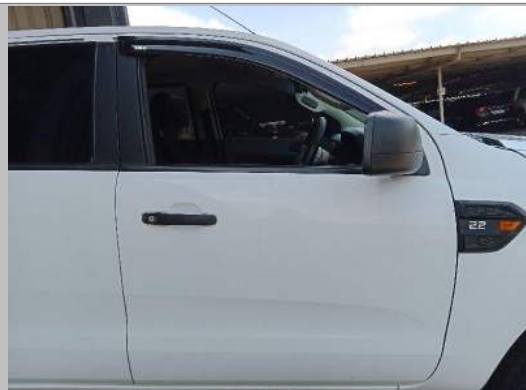
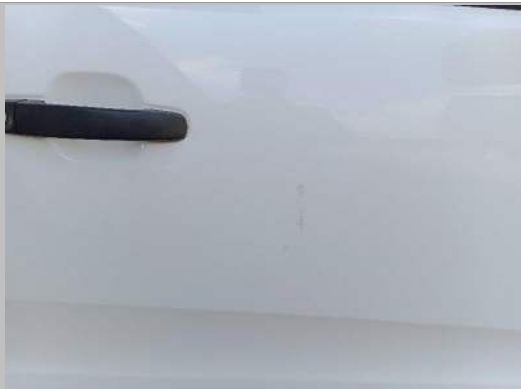
| Damage | Repair Way |
|---|---|
| Door Front Right Paintwork • Scratched | Repair |

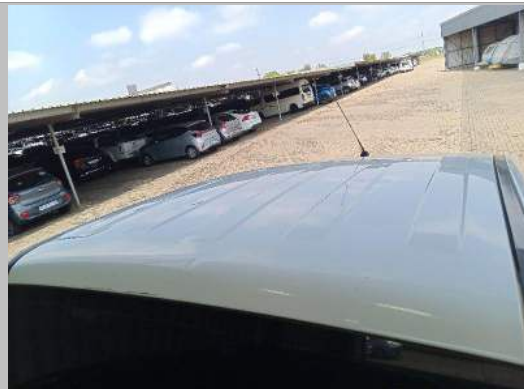
| Damage | Repair Way |
|---|---|
| Roof Dented | Repair |

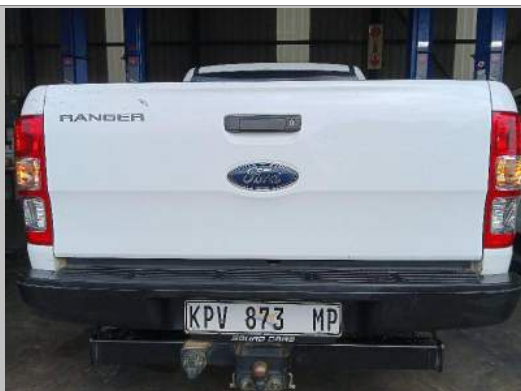
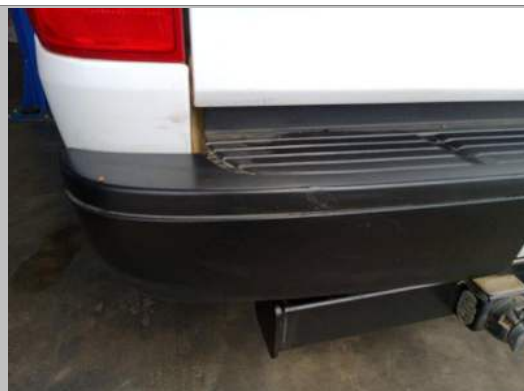
| Damage | Repair Way |
|---|---|
| Rear bumper Damaged | Repair |

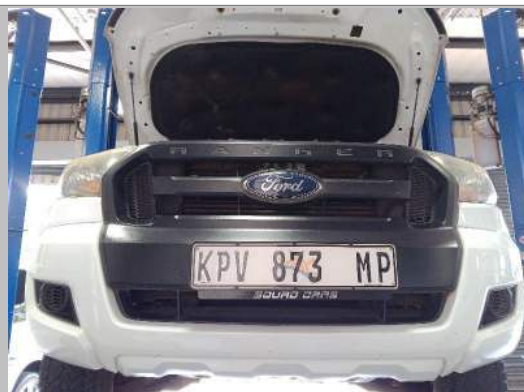
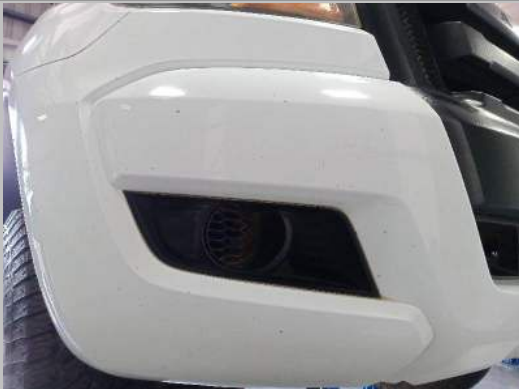
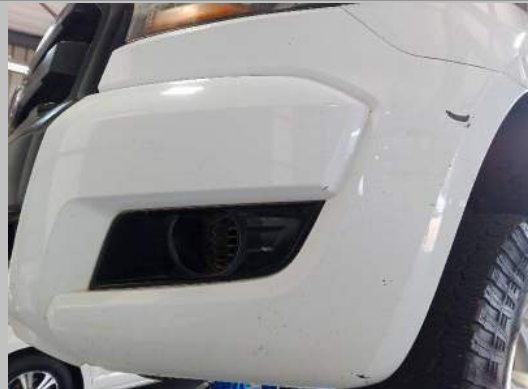
| Damage | Repair Way |
|---|---|
| Front Bumper Paintwork • Scratched | Repair |

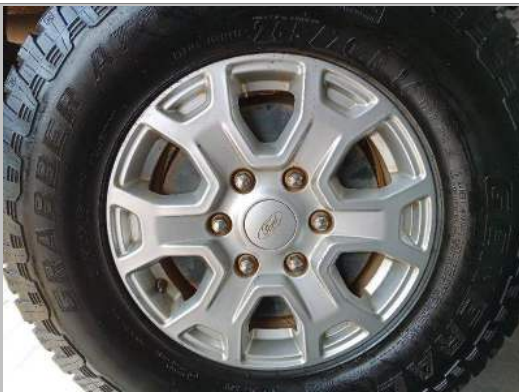
| Damage | Repair Way |
|---|---|
| Rim Rear Right Scratched | Repair |

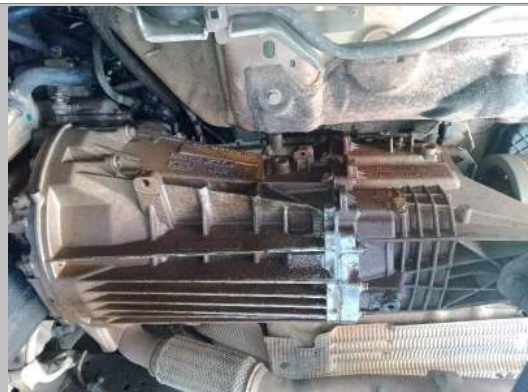
| Damage | Repair Way |
|---|---|
| Gearbox Oil Leak | Repair |

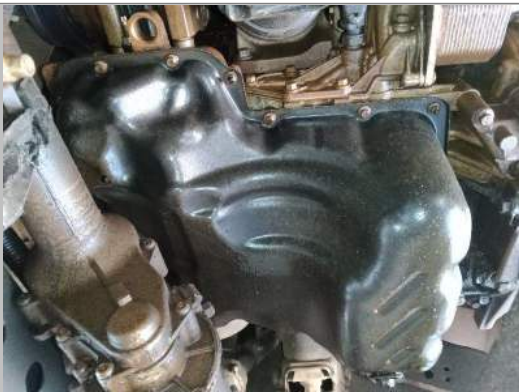
| Damage | Repair Way |
|---|---|
| Engine Oil Leak | Repair |

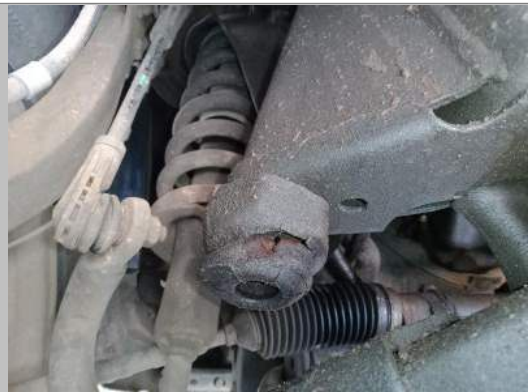
| Damage | Repair Way |
|---|---|
| Rebound Rubber Front Axle Left Damaged | Replace |

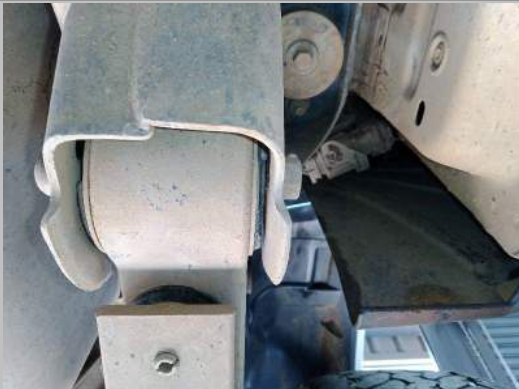
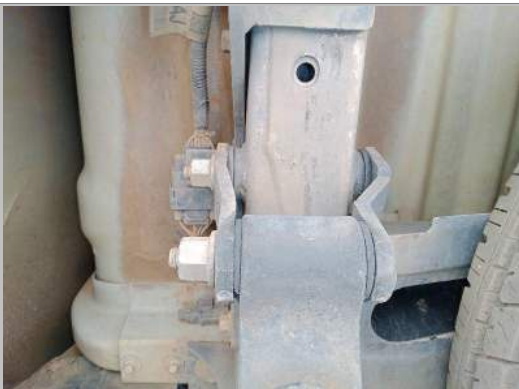
| Damage | Repair Way |
|---|---|
| Mounting Rubber(s) Rear Axle Left Cracked | Replace |

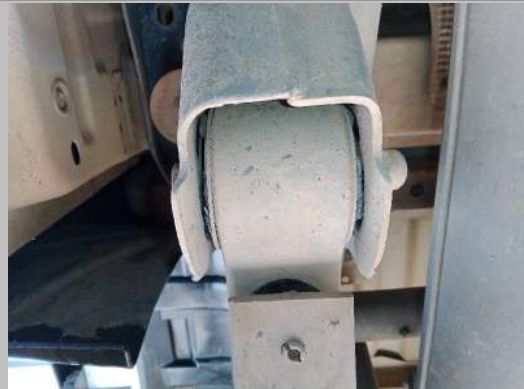
| Damage | Repair Way |
|---|---|
| Mounting Rubber(s) Rear Axle Right Cracked | Replace |

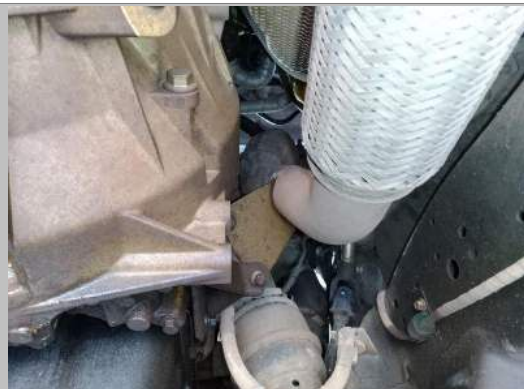
| Damage | Repair Way |
|---|---|
| Catalytic converter Missing | Replace |

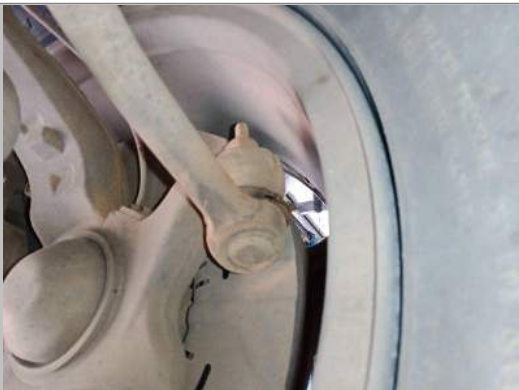
| Damage | Repair Way |
|---|---|
| Tie Rod End left Damaged | Replace |

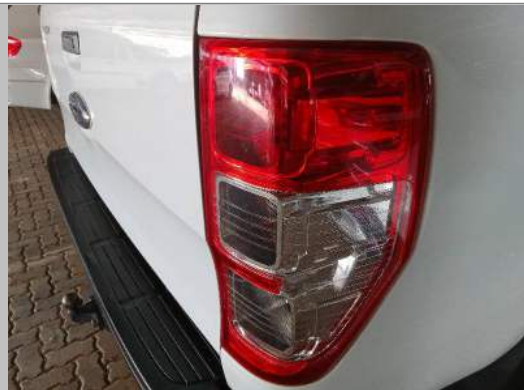
| Damage | Repair Way |
|---|---|
| Tail Light Right Scratched | Repair |
