## CONDITION REPORT

Report No: 2016338674

MFC Auction House  
M57 Pretoria Rd, Glenmarais, KEMPTON PARK  
Gauteng

Vehicle Type	LIGHT LOAD VEHICLE	Registered Owner	MFC AUCTION HOUSE
Manufacturer	FORD	Registration Number	KS48MXGP
Model	RANGER	Register Number	
VIN	AFAPXXMJ2PNJ14765	Date Of First Licensing	
Engine Number		Last COR	
Doors	4	License Expiry Date	31/08/2024
Color	WHITE	Power / Displacement	
Year Model		Paint Finish	TWO COAT UNI
Km Reading	34,597 KM	Fuel	DIESEL
Cab / Body Type	DOUBLE CAB	Transmission	AUTOMATIC

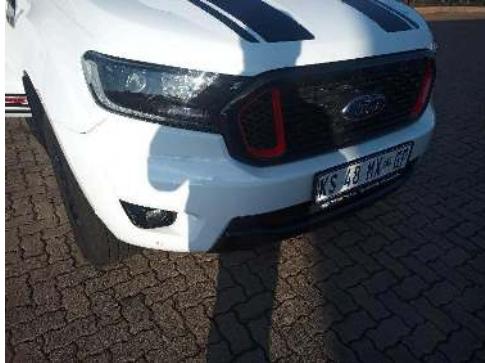
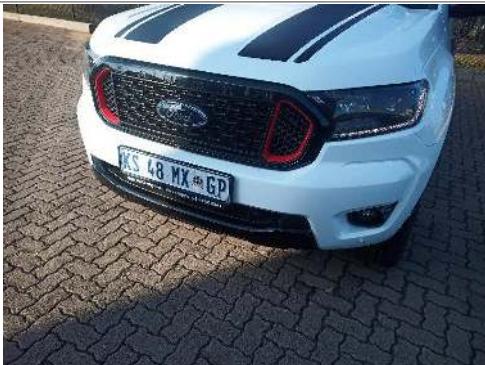
Damage	Repair Way
Front Bumper Damaged	Repair
Bonnet Damaged	Repair
Rear Fender Right Damaged	Repair
Rear bumper Damaged	Repair
Body and exterior	Minor dents and scratches and stone chips.
Body and exterior	Signs of repair work done to somebody panels.
