CONDITION REPORT

Report No: 2016209963

MFC Auction House
M57 Pretoria Rd, Glenmarais, KEMPTON PARK
Gauteng

Vehicle Type	LIGHT LOAD VEHICLE	Registered Owner	MFC
Manufacturer	FORD	Registration Number	NONE
Model	RANGER	Register Number	
VIN	AFAPXXMJ2PPK15055	Date Of First Licensing	
Engine Number		Last COR	
Doors	4	License Expiry Date	22/12/2023
Color	RED	Power / Displacement	
Year Model		Paint Finish	TWO COAT METALLIC
Km Reading	17,800 KM	Fuel	DIESEL
Cab / Body Type	DOUBLE CAB	Transmission	AUTOMATIC

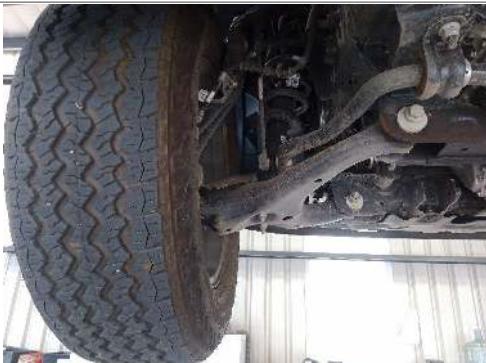
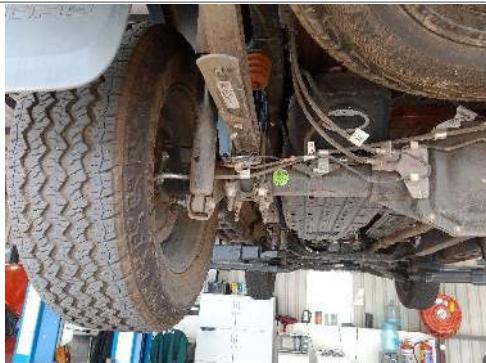
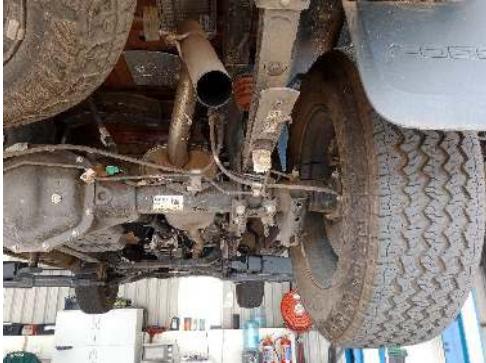
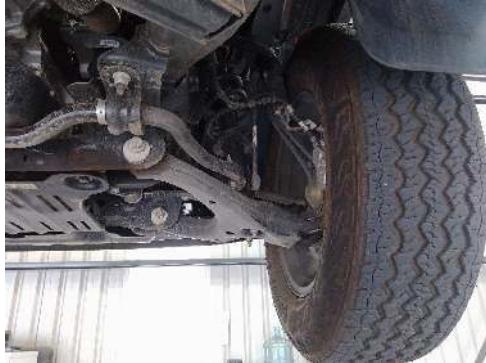
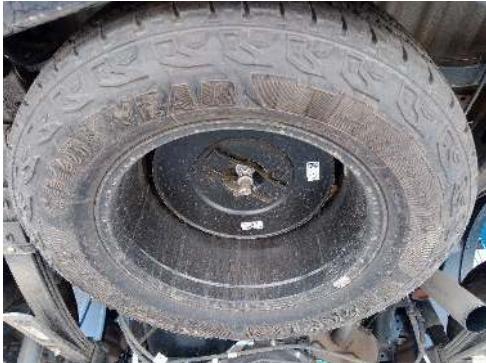
Size	Load/Speed Index	Manufacture	Model	Type*	Production Date	Tread Depth (mm)
Front Left	255/65 R18	111H	Goodyear	Wrangler	V	4722	6 mm
Front Right	255/65 R18	111H	Goodyear	Wrangler	V	4722	7 mm
Rear Left	255/65 R18	111H	Goodyear	Wrangler	V	4622	7 mm
Rear Right	255/65 R18	111H	Goodyear	Wrangler	V	4722	7 mm
Spare	255/65 R18	111H	Goodyear	Wrangler	V	0000	8 mm

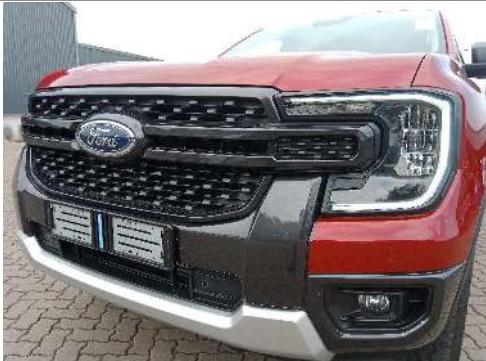
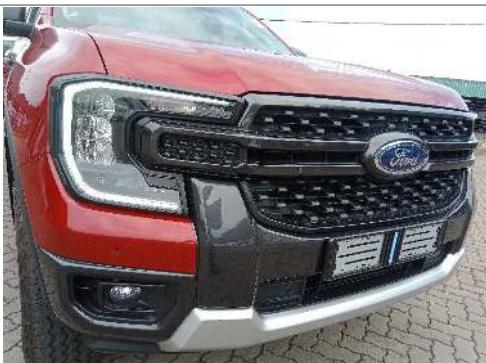
Damage	Repair Way
Side Mirror Left Paintwork • Scratched	Repair
Side Mirror Right Paintwork • Scratched	Repair
Front Bumper Paintwork • Scratched	Repair
Bonnet Dented	Repair
Rear Fender Right Paintwork • Scratched	Repair
Door Front Right Paintwork • Scratched	Repair
Door Rear Right Paintwork • Scratched	Smart Repair
Rear bumper Damaged	Repair
Windscreen Chipped	Repair
