MFC Auction House
M57 Pretoria Rd, Glenmarais, KEMPTON PARK
Gauteng

Vehicle Type	PASSENGER VEHICLE	Registered Owner	MFC AUCTION HOUSE
Manufacturer	TOYOTA	Registration Number	KVK699MP
Model	COROLLA	Register Number	
VIN	AHTBBOJE000006994	Date Of First Licensing	
Engine Number		Last COR	
Doors	4	License Expiry Date	31/03/2024
Color	SILVER	Power / Displacement	
Year Model		Paint Finish	M - METALLIC
Km Reading	185,437 KM	Fuel	PETROL
Cab / Body Type	SEDAN	Transmission	MANUAL

CONDITION REPORT

Report No: 2016368511

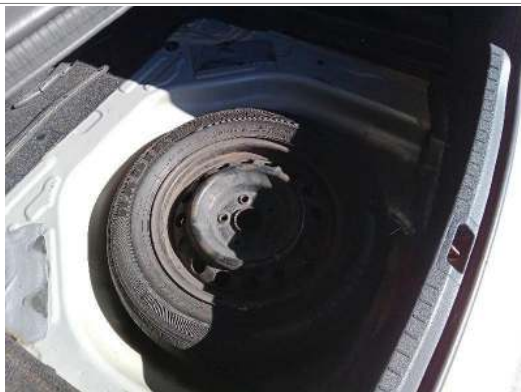
Sparewheel

Size	Load/Speed Index	Manufacture	Model	Type*	Production Date	Tread Depth (mm)
Front Left	195/65R15	91V	Centara	Vanti tourin	V	1622	4 mm
Front Right	195/65R15	91V	Centara	Vanti tourin	V	1622	5 mm
Rear Left	195/65R15	91V	Centara	Vanti tourin	V		6 mm
Rear Right	195/65R15	91V	Sumitomo	BC100	V	0928	6 mm
Spare	195/65R15	91V	Roadking	Radial	V	////////	1 mm

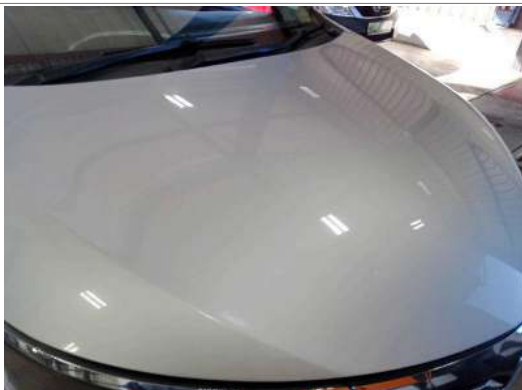
Damage	Repair Way
Engine Oil Sweat	Repair
Front Bumper Paintwork • Scratched	Repair
Bonnet Dented	Repair
C • Pillar Left Dented	Repair
Front Fender Right Paintwork • Runners / Teardrops	Repair
Door Front Left Paintwork • Runners / Teardrops	Repair
Door Rear Left Paintwork • Runners / Teardrops	Repair
Rear bumper Paintwork • Scratched	Repair
Sill Panel Right Paintwork • Runners / Teardrops	Repair
Roof Dented	Repair
Gearbox Oil Sweat	Repair
CV Joint(s) Boot(s) Front Right (inner/outer) Damaged	Replace
Gear Selections Malfunction	Repair
