MFC Auction House  
M57 Pretoria Rd, Glenmarais, KEMPTON PARK  
Gauteng

| Manufacturer | TOYOTA | Registration Number | HT43VDGP |

## CONDITION REPORT

Report No: 2016739385

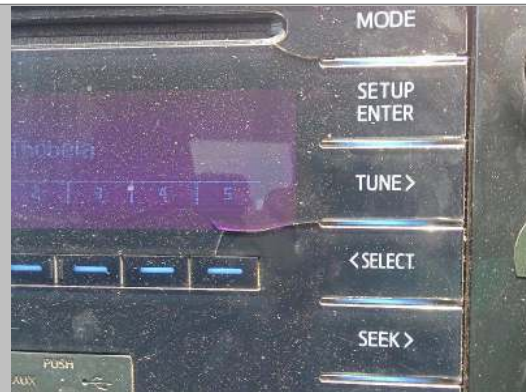
| | Damage | Repair Way |
|---|---|---|
| | Radio/CD/USB Damaged | Repair |

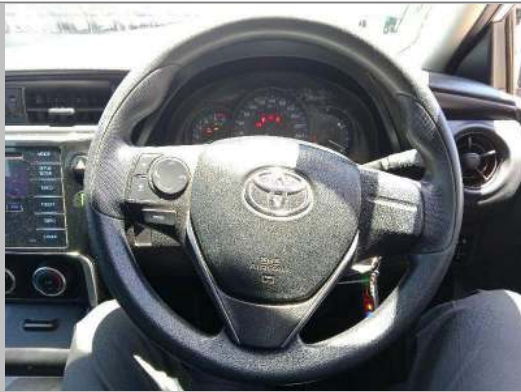
| | Damage | Repair Way |
|---|---|---|
| | Steering Wheel Trim Defective | Repair |

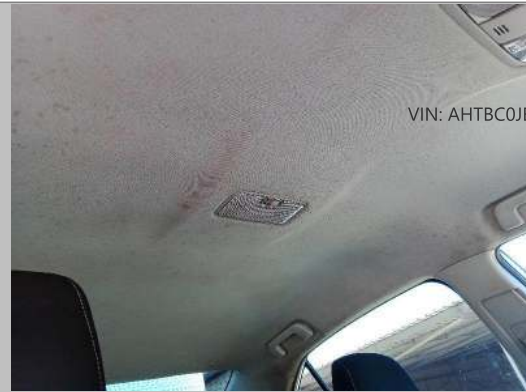
| | Damage | Repair Way |
|---|---|---|
| | Hood Lining Dirty | Repair |

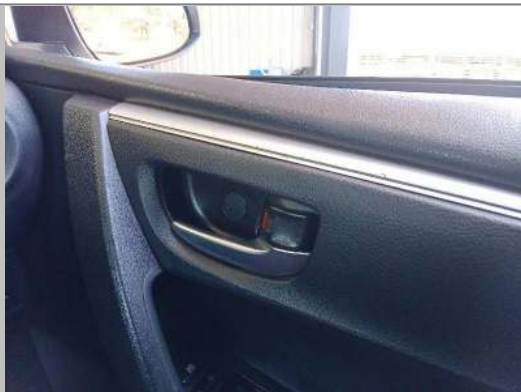
| | Damage | Repair Way |
|---|---|---|
| | Door Handle Front Right Damaged | Replace |

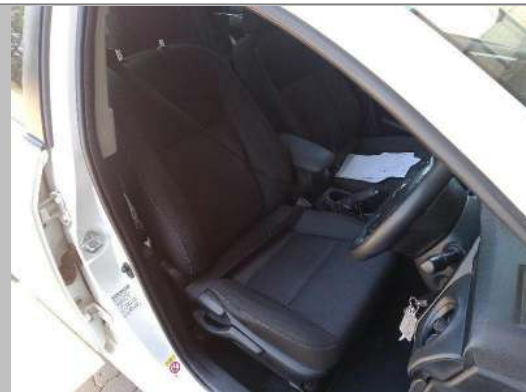
| | Damage | Repair Way |
|---|---|---|
| | Seat Front Right Damaged | Repair |

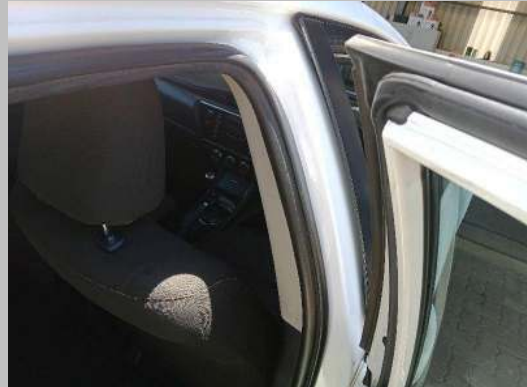
| | Damage | Repair Way |
|---|---|---|
| | B • Pillar Right Dented | Repair |

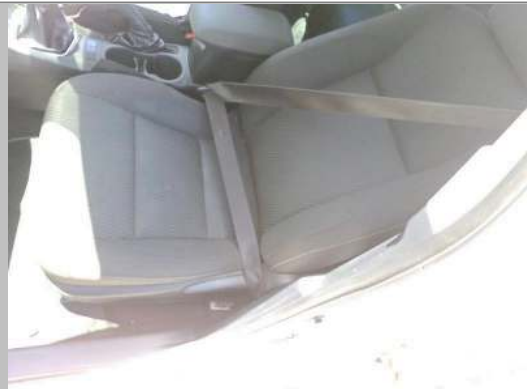
| | Damage | Repair Way |
|---|---|---|
| | Seat Front Left Defective | Repair |

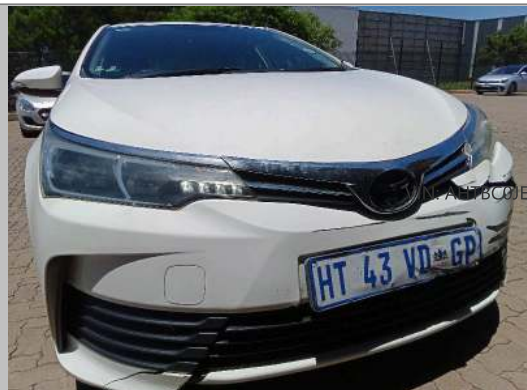
| | Damage | Repair Way |
|---|---|---|
| | Front Bumper Damaged | Replace |

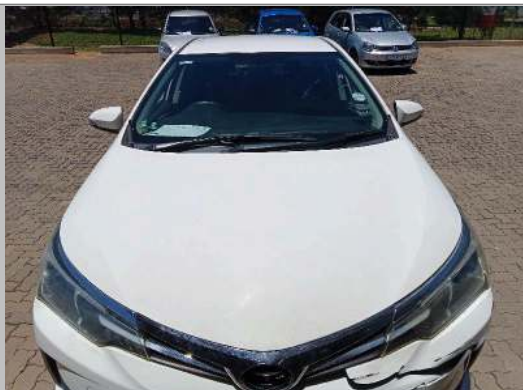
| | Damage | Repair Way |
|---|---|---|
| | Bonnet Damaged | Repair |

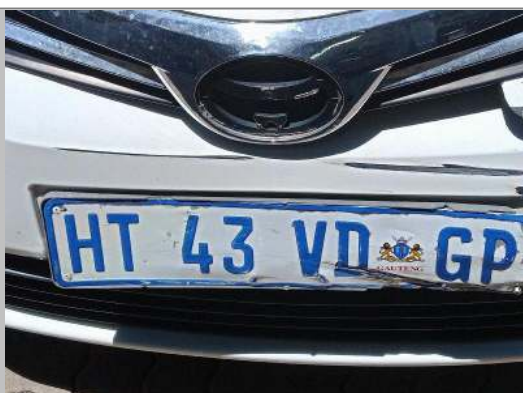
| | Damage | Repair Way |
|---|---|---|
| | Number Plate Front Damaged | Replace |

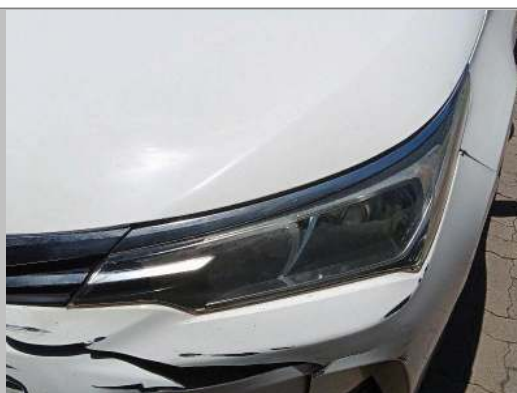
| | Damage | Repair Way |
|---|---|---|
| | Headlight Left Damaged | Replace |

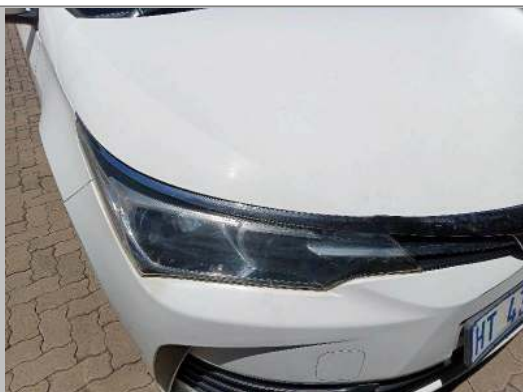
| | Damage | Repair Way |
|---|---|---|
| | Headlight Right Damaged | Replace |

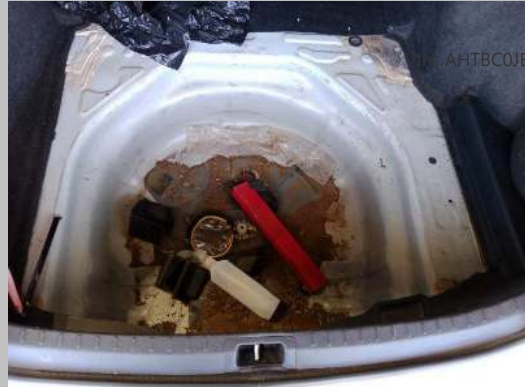
| Damage | Repair Way |
|---|---|
| Inner Boot Floor Pan and Spare Wheel Well Damaged | Repair |

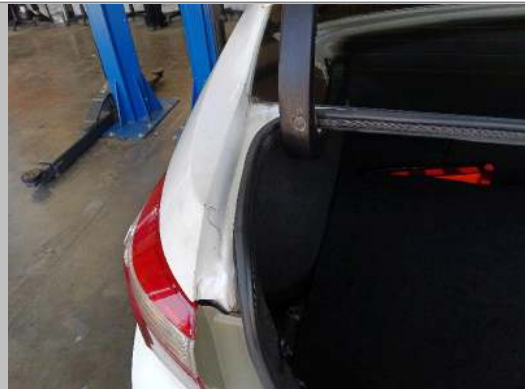
| | Damage | Repair Way |
|---|---|---|
| | C • Pillar Left Residual Traces of Repair | Repair |

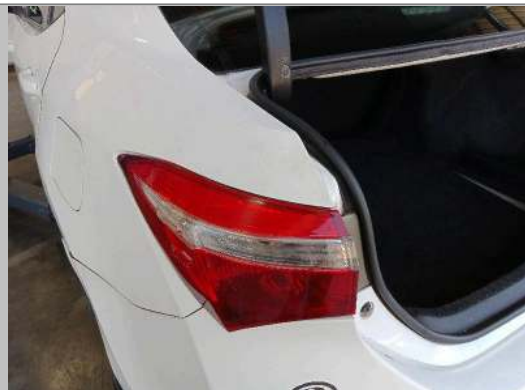
| | Damage | Repair Way |
|---|---|---|
| | Tail Light Left Damaged | Replace |

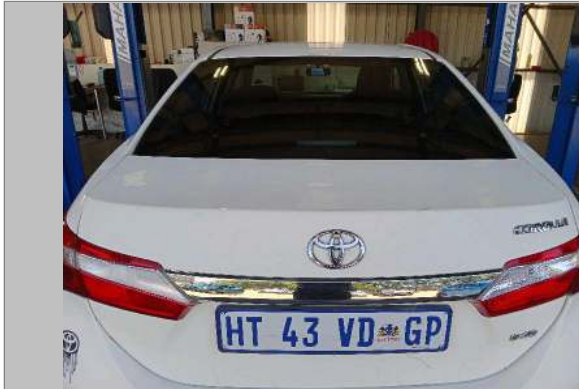
| Damage | Repair Way |
|---|---|
| Boot Lid / Hatch door Residual Traces of Repair | Repair |

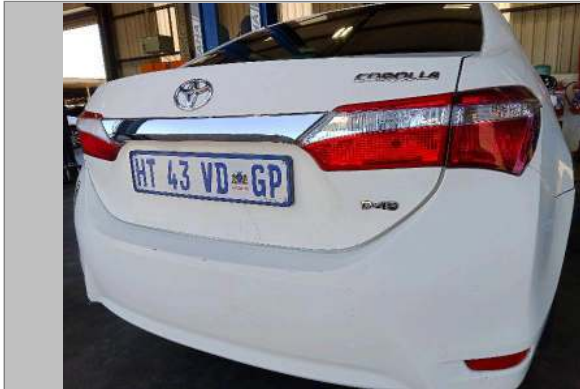
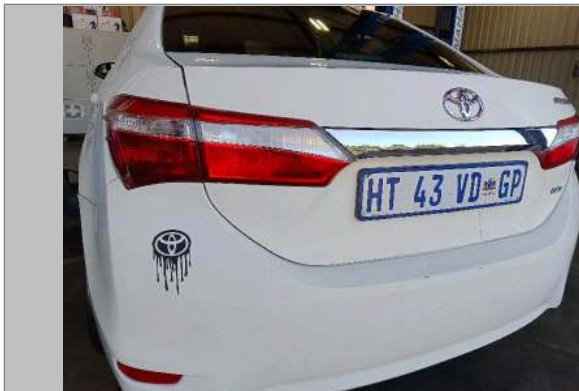
| Damage | Repair Way |
|---|---|
| Rear bumper Damaged | Repair |
| Body and Exterior | Signs of impact damage to rear of vehicle. |

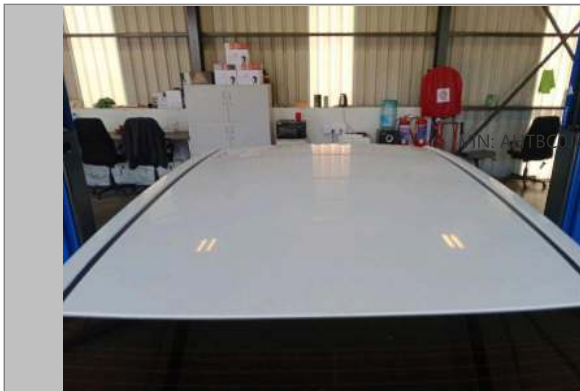
| Damage | Repair Way |
|---|---|
| Roof Damaged | Repair |

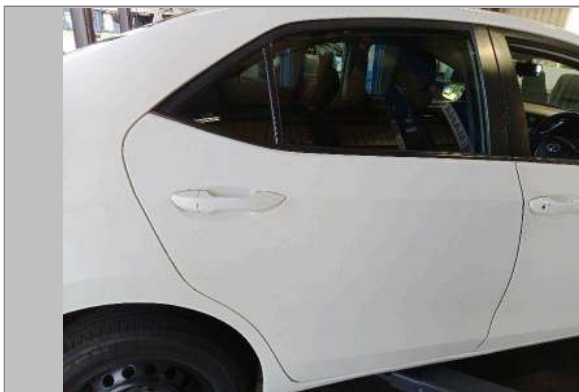
| Damage | Repair Way |
|---|---|
| Door Rear Right Residual Traces of Repair | Repair |

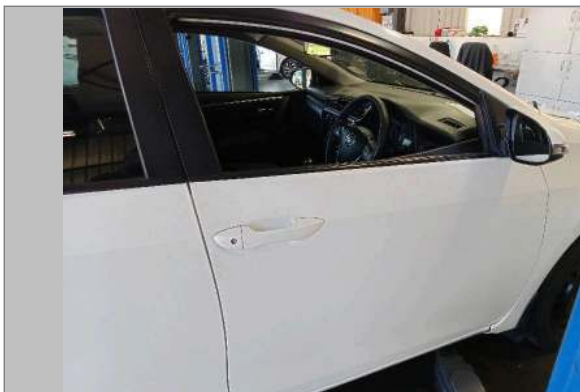
| Damage | Repair Way |
|---|---|
| Door Front Right Paintwork • Dull | Repair |

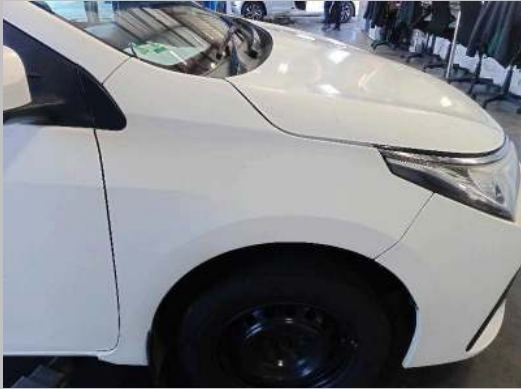
| Damage | Repair Way |
|---|---|
| Front Fender Right Residual Traces of Repair | Repair |

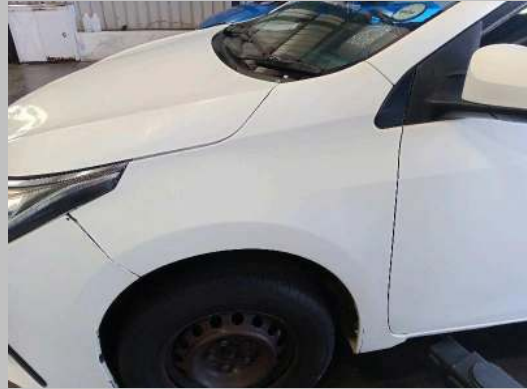
| Damage | Repair Way |
|---|---|
| Front Fender Left Damaged | Repair |

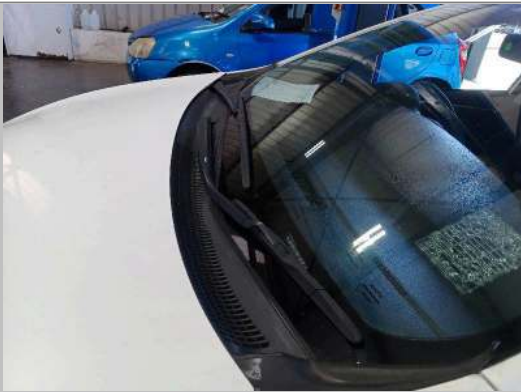
| | Damage | Repair Way |
|---|---|---|
| | Windscreen Wiper Damaged | Replace |

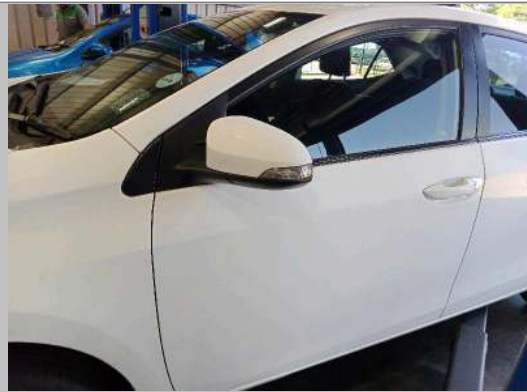
| Damage | Repair Way |
|---|---|
| Door Front Left Paintwork • Dull | Repair |

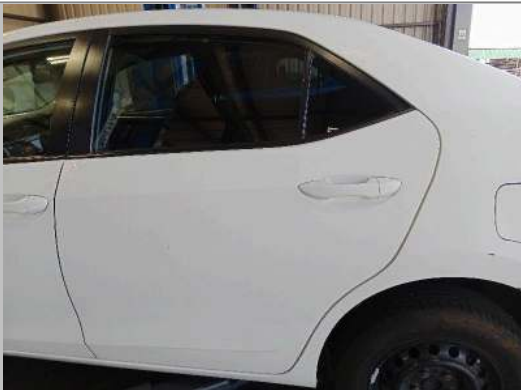
| Damage | Repair Way |
|---|---|
| Door Rear Left Damaged | Repair |

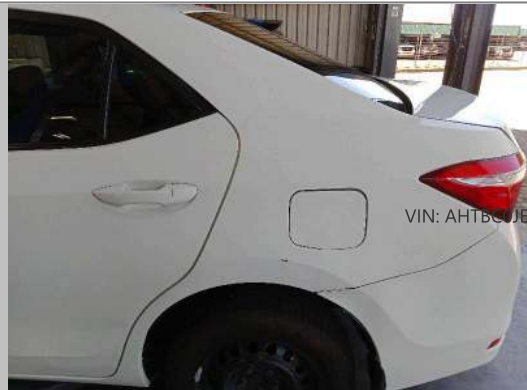
| Damage | Repair Way |
|---|---|
| Rear Fender Left Damaged | Repair |

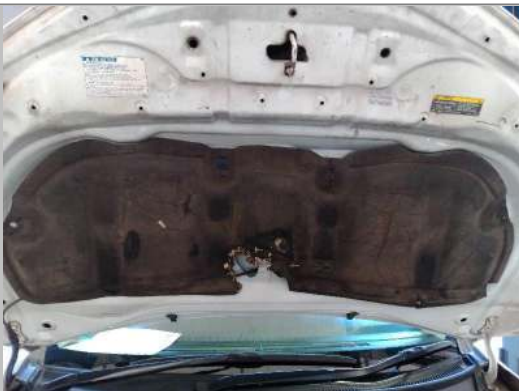
| | Damage | Repair Way |
|---|---|---|
| | Under bonnet insulation cover Damaged | Replace |

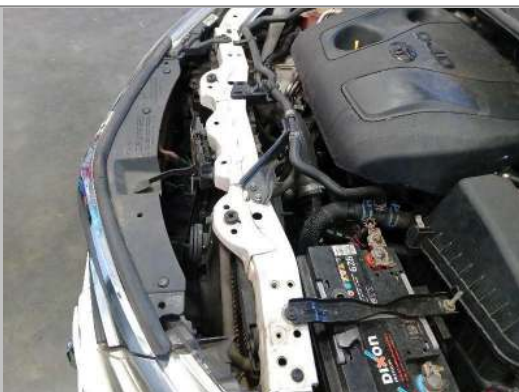
| | Damage | Repair Way |
|---|---|---|
| | Bonnet slam plate (Shock tower/ Inner tray) Damaged | Repair |

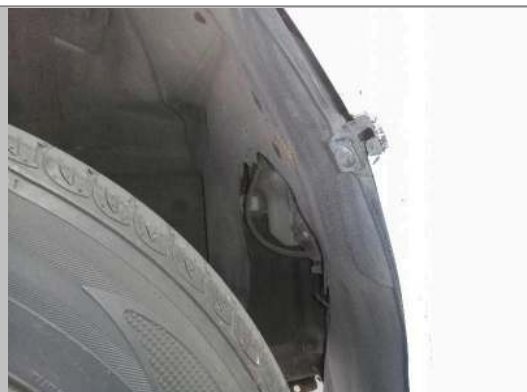
| Damage | Repair Way |
|---|---|
| Front Fender Right / Inner Tray Damaged | Replace |

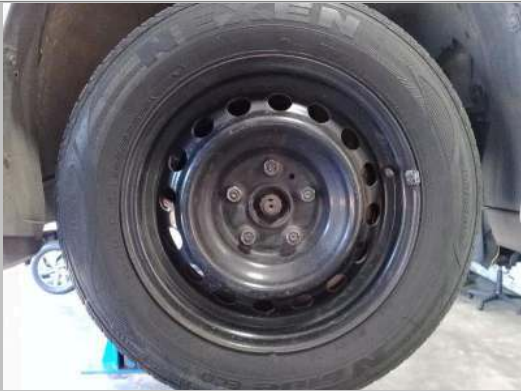
| Damage | Repair Way |
|---|---|
| Rim Front Right Dented | Repair |

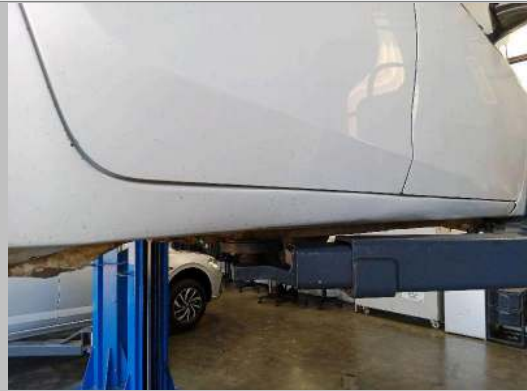
| Damage | Repair Way |
|---|---|
| Sill Panel Right Welded | Repair |

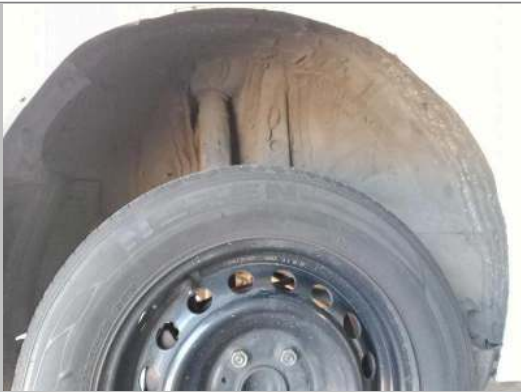
| Damage | Repair Way |
|---|---|
| Rear Fender Right / Inner Tray Welded | Repair |

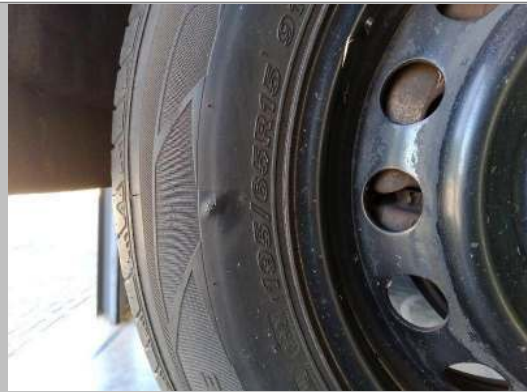
| Damage | Repair Way |
|---|---|
| Tyre Rear Right Defective | Replace |

| | Size | Load/Speed Index | Manufacture | Model | Type* | Production Date | Tread Depth (mm) |
|---|---|---|---|---|---|---|---|
| Rear Right | 195/65 R15 | 91V | Nexen | Nblue | V | 2921 | 1 mm |

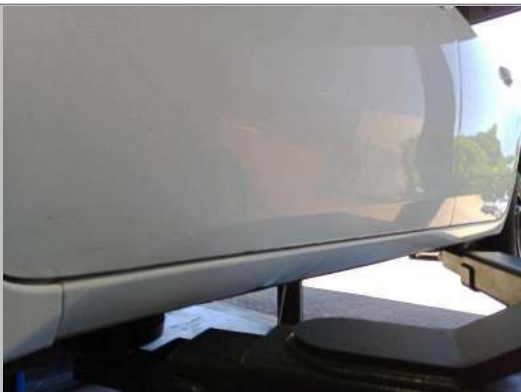
| Damage | Repair Way |
|---|---|
| Sill Panel Left Dented | Repair |

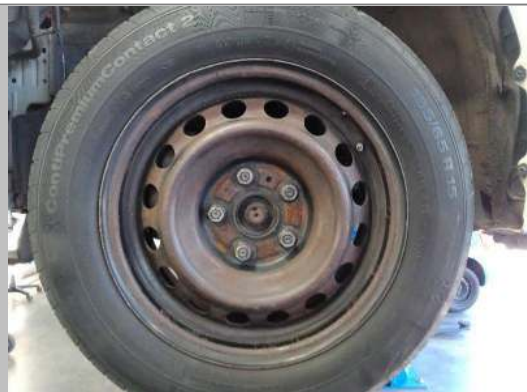
| Damage | Repair Way |
|---|---|
| Rim Front Left Dented | Repair |

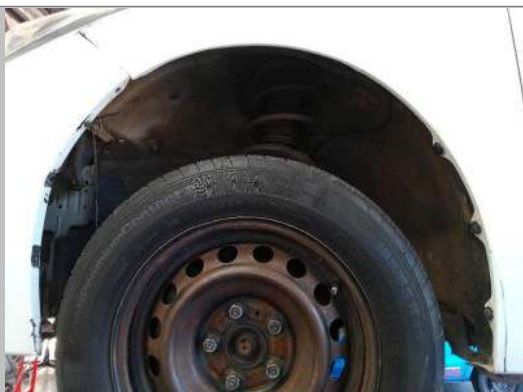
| Damage | Repair Way |
|---|---|
| Front Fender Left / Inner Tray Defective | Repair |

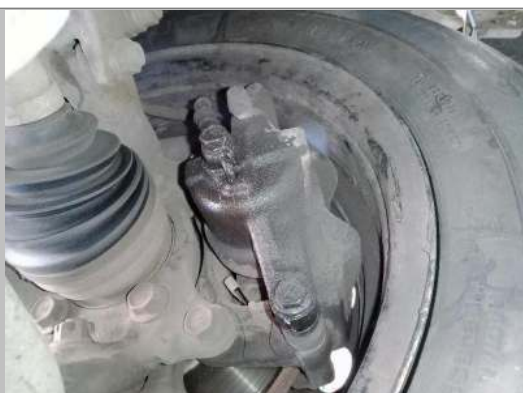
| Damage | Repair Way |
|---|---|
| Caliper 1. Axle left Leak | Repair |

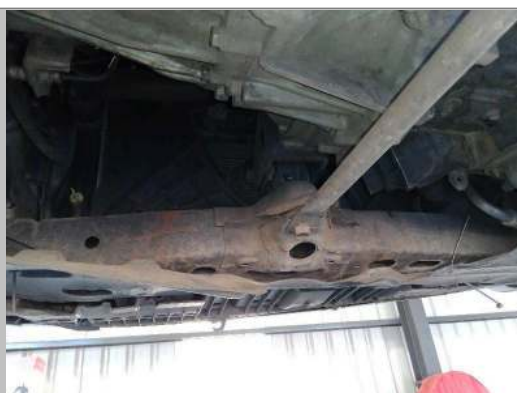
| Damage | Repair Way |
|---|---|
| Radiator Cradle Damaged | Repair |

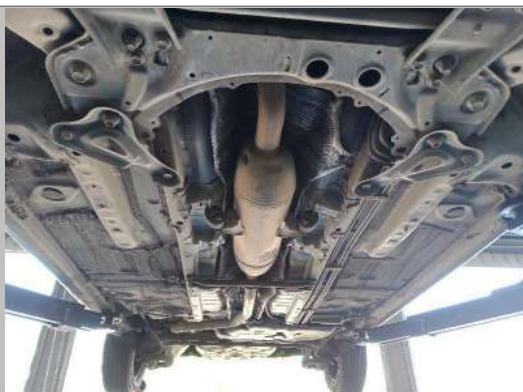
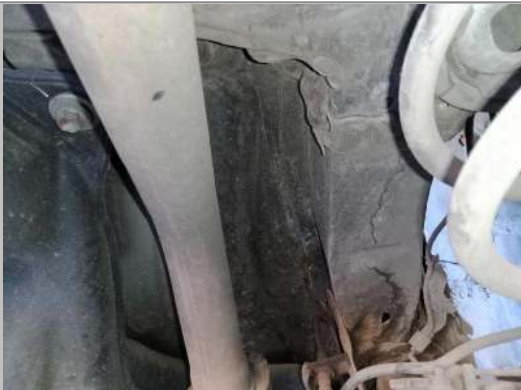
| Damage | Repair Way |
|---|---|
| Chassis Damaged | Repair |

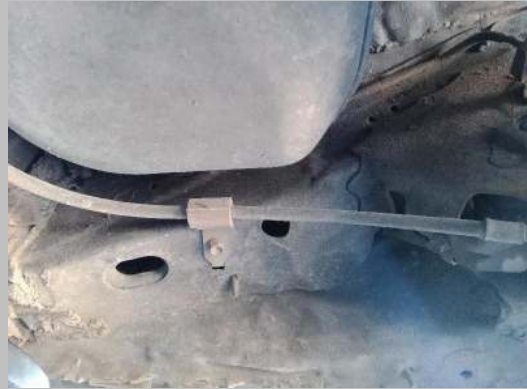
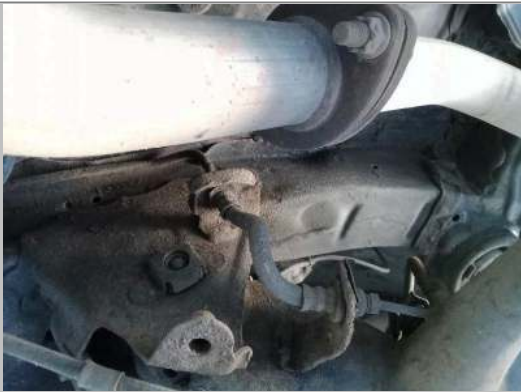
| Damage | Repair Way |
|---|---|
| Main Beam Right Damaged | Repair |

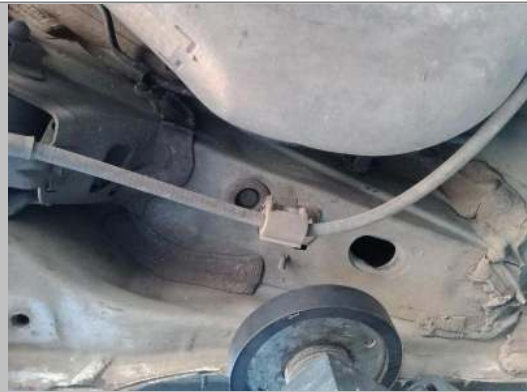
| Damage | Repair Way |
|---|---|
| Main Beam Left Damaged | Repair |
| Body and Exterior | Vehicle is a cut and joint on rear left main beam |

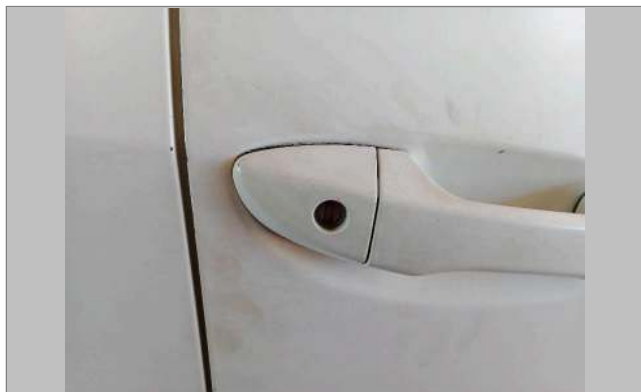
| | Damage | Repair Way |
|---|---|---|
| | Door Lock Front Right Damaged | Replace |
